**STATE OF VERMONT  
AGENCY OF TRANSPORTATION**

**Scoping Report  
FOR  
Worcester BF 0241(57)**

**VT ROUTE 12, BRIDGE 89 OVER NORTH BROOK**

July 31, 2020

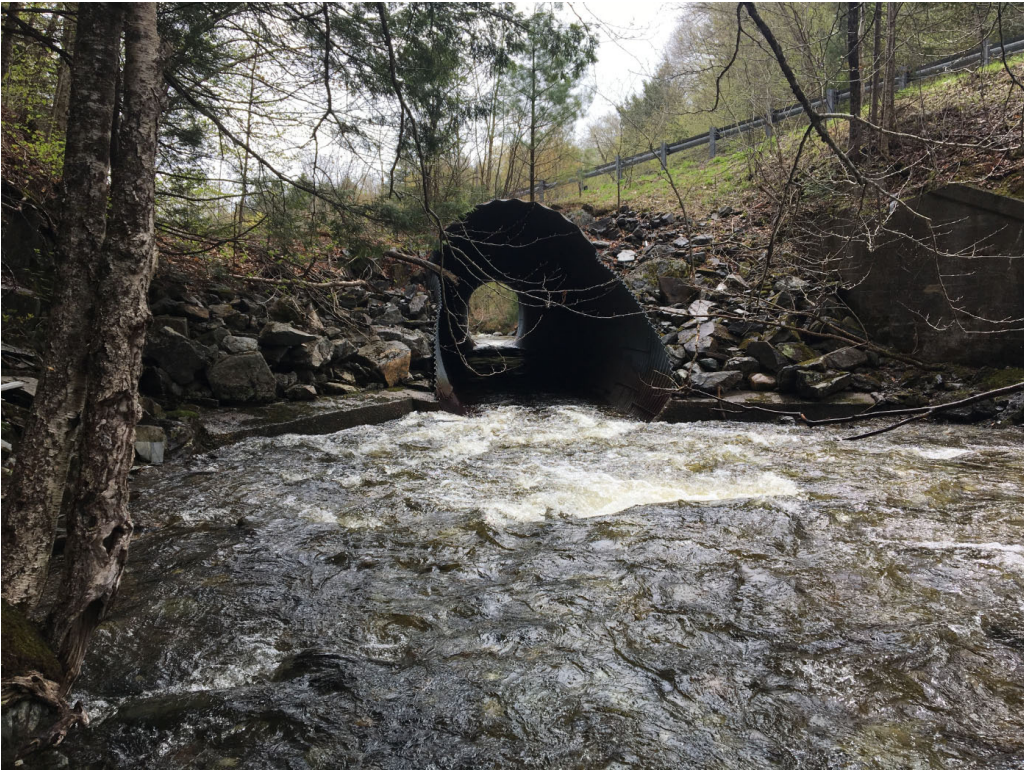
Picture 3: Culvert Inlet

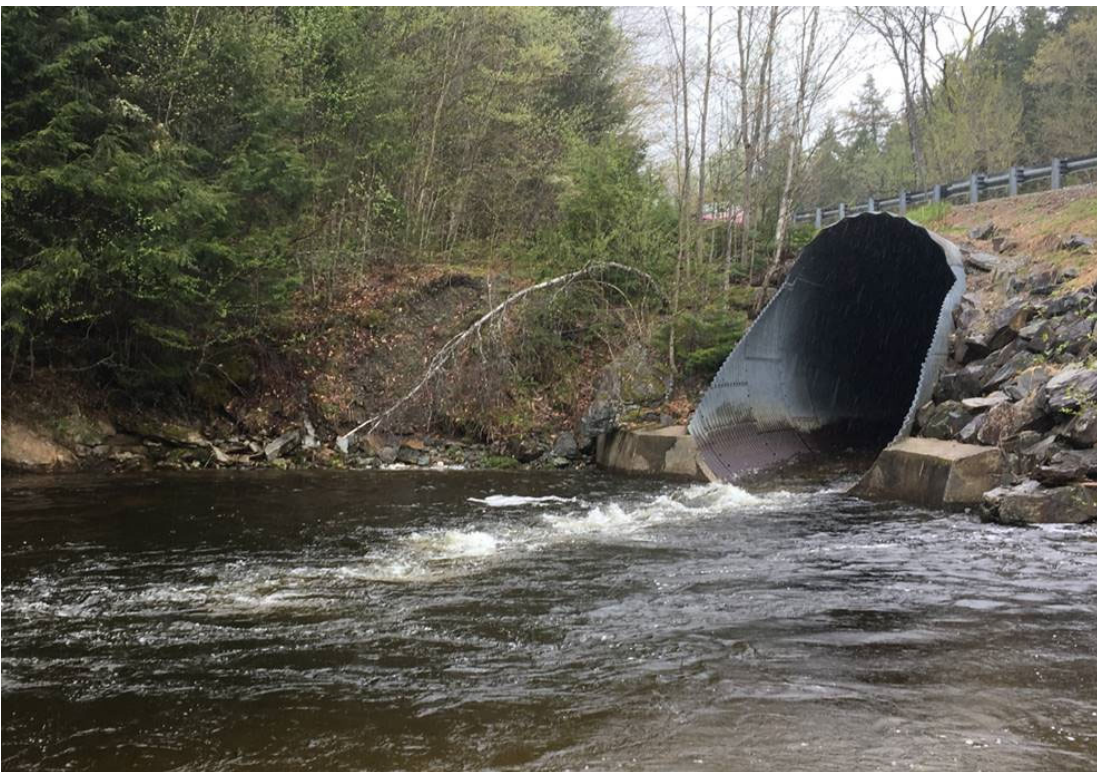
1. The culvert is in fair condition. The invert has some holes and undermining has started at the outlet.
2. The existing culvert does not meet the calculated or measured bank full width.

Picture 4: Culvert Outlet

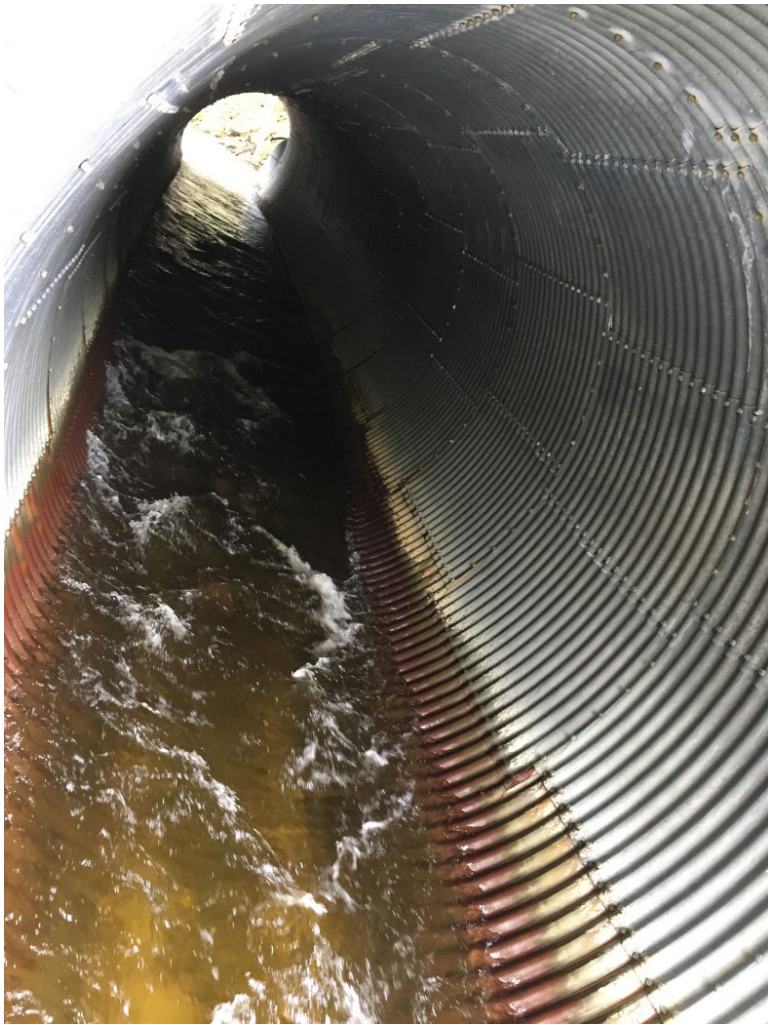
11/23/2016 – The invert has some holes and undermining has started at the outlet. This culvert is large and would be costly to replace when a new invert would give the structure years of service.  
 ~JAS

While the culvert is in fair condition with no distortion, the invert is deteriorated along approximately half the length of the culvert. An invert repair would extend the life of the culvert approximately 20 more years, however the substandard bankfull width and wildlife crossing potential would not be addressed with an invert repair. The existing culvert is 55 years old and has reached the end of its anticipated design life, and replacement with a hydraulically adequate structure is recommended.

Picture 4: Culvert Barrel

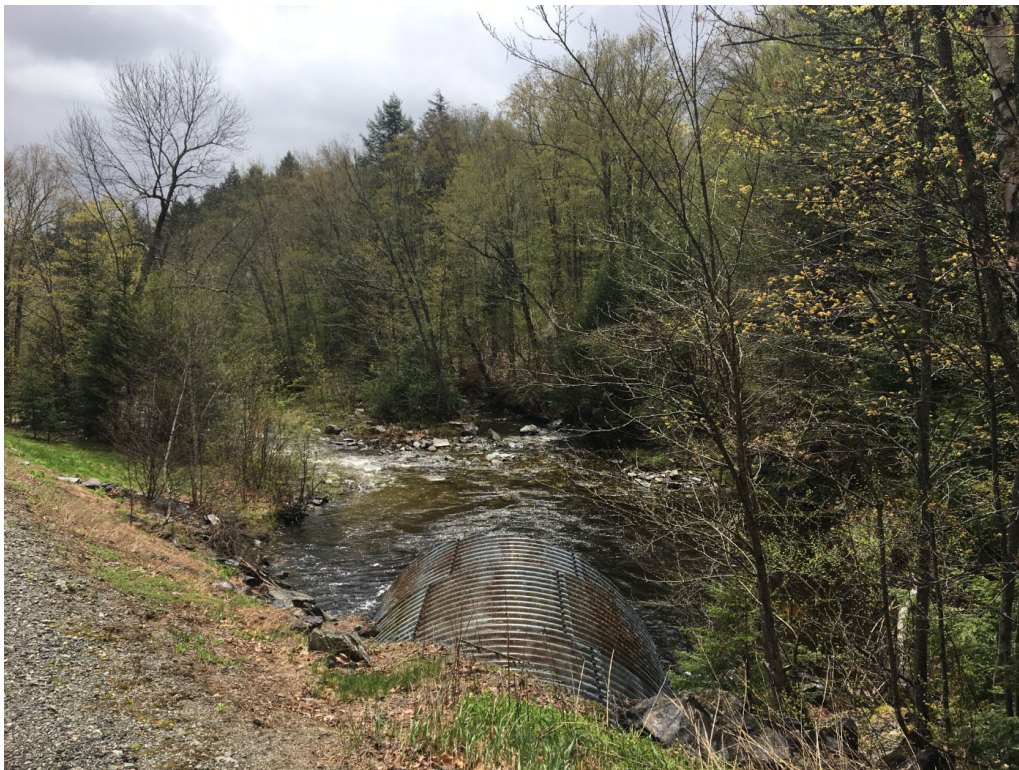
Picture 5: Looking Downstream (Note Scour Pool)

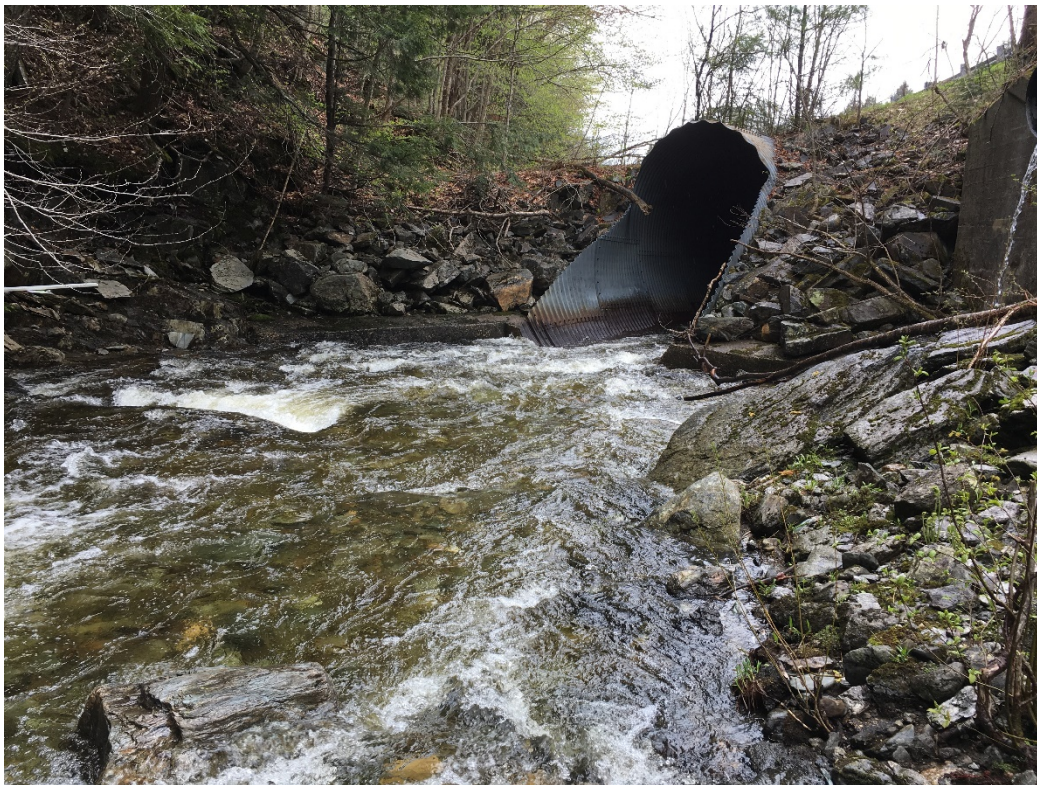
**Figure 3.1:** *Exposed bedrock in the area of the inlet. [Structures photo dated April 2019]*

There is visible bedrock on both the inlet and outlet ends of the existing culvert. Borings should be taken at the project site, to verify the in-situ conditions. The substructure would likely be reinforced concrete abutments on spread footings. The preliminary geotechnical report can be found in Appendix E for additional information.

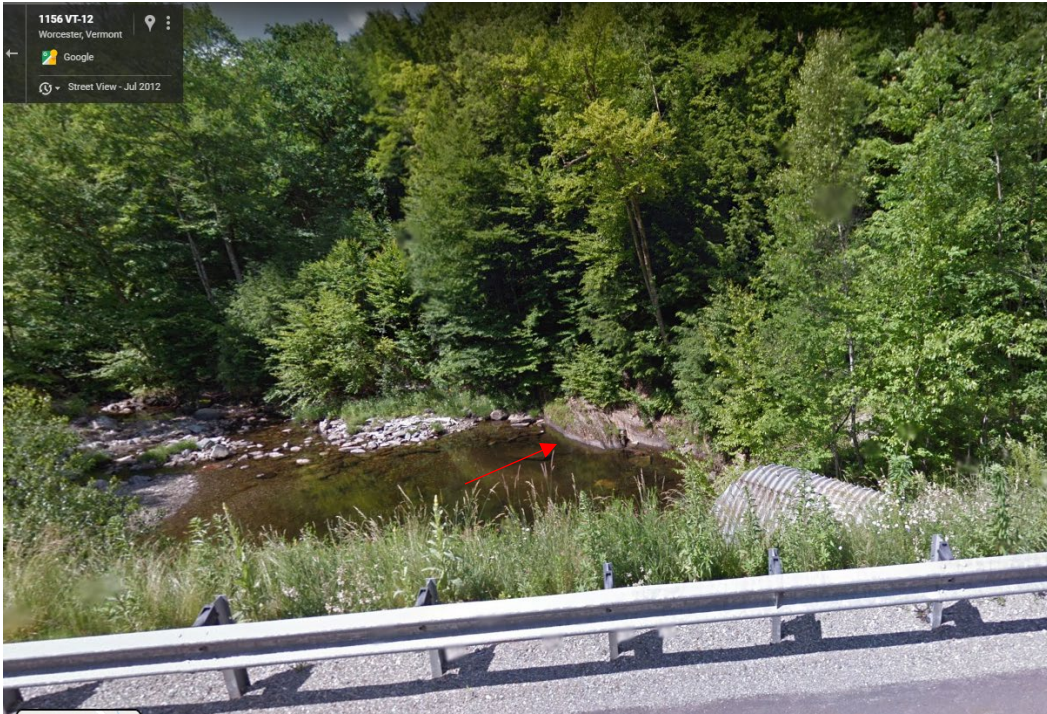
**Figure 3.2:** *Bedrock in the area of the outlet. [Google Earth image July 2012]*

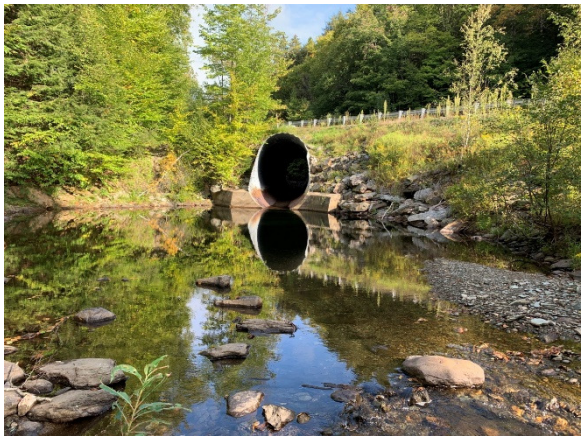
<p>Scour pool downstream of culvert</p>
