Town: 206 - SPRINGFIELD

District 2, 27 - WINDSOR County

IDENTIFICATION	
(1) State Names	50 - Vermont
(8) Structure Number	200091025N14182
(5) Inventory Route	1
(2) Highway Agency District	2 - District 2
(3) County Code	27 - WINDSOR

Team Lead: Stephen Piro, Inspection Date: 05/24/2022

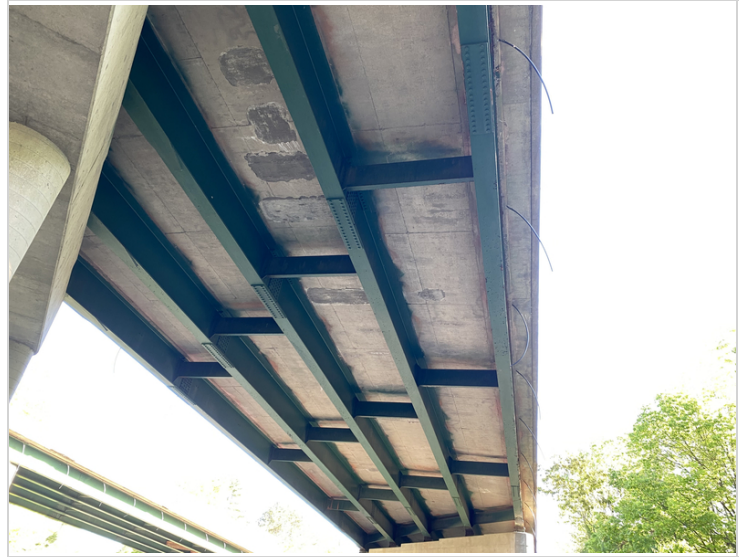
Five (5) painted continuous steel rolled beams are in satisfactory condition with cover plates present over both piers. Beam ends have minor to moderate rust scaling and pitting where joint leakage has initiated steel corrosion. Paint distress is present below joint areas with minor to moderate paint distress such as peeling and flaking. Superstructure is also grease coated over both abutments below both joints. Other light various areas along webs and flanges with paint starting to bubble, flake and peel. Fascia beams have light paint failure along the lower portions of webs and flanges with surface rusting and minor rust scaling occurring.

Span #2 Superstructure

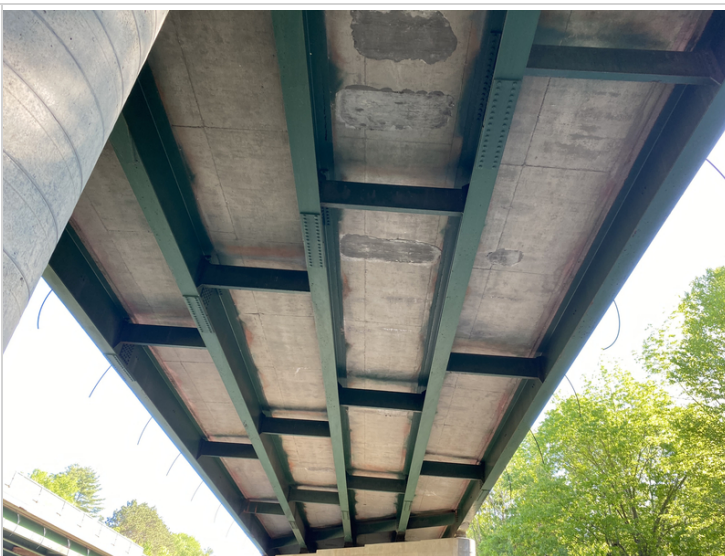
Reinforced concrete deck is in okay condition having multiple areas of concrete patches scattered throughout the bays and spans. Other various light transverse cracking with light efflorescence leakage is present throughout the deck.

Span #2 Deck

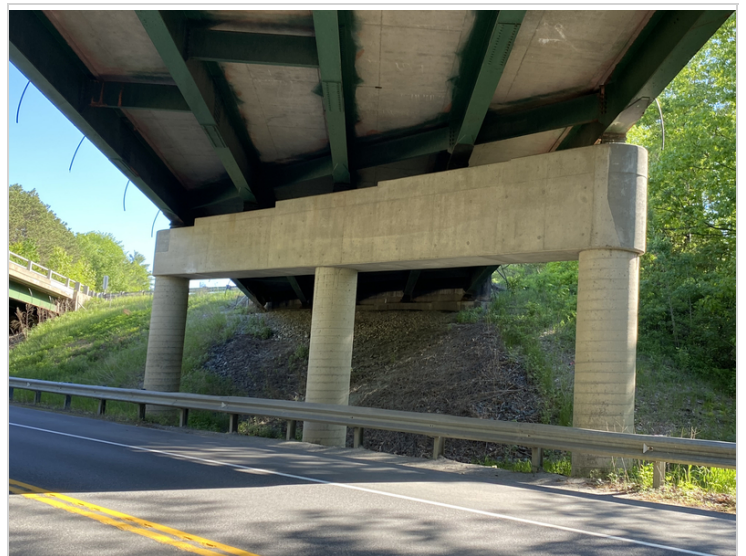
Concrete pier caps are in fairly good condition with having some previous concrete patches along the eastern side of pier #1 and both ends of pier #2

Pier #2 Span #2

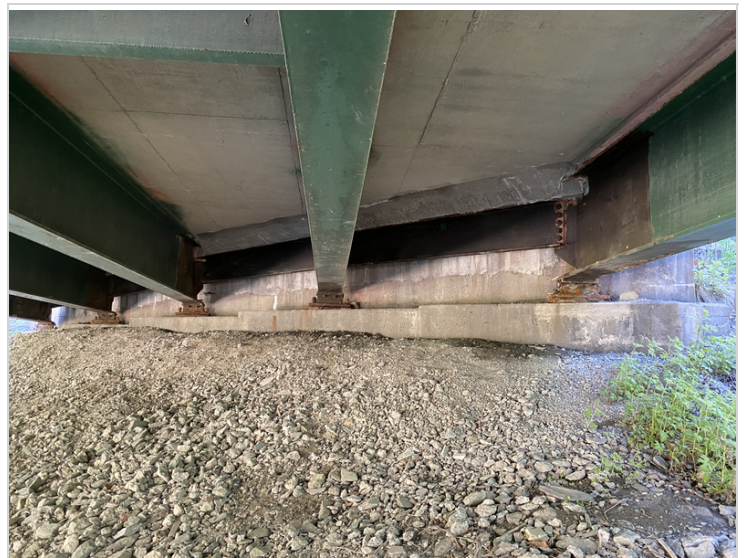
Abutment #2 is in satisfactory condition with some lightly saturated concrete with debris build up and some various staining along the outer edges. Scattered areas of rust staining and some various cracking are present along the stem and bridge seat scattered throughout.

Abutment #2

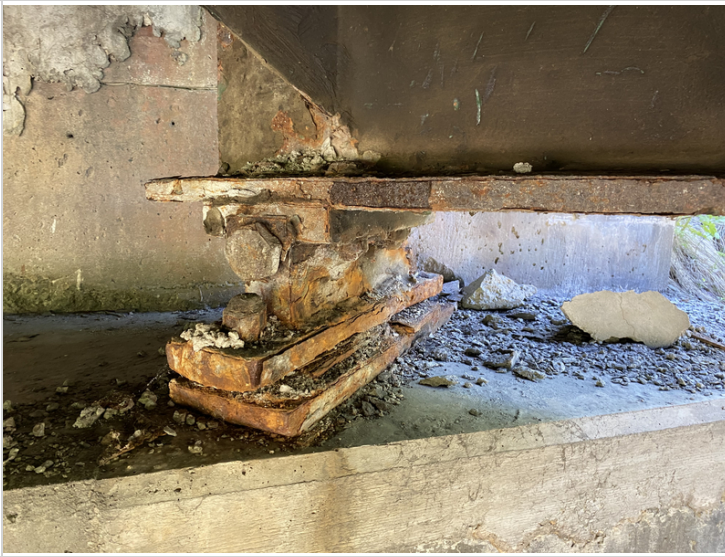
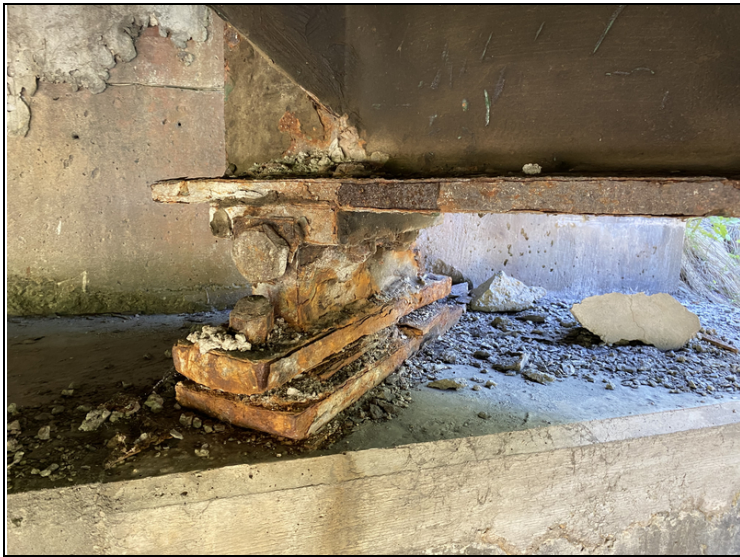
Rocker bearings are present over both abutments and pier #1 are in fair condition with areas of minor to moderate rust scaling and pitting present. Fascia bearings and bearings below joint areas have heavier corrosion. Pier #2 has fixed rocker bearings having minor rusting. Anchor bolt is missing in bearing #5 over abutment #1. Bearing #1 over abutment #2 has moderate to heavy debris build up around bearing area.

Bearing #5 at Abutment #2

Movable bearings at both abutments have minor to moderate rust scaling forming and light pitting present with no protective coating and continue to have corrosion progress. Bearings should be cleaned and painted or fully replaced.

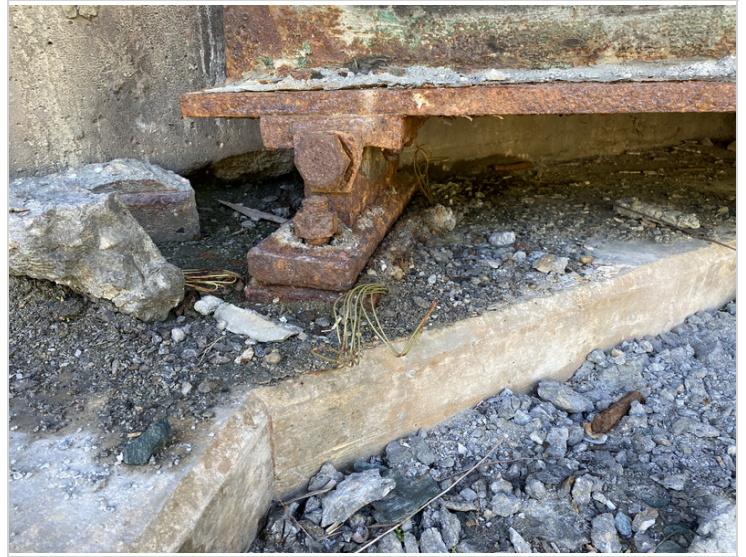
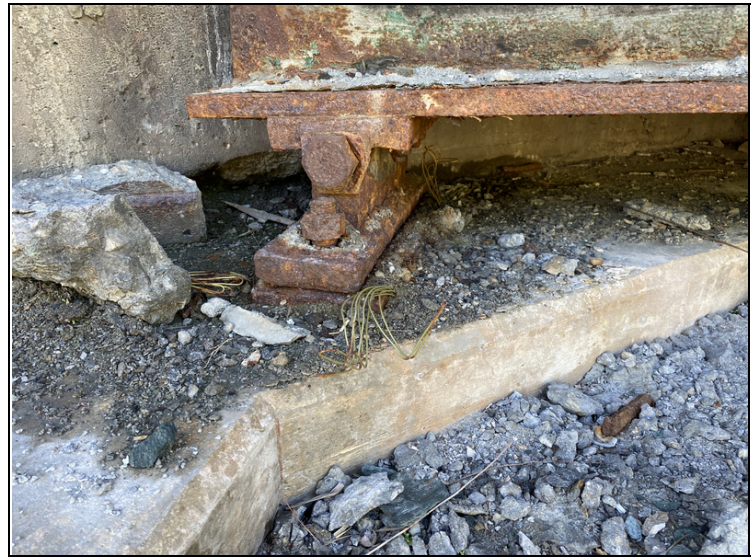
Bearing #1 at Abutment #2

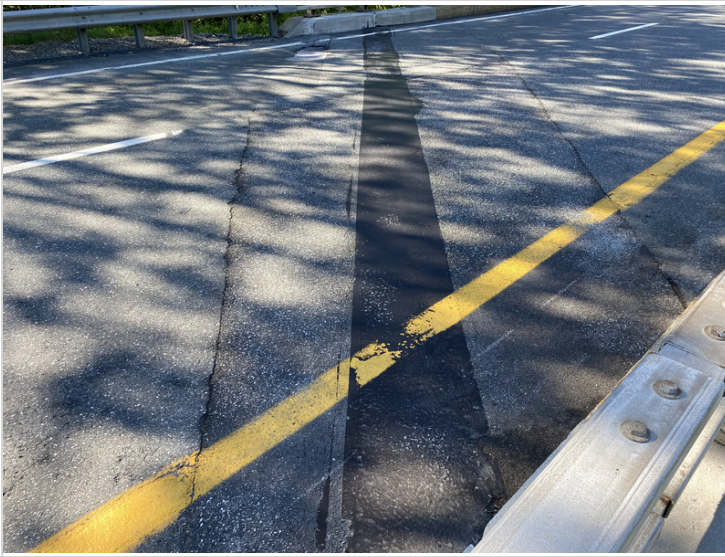
Asphaltic plug joints are present at both ends of structure with recent joint elimination / rehabilitation project having minor wearing in the travel lanes and some various cracking starting to form.

Asphaltic Plug Joint over Abutment #2

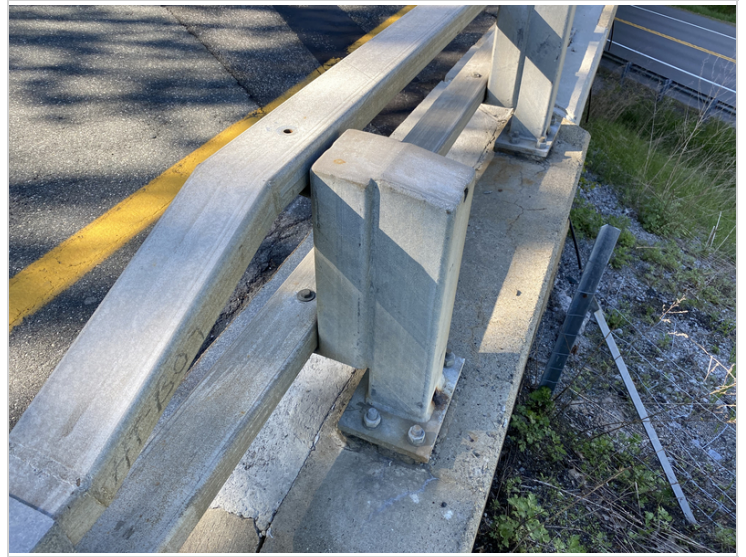
Galvanized two (2) tier box beam rail is in satisfactory condition having some minor scrapes and dents with some light surface rusting around scrapes. Connections in the top section of rail at posts #12 and #13 away from abutment #1 on the western side is missing the connection bolts. First post along the West side away from the abutment #2 end is also missing the top tier connection bolt.

Missing Connection Bolt on Top Tier of Rail at Post #1 away from Abutment #2 on West Side

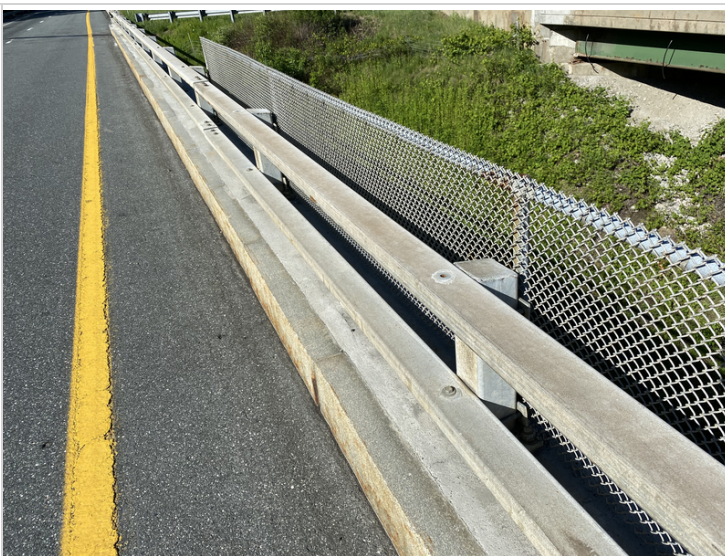
Missing Connection Bolts on Top Tier of Rail at Post #12 and #13 away from Abutment #1 on West Side

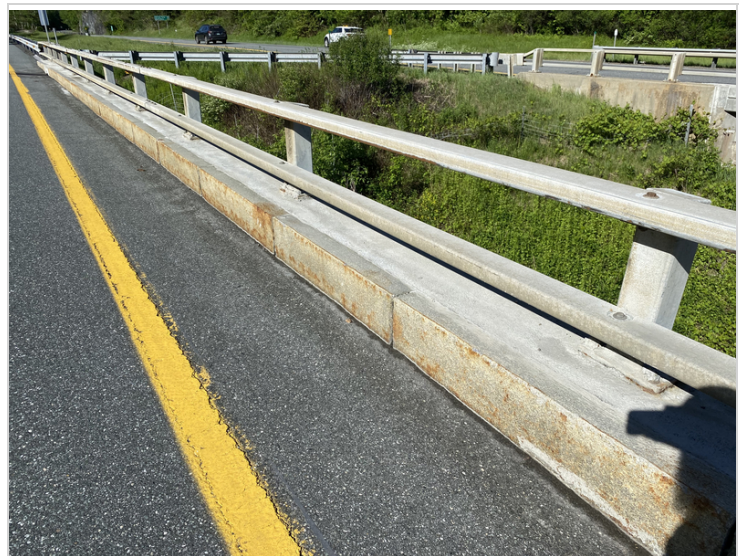
Concrete curbing with granite block facing is in satisfactory condition having recent concrete patches present along the top surface of curbing behind the granite blocks. Small areas of scaling behind granite blocks still exist along the top surface of curbs.

Western Repaired Curb / and Bridge Rail

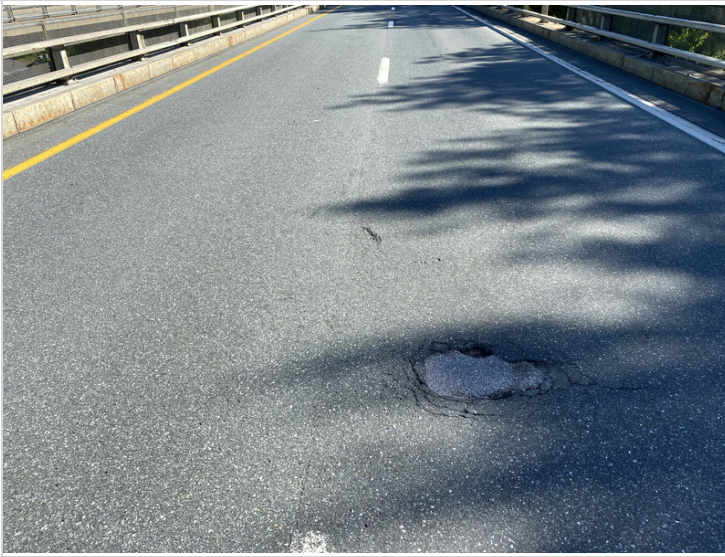
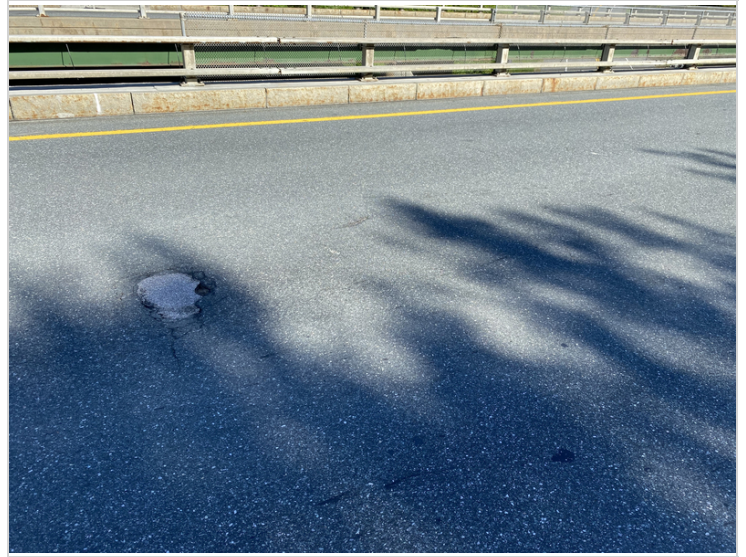
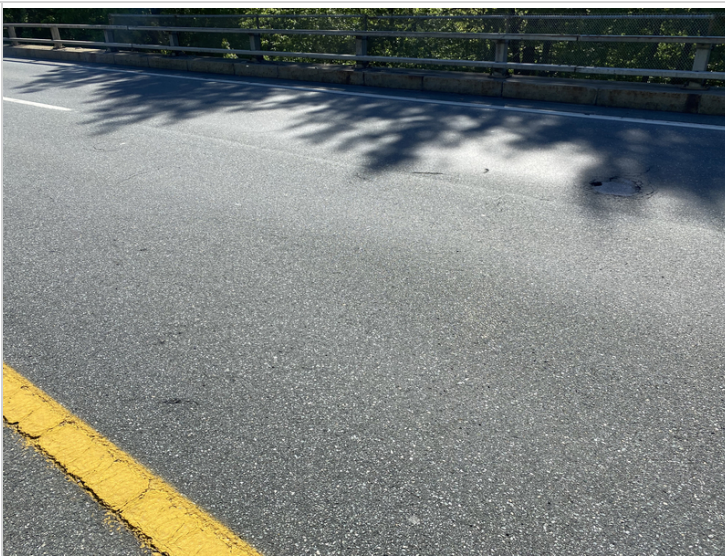
Asphalt is in satisfactory condition with some light wearing on deck in the travel lanes. Small pothole has formed near the southern end of span #2 in the main travel lane with other various cracking and depressions forming in nearby area in both travel lanes.

Pothole in Main Travel Lane with other Depression
Nearby near South End of Span #2

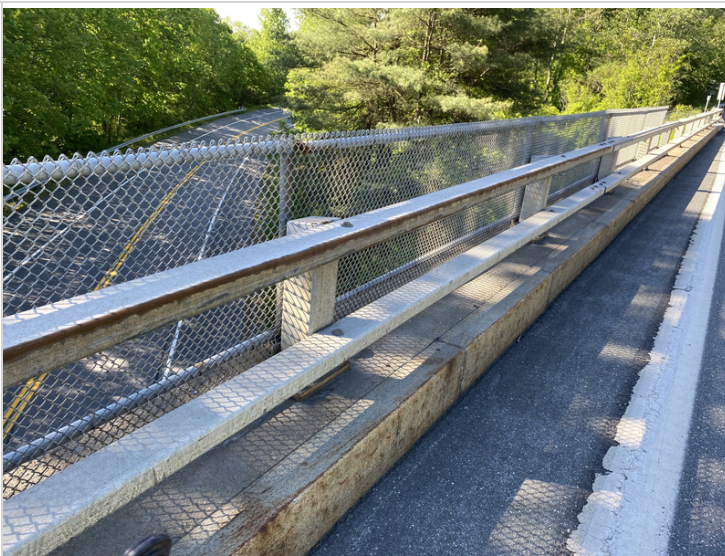
Bridge Rail Scraping / Dents on Eastern Side

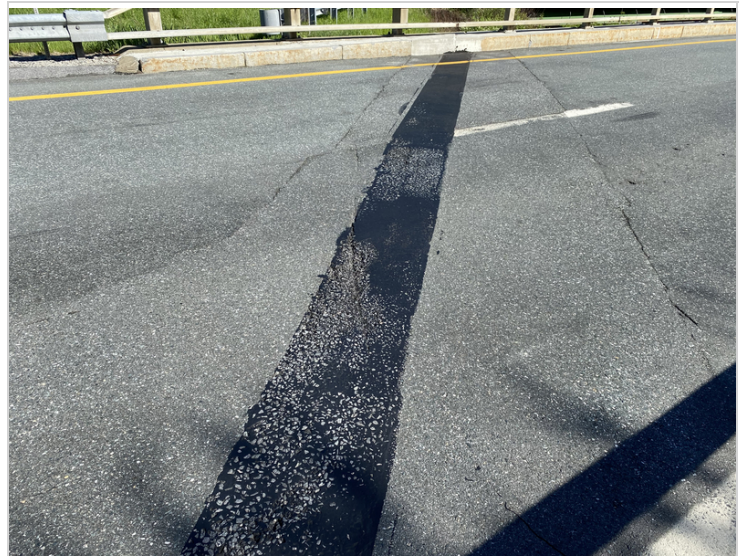
Asphaltic Plug Joint over Abutment #1

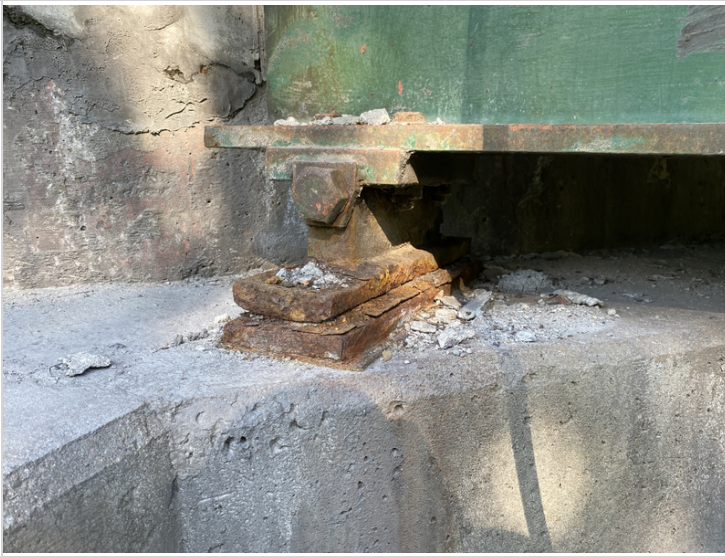
Bearing #5

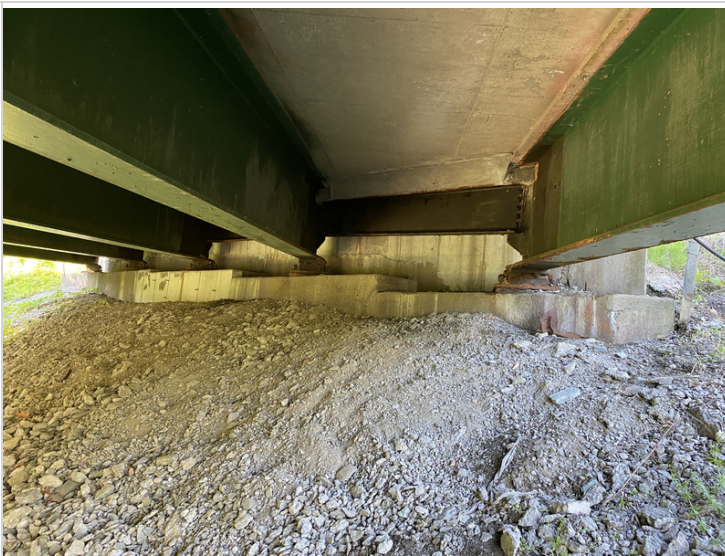
Abutment #1 is in satisfactory condition with some areas of lightly saturated concrete with rust staining and efflorescence leakage along the outer portions. Minor debris build up and small pockets of spalling are present along the bridge seat near bearing #1. Small rust stains and various cracking are present along the upper portions of stem and bridge seat are present.

Abutment #1

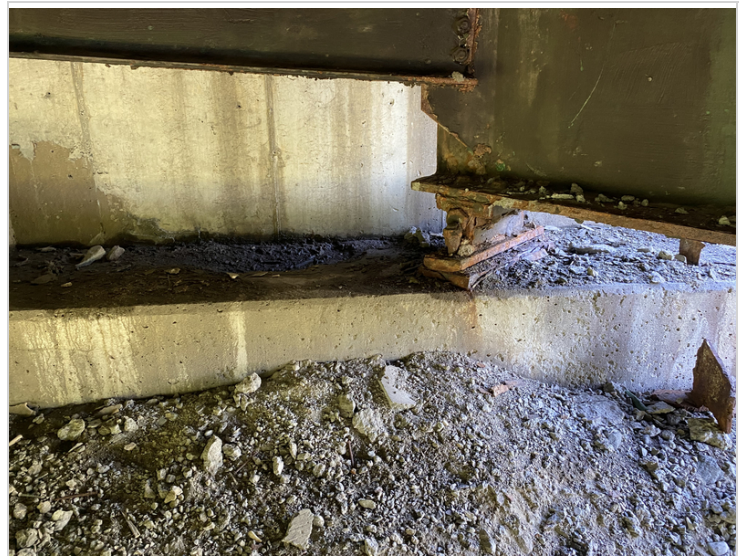
Abutment #1 West End / Bearing #1 / Bridge Seat Spalling

Structure has had a recent small rehabilitation project which consisted of cleaning / patching of concrete curbs along with joint elimination at both ends of structure along with associated cleaning / patching along abutment stems / backwalls. Concrete curbing still has some small areas of concrete deterioration along the top surface of curbs behind the granite blocks that could be cleaned and patched. Bearings should be replaced at both abutments or rehabbed with having rust scaling cleaned, repainted and reset to allow for proper structure expansion with missing anchor bolts replaced. Bearing #5 at abutment #1 is missing anchor bolts in sole plate. Abutment #1 has small spalled area along the bridge seat on the West end that should be cleaned and patched.

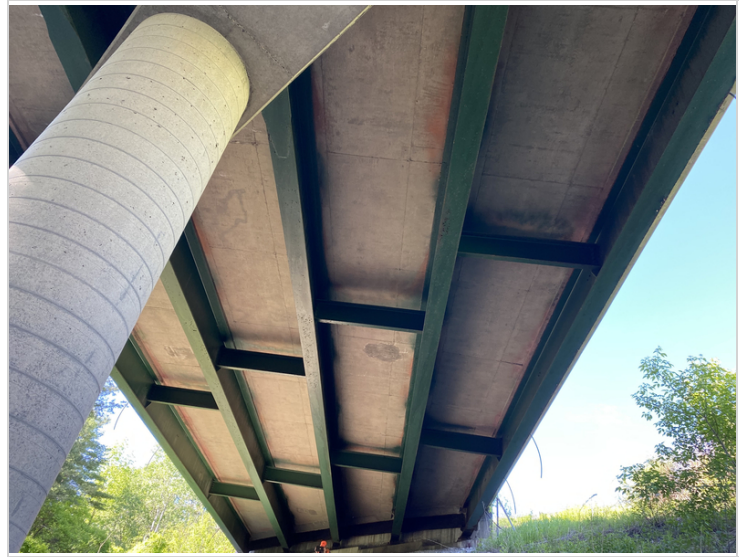
Concrete fascia is in satisfactory condition with light to minor cracking and some efflorescence leakage throughout. Heavier concrete scaling is present over both piers. Small spalls with rust staining are present along the soffit of both fascias with small delaminations forming and various cracking.

Span #1 Deck Soffit

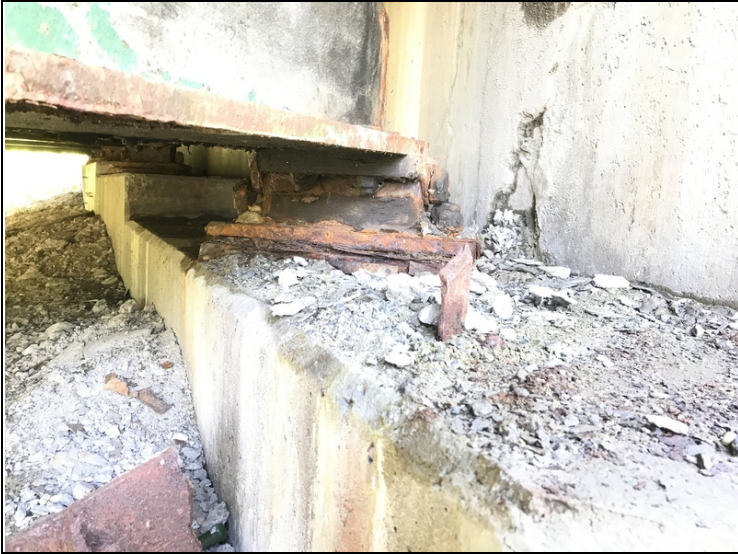
Bearing #1 at Abutment #1
