Town: 206 - SPRINGFIELD

(4) Place Code	69550
(6) Features Intersected	I 91 OVER US 5
(7) Facility Carried	I 00091 ML
(9) Location	0.8 MI S EXIT 7
(11) Mile Point	40.911 mi
(12) Base Highway Network	Yes

INSPECTIONS *			
(90) Inspection Date			05/24/2022
(91) Frequency			24
(92) Critical Feature Inspection	Done	Freq. (Mon)	Date
A: Fracture Critical Detail	No		
B: Underwater Inspection	No		
C: Other Special Inspection			
* The inspection date and frequency information in this box contains the current NBI date and frequency information. Please refer to the report header for the date this inspection was conducted.

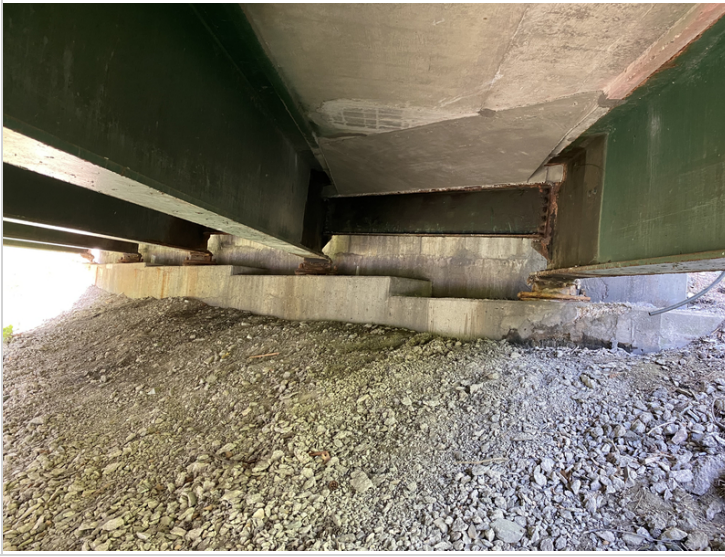
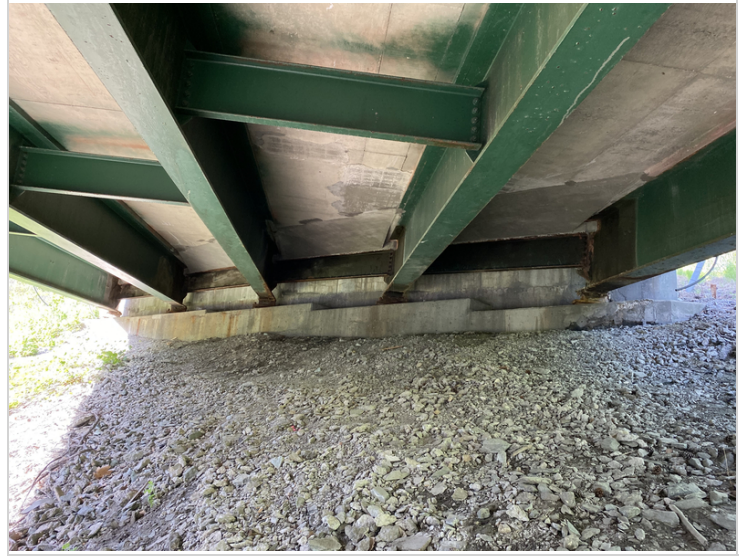
Abutment #1 is in satisfactory condition with some saturated concrete with rust staining and cracking along the outer edges. Recent concrete patches are present along the bridge seat and upper portions of stem scattered throughout and are in sound condition. Scattered rust staining and cracking are present along the upper portions of stem and bridge seat. Minor debris build up and small areas of spalling are present along the bridge seat.

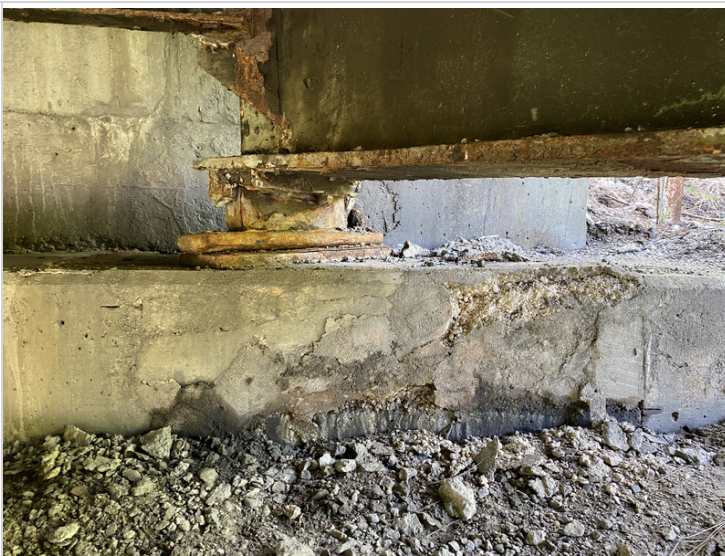
Bearing #1 at Abutment #1

Rocker bearings are present over both abutments and at pier #1 in fair condition with areas of minor to moderate rust scaling and pitting present. Fascia bearings at piers and bearings at both abutments have the heaviest deterioration. Sole plate below bearing #5 over abutment #1 has base plate mitigating out from under rocker. Pier #2 has fixed rocker bearings having minor rusting.

Movable bearings at both abutments have minor to moderate rust scaling forming and light pitting present with no protective coating and continue to have corrosion progress. Bearings should be cleaned and painted or fully replaced. Bearing #5 at Abutment #1 has twisted sole plate and is no longer functioning as intended.

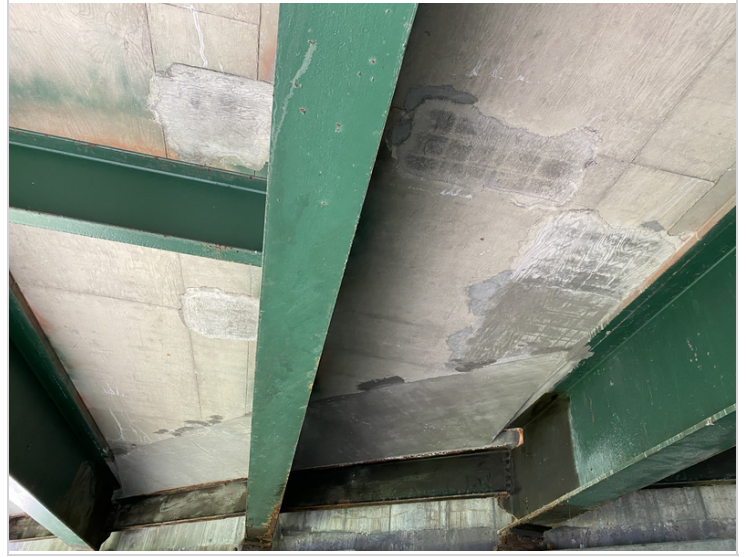
Span #1 Deck Soffit Bays #2 and #3

Reinforced concrete deck is in okay condition having multiple areas of concrete patches throughout the bays and spans. Other various light transverse cracking with light efflorescence leakage is present throughout the deck. Bay #3 in span #2 has catch form below small spall and delaminated area to catch falling debris.

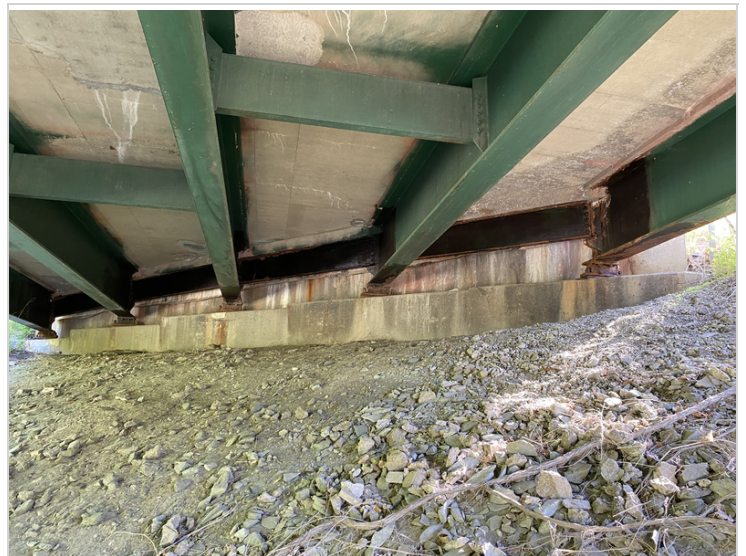
Abutment #2 is in okay condition having recent concrete patching repairs completed with spalled / scaled areas being patched along the western end of the abutment stem / bridge seat and below bearing #3. Other areas of various cracking with scattered rust stains are present along the abutment bridge seat / stem and minor debris build up along the bridge seats scattered throughout.

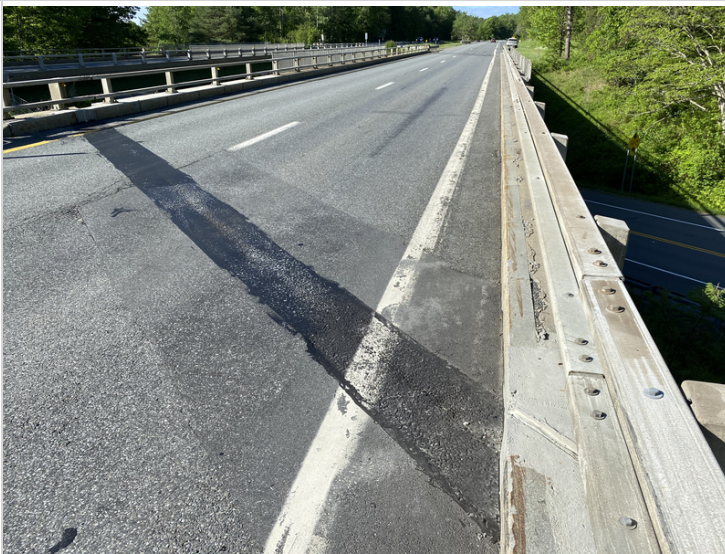
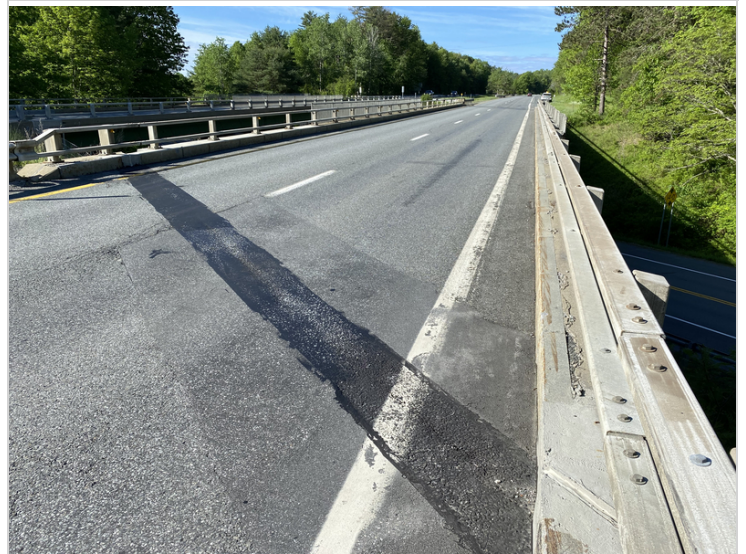
Deck Wearing Surface from Abutment #2

Asphalt is in satisfactory condition with minor wear in tire tracks and some areas of minor cracking that has been sealed.

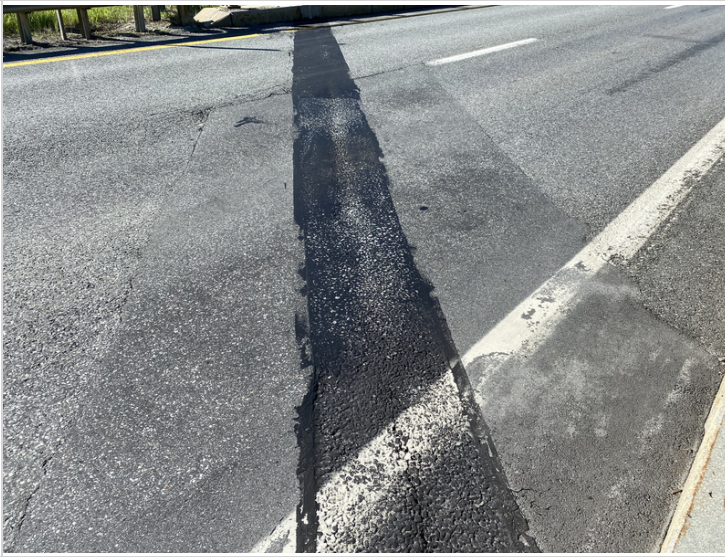
Asphaltic Plug Joint over Abutment #2

Asphaltic plug joints are present at both ends of structure with recent joint elimination / rehabilitation project having minor wearing in the travel lanes and some various cracking starting to form.

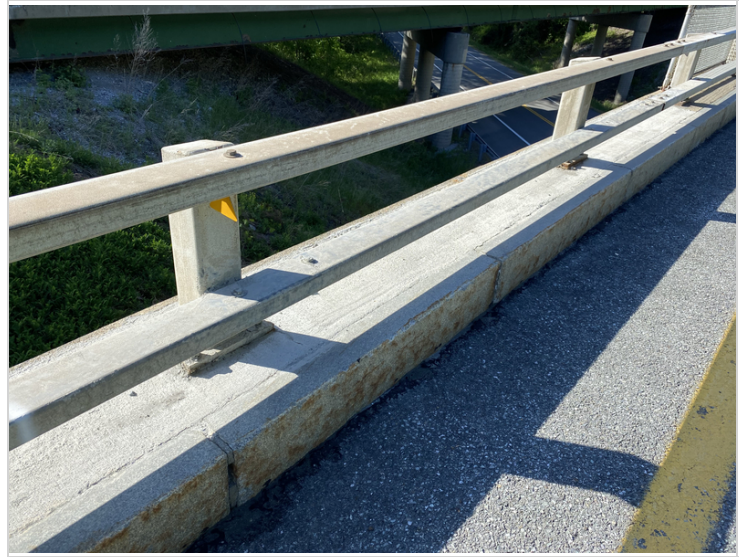
Eastern Curb Repairs

Concrete curbing with granite block facing is in satisfactory condition having some light cracking along the top surface and some very light concrete scaling behind the granite face with recent concrete patches along the heaviest scaling.

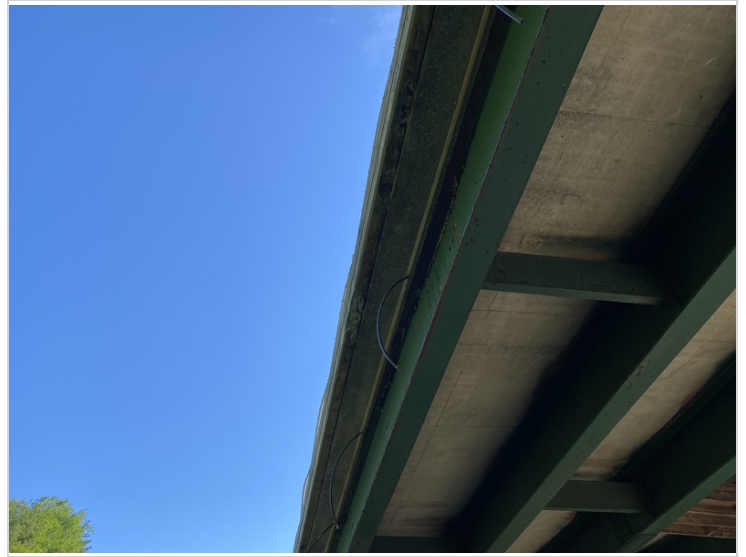
Eastern Fascia Soffit over US-5

Concrete fascia's are in satisfactory condition with light to minor cracking and some efflorescence leakage throughout. Small spalls with rust staining are present along the soffit of both fascias with small delaminations forming and various cracking.
