Town: 206 - SPRINGFIELD

District 2, 27 - WINDSOR County

IDENTIFICATION	
(1) State Names	50 - Vermont
(8) Structure Number	200091026N14182
(5) Inventory Route	1
(2) Highway Agency District	2 - District 2
(3) County Code	27 - WINDSOR

(4) Place Code	69550
(6) Features Intersected	BLACK RIVER
(7) Facility Carried	I 00091 ML
(9) Location	0.4 MI S EXIT 7
(11) Mile Point	41.251 mi
(12) Base Highway Network	Yes

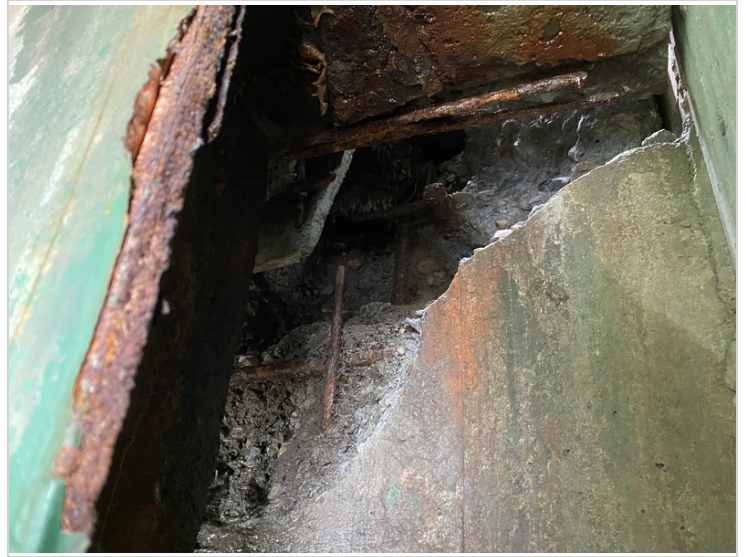
Heavy Spalling with Exposed Steel Reinforcing
West End Abutment #1

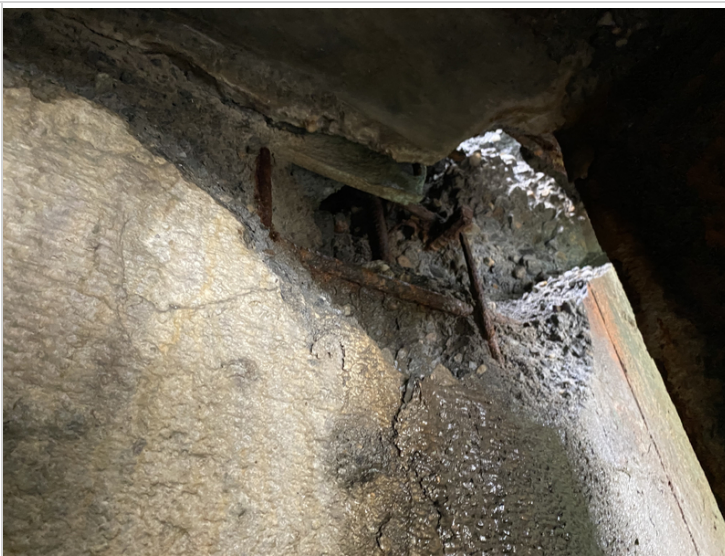
Heavy Spalling with Exposed Steel Reinforcing
West End Abutment #1

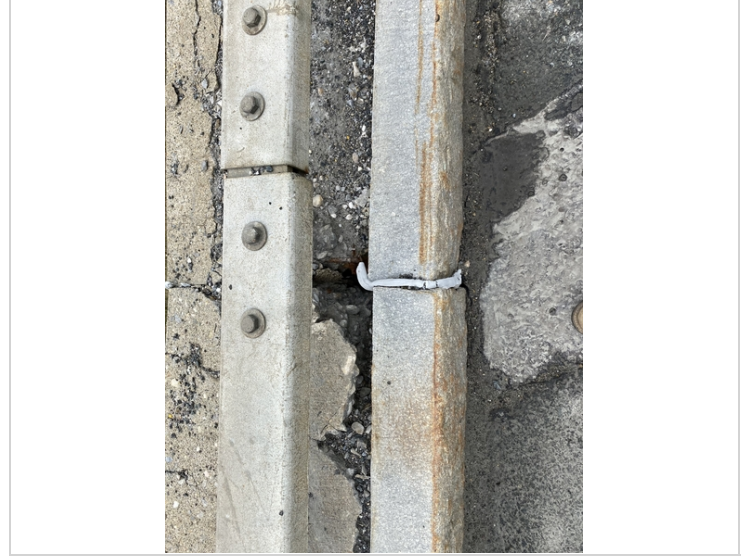
Curb Spalling along the East Side of Structure over Pier #1

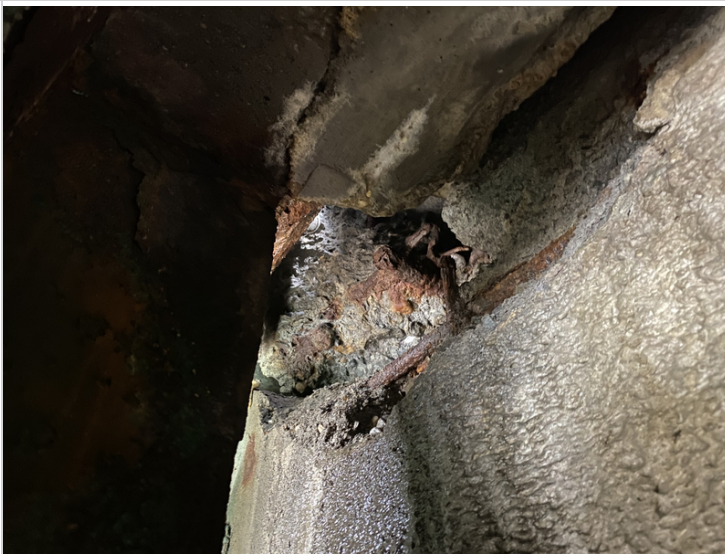
Backwall behind Girder #5 at Abutment #1

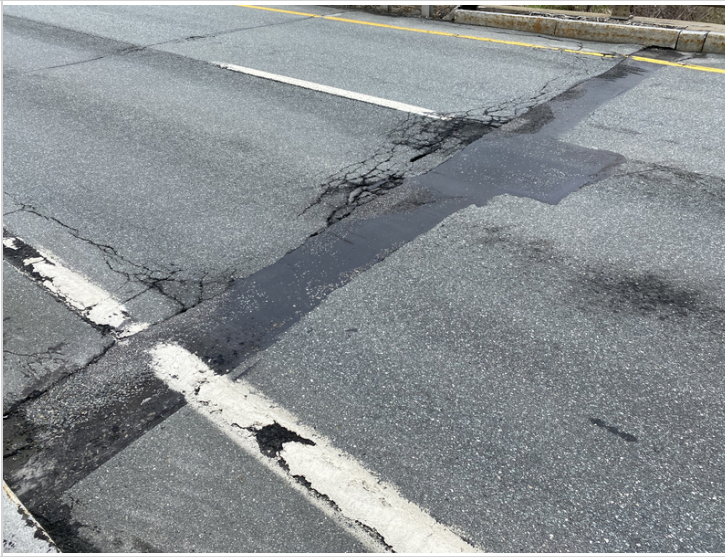
Asphaltic Plug Joint over Abutment #1

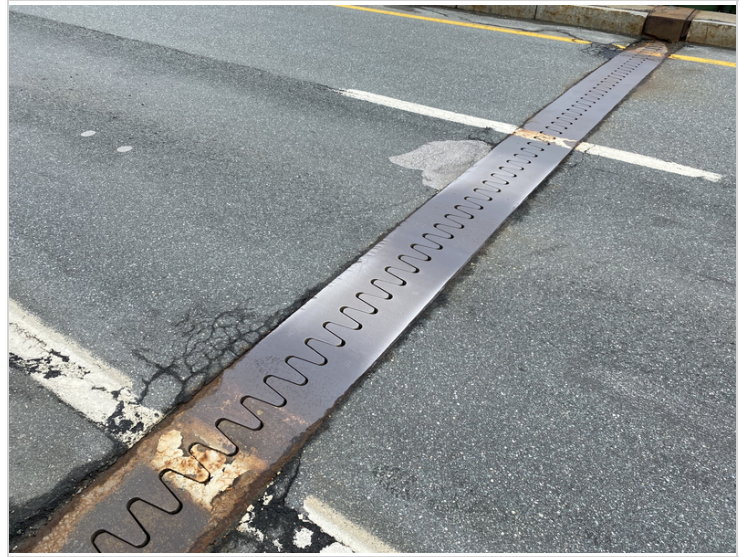
Steel Finger Joint over Pin Section #1 in Span #2

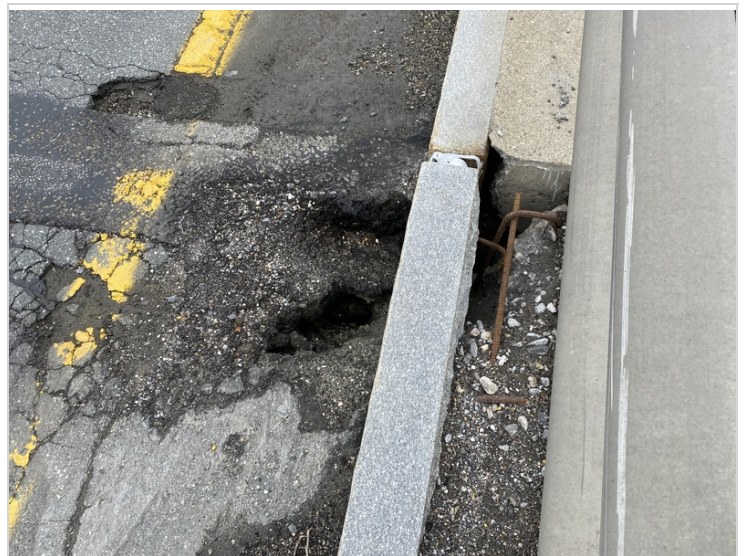
Full Depth Hole over West Shoulder at Abutment #2

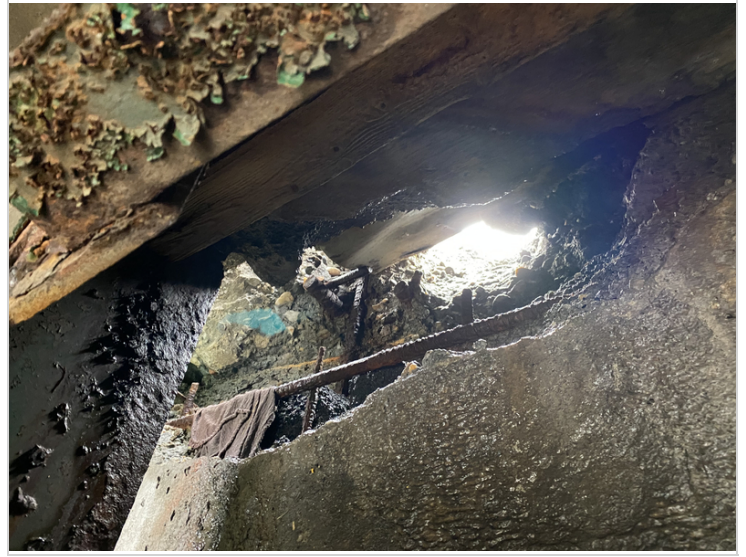
Full Depth Hole West Side of Abutment #2

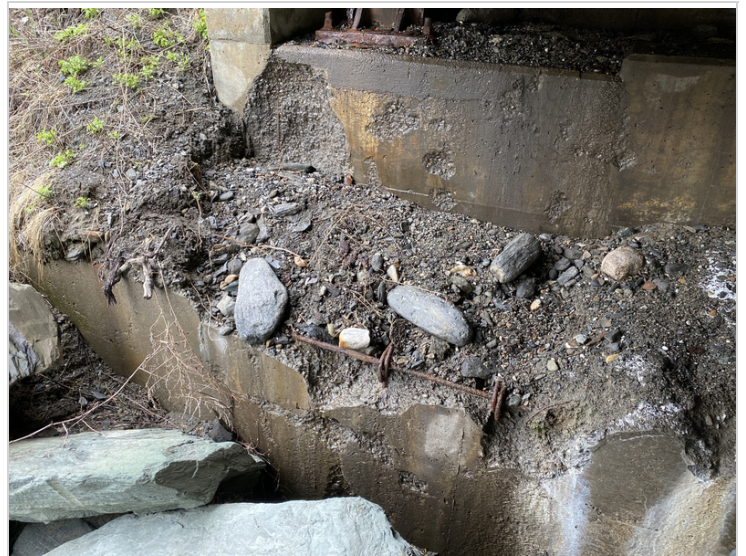
Concrete footing is exposed along abutment #2 on the west side only and has moderate to heavy concrete spalling / scaling that has exposed the steel reinforcing with rust stains, cracking and efflorescence leakage present.

Heavy Spalling along Abutment #2 Footing

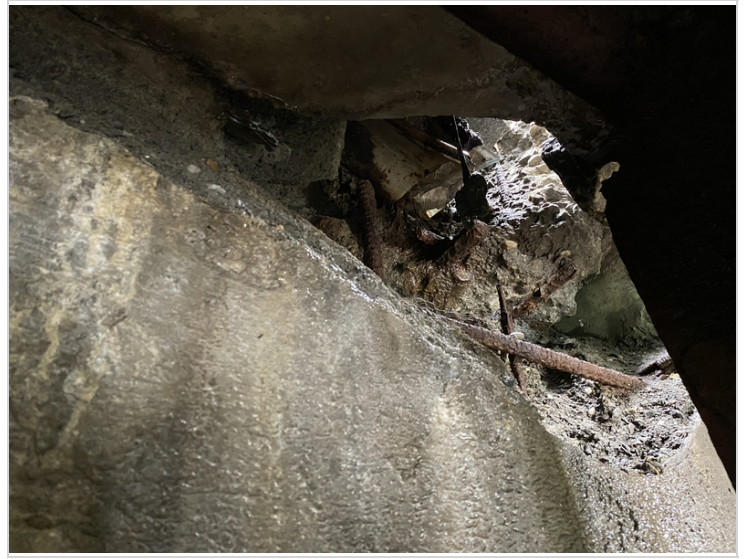
Spalling along Abutment #2 East Backwall

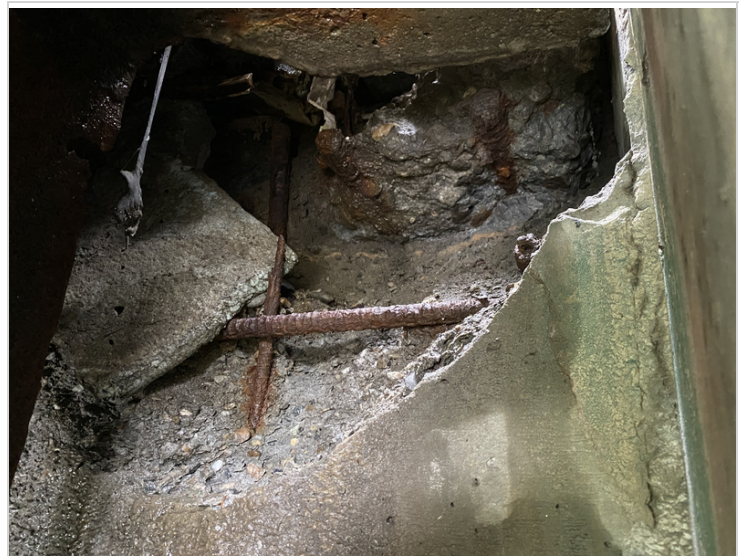
Spalling along Abutment #2 East Backwall

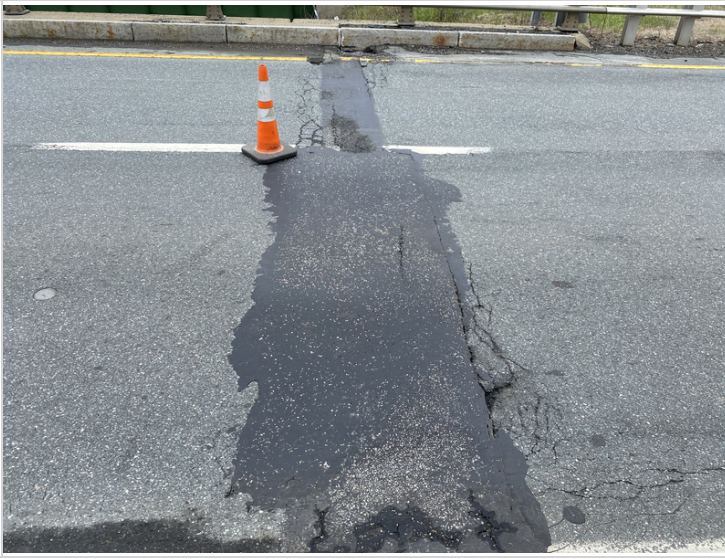
Asphaltic Plug Joint over Abutment #2

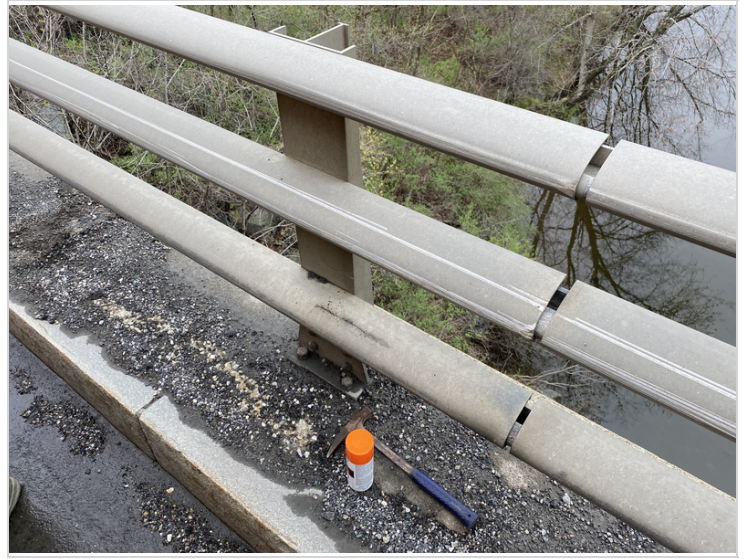
Typical Bridge Rail Scrapes

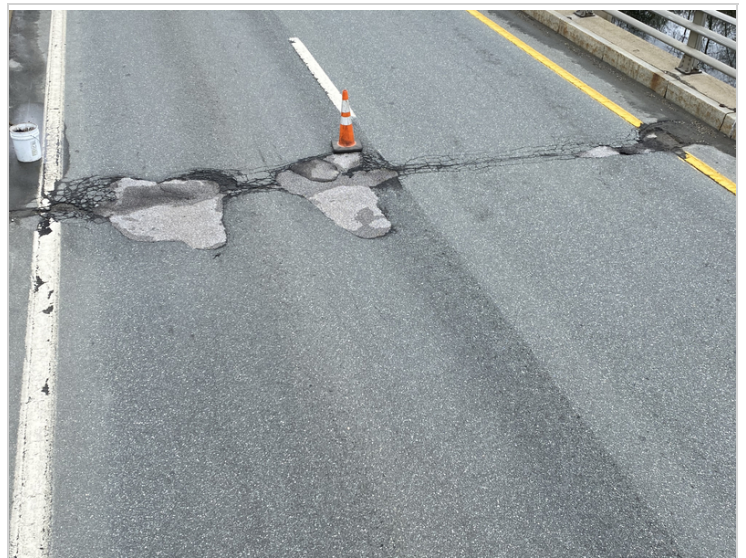
Breakup in Asphalt over Second Section of Pins in Span #2

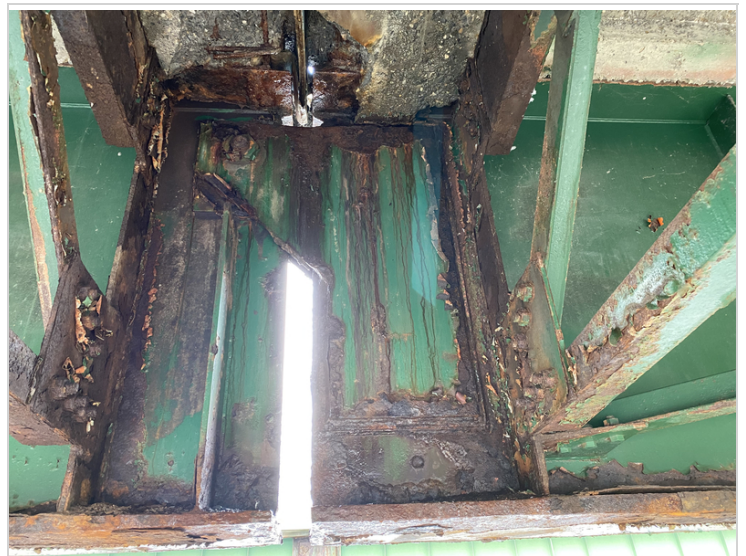
Girder #1 at Second Section of Pins in Span #2

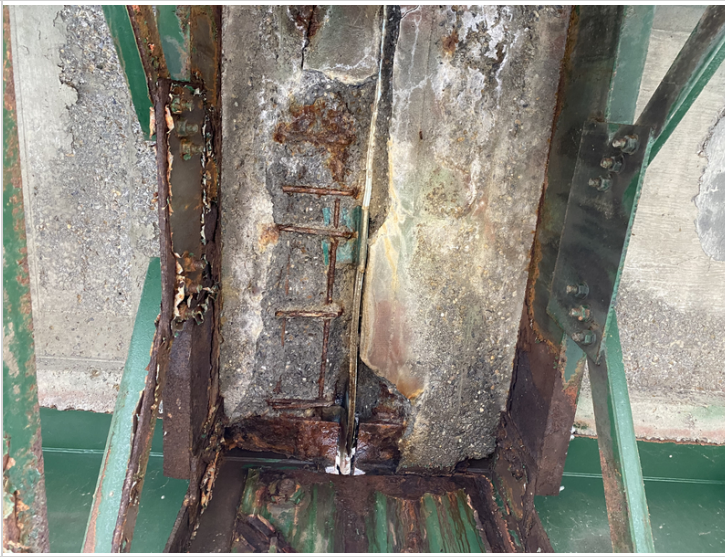
Deck Spalling over Second Section of Pins in Span #2 in Bay #1

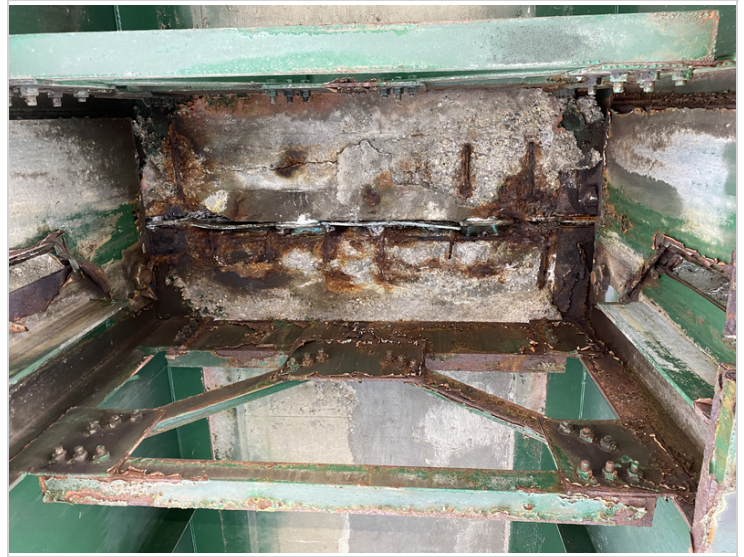
Deck Spalling over Second Section of Pins in Span #2

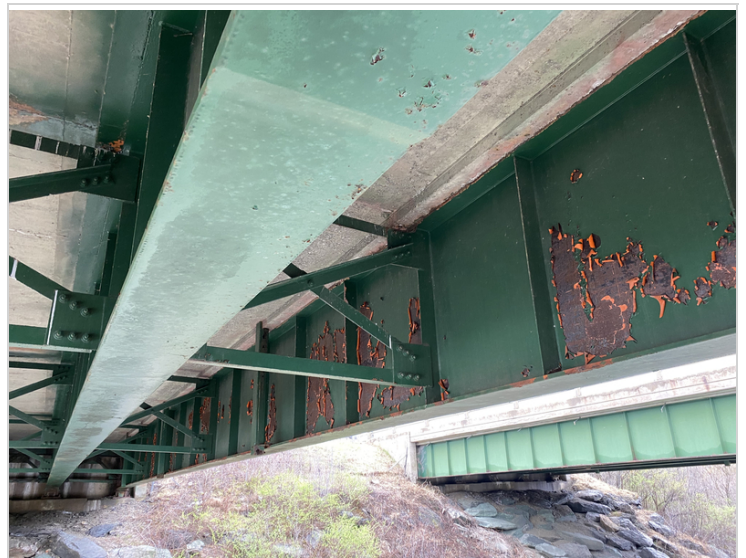
Girder #1 Span #1 Paint Peel

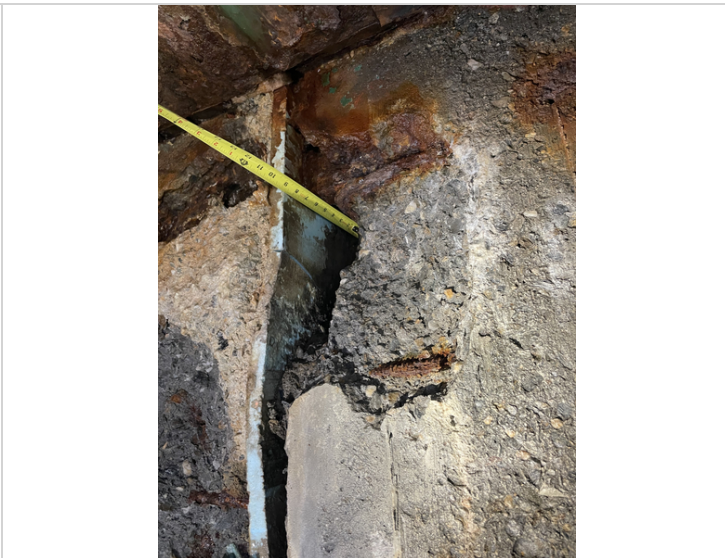
Deck Spalling over Second Section of Pins in Span #2

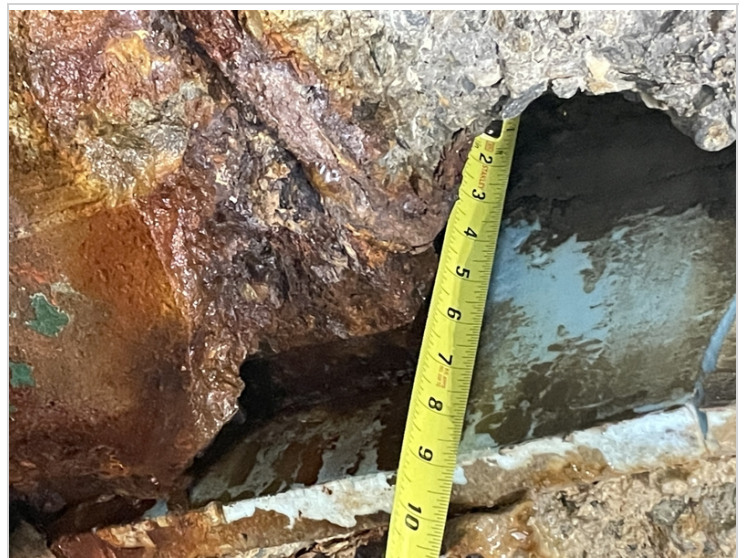
Deck Spalling at Second Section of Pins in Span #2

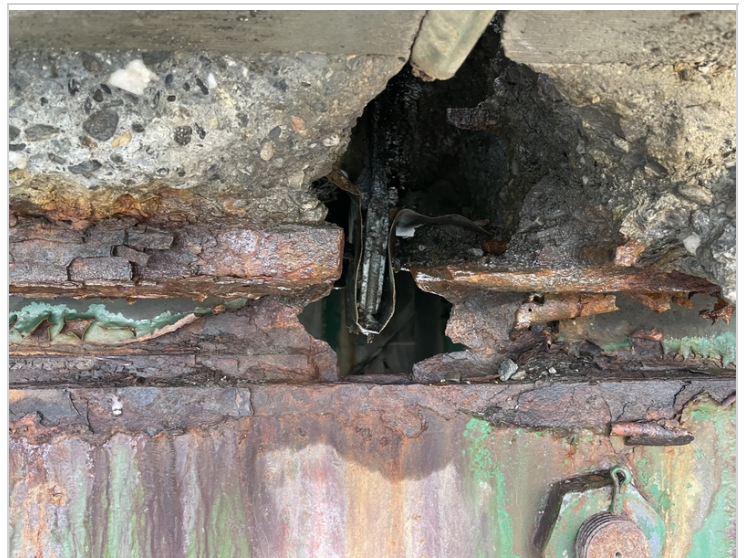
Pin Assembly Girder #1 Section Loss along Top Flange / Web and Deck Spalling

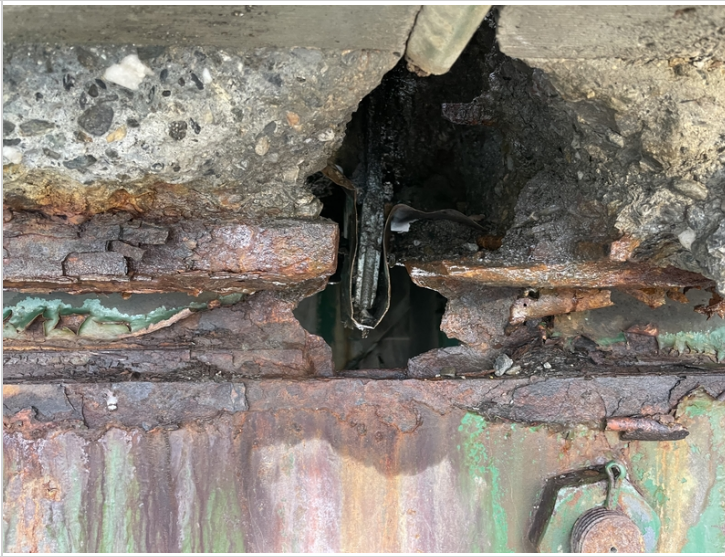
Pin Assembly Girder #1 Section Loss along Top Flange / Web and Deck Spalling

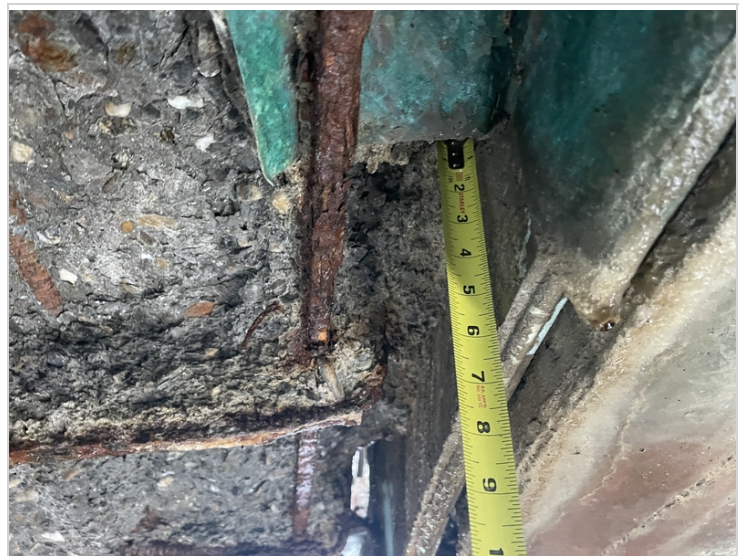
Spalling Depth at Second Section of Pins in Span #2

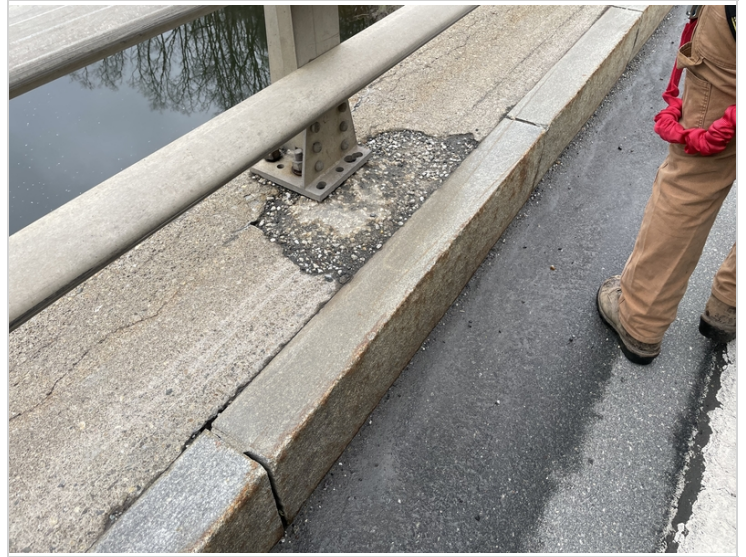
Patched Curb and Loose Anchor Bolts

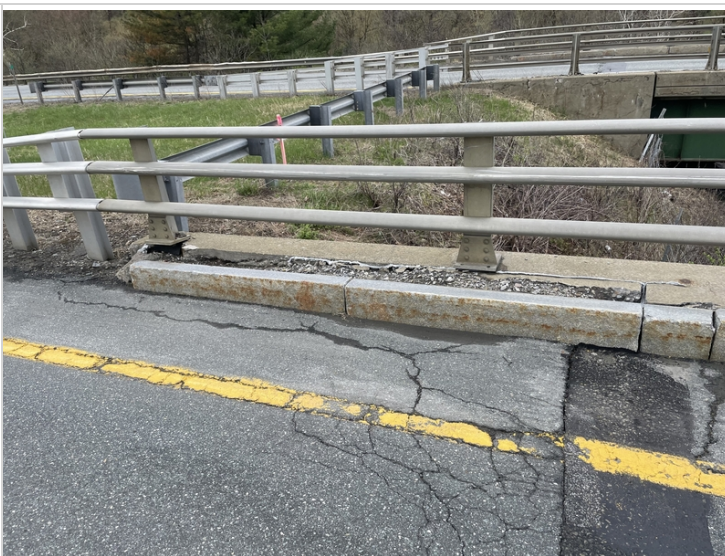
Pedestal mounted aluminum posts are in satisfactory condition having some minor scrapes and gouges along the posts mainly along the eastern fascia only. Post along the eastern side in span #2 has concrete scaling along the curb with multiple anchor bolts missing. Southwest corner of structure has heavy spalling / scaling in curb that is exposing anchor bolts of bridge rail posts.

Spalling Curb along Southwest Corner

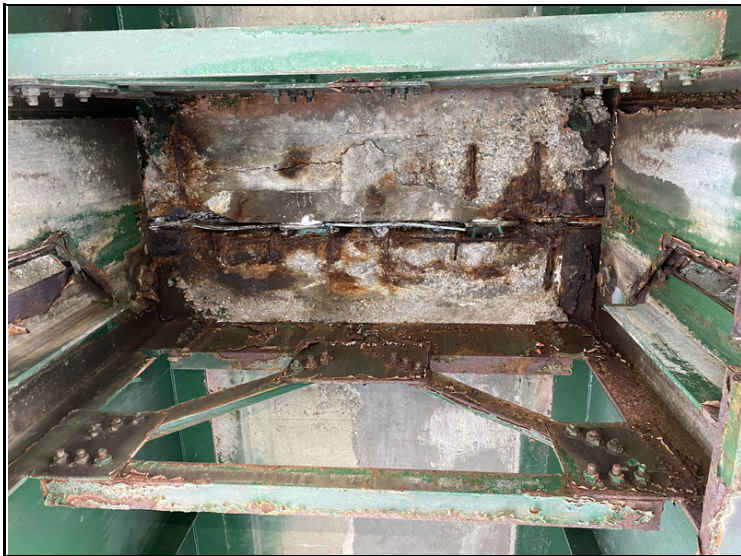
Possible full depth holes are present in bay #4 in span #2 over the second section of pins along the superstructure. Concrete is heavily saturated with heavy spalling that has exposed the steel reinforcing and spalling has penetrated up to 9" at joint and is highly saturated. Asphalt over this locations is heavily patched with unsound asphalt and large depressions present.

Deck Spalling over Second Section of Pins in Span

Date Reported: 05/03/2022
Priority: 2 - Critical - 90 Days
Type of Work: 14 - Deck - Joint repair or replacement
Status: Open
Component: Deck

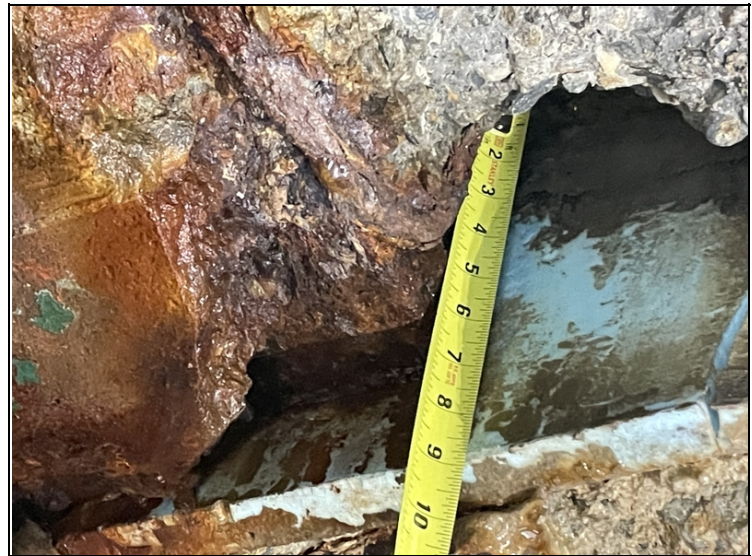
Deck Spalling at Second Section of Pins in Span #2

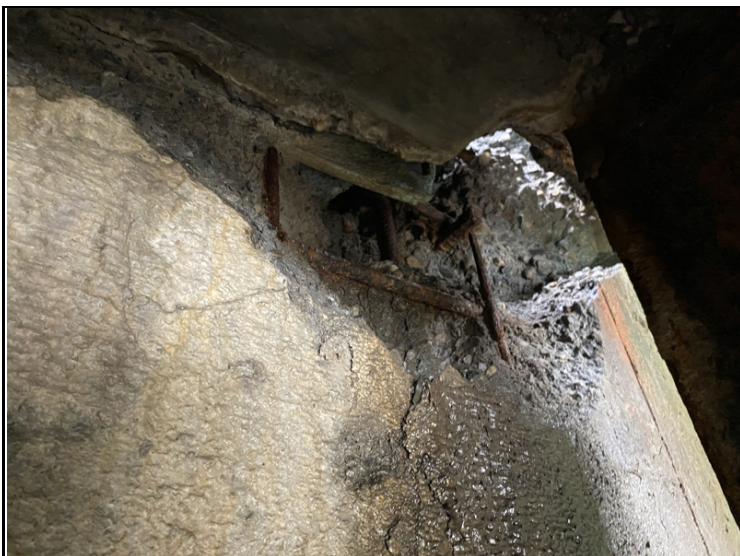
Heavy Spalling with Exposed Steel Reinforcing

Structure is in need of major rehabilitation project with large deck patching or full deck replaced with associated substructure and superstructure repairs. Deck has multiple patched areas scattered throughout the underside in each span with heavy deterioration present at ends of deck over abutments and over second set of pins in span #2. Deck has deep ~9" spalled areas with severe saturated concrete, exposed steel reinforcing over superstructure pins in the north end of span #2. Backwalls along both abutments have deep spalling with exposed steel reinforcing and growing full depth holes along the outer portions of both abutments that need to be cleaned and patched. Abutment #2 has heavy spalling present along the bridge seat / stem along the outer portions that have exposed the steel reinforcing and are in need of cleaning and patching. Spalling along eastern side of abutment #2 has started to undermine bearing #5. Asphaltic plug joints have been heavily patched with surrounding asphalt having heavy map cracking and pot holes forming and should be replaced over both abutments. Trough should be cleaned out at finger plate joint. Concrete curbs have heavy concrete scaling behind granite facing and large voids at joint areas that should be cleaned and patched to prevent further leakage. Full depth holes are forming along the western side of second set of pins in span #2 and along the outer portions at joint over abutment #2 due to continued leakage and spalled areas in concrete. Perforations are forming along the lower portions of web along girder #5 in span #2 below second set of pins due to severe leakage through joint in deck. Superstructure has large areas of failed protective layer at second set of pins in span #2. Protective coating has heaviest distress in span #2 at second set of pins and along the exterior girders and below deck joints from continuous leakage.

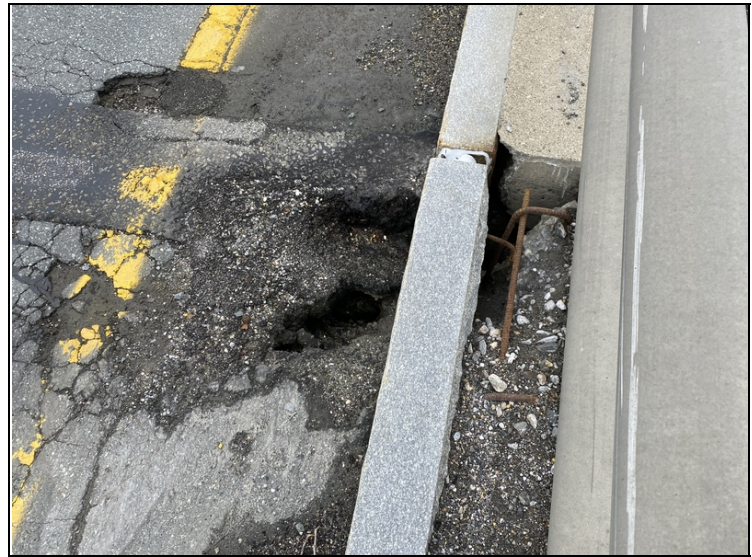
Full Depth Hole over West Shoulder at Abutment
#2
