Town: 206 - SPRINGFIELD

District 2, 27 - WINDSOR County

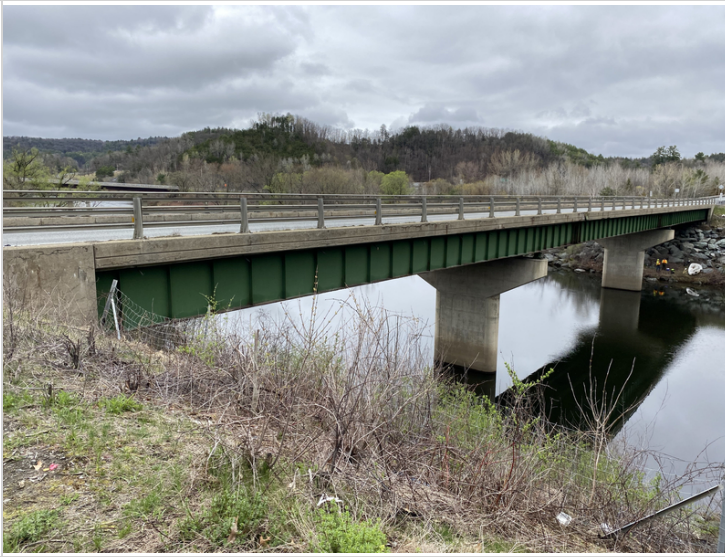
Downstream Elevation (Southeast Corner)

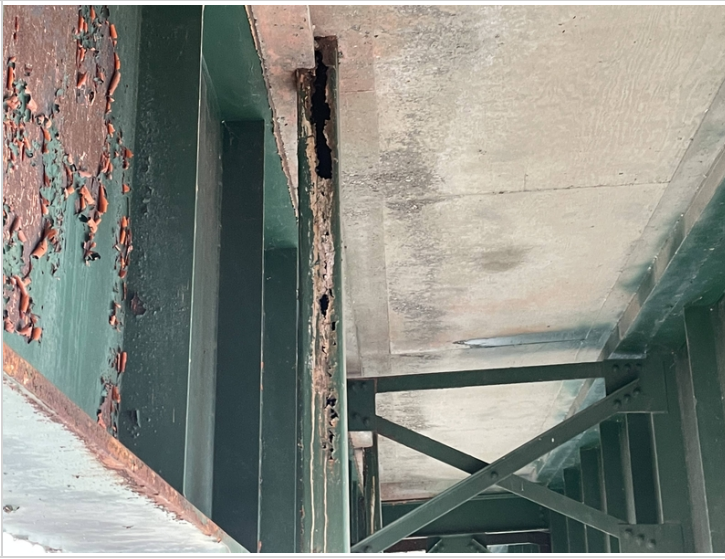
Rusted Through Drain

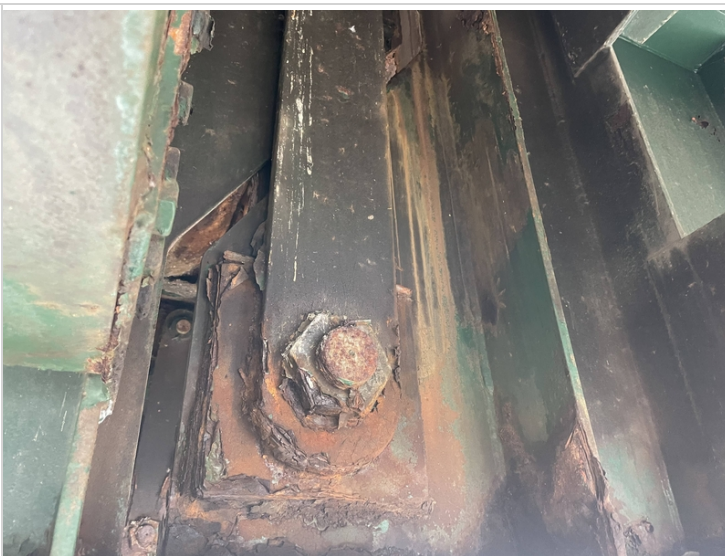
Beam #2 corrosion in Span #2 at First Pin Assembly

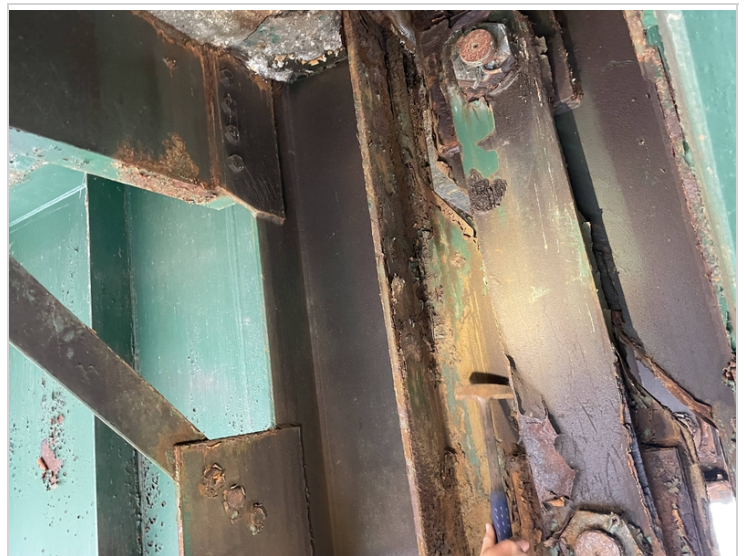
Beam #2 Pack Rust Behind Hanger Bars

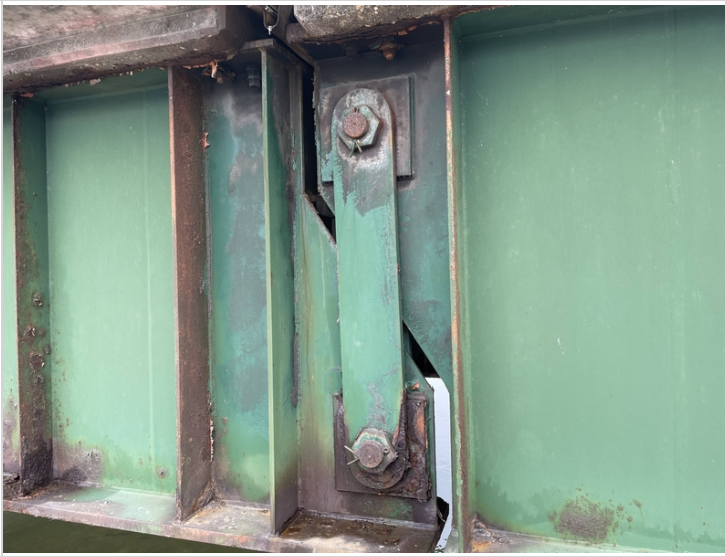
Beam #5 Span #2 First Pin Assembly

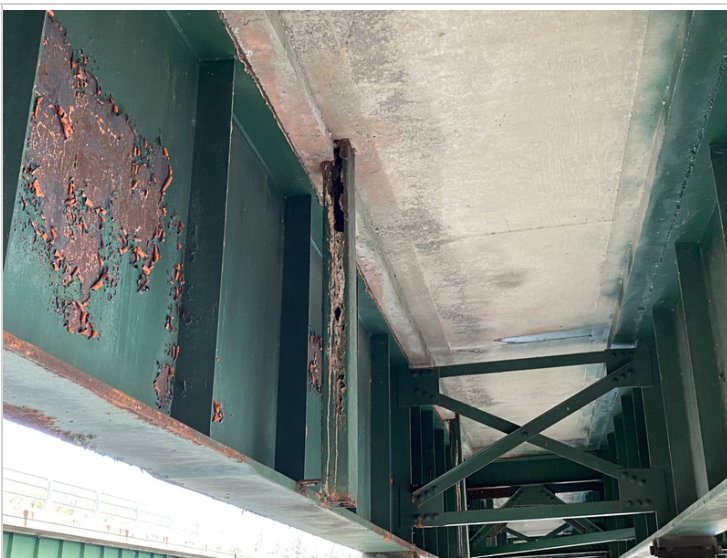
Severely Corroded Drain Downspout

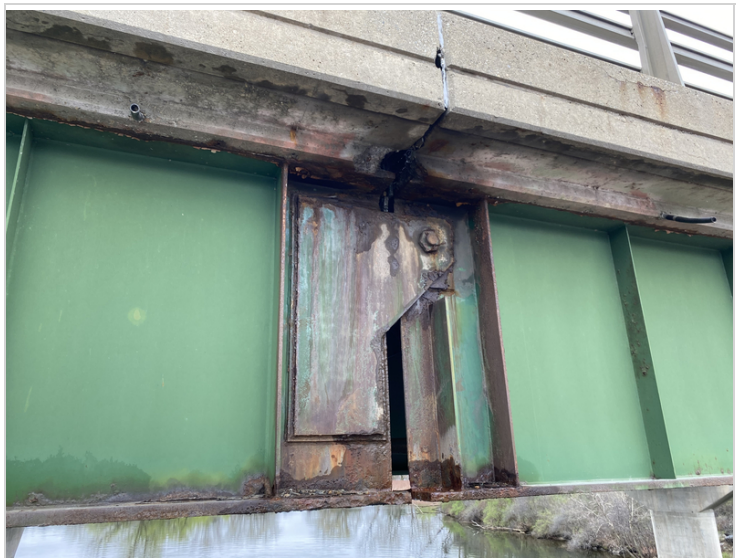
Beam #1 Second Pin Span #2

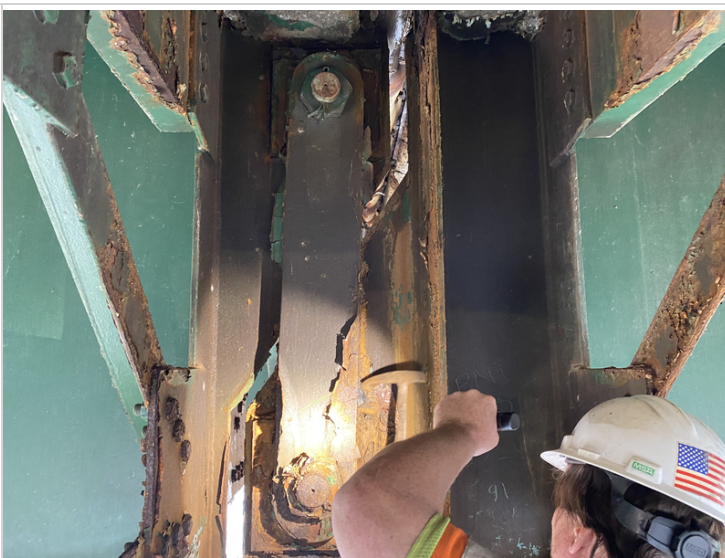
**Girder #3 at First Section of Pins in Span #2 with Heavy Rust Packing and Scaling / Pitting**

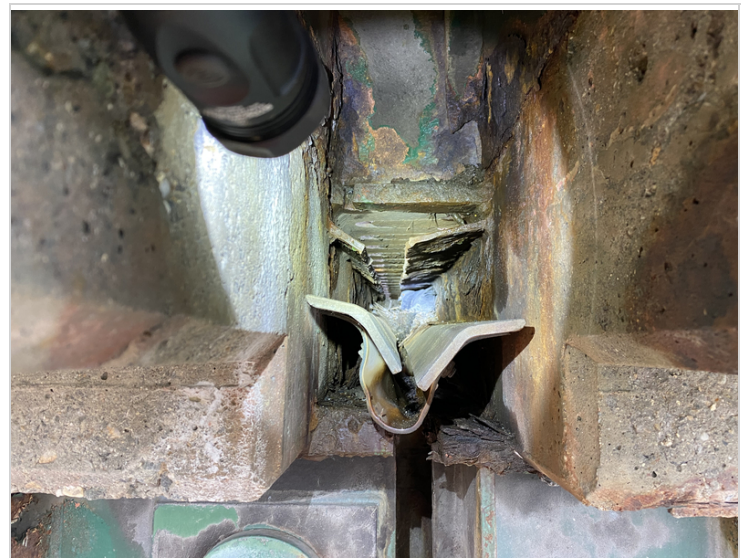
**Heavy Debris in Trough at First Pin Section in Span #2**

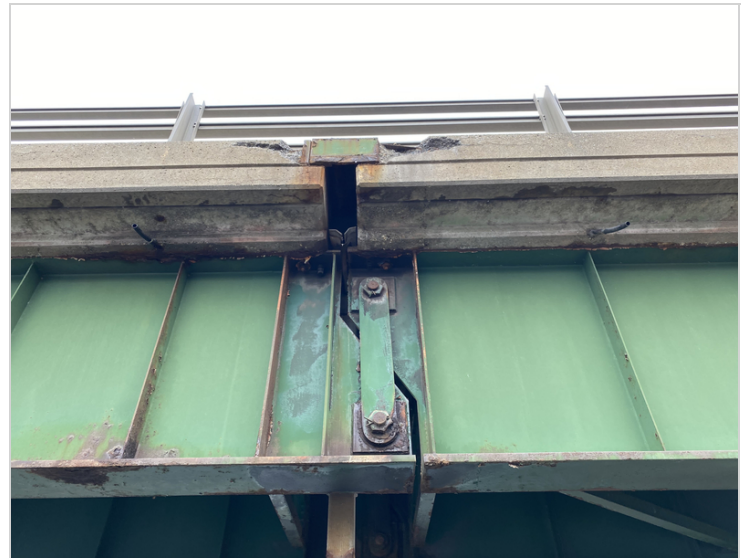
Girder #1 Span #2 First Pin Section / Deck Spalling

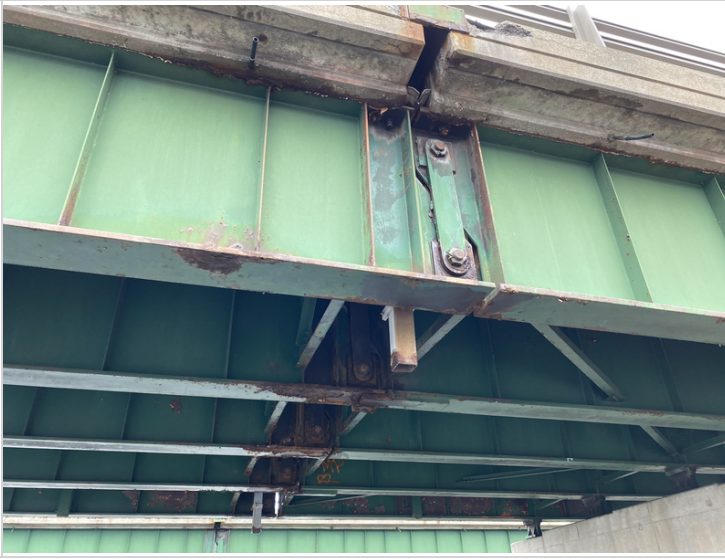
Girder #1 Span #2 First Pin Section / Deck Spalling

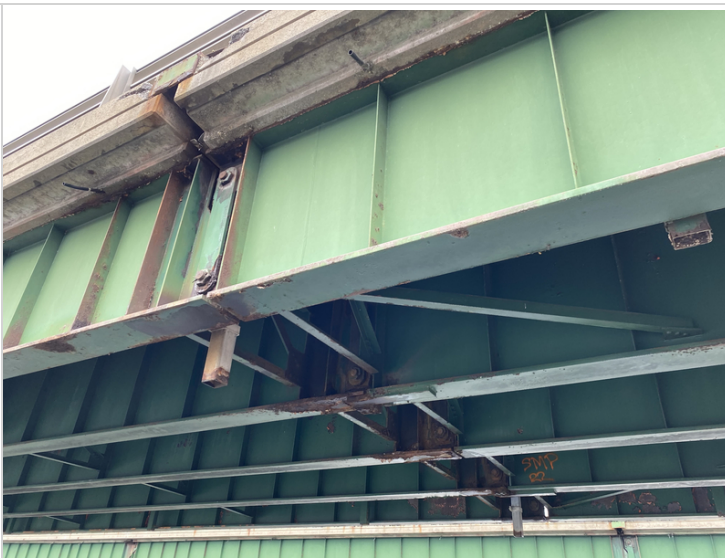
Girder #1 Span #2 First Pin Section / Deck Spalling

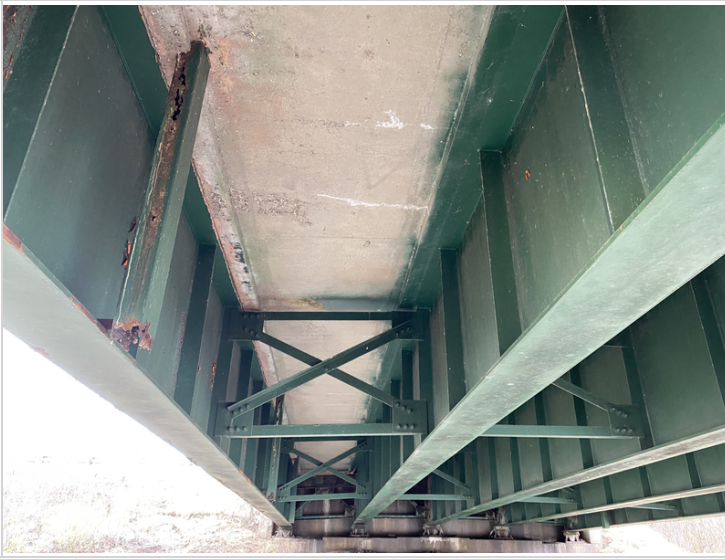
Bay #4 Deck Soffit / Deck Drains with Severe Corrosion

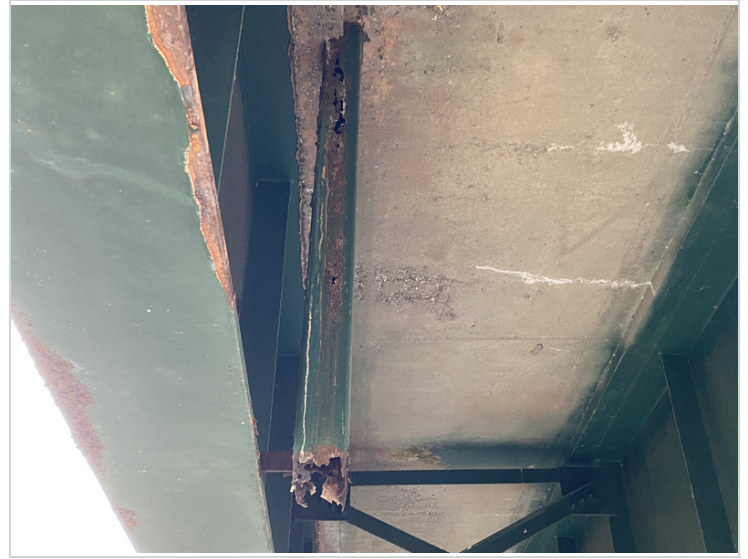
Deck Drain along Bay #4 in Span #1

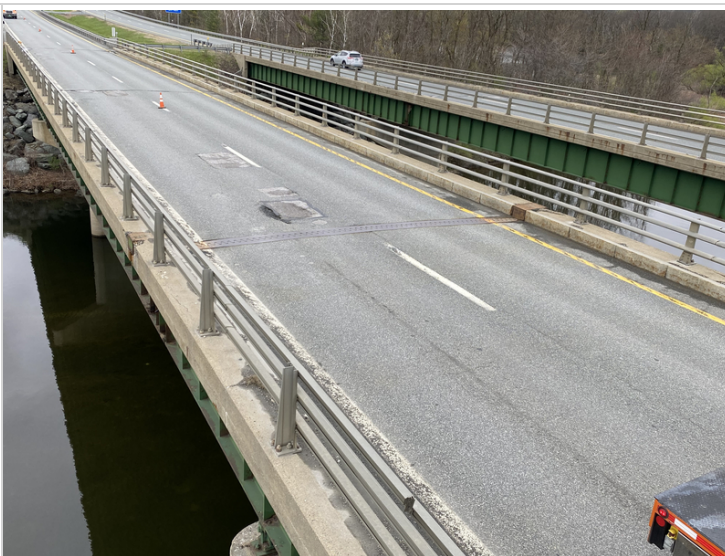
Deck Wearing Surface from Span #1

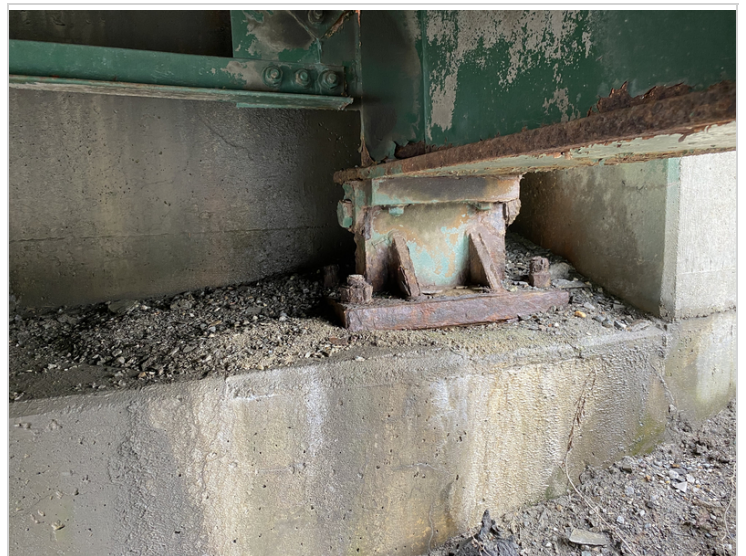
Bearing #1 at Abutment #1

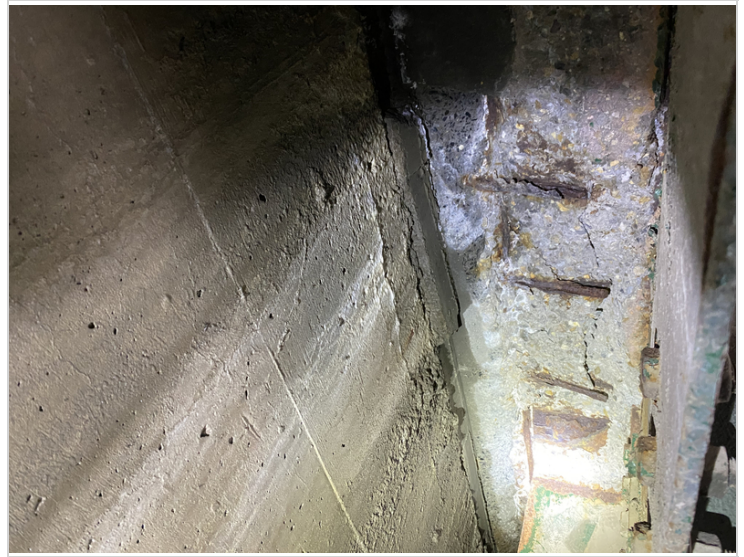
Spalling along Backwall / Deck Soffit over Abutment #1

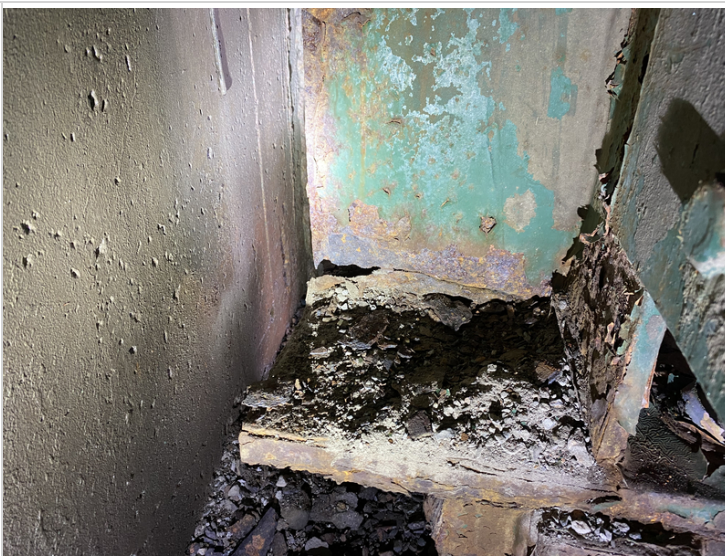
Girder #1 Perforation / Cracking Behind Bearing Area at Abutment #1

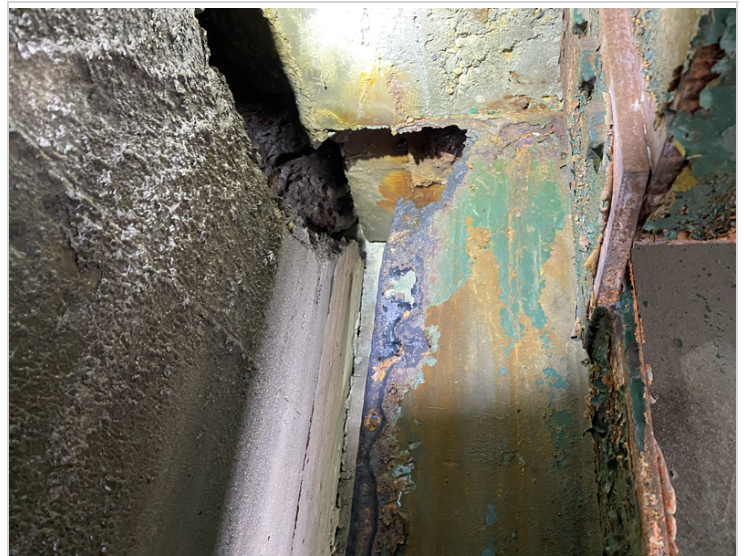
Girder #1 Perforation Behind Bearing Area at Abutment #1

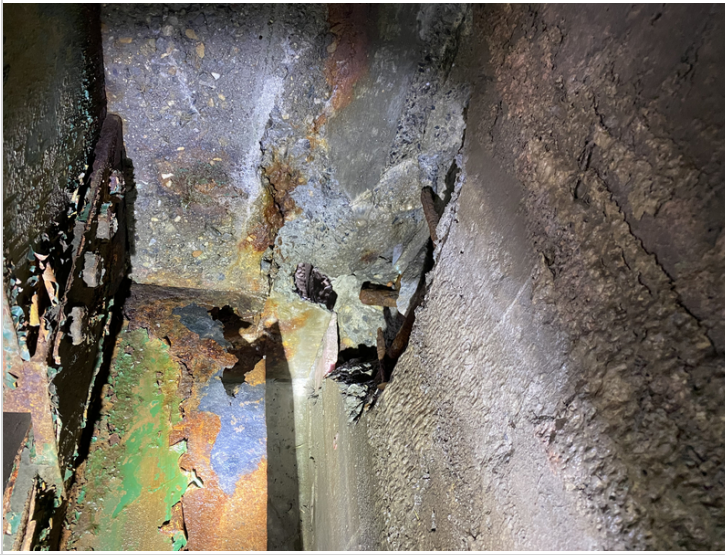
Girder #5 Corrosion at Abutment #1

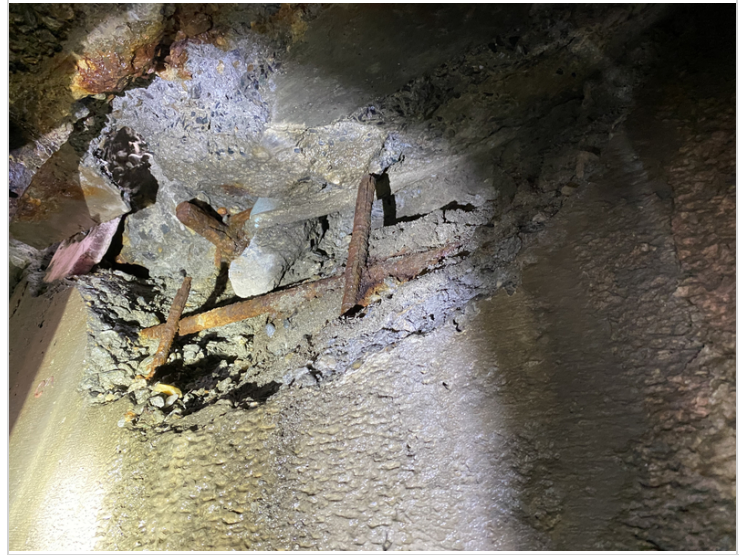
Backwall Spalling Abutment #1 East End Behind  
Girder #5

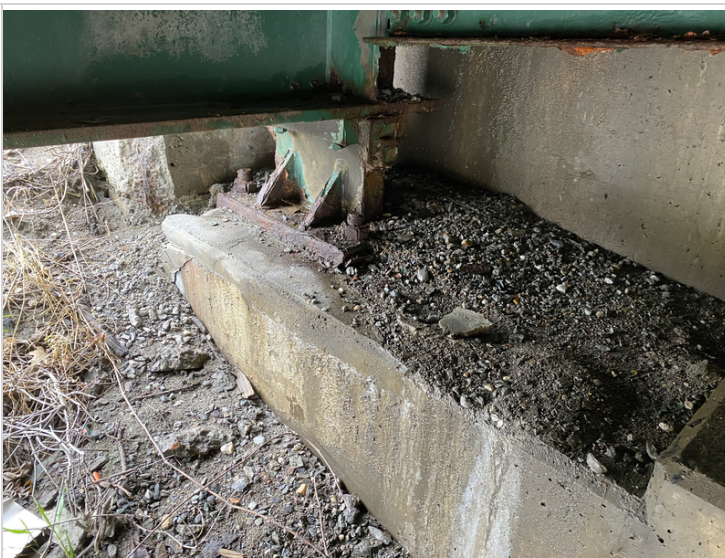
Bearing #5 at Abutment #1

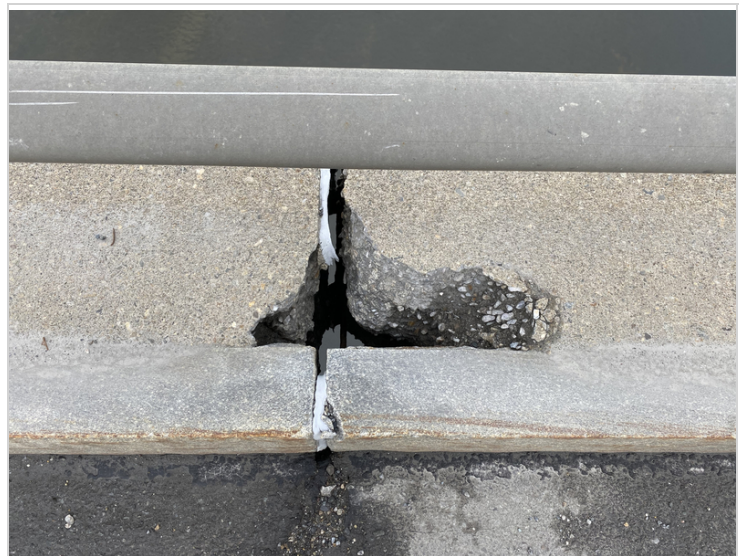
Full Depth Spalling along Curb

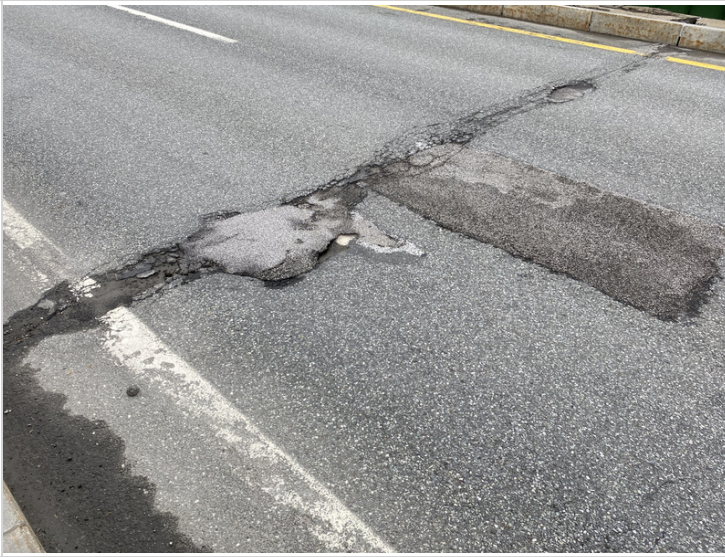
Joint / Asphalt over Second Pin Section in Span #2

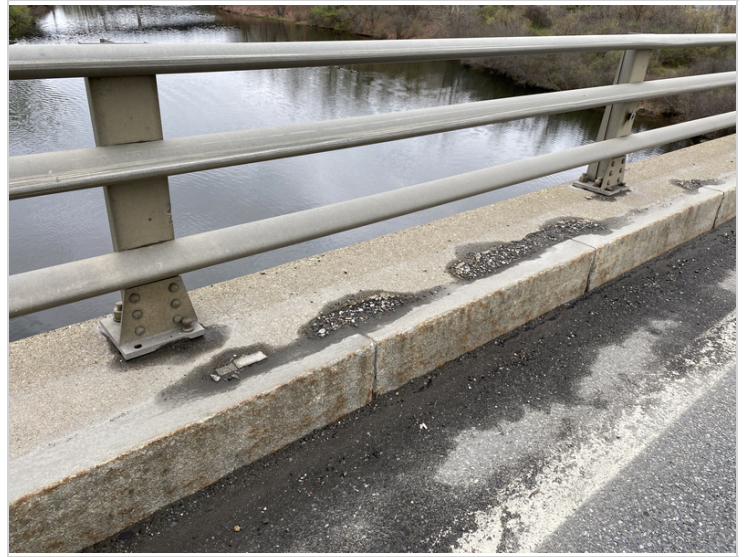
Damaged Anchor Bolts in Posts

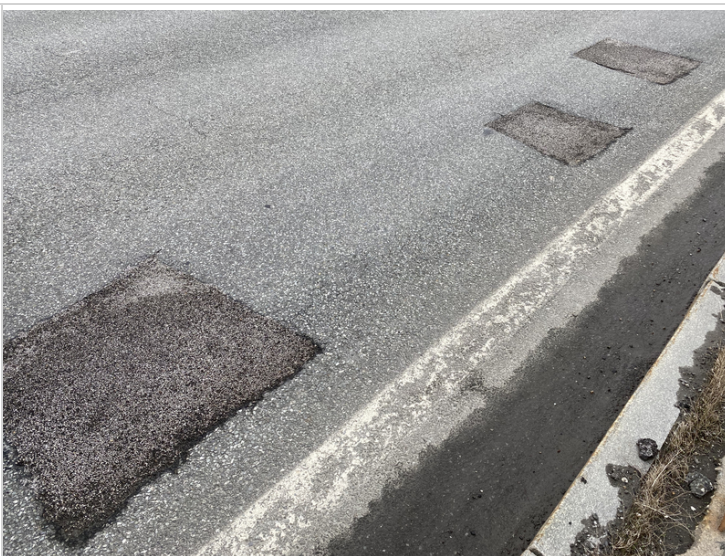
Span #3 Deck Wearing Surface

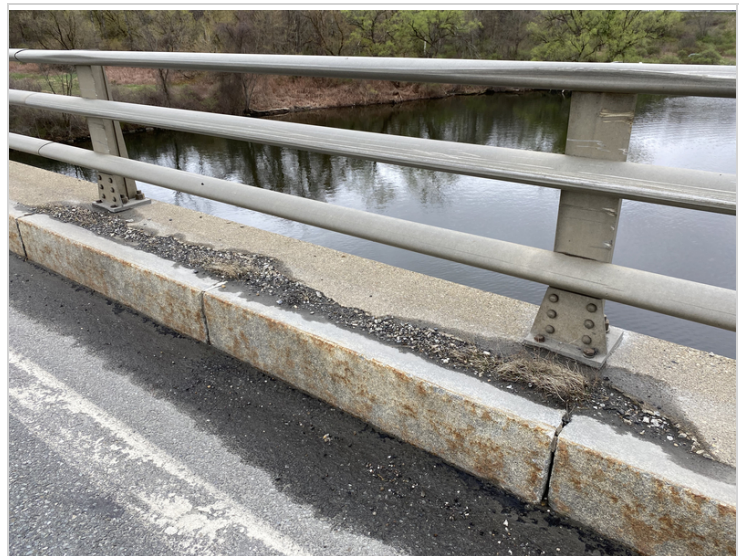
Aluminum Bridge Rail / Posts Scrapes / Gouges and Dents

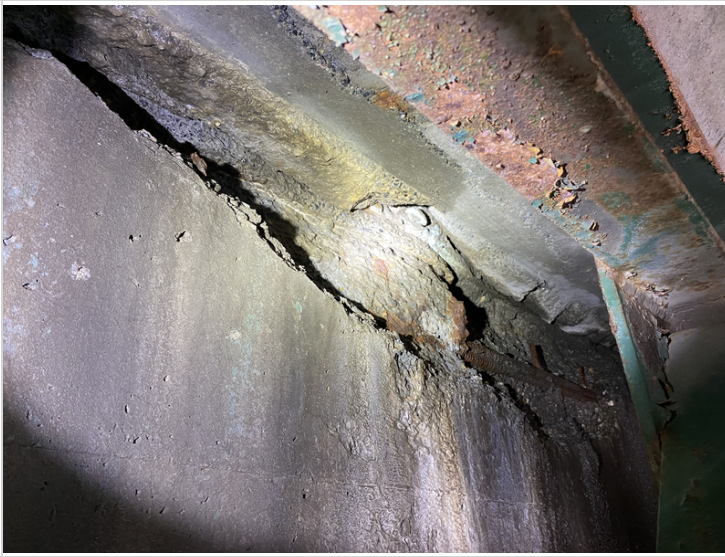
Spalling in Abutment #2 Backwall

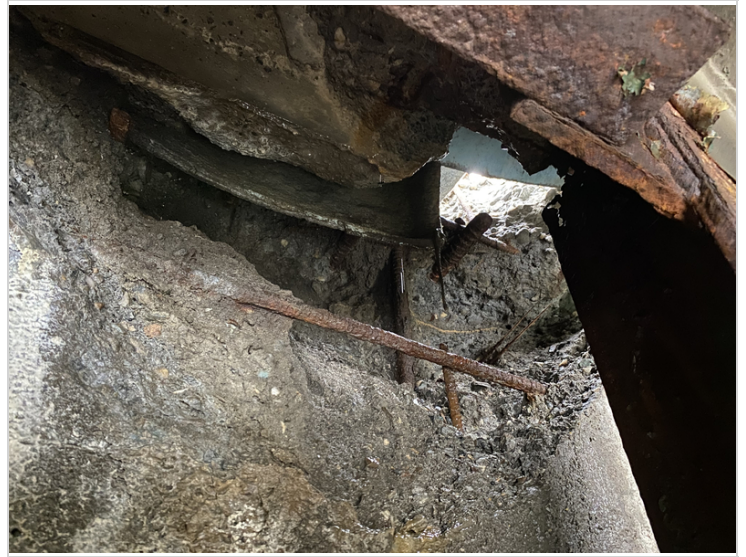
East End Abutment #2 Backwall

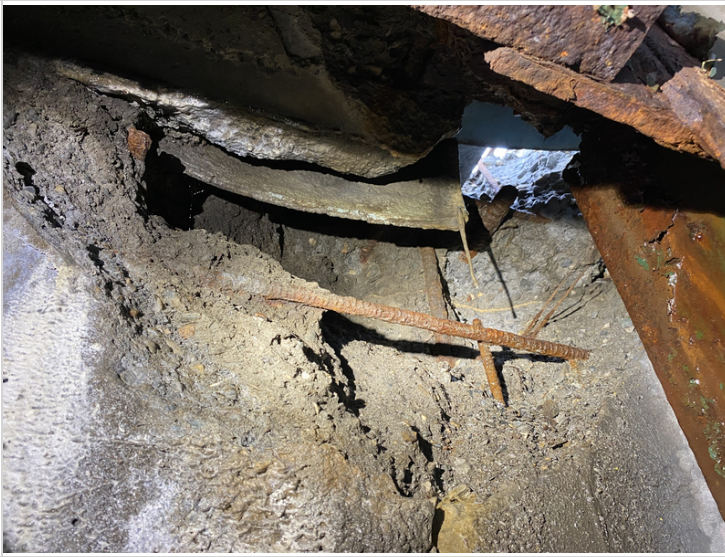
Backwall Spalling at Abutment #2 East End

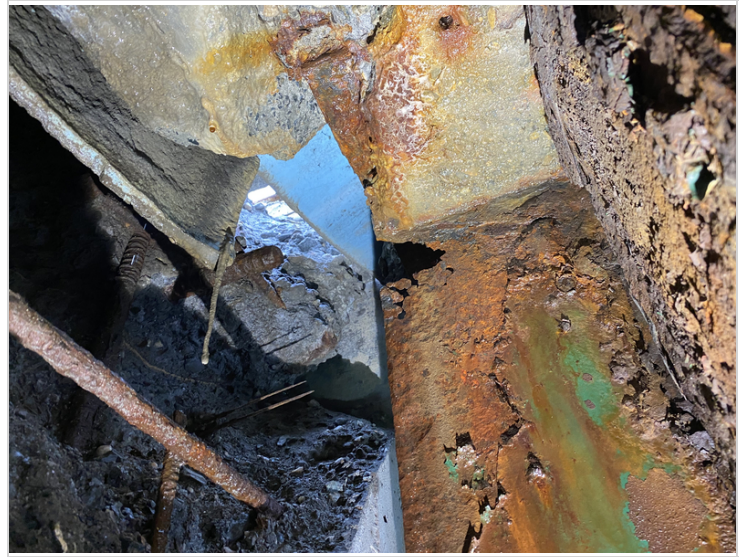
Girder #5 End over Abutment #2

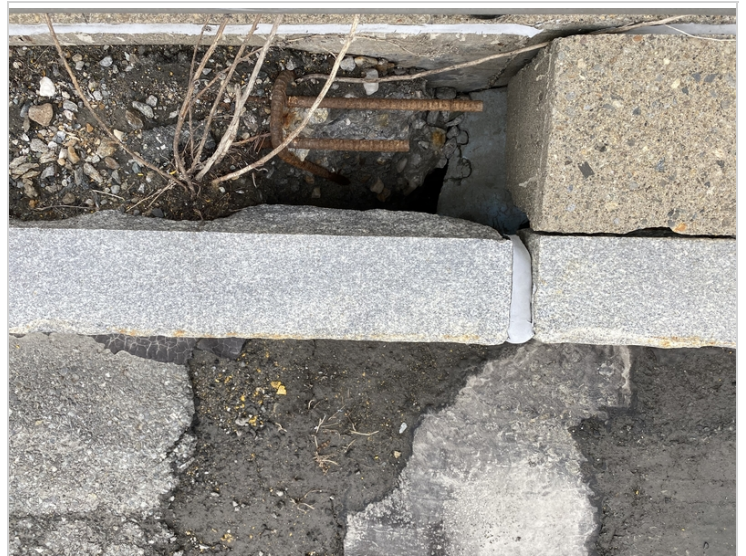
Spalling along Eastern Curbing over Abutment #2

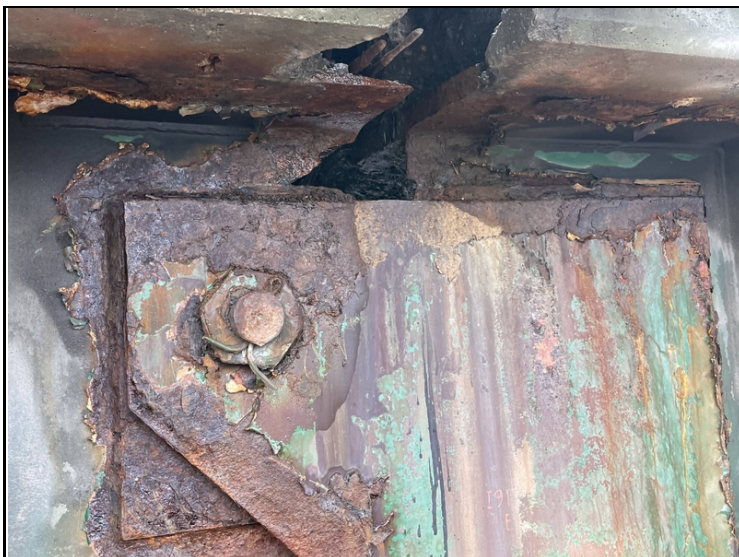
Beam #5 Pin Joint Top Flange (A1)

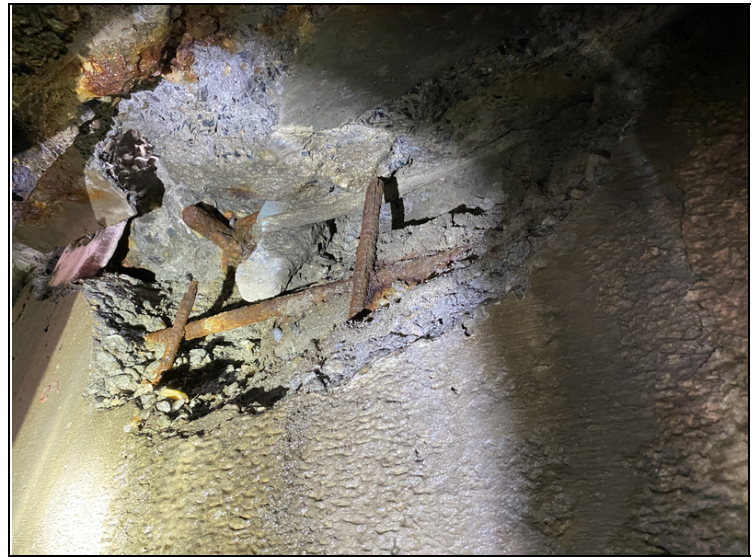
Backwall Spalling Abutment #1 East End Behind Girder #5

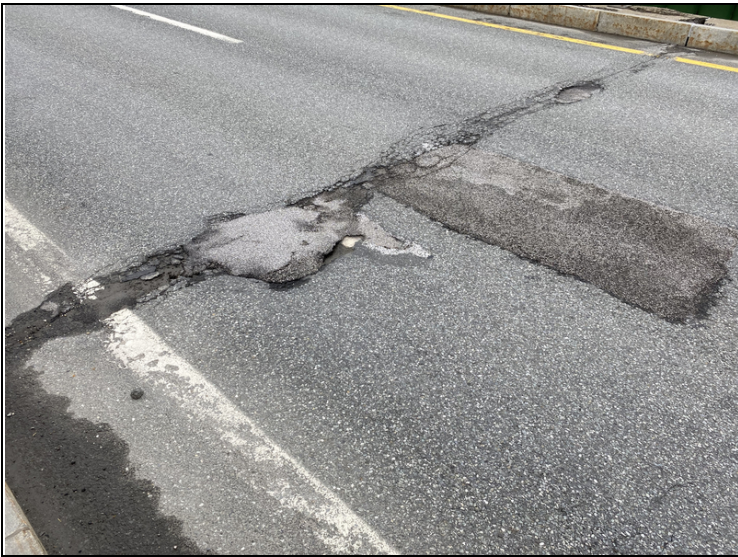
Joint / Asphalt over Second Pin Section in Span #2

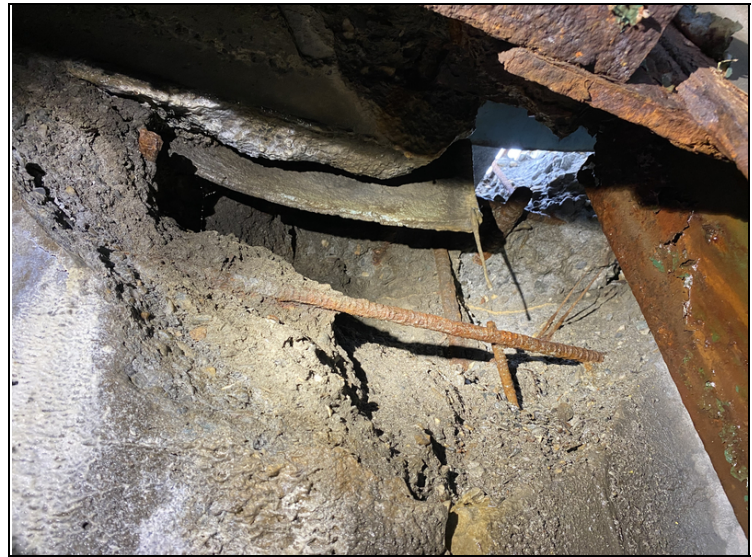
Backwall Spalling at Abutment #2 East End

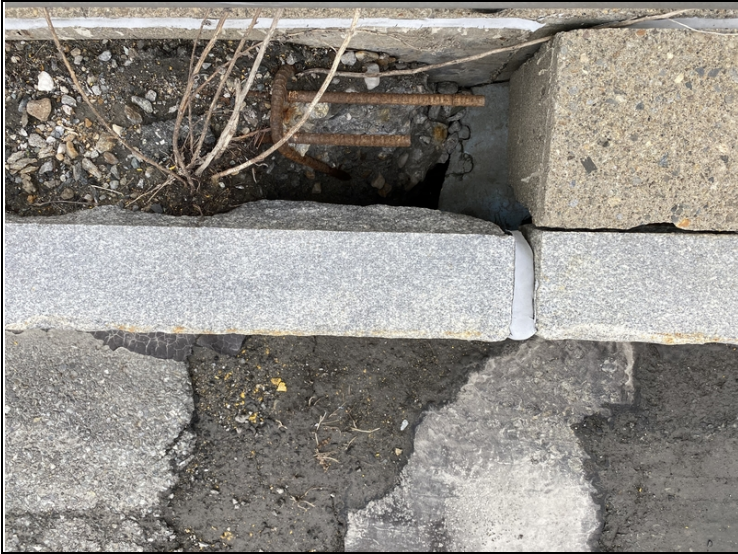
Spalling along Eastern Curbing over Abutment #2
