Town: 96 - HARTFORD

District 4, 27 - WINDSOR County

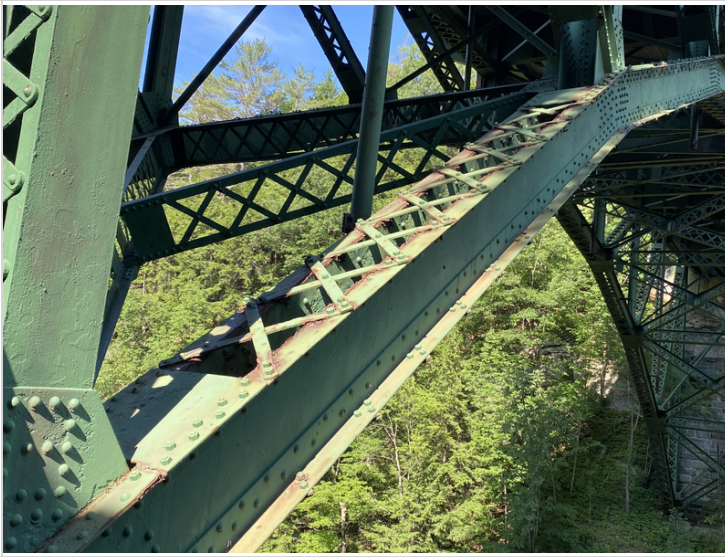
Bottom Chord Upstream between Verticals #8 and #9

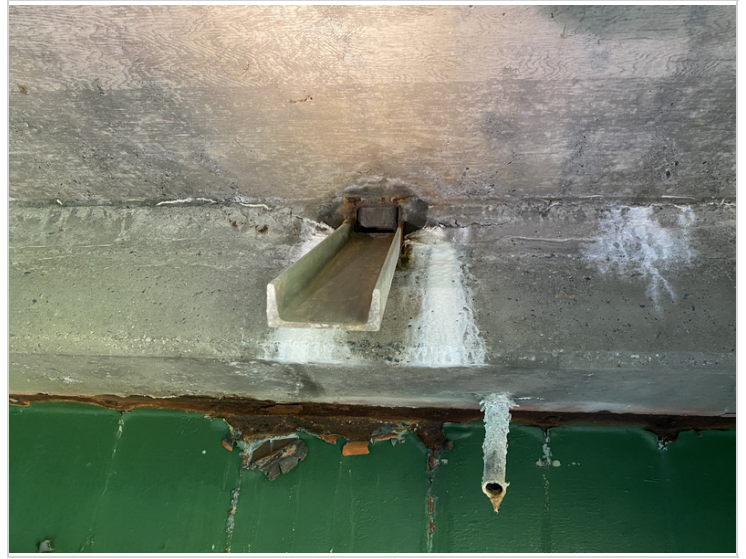
Typical Deck Scupper / Weep Tube /
Efflorescence Leakage

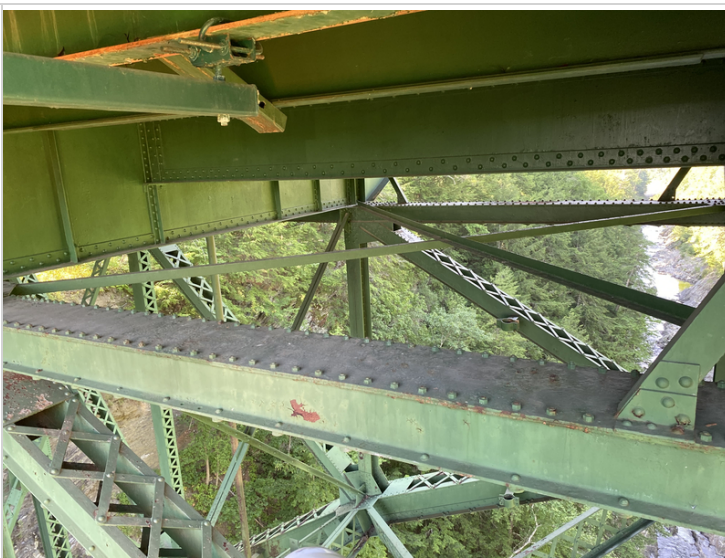
Top Chord Pitting between Floor Beams #7 and #8

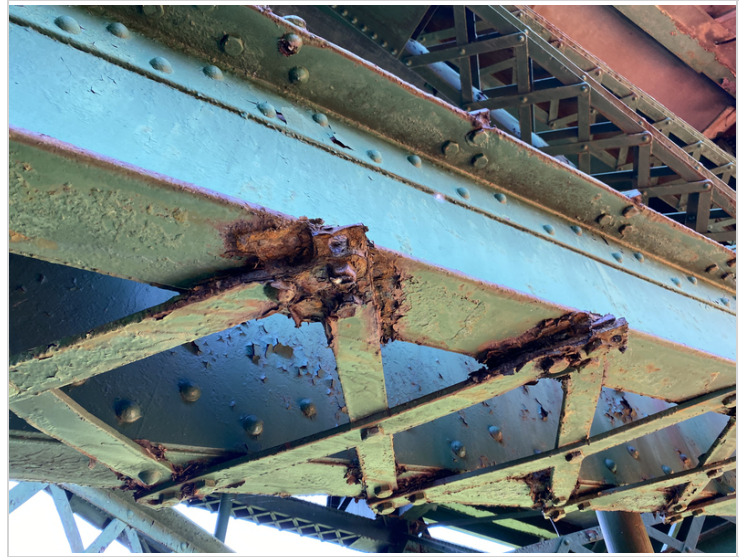
Bottom Chord Section #6 Upstream Pitting / Rust
Scaling

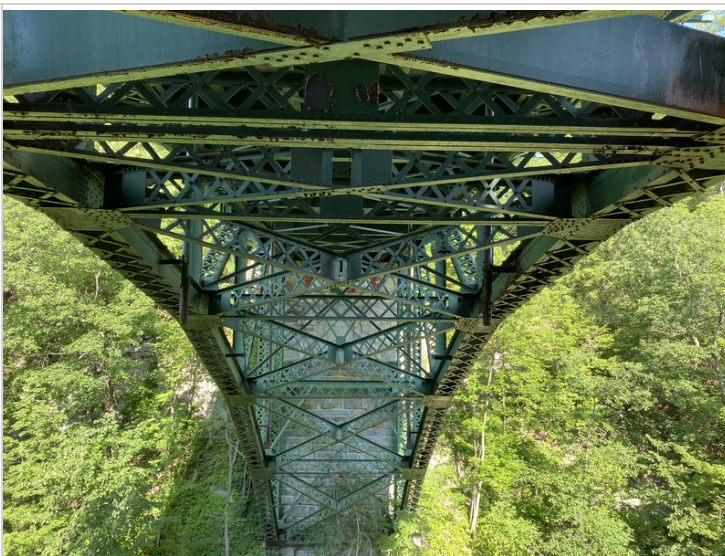
Lower Section of Truss towards Abutment #1

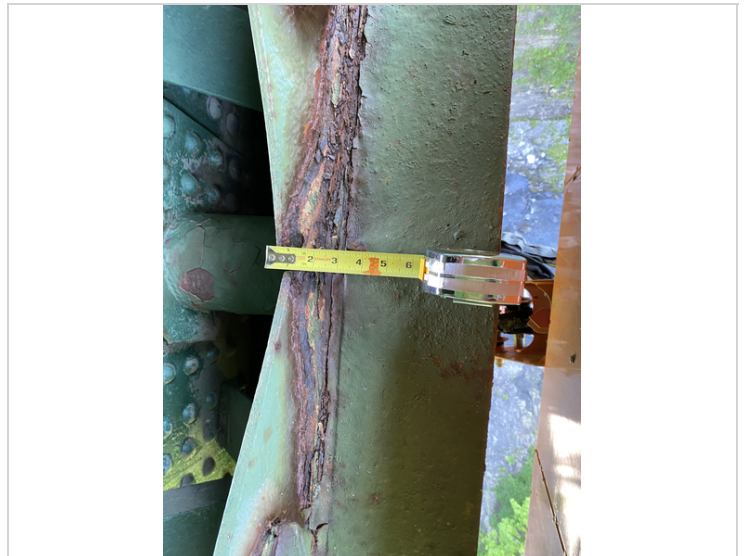
Pack Rust at Upstream Pin at Center of Arch

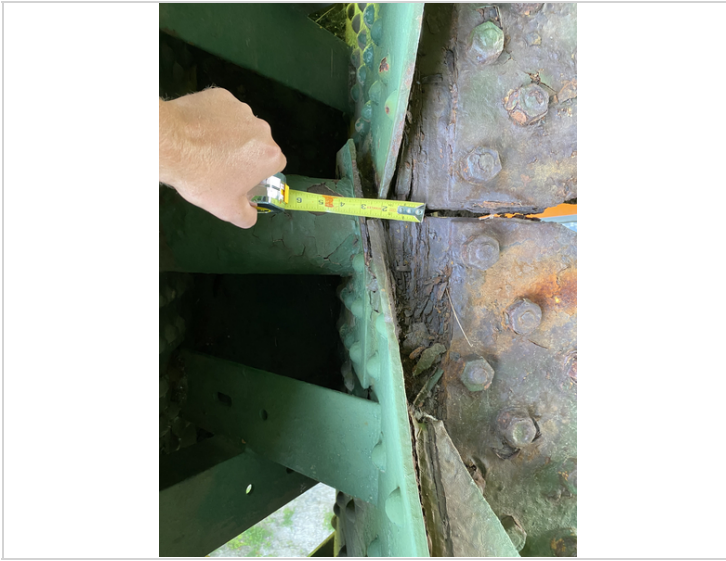
Pack Rust at Upstream Pin at Center of Arch

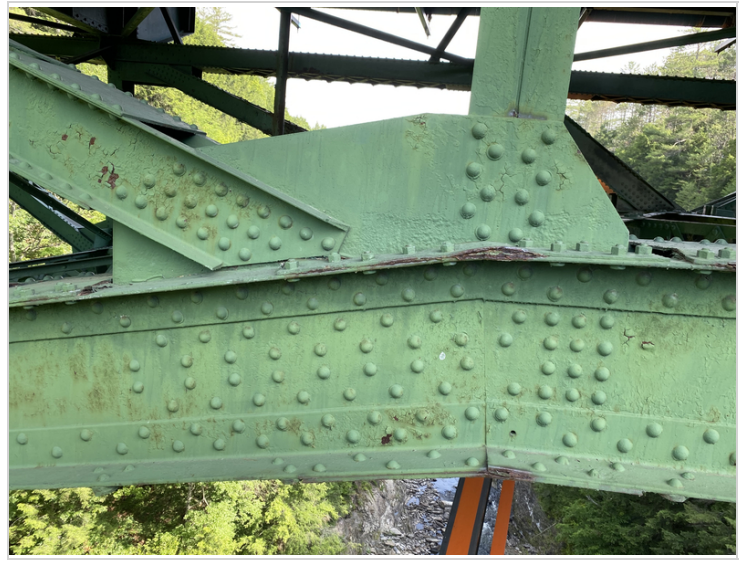
Downstream Bottom Chord / Gusset at Vertical #5

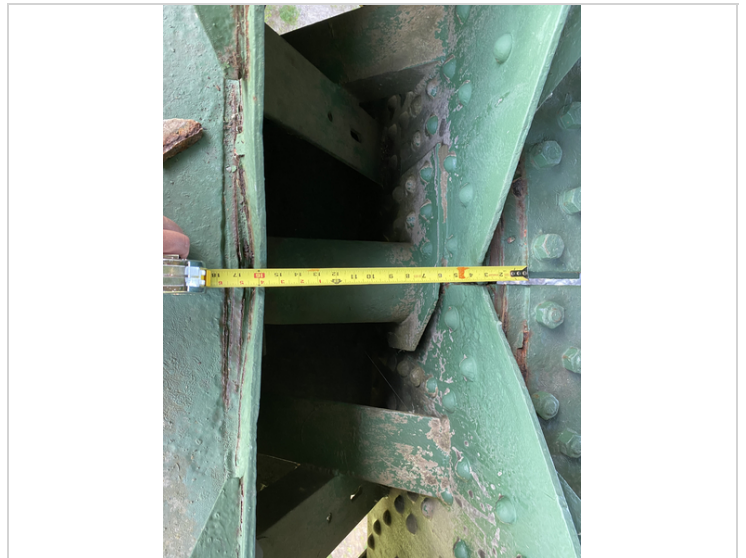
Upstream Center Pin Condition

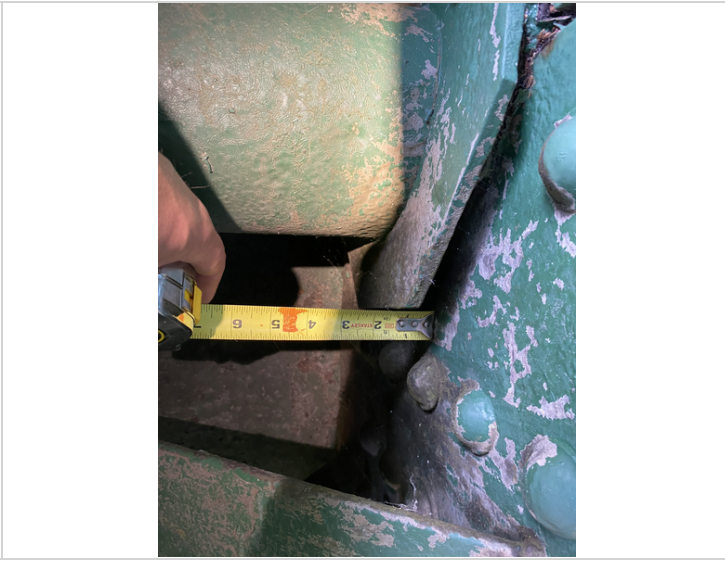
Upstream Interior Plate Bending / Displacement at Center Pin

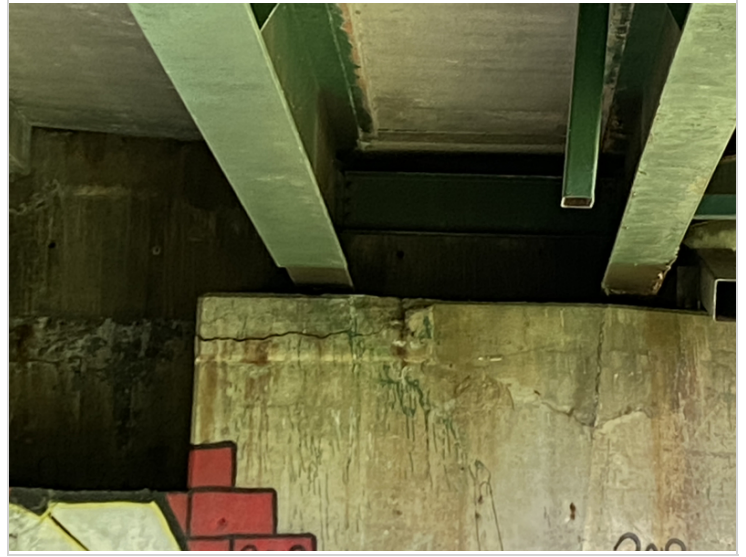
Abutment Cracking below Beam #3

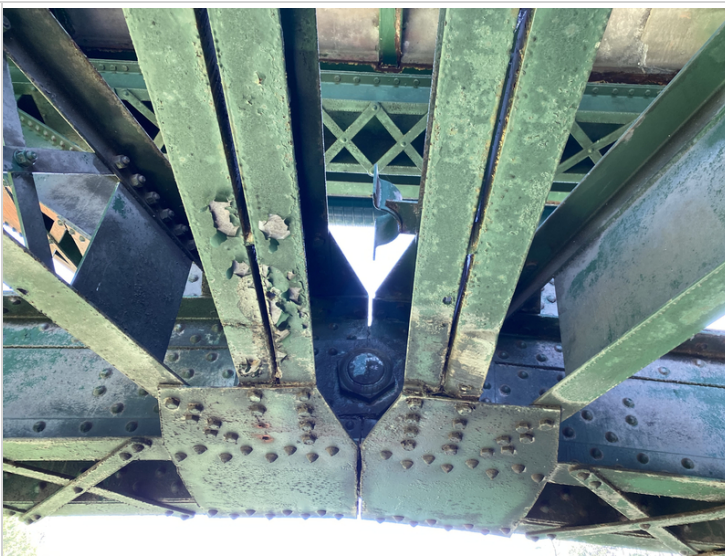
Pin at Center of Arch Upstream

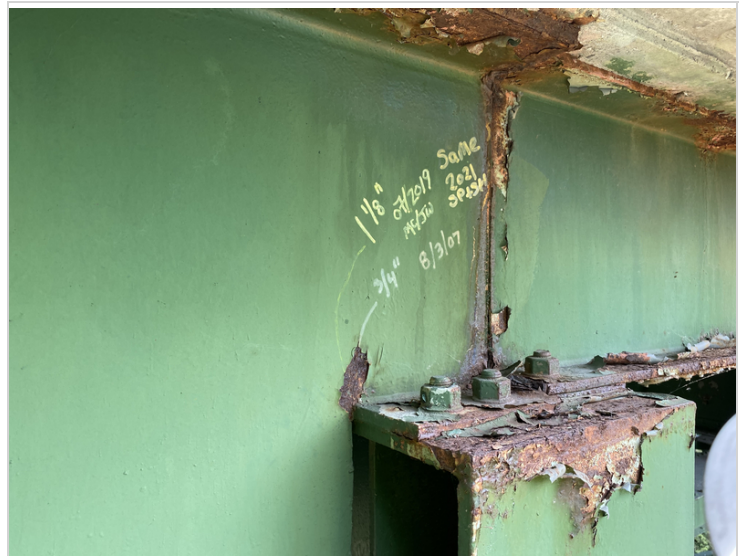
Girder #8 over Floor Beam #1 with ~1-1/8" Crack

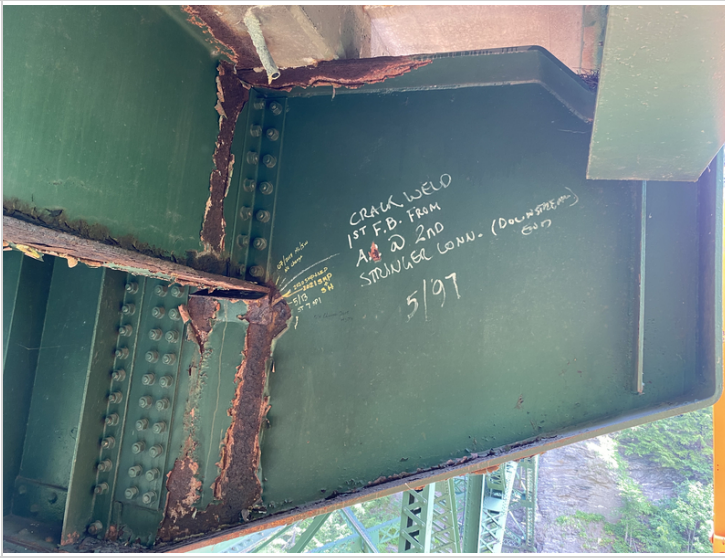
Cracked Weld at Floor Beam #1 West Side along Beam #7

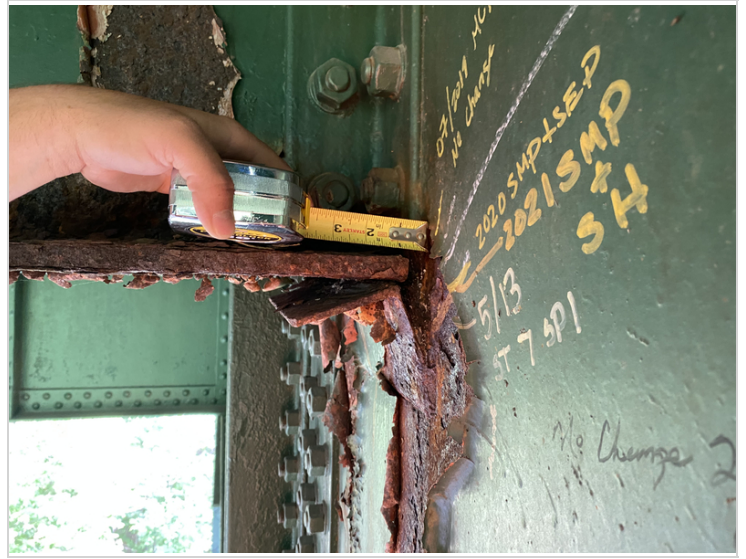
Cracked Weld at Floor Beam #1 West Side along Beam #7

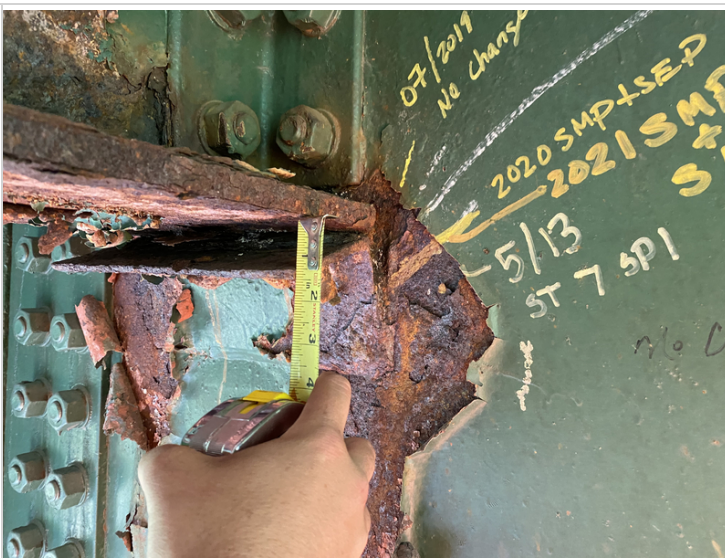
Cracked Weld at Floor Beam #1 West Side along Beam #7 with ~1-1/4" of Downward Transition

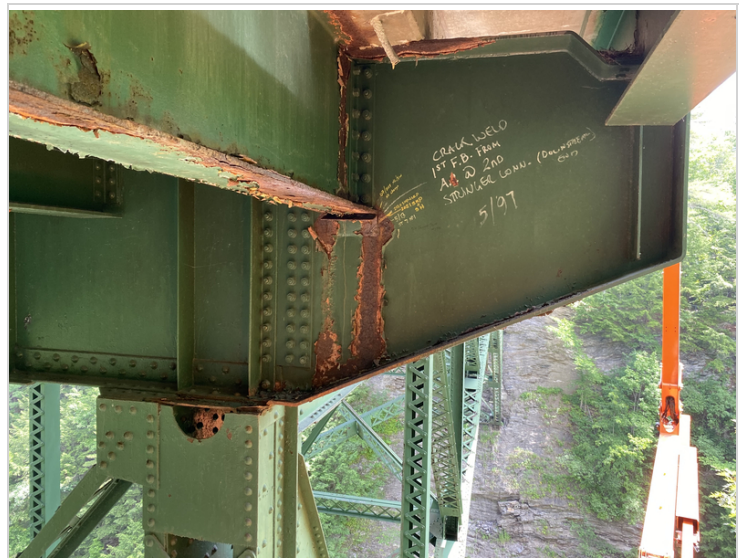
Downstream End of Floor Beam #1

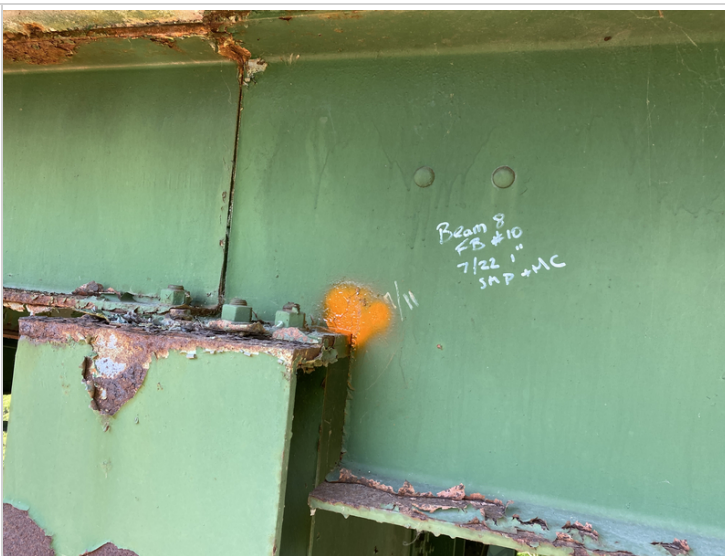
Beam #8 at Floor Beam #10 Downstream with ~1" Crack at Coped End

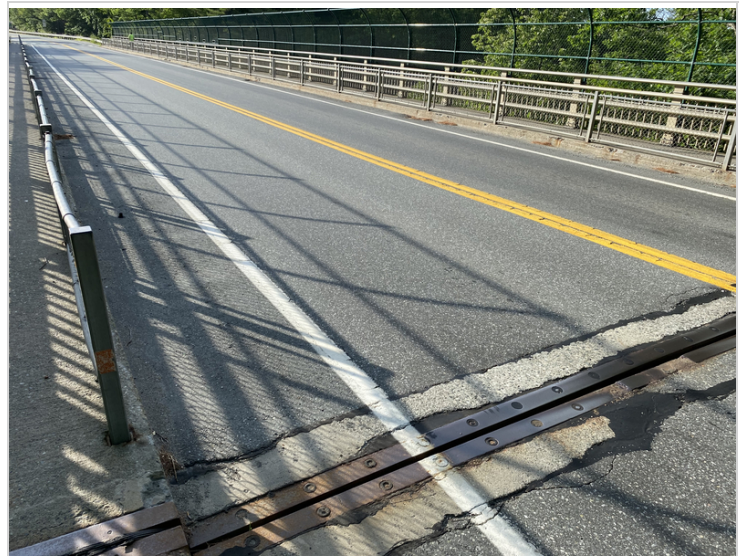
Deck Wearing Surface from Upstream Abutment #1

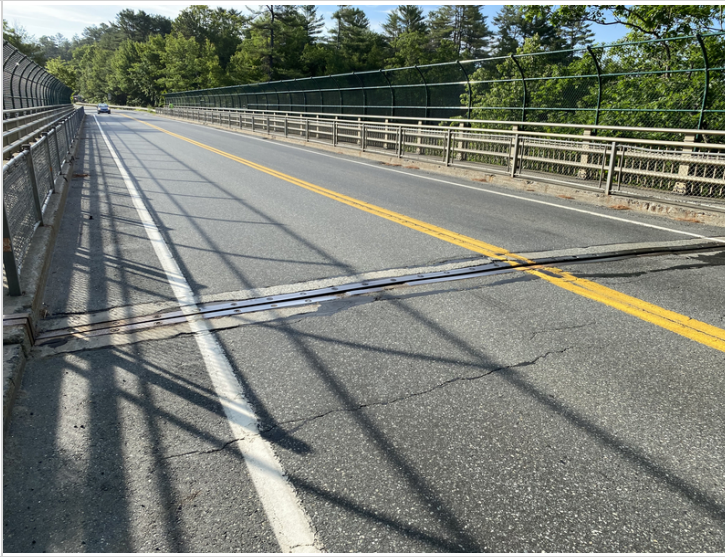
Deck Wearing Surface from Abutment #1 End

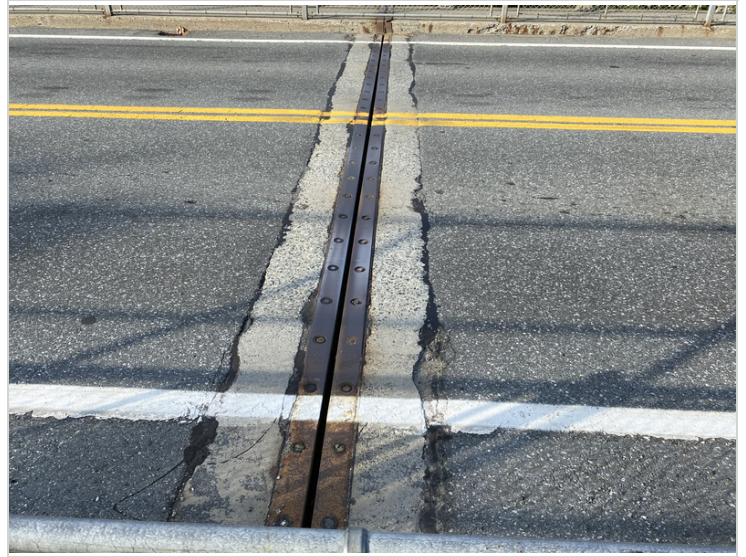
Vermont Type Joint over Center

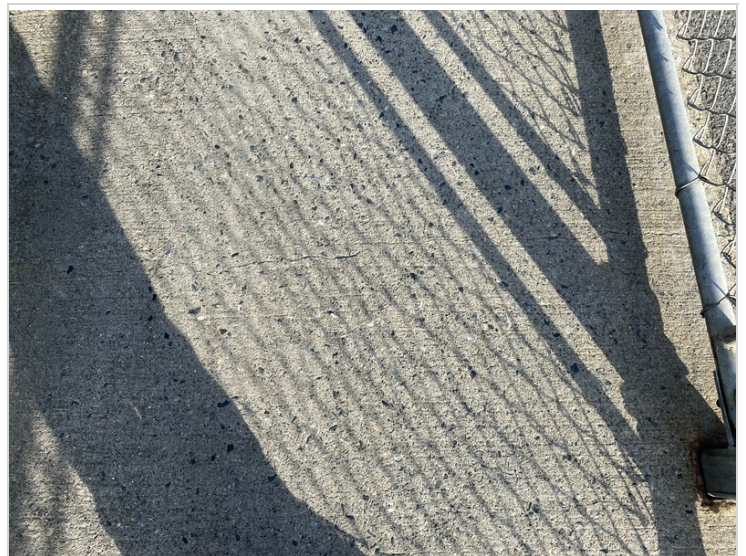
Transverse Cracks in Downstream Sidewalk

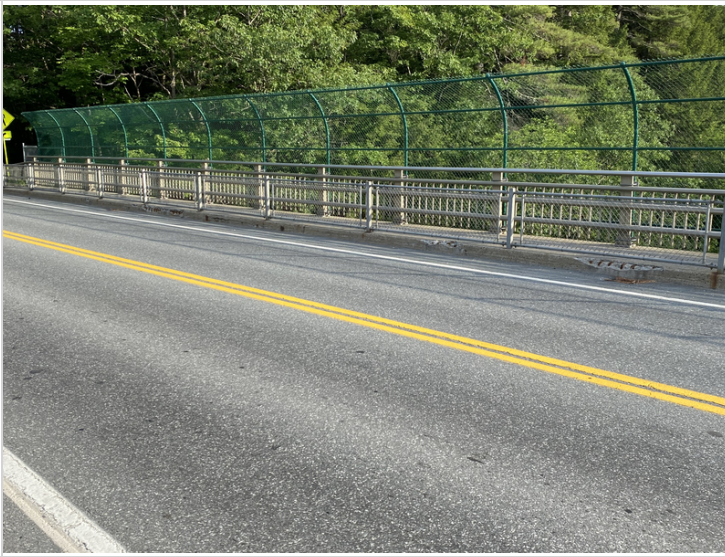
Upstream Curb Spalling

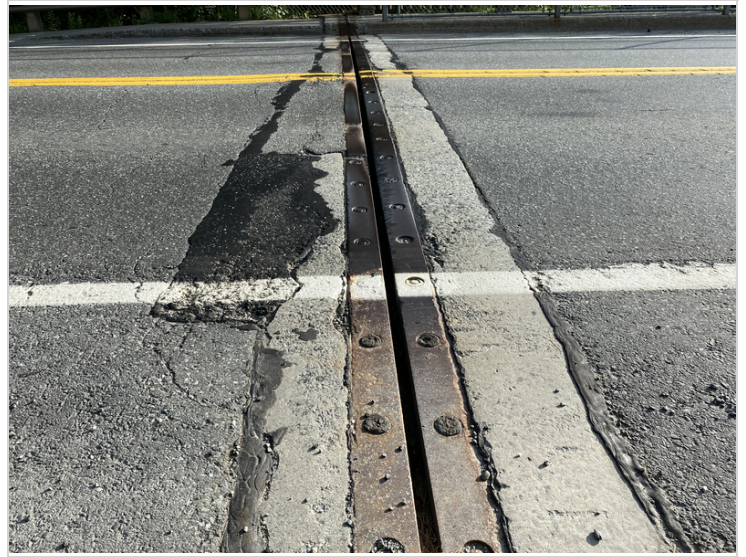
Vermont Type Joint over Abutment #1

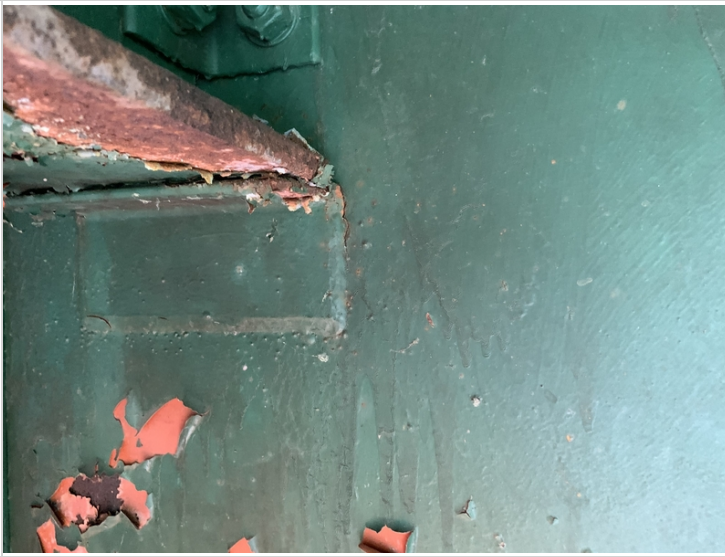
Cracking in Weld at Floor Beam #10

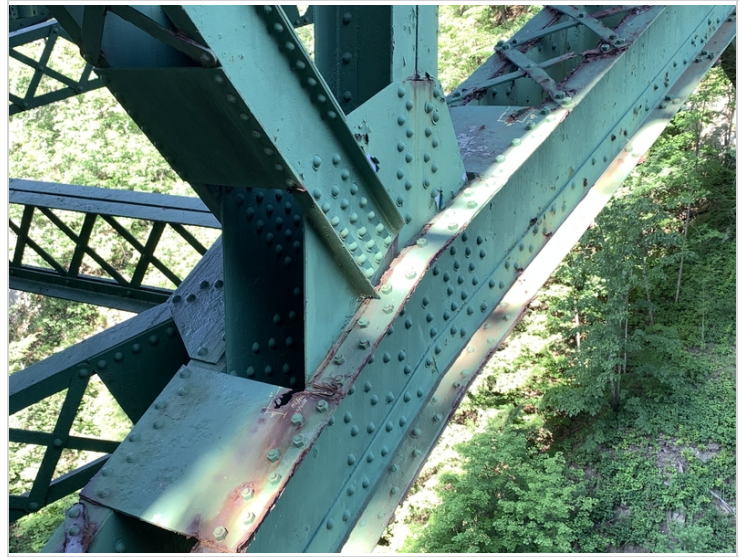
Section Loss in Plating at Vertical #9 Upstream on Bottom Chord

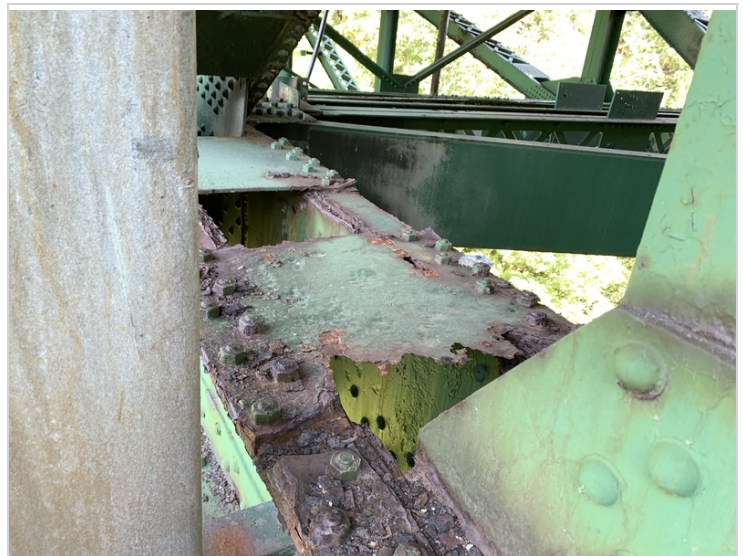
Section Loss along Upstream Bottom Chord Connection Plate between Vertical #4 and #5

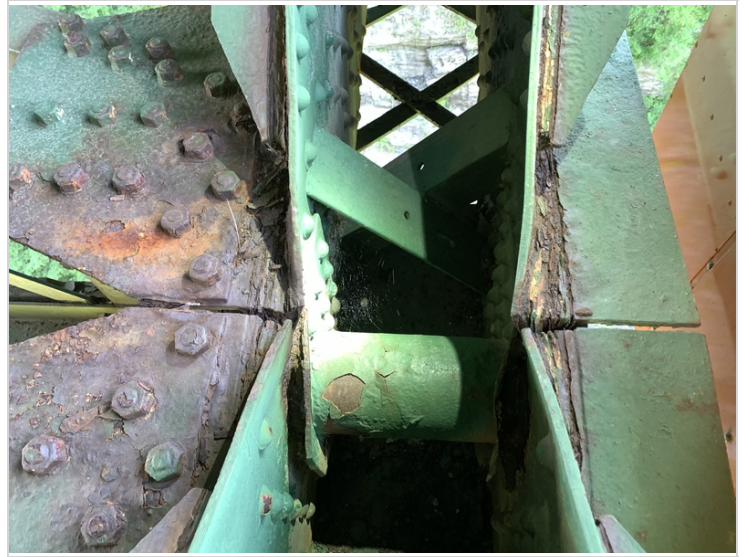
Downstream Pin Condition

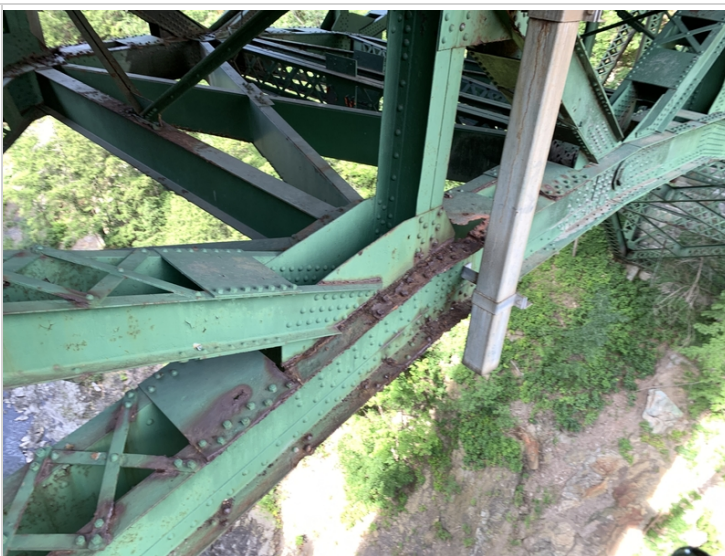
Bottom Chord at Vertical #6 Gusset / Connection Plate with Section Loss

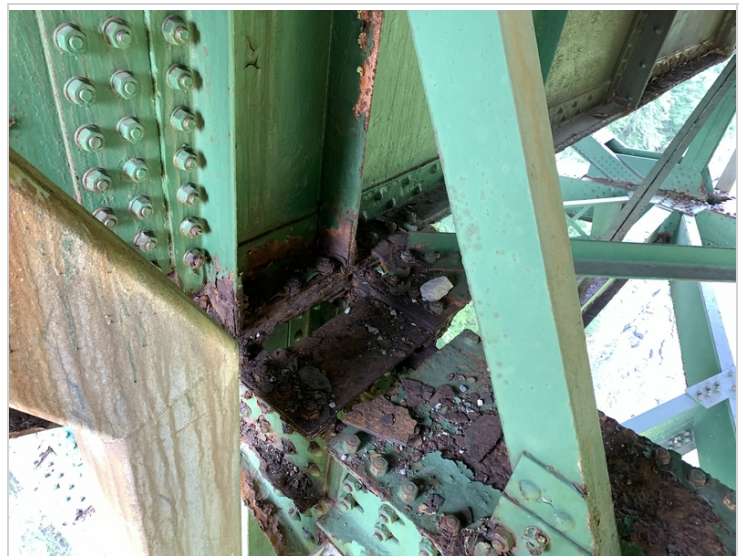
Rust Scaling on Top Chord below Floor Beam #6 on West Side

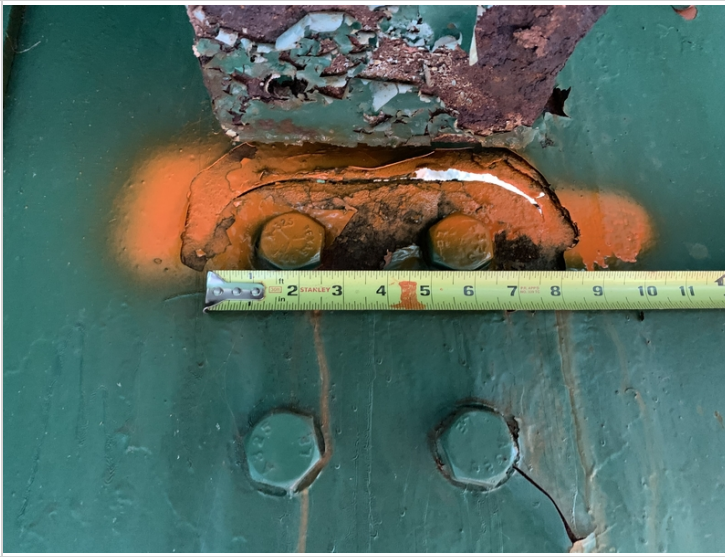
Crack/Perforation in Floor Beam Web #6 from East Side on Stringer #2

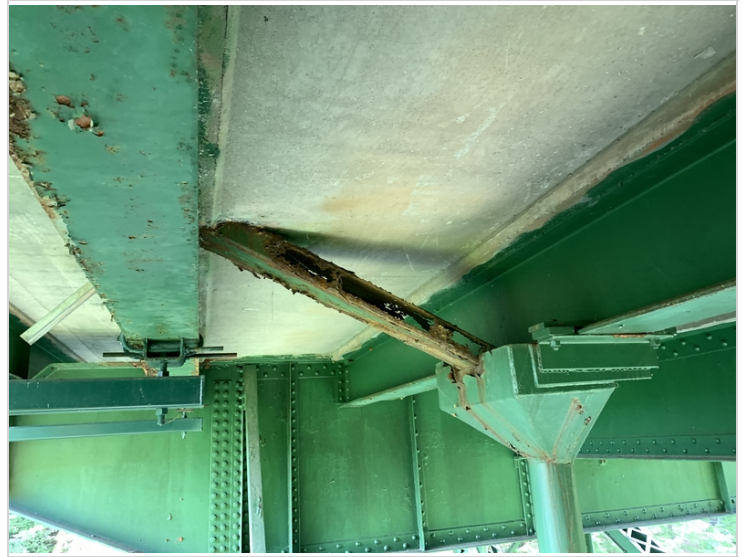
Heavy Section Loss in Deck Drain

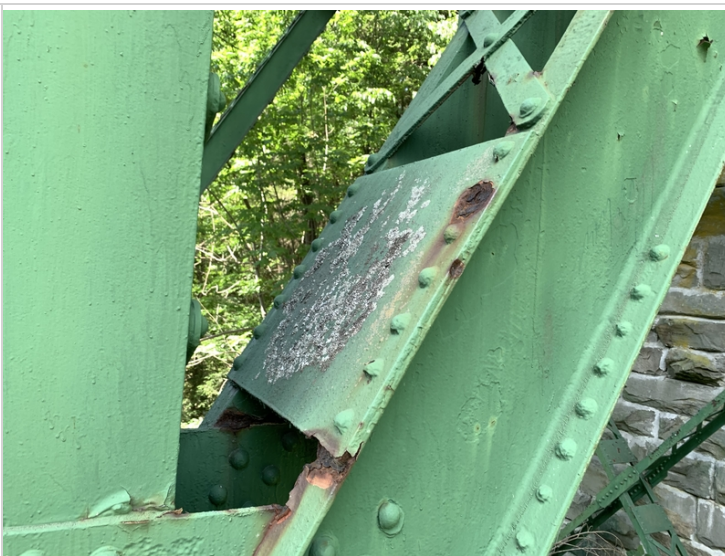
Failed Rivet in Bottom Chord at Diagonal #1 Upstream Side

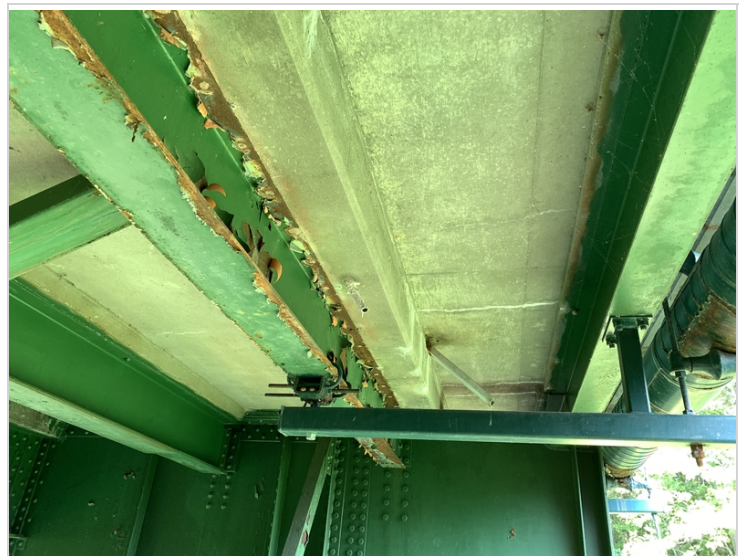
Cracking in Deck Underside

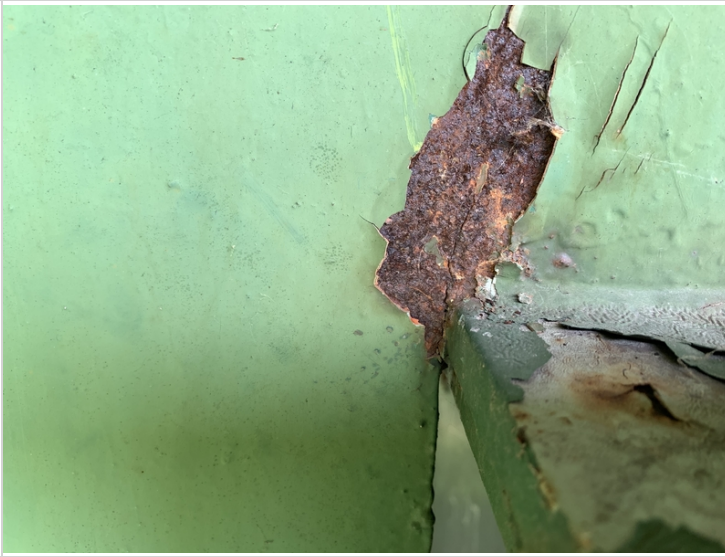
Crack in Stringer #8 at Floor Beam #1 ~1-1/8" in Length

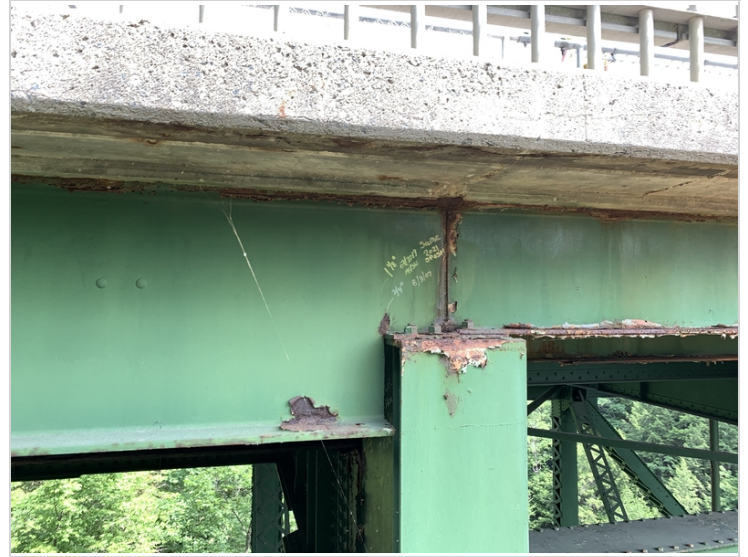
Crack in Stringer #8 at Floor Beam #1 ~1-1/8" in Length

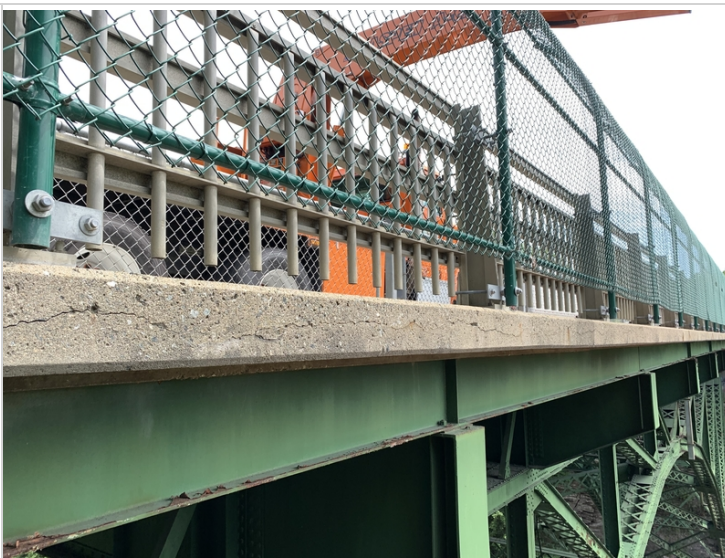
Cracking along Downstream Fascia

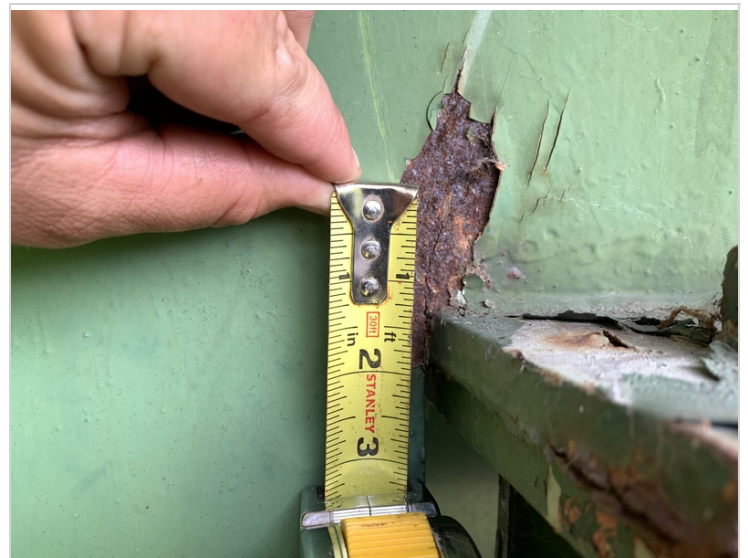
Crack in Stringer #8 at Floor Beam #1 ~1-1/8" in Length

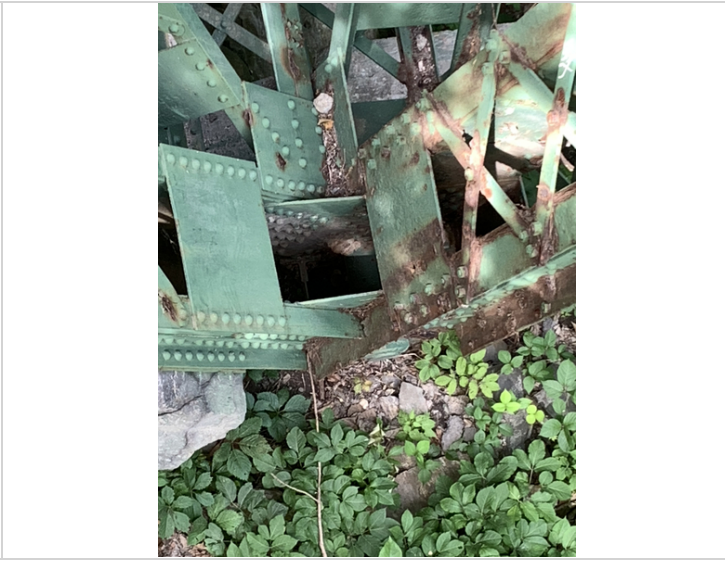
Bearing on Downstream Side of Arch on West End

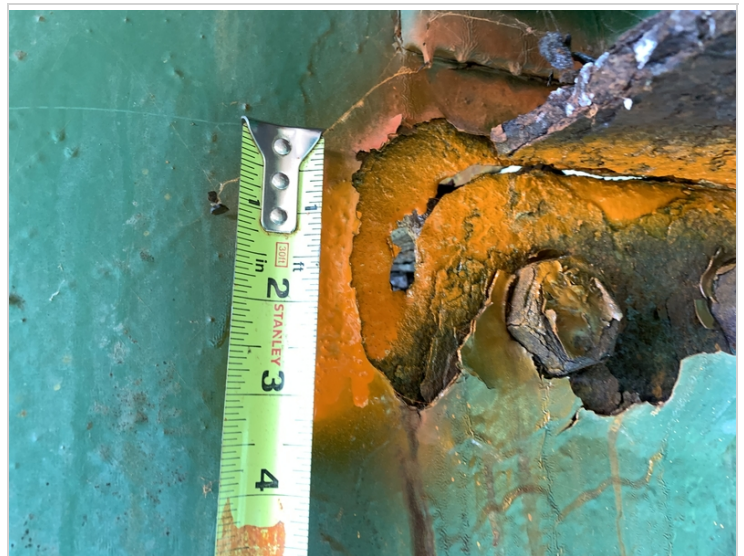
Crack along Web on Downstream side of Floorbeam #6 below Connection with Stringer #7

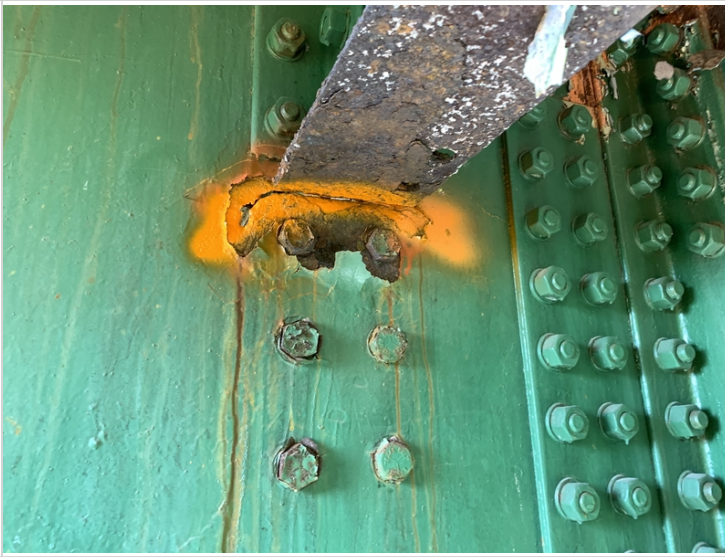
Crack along Web on Downstream side of Floorbeam #6 below Connection with Stringer #7 on East Side

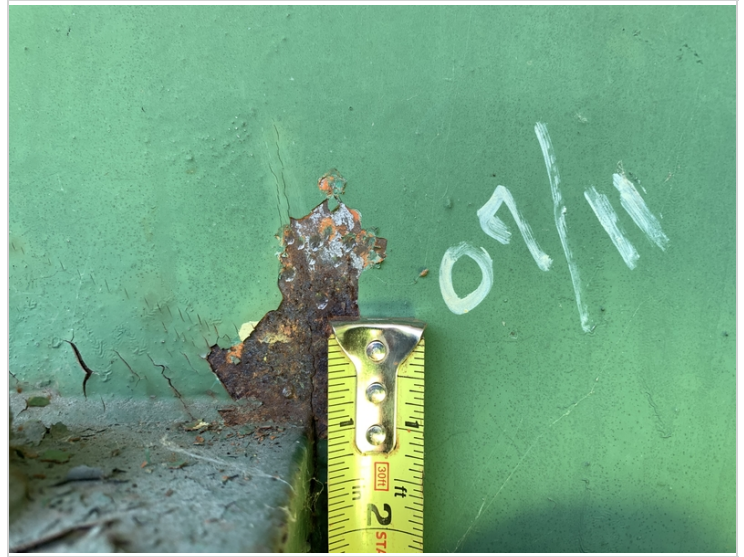
Crack in Stringer #8 at Floor Beam #10 ~1" in Height on Bottom of Coped End

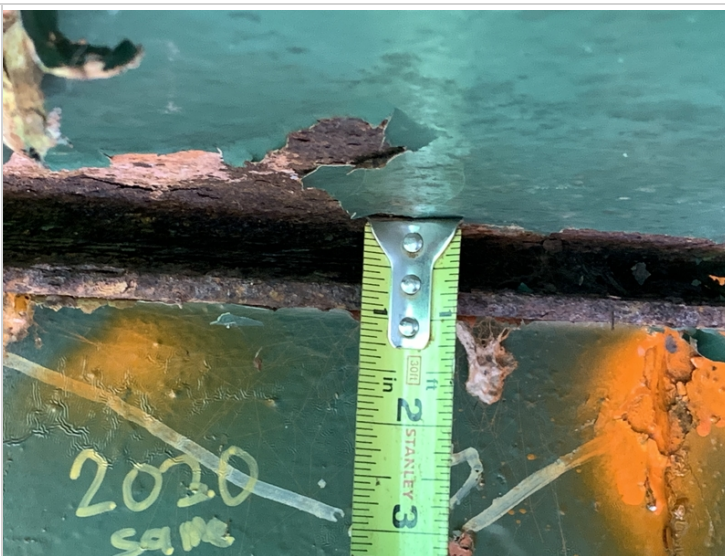
~3/4" Movement of Connection Plate on Stringer #7 at Floor Beam #10

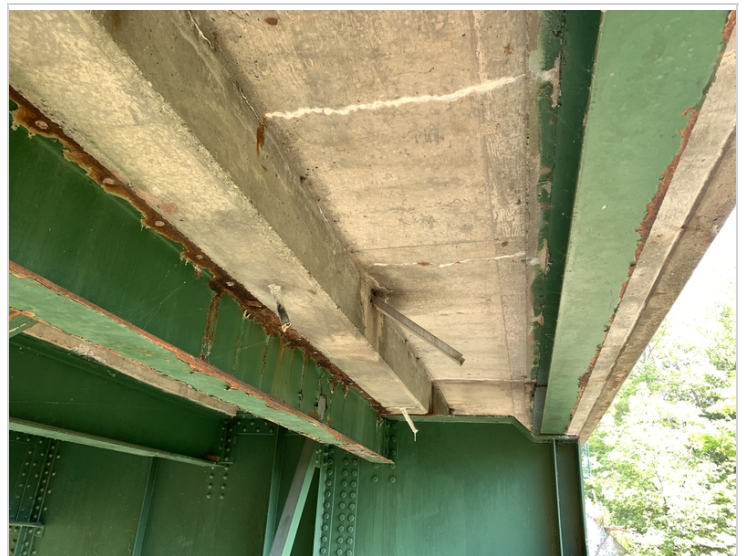
Cracking in Deck in Bay #7 near Abutment #2

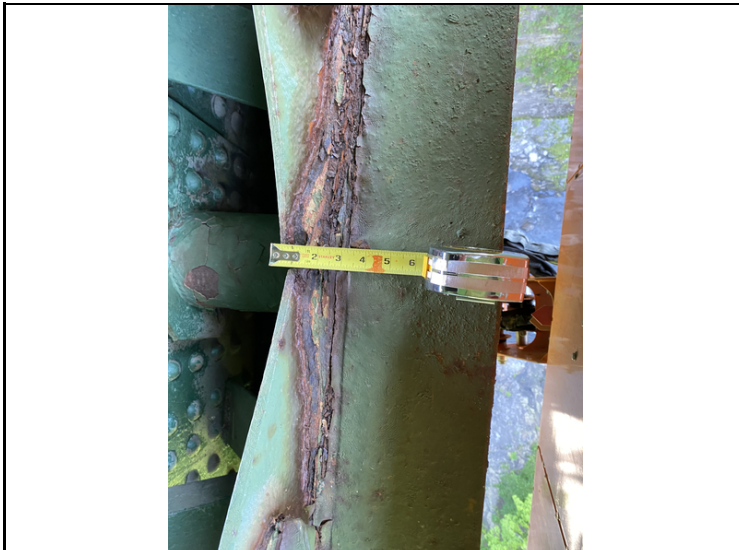
Pack Rust at Upstream Pin at Center of Arch

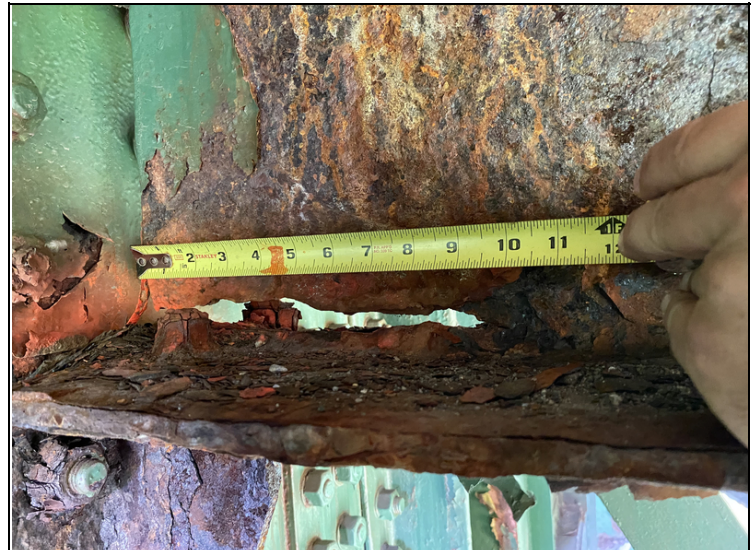
~10" Perforation along Lower Portion of Web at Beam #2 at Floor Beam #6

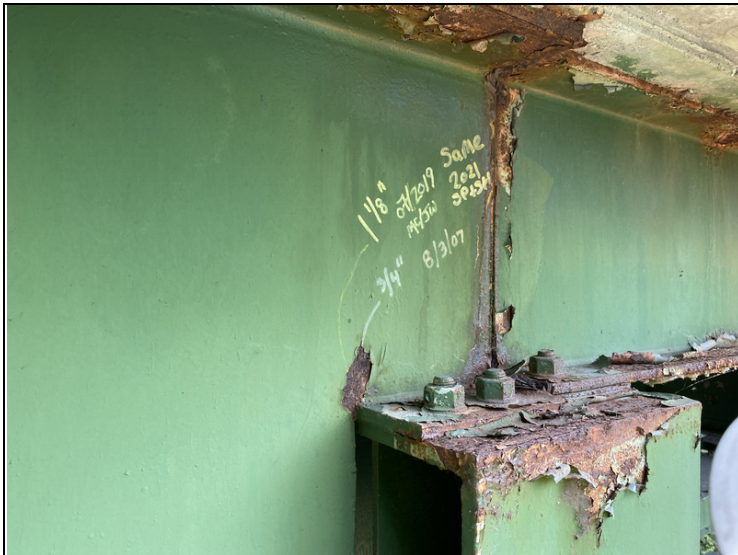
Girder #8 over Floor Beam #1 with ~1-1/8" Crack

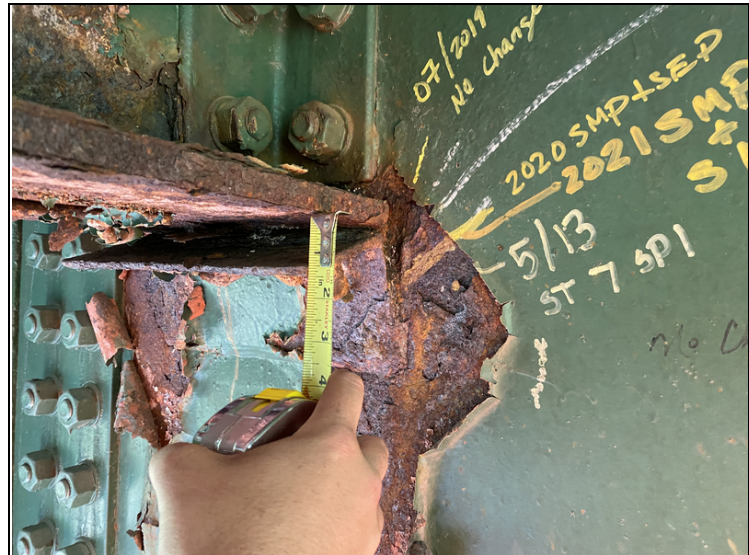
Cracked Weld at Floor Beam #1 West Side along Beam #7 with ~1-1/4" of Downward Transition

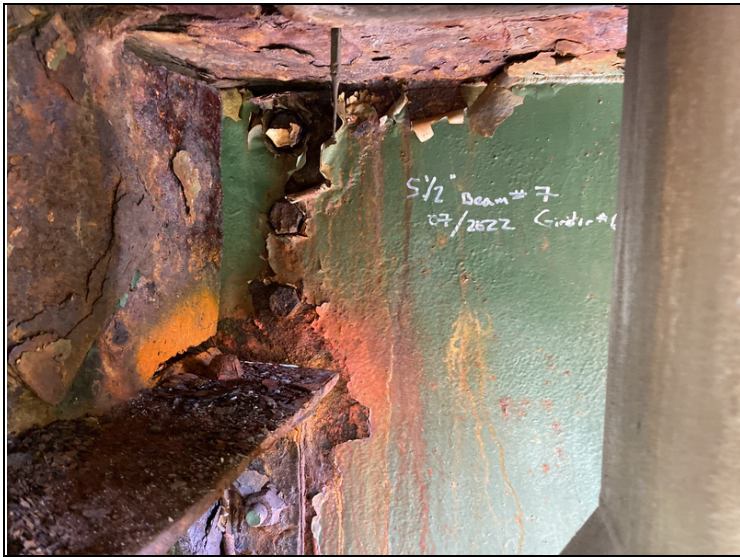
~5-1/2" Perforation along Lower Portion of Web on
