Town: 206 - SPRINGFIELD

IDENTIFICATION	
(1) State Names	50 - Vermont
(8) Structure Number	200091027N14182
(5) Inventory Route	1
(2) Highway Agency District	2 - District 2
(3) County Code	27 - WINDSOR

(4) Place Code	69550
(6) Features Intersected	BIKE PATH
(7) Facility Carried	I 00091 ML
(9) Location	0.1 MI S EXIT 7
(11) Mile Point	41.541 mi
(12) Base Highway Network	Yes

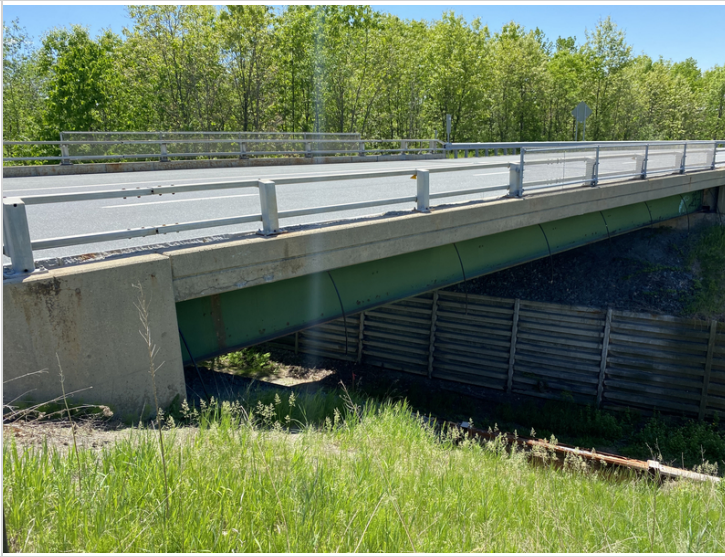
Concrete fascia has some areas of light cracking and small rust stains in various locations along both fascias. Top surface of fascia's have minor to moderate longitudinal cracking forming.

Western Fascia

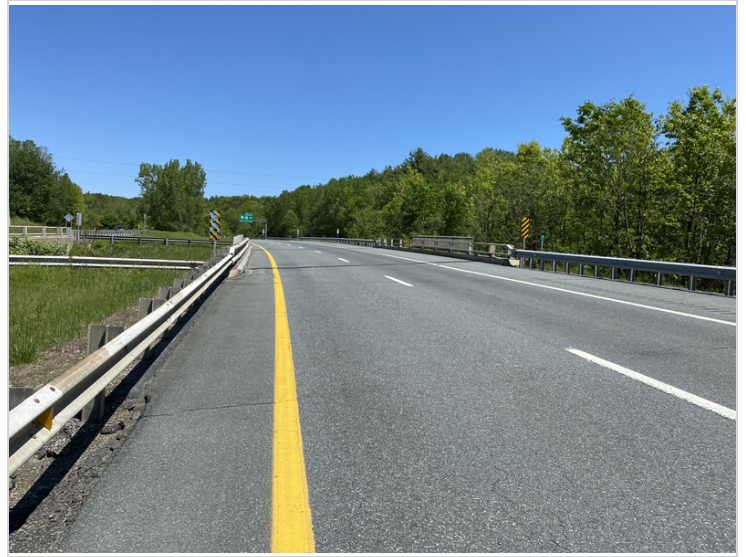
Southern Approach

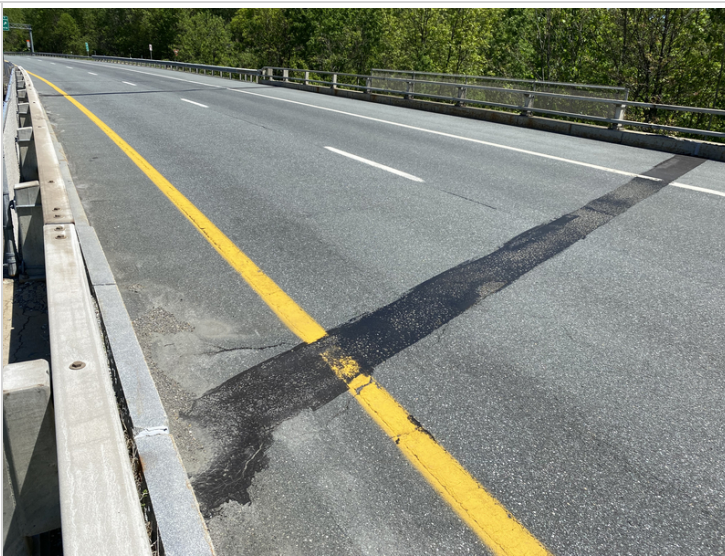
Asphalt is in fairly good condition with light wear in travel lanes and some light sealed cracking.

Deck Wearing Surface from Abutment #1

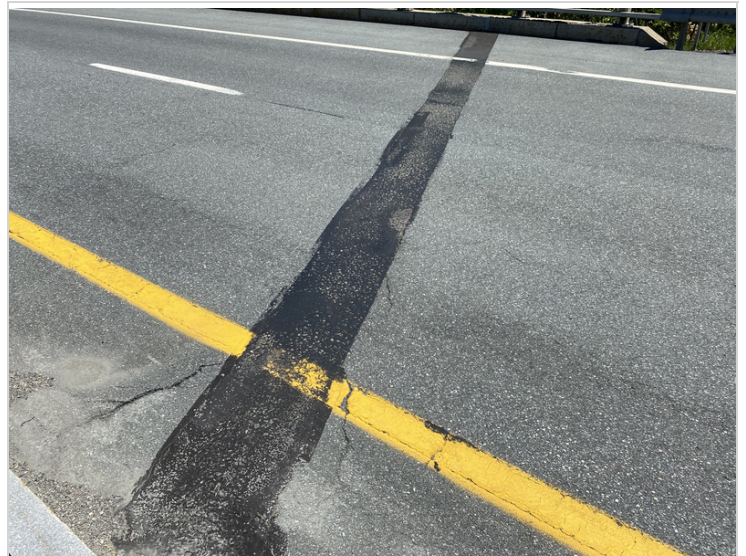
Asphaltic plug joints are present over both abutments with joints having some minor wearing in the travel lanes and some scattered minor transverse cracking along the joint edges.

Asphaltic Plug Joint over Abutment #1

Asphaltic plug joints over both abutments have minor transverse cracking along edges and should be considered for replacement to prevent leakage to structure below. Both sides of concrete curbing have areas of deep concrete scaling and should be cleaned and patched. Debris should be cleaned off abutment bridge seats. General cleaning of the paint is needed along the lower flanges at beam ends and bearings should be cleaned and repainted.

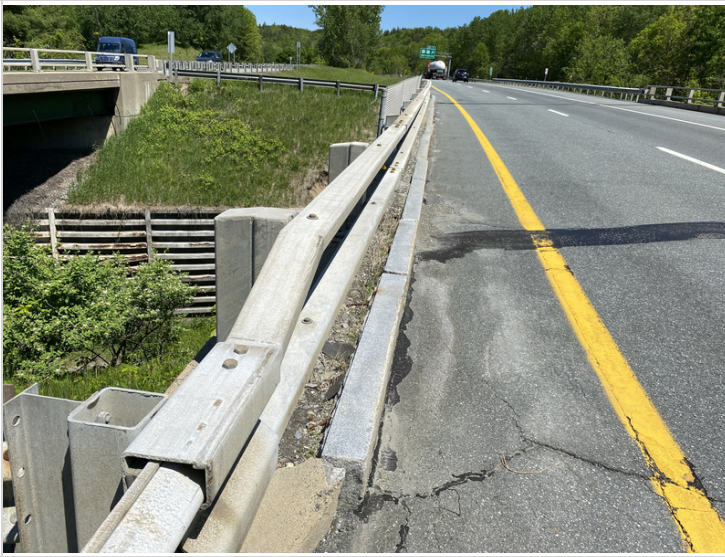
Concrete curbing with granite block facing is in poor condition with the concrete behind the granite facing having areas of moderate to heavy concrete scaling and areas of minor cracking. Granite blocks along the western curb are loose and have slight misalignment present. Western curb has heavier deterioration with the heaviest being present along the curbing over the wingwalls.

Western Curb Face

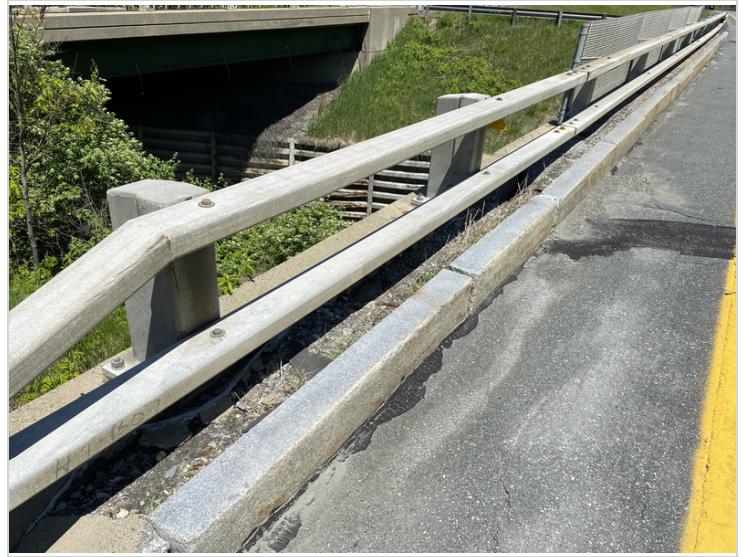
Curb Scaling along Western Side

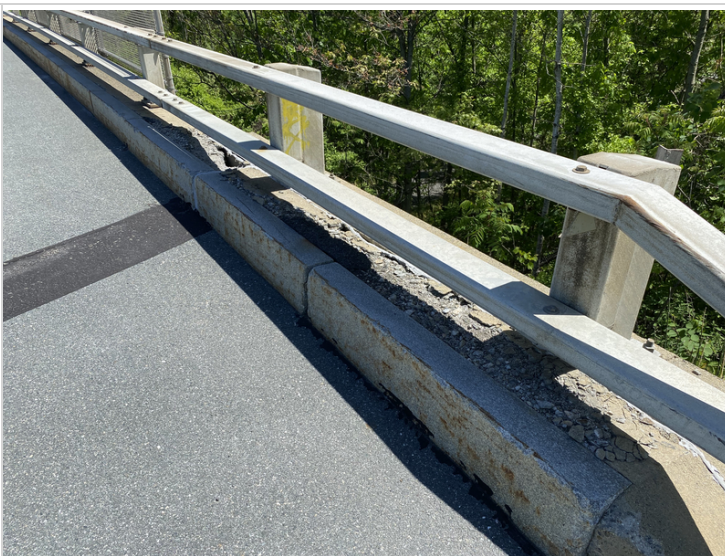
Eastern Curb Spalling / Scaling along the Southern Corner

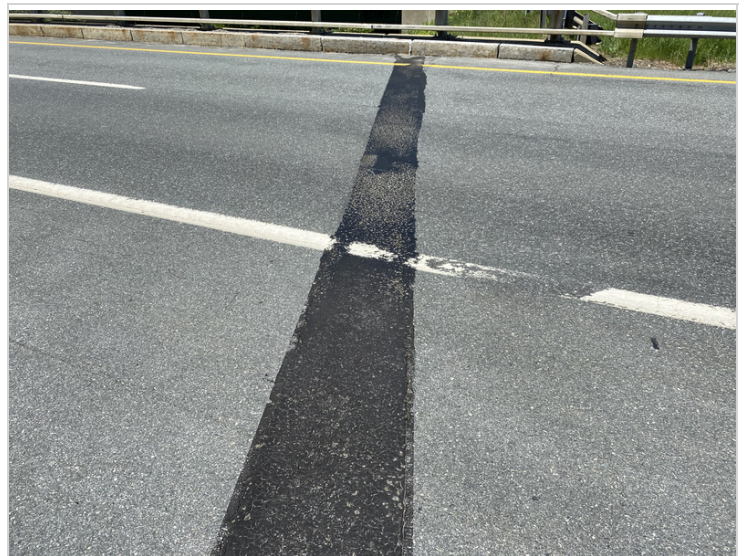
Asphaltic Plug Joint over Abutment #2

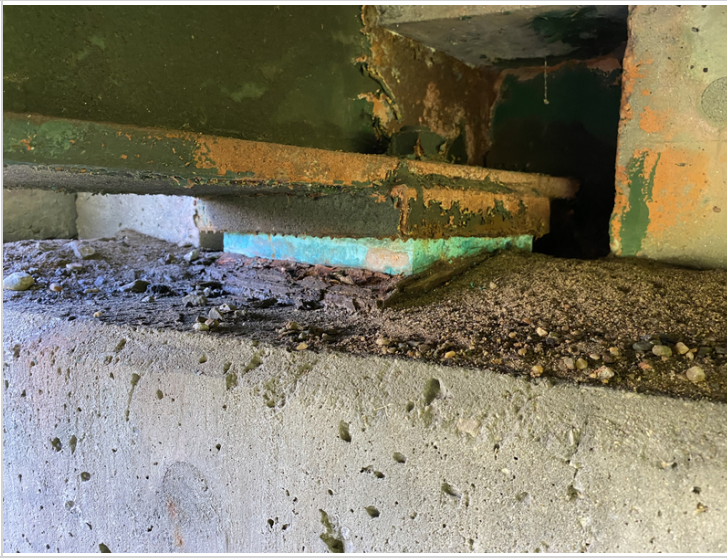
Abutment #2 has bronze bearings with interior bearings having some minor rusting and fascia bearings having minor rust scaling forming (mainly along the western side of structure). Sliding steel plates are present over abutment #1 having light rusting along the interior with fascia bearings having minor rust scaling forming.

Bronze Bearing #1 at Abutment #2

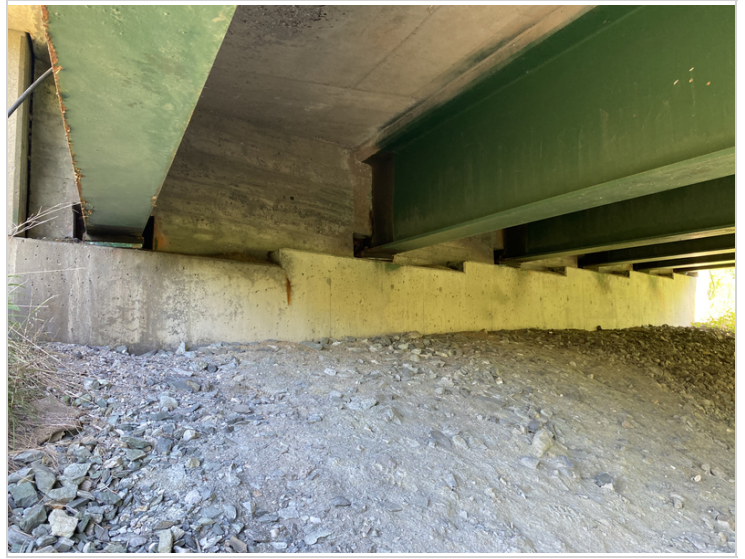
Abutment #2 is in fairly good condition having a few hairline vertical shrinkage cracks. Minor sandy debris build up is present along bridge seat.

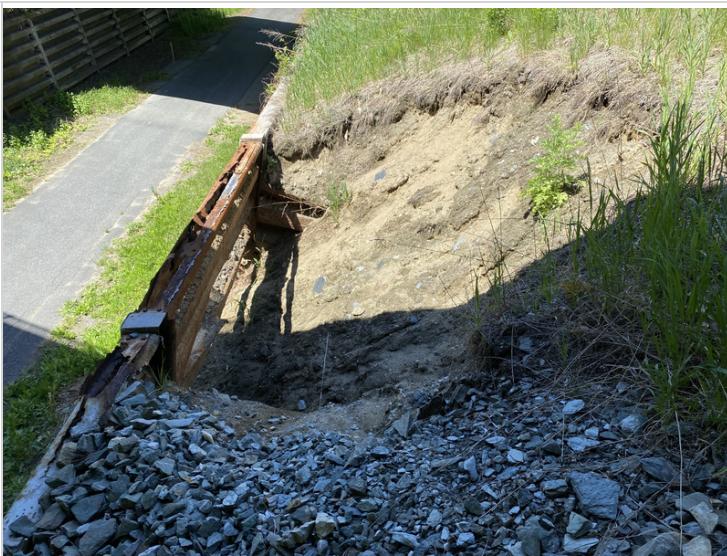
Retaining Wall Blow Out along Northwest Corner
of Structure

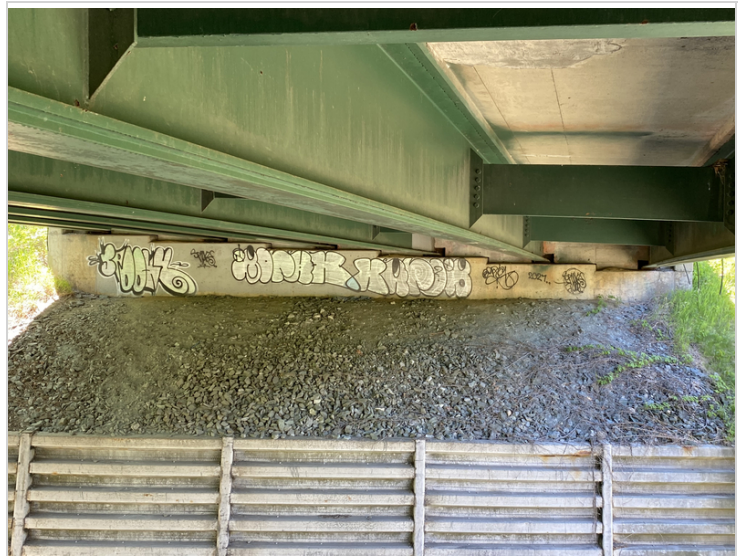
Abutment #1 is in fairly good condition having a few hairline vertical shrinkage cracks. Minor sandy debris build up is present along bridge seat. Minor saturated concrete and efflorescence leakage on the eastern end of abutment stem.

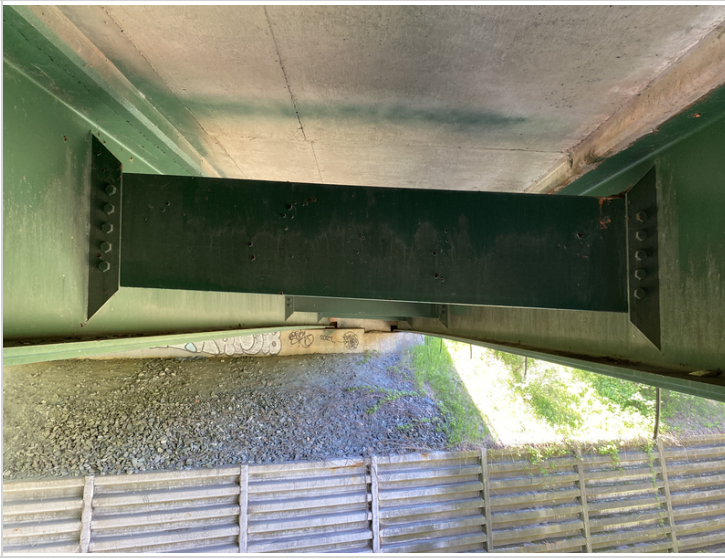
Three (3) painted steel c-channel diaphragms that are bolted to plates that are welded to the webs of the rolled beams are in fairly good condition with some very small areas of corrosion.

Typical Cross Bracing

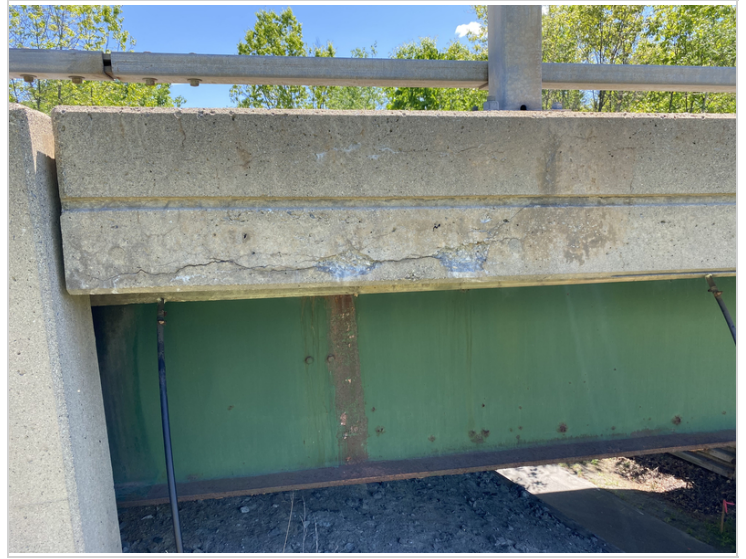
Northwest Corner Fascia

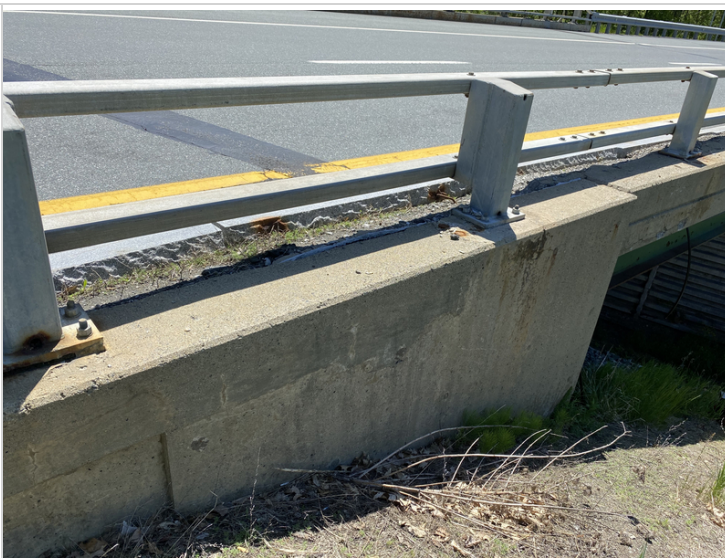
Northwest Curb Scaling / Spalling

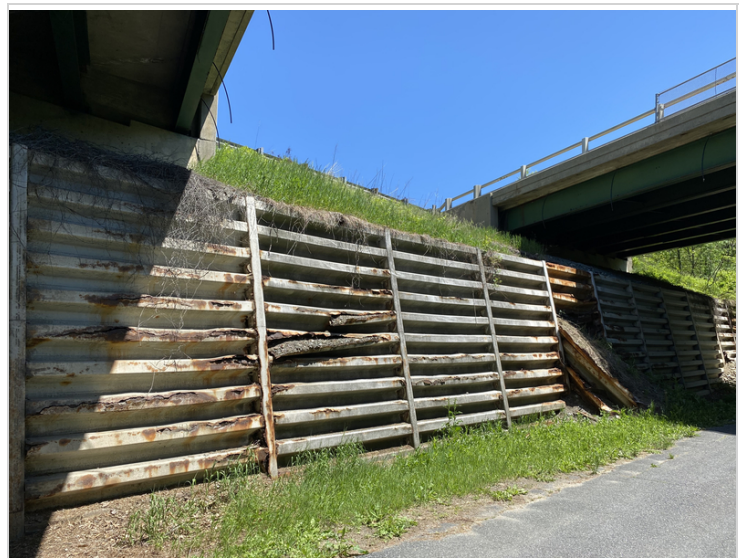
Northern Retaining Wall with Multiple Section Failing

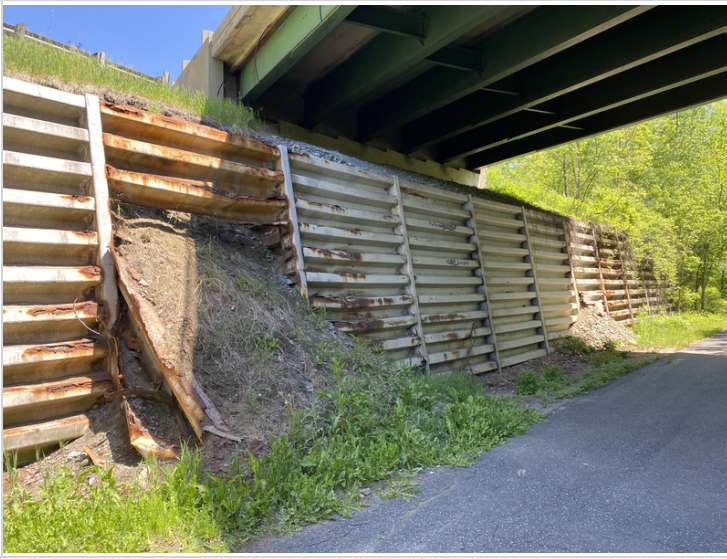
Northern Retaining Wall with Multiple Section Failing

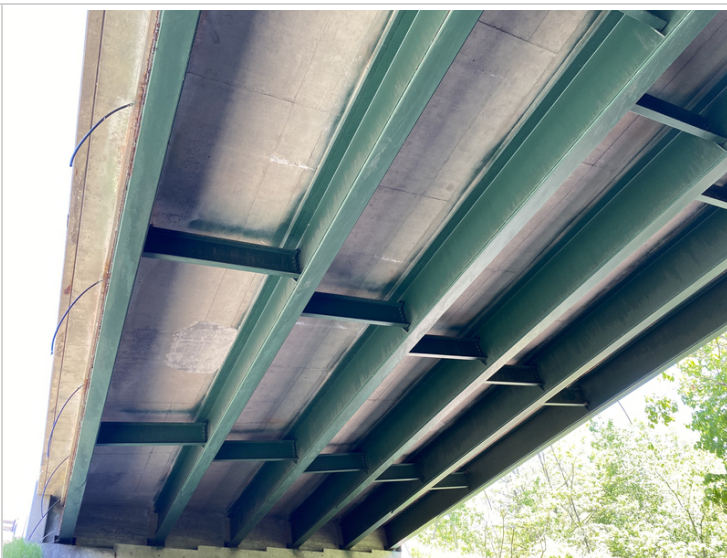
Superstructure

Six (6) painted steel rolled beams are in fairly good condition having positive camber and cover plates. Small areas of surface rusting mainly along the lower flanges and lower sections of the webs near the ends of the beams. Paint has minor distress along the lower flanges near the beam ends with steel corrosion initiated. Paint has small areas where paint is starting to bubble, flake and peel.

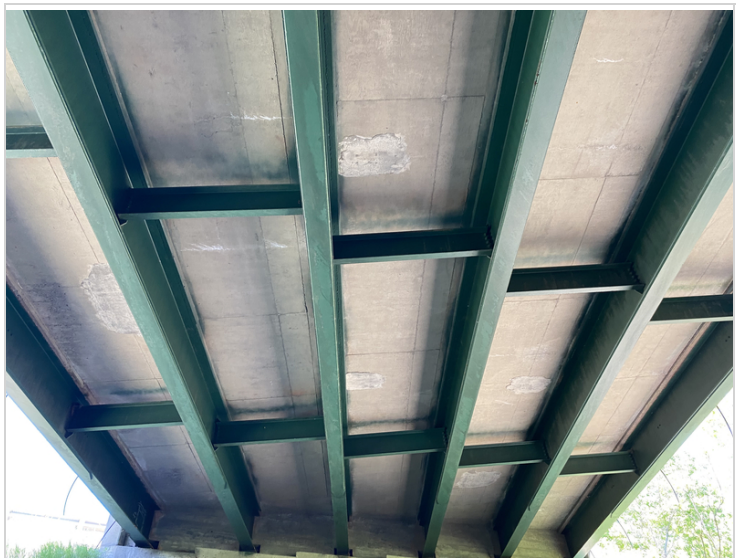
Reinforced concrete deck is in satisfactory condition being fairly clean with scattered areas of minor transverse cracking with efflorescence leakage present. Delaminations are forming around a few of the cracks scattered around the soffit. Deck has a few small patched areas which are in sound condition.

Deck Soffit Northern End

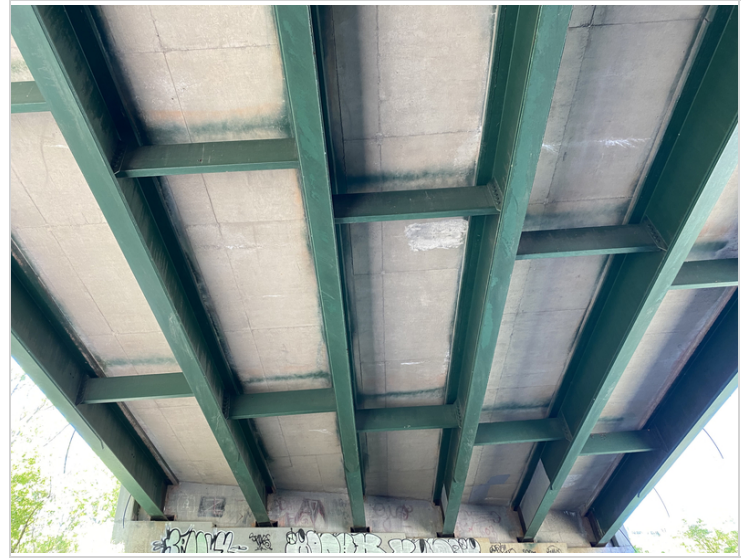
Deck Soffit Southern End

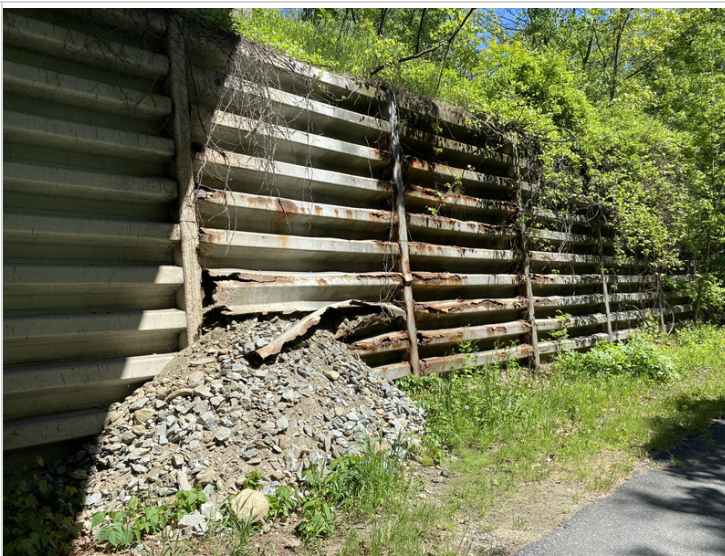
Failing Retaining Wall Northeast Corner

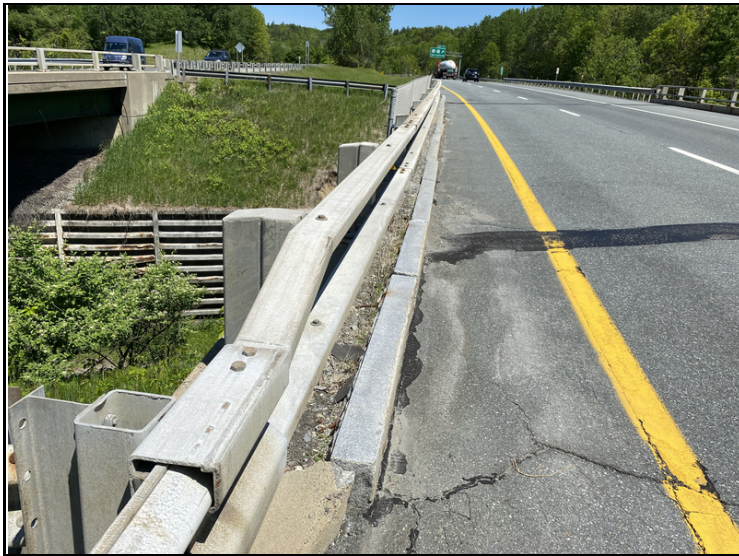
Concrete curbs have deep spalling / scaling scattered throughout and need to be cleaned and patched. Fascia's have longitudinal cracking that are starting to delaminate and have scaling in surrounding areas along the top surface and should also be considered for repairs.

Western Curb Face

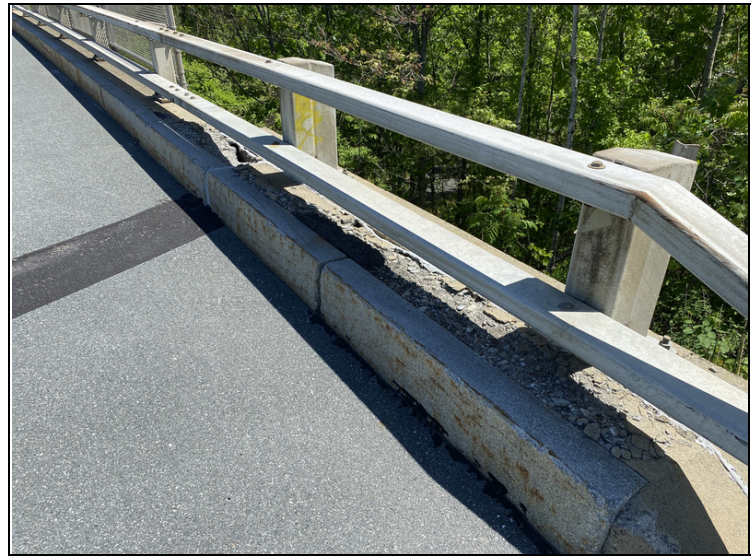
Eastern Curb Spalling / Scaling along the Southern Corner
