**STATE OF VERMONT
AGENCY OF TRANSPORTATION**

**Scoping Report
FOR
Elmore STP CULV(64)**

VT ROUTE 12, BRIDGE 90 OVER UNNAMED BROOK

May 28, 2020

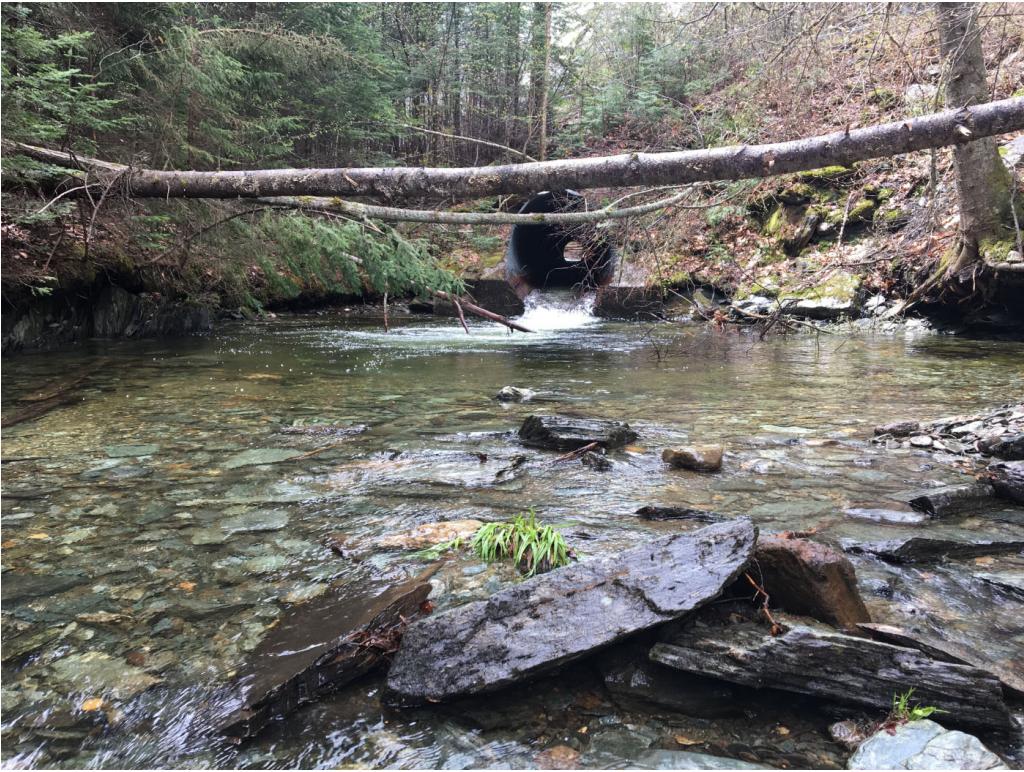
Picture 3: Culvert Outlet

This alternative is not recommended. The culvert is in serious condition and will continue to deteriorate if no action is taken. Additionally, there is a large drop at the outlet of the culvert making it impossible to pass fish. Something will have to be done to improve this culvert in the near future. In the interest of safety to the traveling public, the No Action alternative is not recommended. No cost estimate has been provided for this alternative since there are no immediate costs.

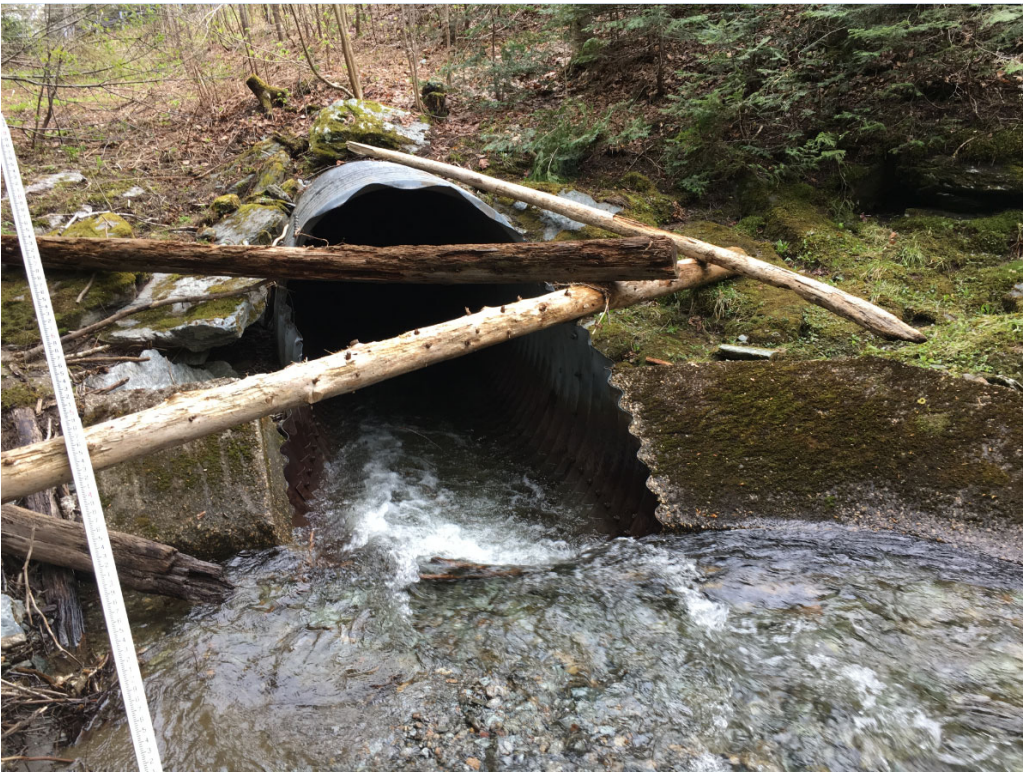
Picture 4: Culvert Inlet

12/28/2017 – Structure is in poor condition. There is distortion and signs of buckling. Pipe is in need or replacement or repair. Cracking and holes present throughout structure. A liner wouldn't work due to condition of culvert. Some debris is present at inlet and should be removed. ~MC/MJ

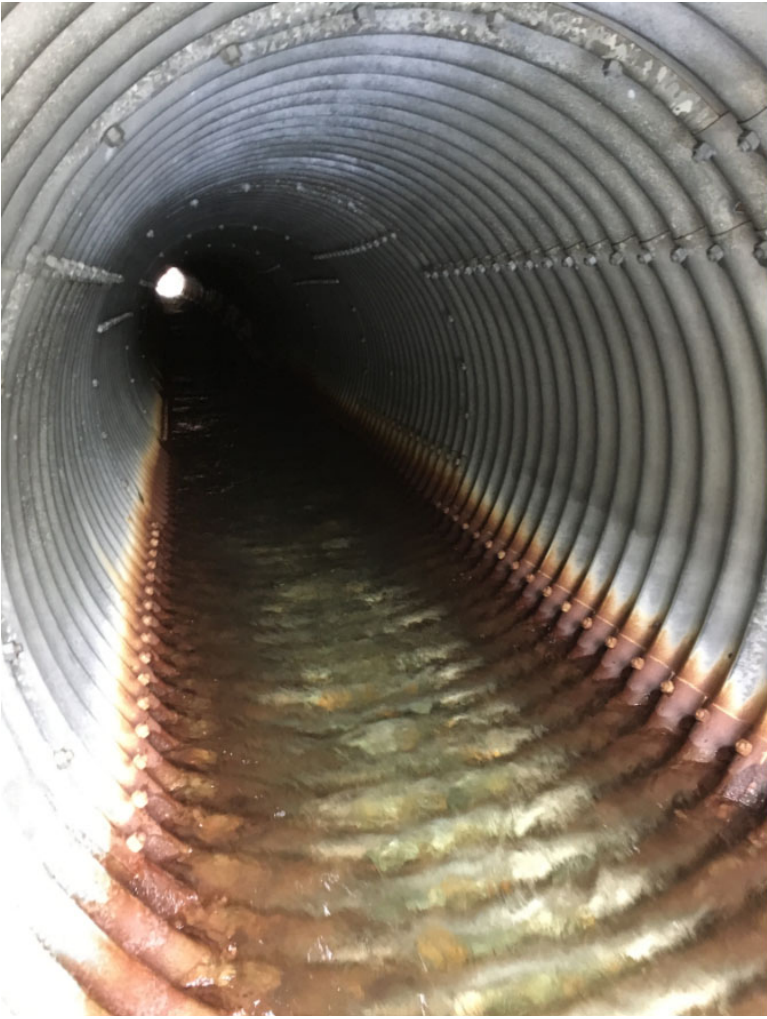
Picture 5: Culvert Barrel

1. The culvert is in serious condition. There is heavy rust scaling and holes throughout the invert. The pipe has buckled under the roadway and cracks have formed.
2. The existing culvert does not meet the calculated or measured bank full width and does not meet the minimum hydraulic standard.

12/5/2018 – Structure is in poor condition with heavy rust scaling and holes through out invert and haunches. The center of the pipe is buckling, and cracks have formed. Structure should be replaced. ~ABC/JAS

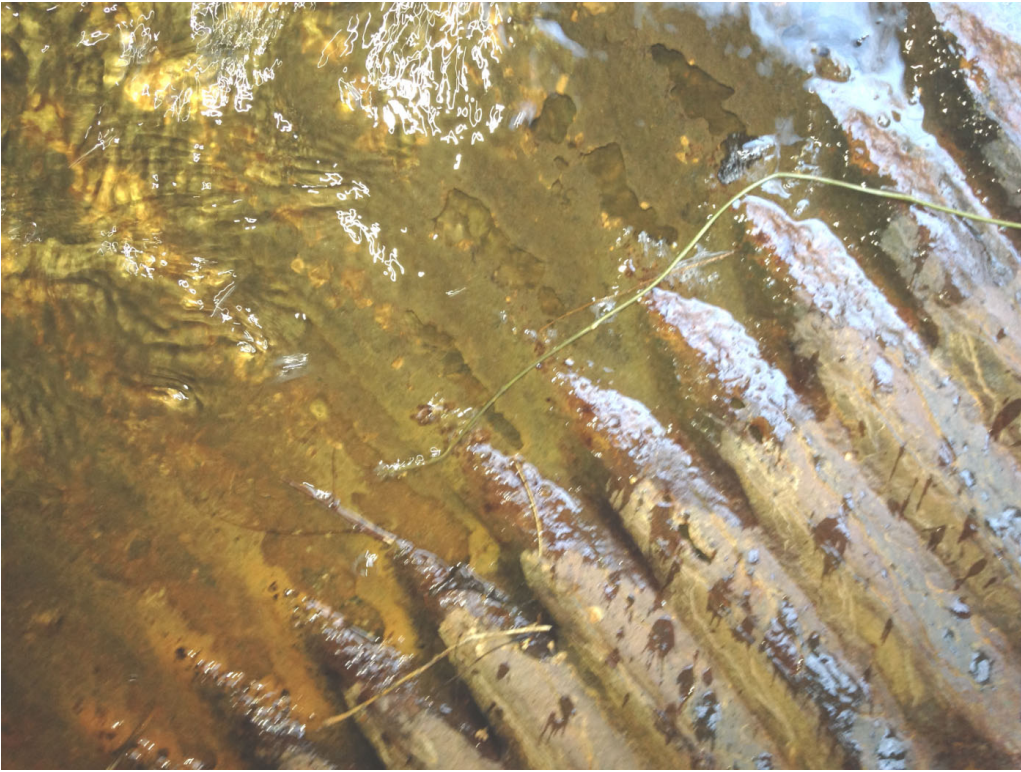
Picture 6: Perforations in Culvert Invert

11/20/2014 – There are scattered large perforations throughout along the invert. This has led to ex-filtration of soils and squashing of the center area of the pipe. The sides have bowed out and the top of the pipe has dropped 4"(+/-). This structure should be replaced in the near future. ~JWW/JDM

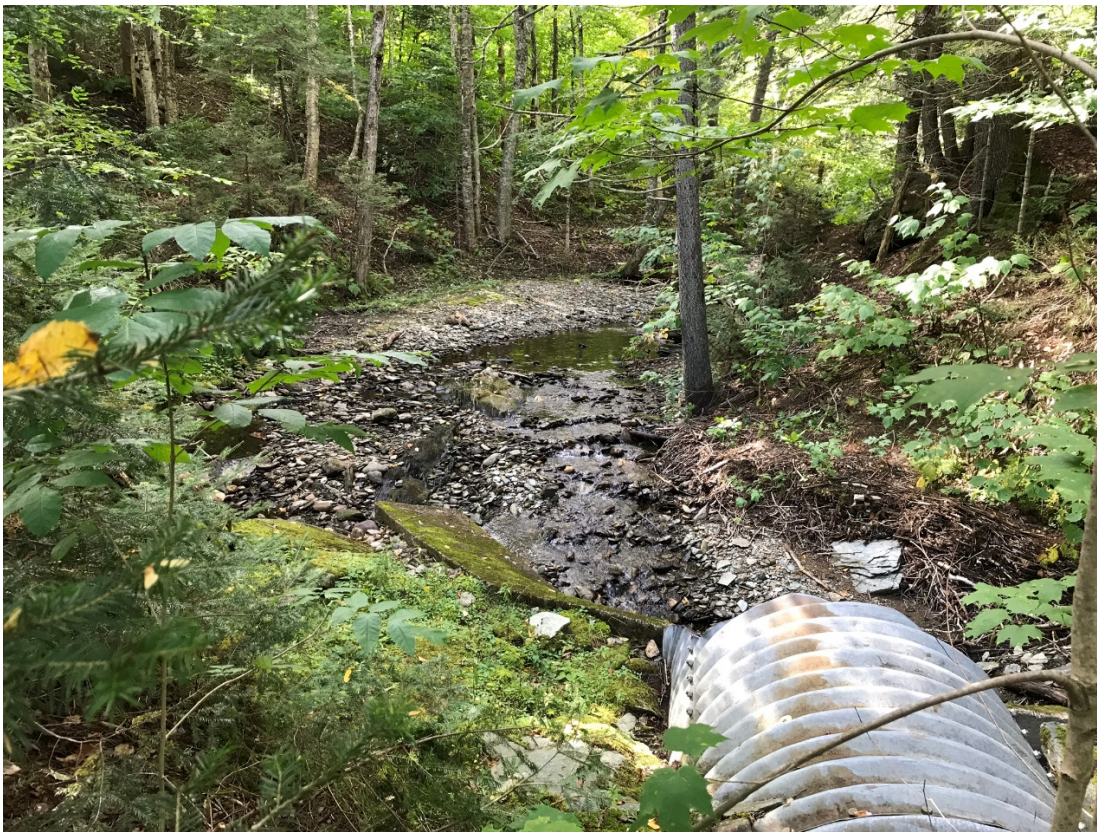
Figure 3.1: Facing upstream; note high frequency of gravel, cobbles, and boulders within streambed and possible bedrock outcroppings.

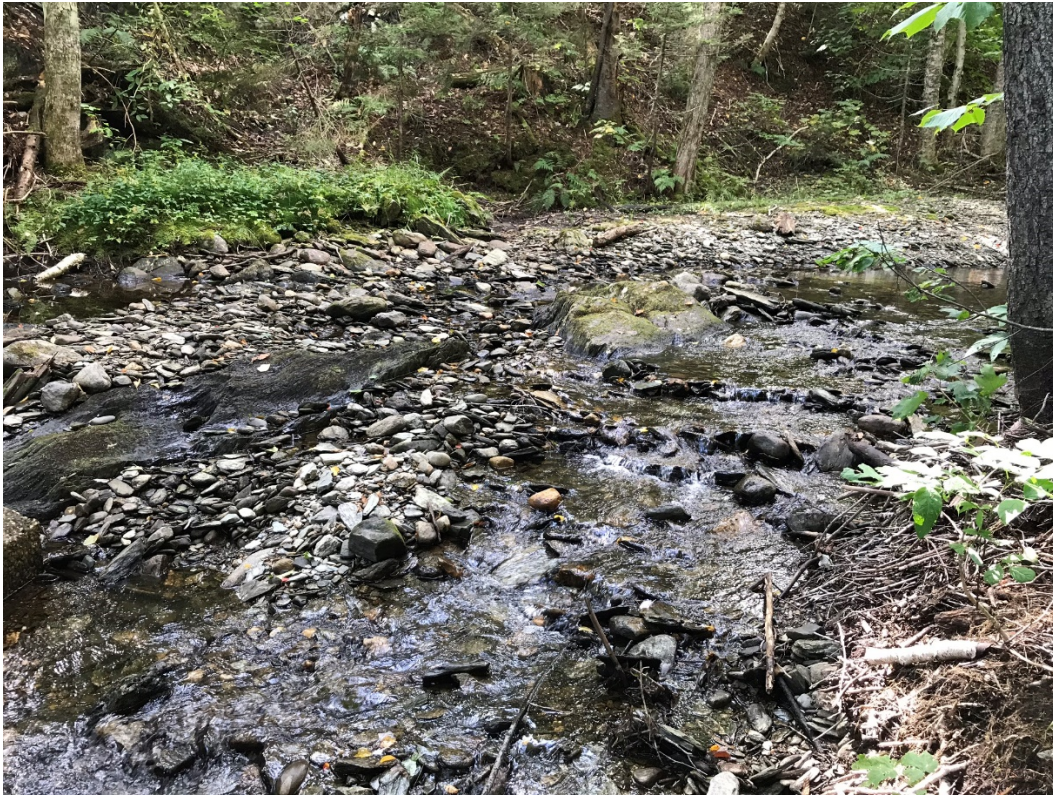
Figure 3.2: *Facing upstream; note high frequency of gravel, cobbles, and boulders within streambed and possible bedrock outcroppings.*

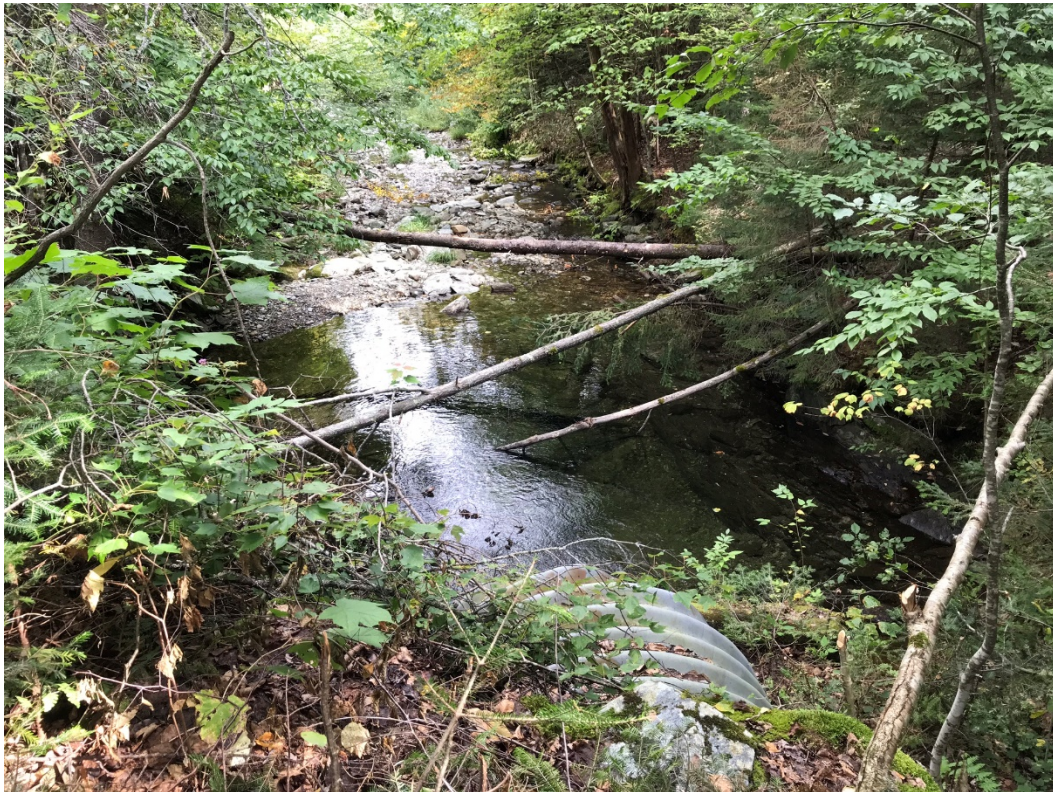
Figure 3.3: *Facing downstream; note high frequency of gravel, cobbles, and boulders within streambed and possible bedrock outcroppings.*

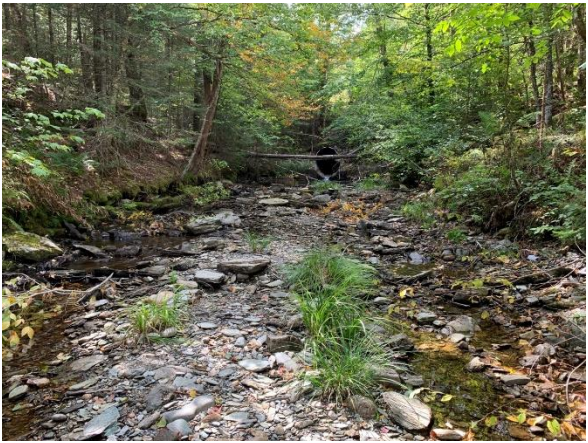
<p>Downstream looking upstream to perched culvert outlet</p>
Photo Date: 9/16/19	Photo Date: 9/16/19
