Town: 206 - SPRINGFIELD

IDENTIFICATION	
(1) State Names	50 - Vermont
(8) Structure Number	200091027S14182
(5) Inventory Route	1
(2) Highway Agency District	2 - District 2
(3) County Code	27 - WINDSOR

(4) Place Code	69550
(6) Features Intersected	BIKE PATH
(7) Facility Carried	I 00091 ML
(9) Location	0.1 MI S EXIT 7
(11) Mile Point	41.541 mi
(12) Base Highway Network	Yes

INSPECTIONS *			
(90) Inspection Date			05/24/2022
(91) Frequency			24
(92) Critical Feature Inspection	Done	Freq. (Mon)	Date
A: Fracture Critical Detail	No		
B: Underwater Inspection	No		
C: Other Special Inspection			
* The inspection date and frequency information in this box contains the current NBI date and frequency information. Please refer to the report header for the date this inspection was conducted.

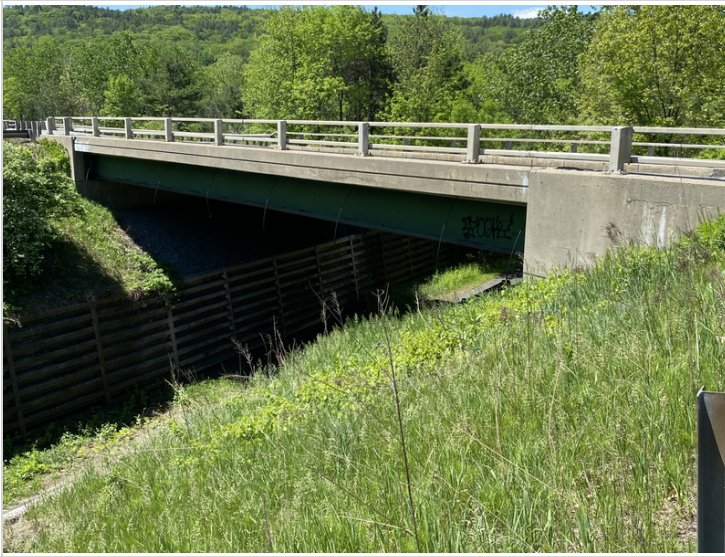
Eastern Elevation

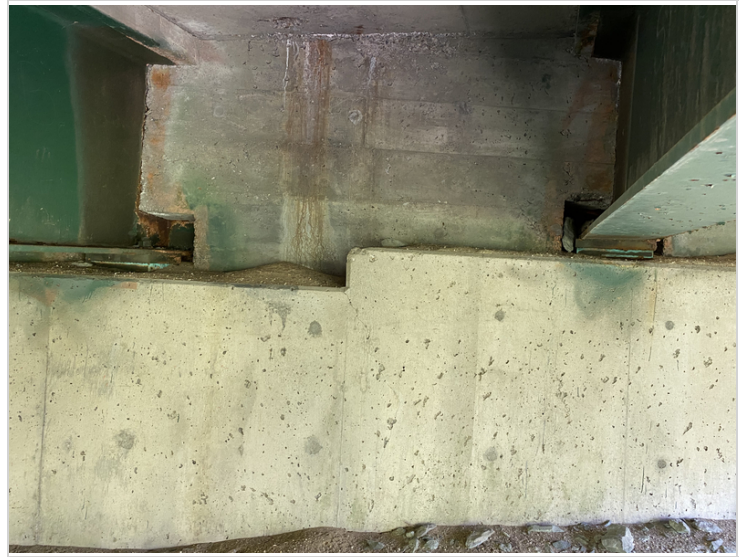
Abutment #2 between Beams #4 and #5

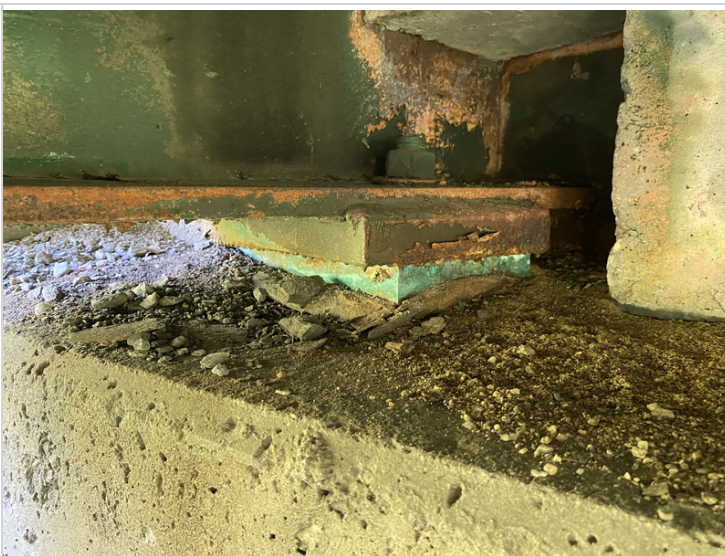
Abutment #2 has bronze bearings with interior bearings having some light surface corrosion starting and fascia bearings having minor rust scaling starting to form. Sliding steel plates are present over abutment #1 having light surface corrosion starting along the interior with fascia bearings having minor rust scaling starting to form. Bearings #1 at both ends have heaviest corrosion.

Bronze Bearing #1 at Abutment #2

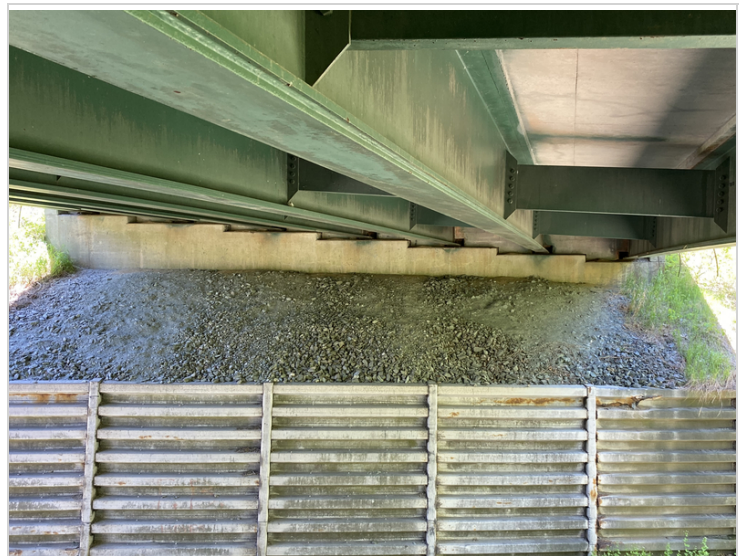
Abutment #1 is in fairly good condition with some hairline vertical shrinkage cracks scattered throughout the stem. Minor sandy debris build up is present along bridge seat. Minor saturated concrete and efflorescence leakage on the eastern end of abutment stem.

Abutment #1

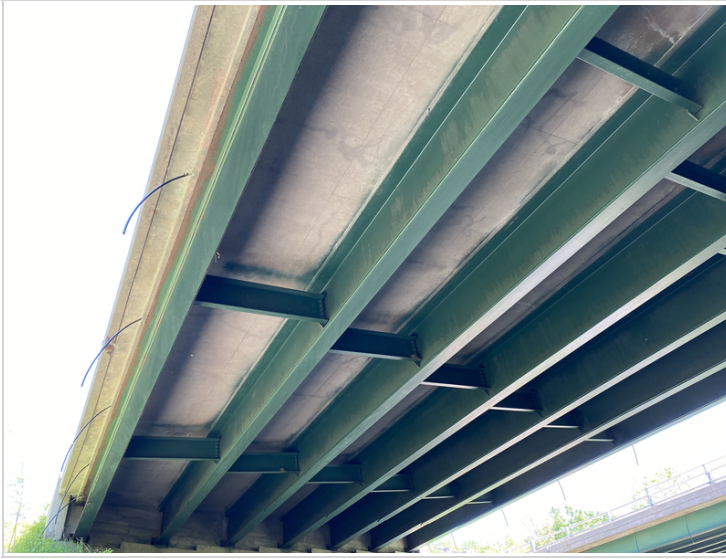
Seven (7) painted steel rolled beams are in fairly good condition having positive camber and cover plates welded along the bottom of the beams. Small areas of surface rusting are present mainly along the lower flanges and lower sections of the webs near the ends of the beams. Paint has minor distress along the lower flanges near the beam ends with steel corrosion initiated. Paint has small areas where paint is starting to bubble, flake and peel.

Superstructure from South End

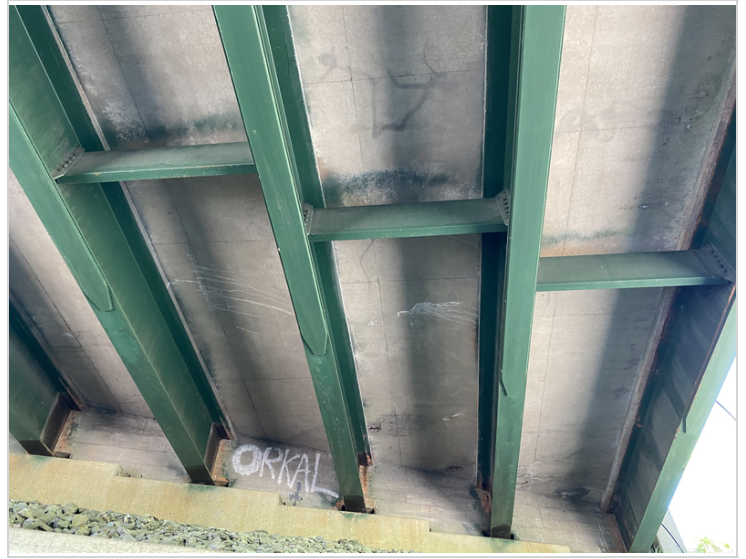
Reinforced concrete deck is in satisfactory condition being fairly clean with scattered areas of minor transverse cracking with efflorescence leakage present. Delaminations are forming around a few of the cracks scattered around the deck.

Bays #1 through #3 Deck Soffit South End

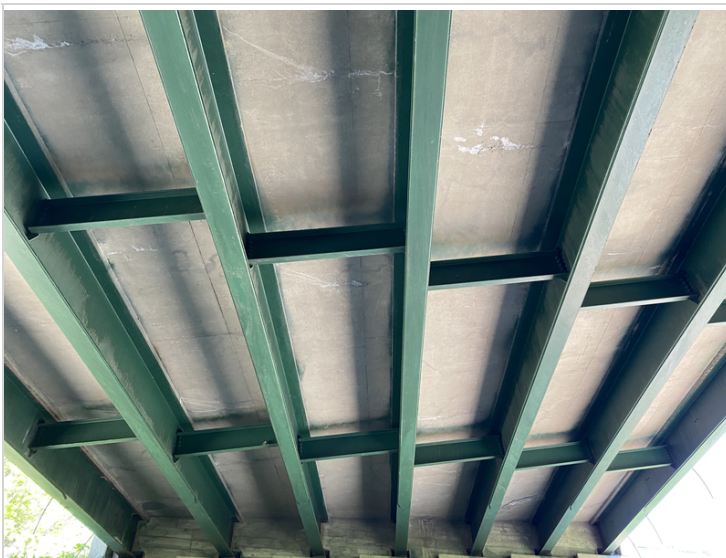
North End Deck Soffit

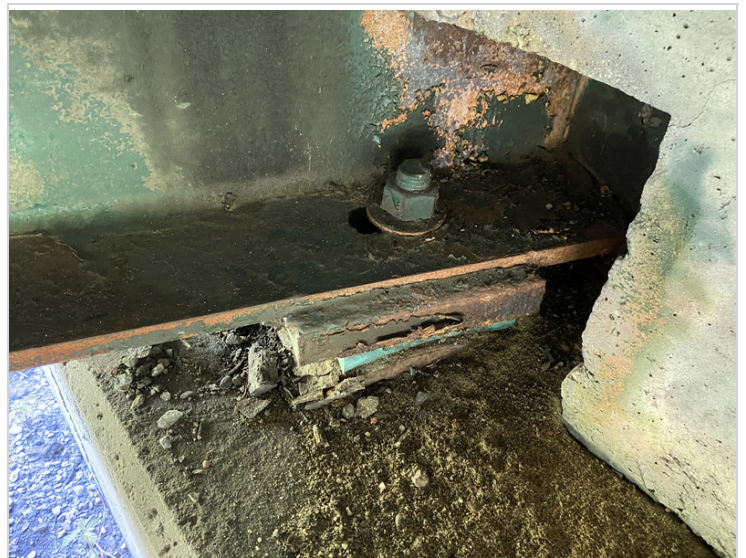
Bronze Bearing #1 at Abutment #1

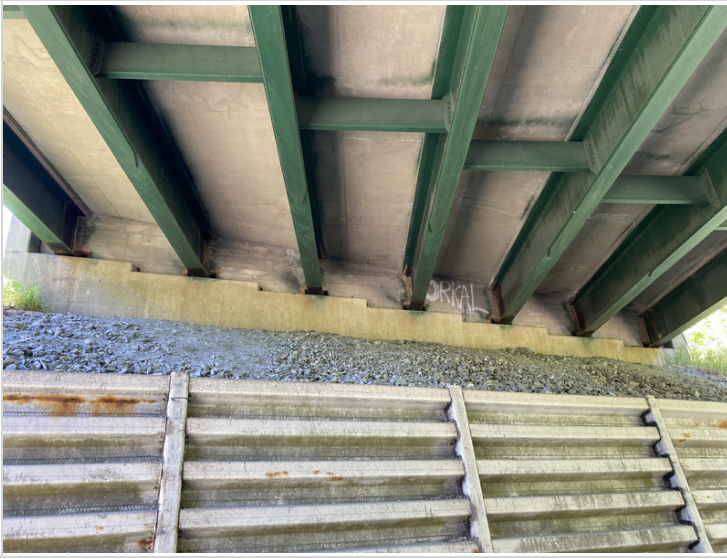
Abutment #1

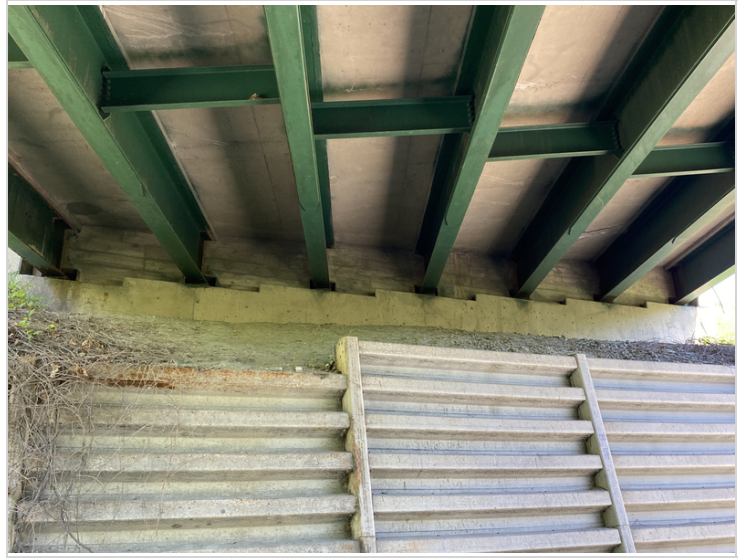
Abutment #2 is in fairly good condition with some hairline vertical shrinkage cracks scattered throughout the stem. Minor sandy debris build up is present along bridge seat.

Abutment #2

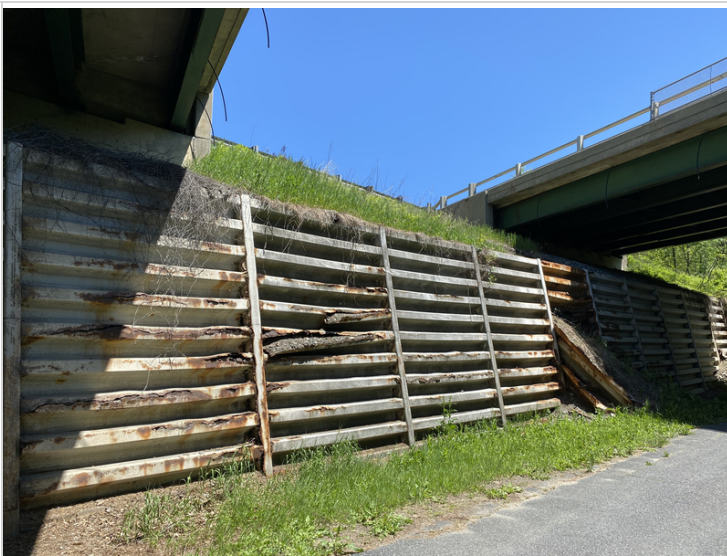
Concrete wingwalls are in fairly good condition having some light map cracking.

Failing Retaining Wall Northeast Corner of
Structure

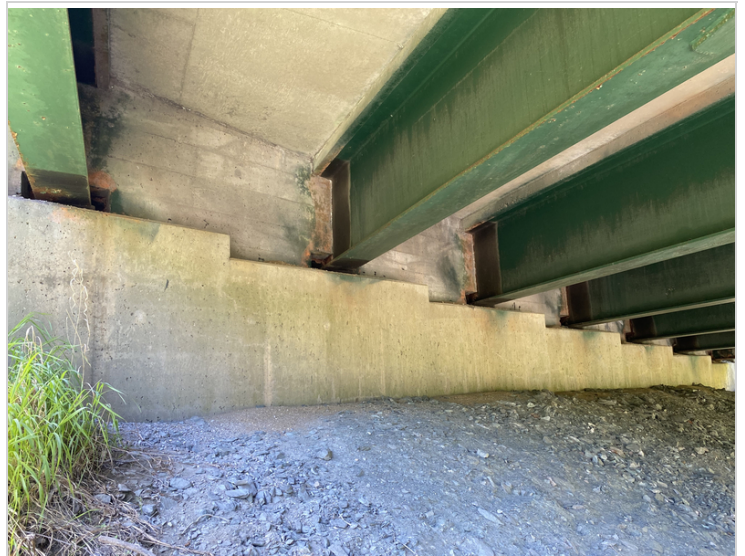
Abutment #1

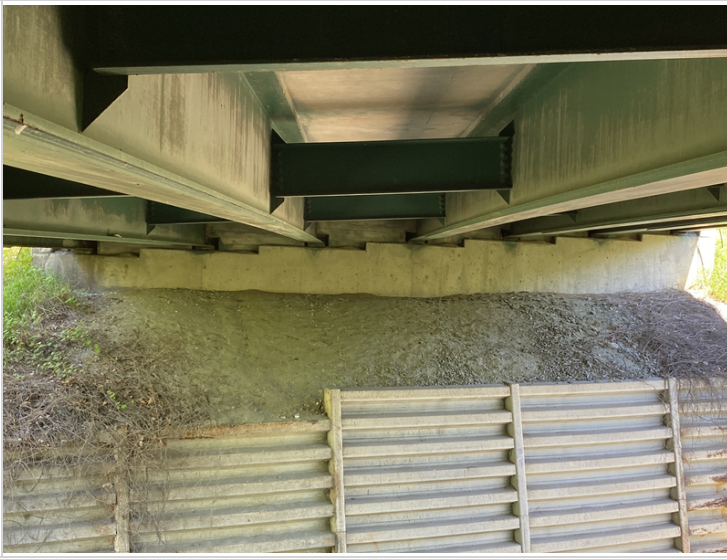
Abutment #2

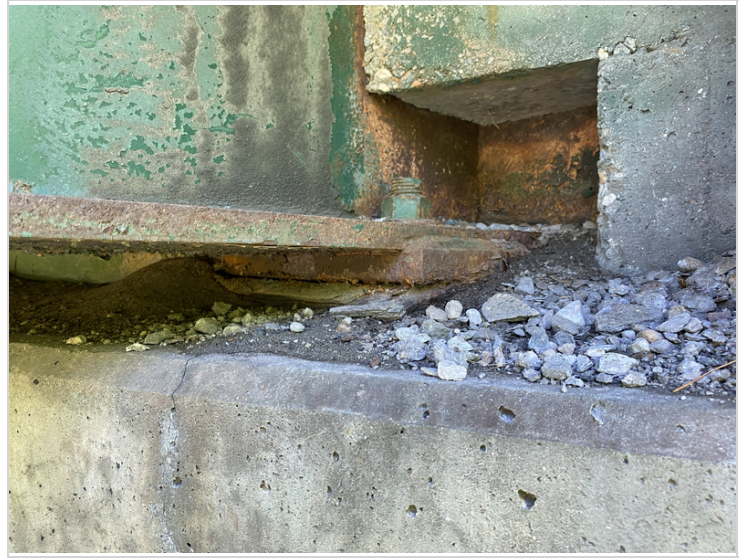
Fixed Steel Bearing #1 at Abutment #1

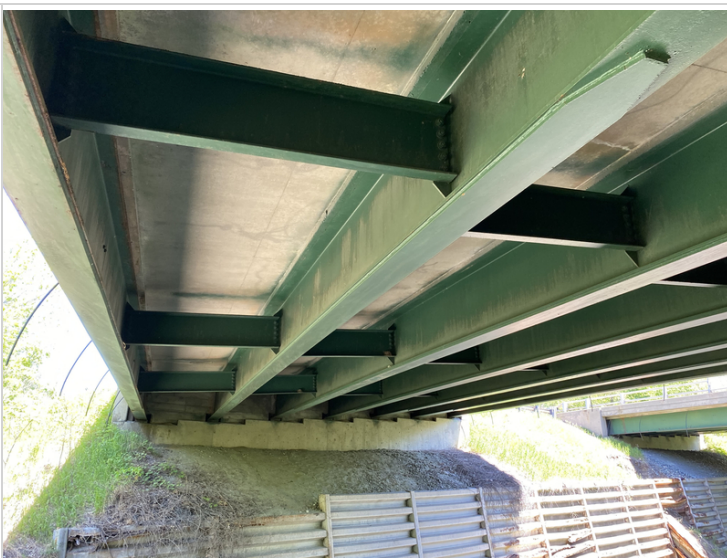
Superstructure from Southwest Corner

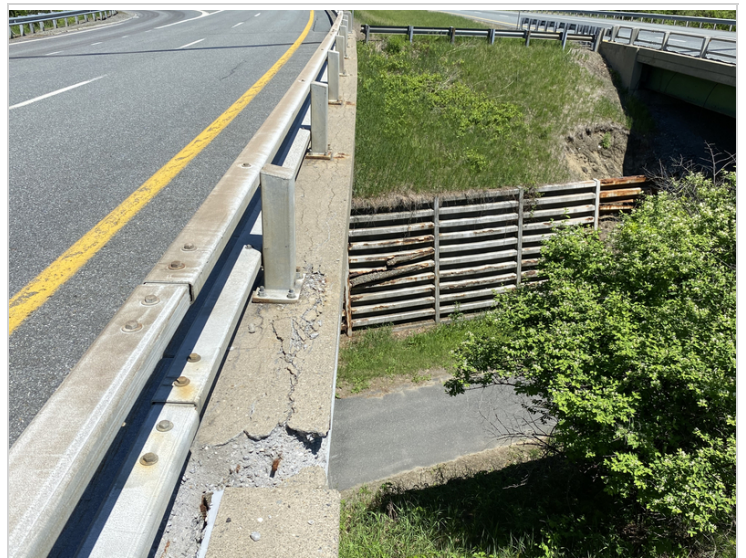
Concrete curbing with granite block facing is in poor condition with the concrete behind the granite facing having areas of moderate to heavy concrete scaling and areas of minor cracking. Curbing over wingwalls have heaviest deterioration present.

Concrete fascia has some areas of minor cracking and small rust stains in various locations along both fascias. Delaminations are starting to form along the top surface where cracking is progressing.

Eastern Curb / Fascia Cracking / Scaling

Concrete curbs have deep spalling / scaling scattered throughout and need to be cleaned and patched. Fascia's have longitudinal cracking that are starting to delaminate and have scaling in surrounding areas along the top surface and should also be considered for repairs.

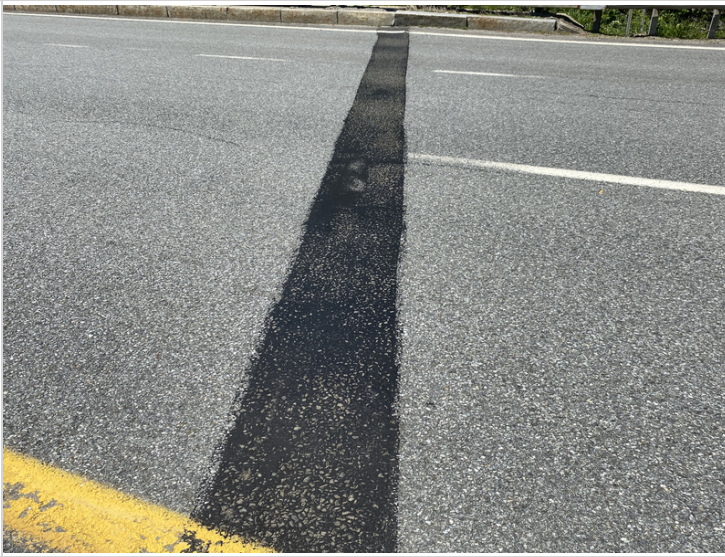
Asphaltic plug joints are present over both abutments in fairly good condition with joints having some light wear and some minor transverse cracking at edges of joints.

Asphaltic Plug Joint over Abutment #2

Structure is in fairly good condition but still needing a few repairs. Older sections of galvanized steel beam rail and damaged rail should be replaced. Asphaltic plug joints over both abutments have minor transverse cracking along edges and should be considered for replacement to prevent leakage to structure below. Both sides of concrete curbing have areas of deep concrete scaling and should be cleaned and patched. Debris should be cleaned off abutment bridge seats. General spot cleaning of the paint is needed along the lower flanges at beam ends and bearings should be cleaned and repainted.

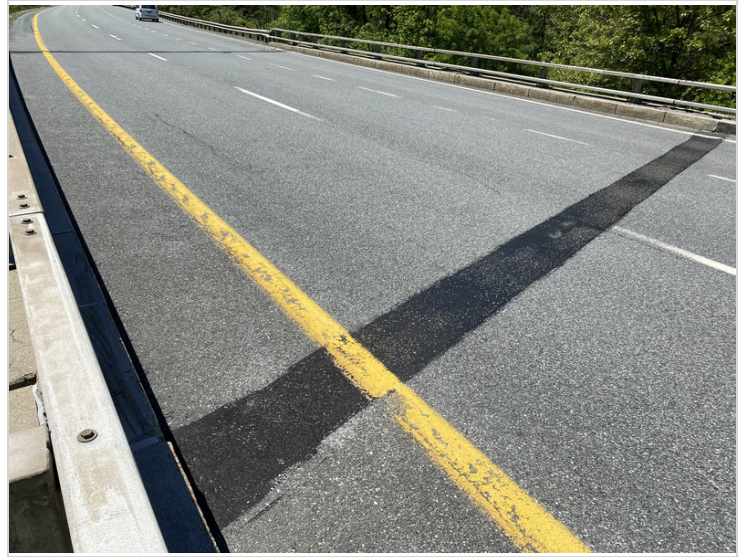
Asphalt is in fairly good condition with light wear in travel lanes and some light cracking.

Deck Wearing Surface from Northeast Corner

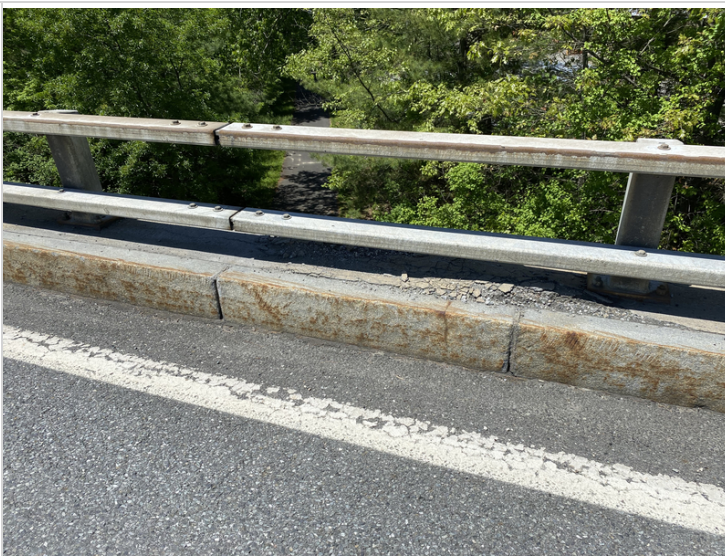
Western Curb Heavy Spalling

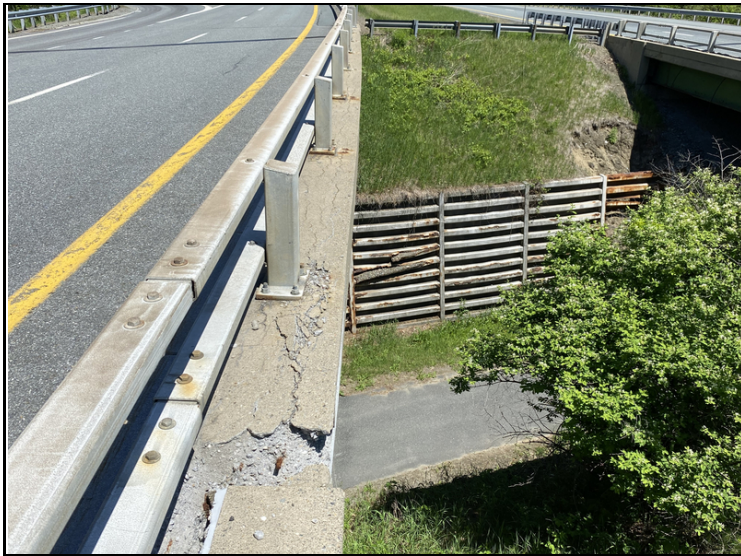
Eastern Curb / Fascia Cracking / Scaling

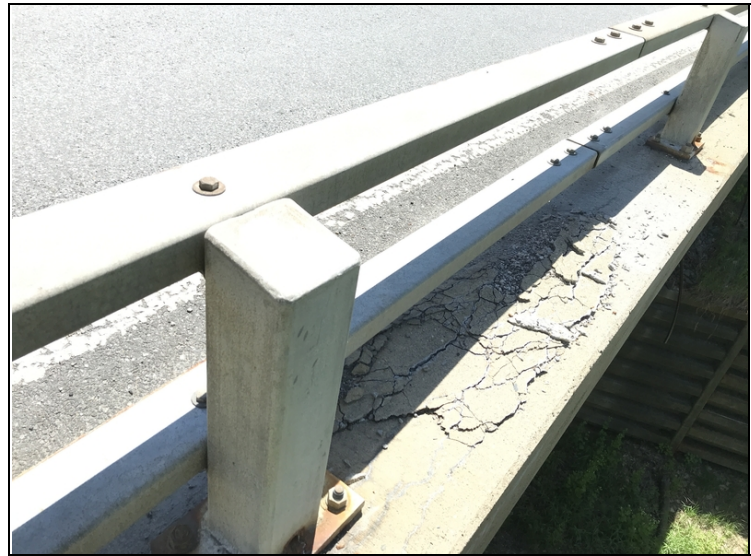
Eroding curbing at West mid-span
