Town: 206 - SPRINGFIELD

IDENTIFICATION	
(1) State Names	50 - Vermont
(8) Structure Number	200091028N14182
(5) Inventory Route	1
(2) Highway Agency District	2 - District 2
(3) County Code	27 - WINDSOR

(4) Place Code	69550
(6) Features Intersected	I 91 OVER US 5
(7) Facility Carried	I 00091 ML
(9) Location	I 91 EXIT 7
(11) Mile Point	41.681 mi
(12) Base Highway Network	Yes

Team Lead: Martin Kelley, Inspection Date: 05/25/2022

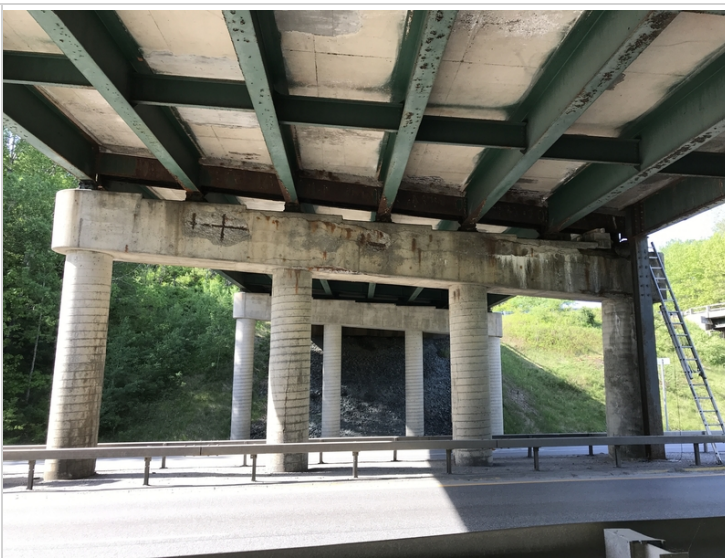
Pier #2 Span #3

Seven (7) painted steel rolled beams are present per span are in fair to poor condition having areas of heavy rust scaling and thinning with beam #1 in spans #2 and #3 having heaviest corrosion and section loss at pier #2. Beam #1 at Pier #2 in Span #3 has section loss along the lower portion of web with large perforation that continues to corrode. Steel I-beam support has been put in place to supplement for loss in front of bearing area the extends from ground to bottom of flange with web stiffeners bolted in place. Heaviest corrosion is present along the beam ends at both abutments and over pier #2 where continuous leakage from open joints progresses corrosion. Fascia beams have lighter corrosion from weathering. Beams have neutral to slightly positive camber. Protective layer has failed at both abutments and at pier #2 below deck joints that continually allow leakage to structure below. Paint has areas of distress along the lower portions of the web and flanges throughout remaining beams and spans with peeling and flaking of protective layer.

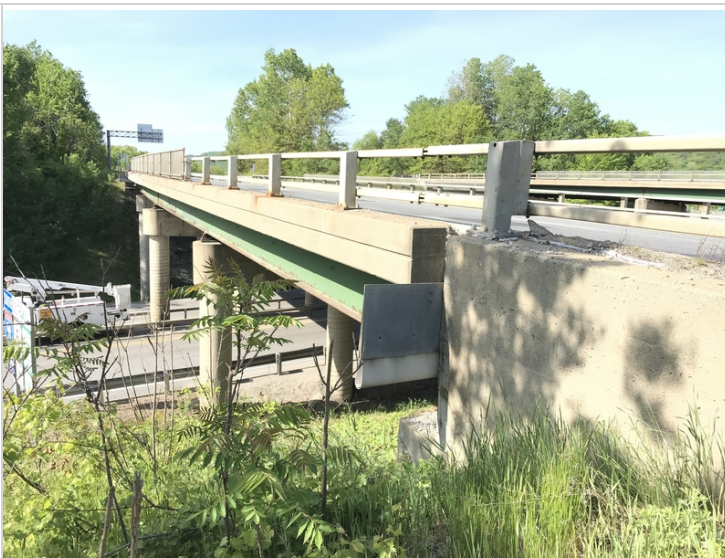
Eastern Fascia

Concrete fascia is in poor condition having heavy spalling exposing the steel reinforcing in span #2 on the eastern fascia. Other areas of heavy spalling / scaling are present around joints and minor cracking and rust stains are scattered throughout. Areas surrounding joints have heavy spalling that has exposed the steel reinforcing.

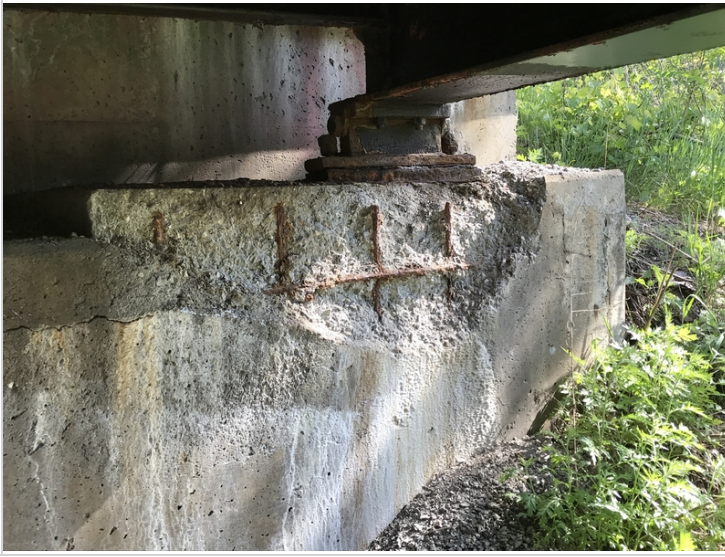
Beam #7 at Abutment #2

Reinforced concrete abutment #2 is in fair condition nearing poor condition having heavy to severe concrete scaling below bearing #1 exposing thinning steel reinforcing. Delaminations are forming along bridge seat / abutment stem around previously patched areas and heavy cracking. Efflorescence leakage and rust staining is present surrounding cracking and previously patched areas with some of them becoming unsound.

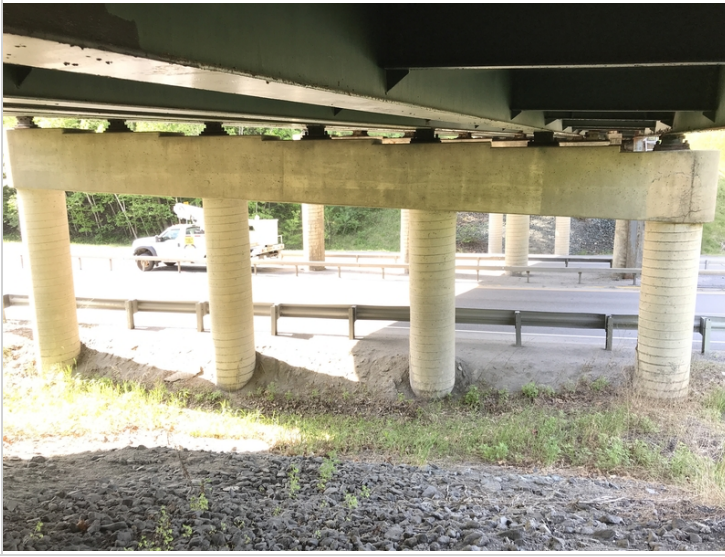
Pier #3 Span #4

All three (3) piers have four (4) columns each. Pier #1 columns are in fairly good condition with a few hairline cracks. Pier #2 has unsound concrete patch on column #1 and large delaminations and cracking ~1/4"+ wide throughout other columns with rust staining. Pier #3 has spalling that has exposed the steel reinforcing and delaminations forming in each column with cracking up to 1/4" wide.

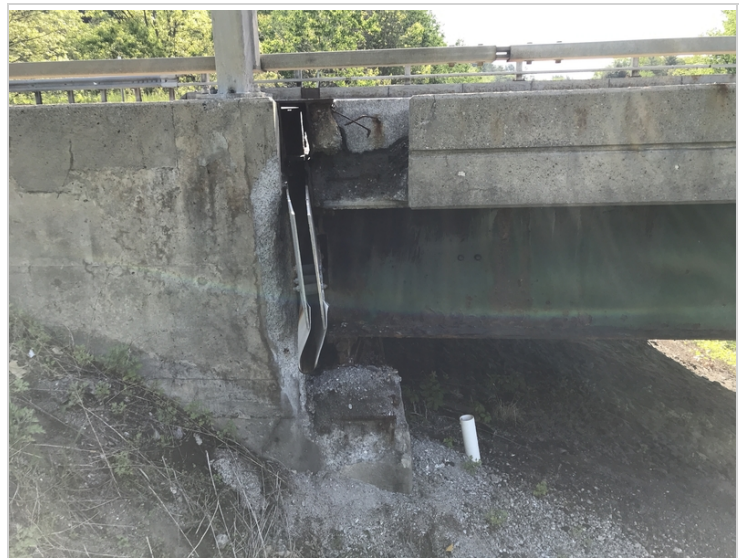
Northwest Corner

Heavy erosion along northwest embankment.

Severe erosion along northwest end of structure at trough end needs to be filled in

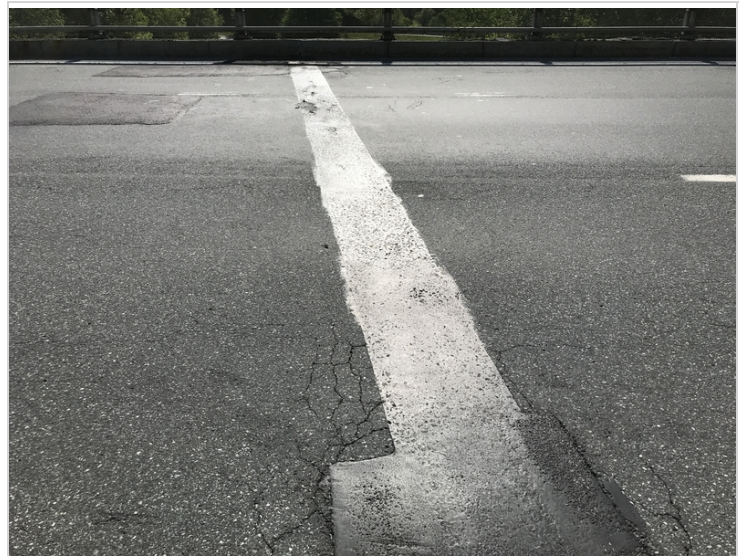
Asphaltic Plug Joint over Pier #2

Steel finger plate joints are present over both abutments with steel plates having minor to moderate pitting and rusting along the curb lines and gouges and scrapes in travel lanes. Small section of steel plate is missing over abutment #2 near center line. Steel housing below has heavy rusting. Asphaltic plug joint is present over pier #2 having minor wear and a small patch on the eastern side.

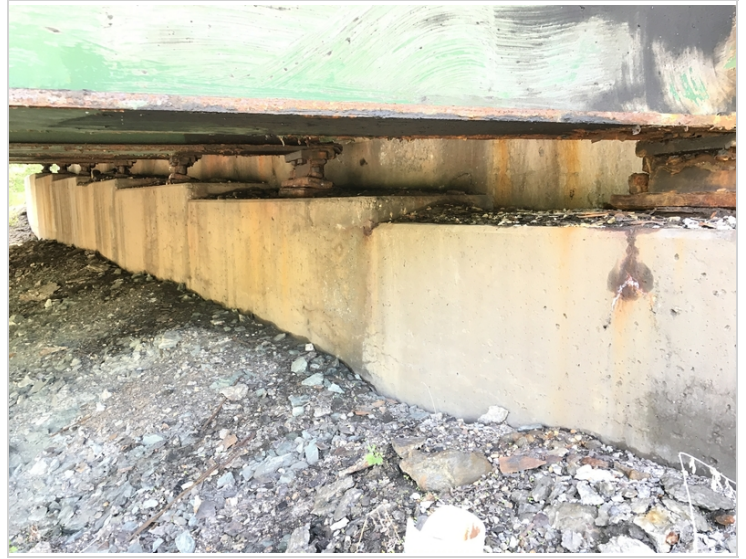
Bearings at Abutment #1

Steel rocker bearings are present over both abutments and piers #1 and #3. Pier #2 has fixed rockers. Both abutments and pier #2 have joints present allowing leakage with bearings having moderate to heavy rust scaling. Rockers over abutments and pier #1 and #3 have allowable rotation. Bearing #1 over pier #2 has heavy concrete scaling around bearing area. Bearing #1 at abutment #2 has heavy spalling around bearing area. Bearing #7 is "floating" with large delamination present at bearing area over abutment #2. *2019 Repair has installed steel w-shape vertical member before bearing#1 in span #3 at pier #2.

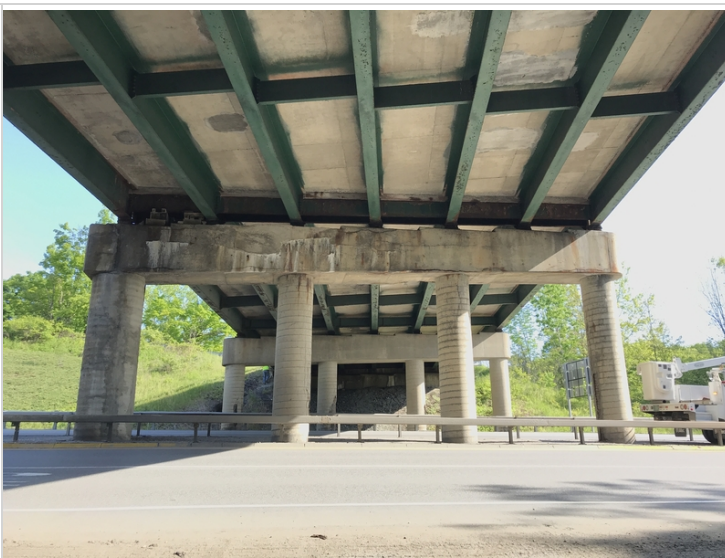
Pier #2 Span #2 and Timber Blocking

Pier #1 and #3 are in fairly good condition. Pier #2 has heavy concrete scaling / spalling exposing steel reinforcing with heaviest deterioration present along the western side of cap. Pier #2 cap has delaminations and cracking with rust stains and efflorescence scattered throughout. Laid up timber bunking is present along the western side to stabilize superstructure having

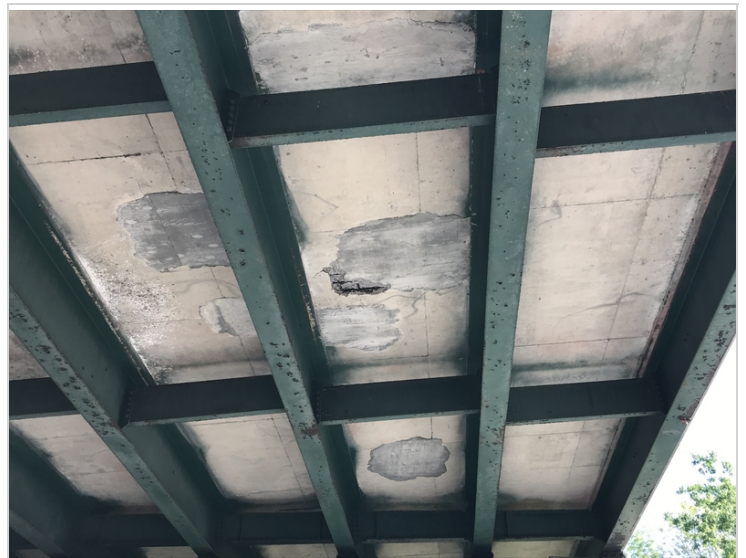
Span #3 Bay #5

Reinforced concrete deck is in fair condition having scattered large delaminations and transverse cracking with rust staining and efflorescence leakage present along the underside of deck. Large areas of patched areas are scattered throughout the deck underside are starting to become unsound with areas respalling. Large area of spalling is present in span #2 bay #3 that has exposed the first and second layer of steel reinforcing that has started to progress into concrete above reinforcing. Span #3 bay #5 has large patched area that is unsound with exposed steel reinforcing and is respalling.
