**STATE OF VERMONT  
AGENCY OF TRANSPORTATION**

**Scoping Report  
FOR  
Elmore BF 0241(55)**

**VT ROUTE 12, BRIDGE 94 OVER UNNAMED BROOK**

April 22, 2020

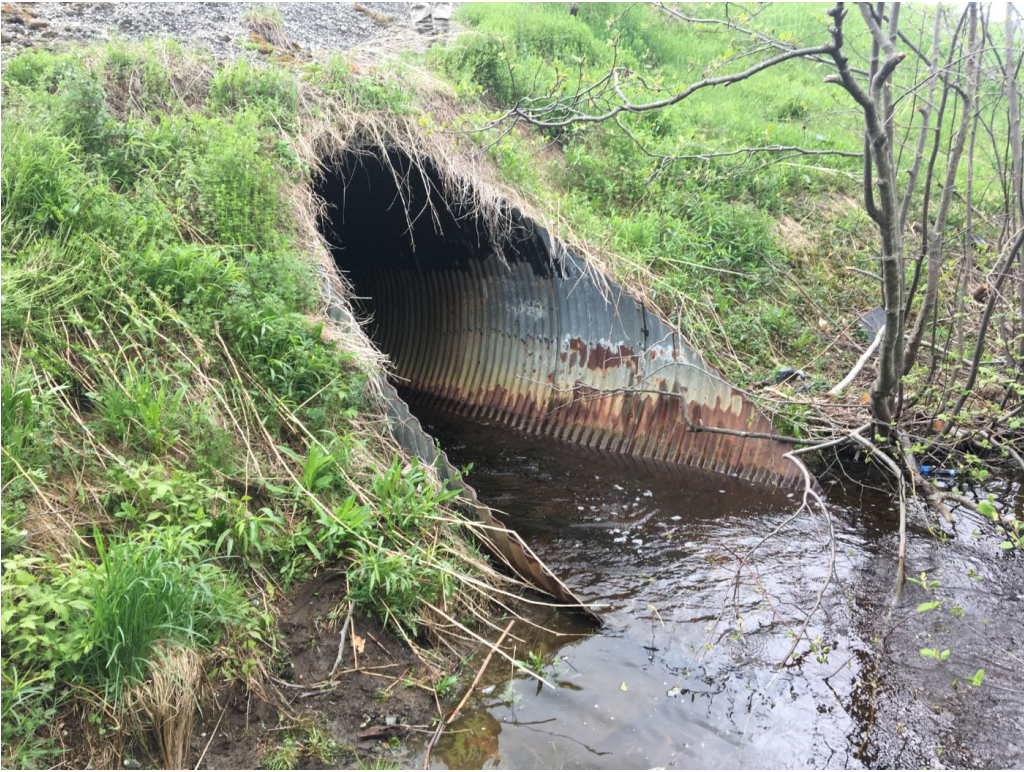
Picture 3: Culvert Outlet

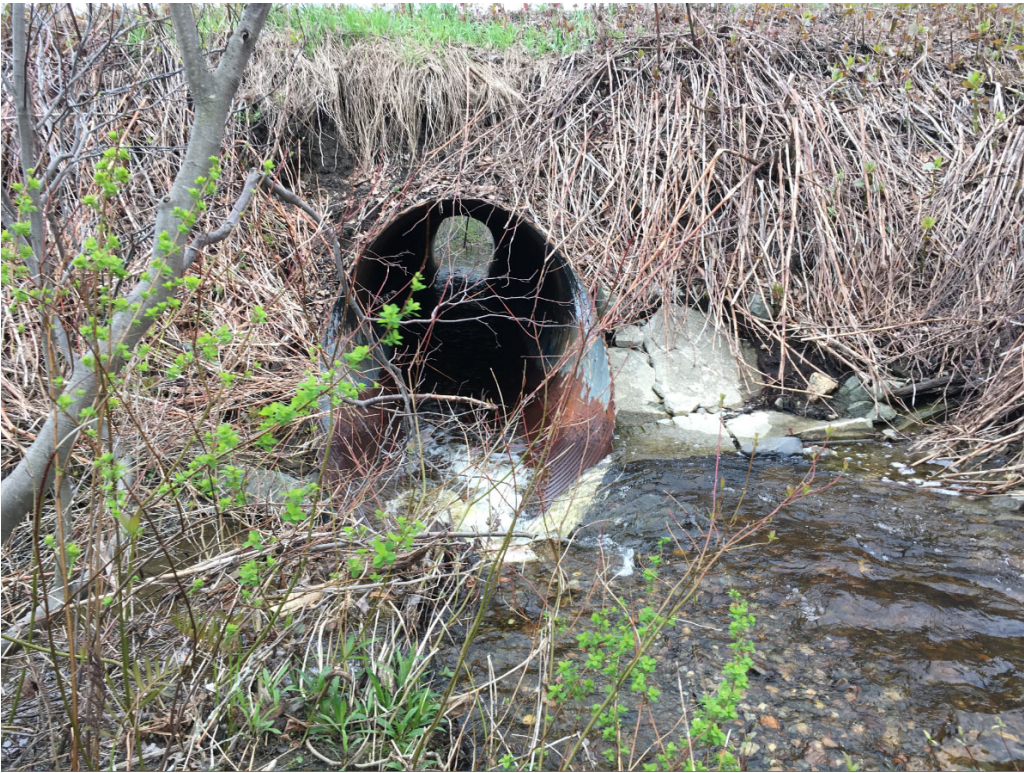
Picture 4: Culvert Inlet

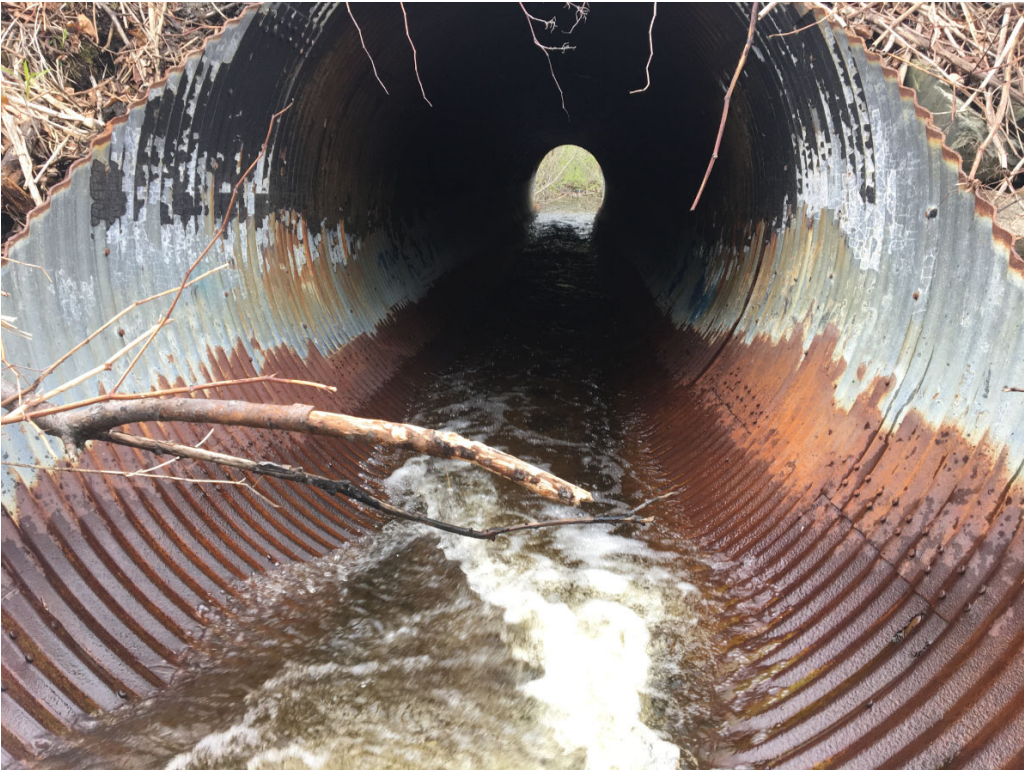
1. The culvert is in fair condition. There are holes throughout the invert up to 2-inches in diameter.
2. The asphalt coating is wearing off. Additionally, the outlet of the pipe has moved up causing some deflection in the culvert.
3. The vertical alignment along VT Route 12 through the project area has a slightly substandard sag curve.
4. The existing culvert does not meet the calculated or measured bank full width.

Picture 5: Culvert Barrel

This option involves removal of the degraded invert and pouring a 2-inch to 3-inch thick section of concrete in its place. Additionally, there would be repair of a number of large holes along the circumference of the pipe. This option would have the least impacts to the hydraulic capacity of the existing culvert. While this option is a good solution to the current degradation of the culvert invert, it adds little structural stability to the current structure, which has shown evidence of squashing.

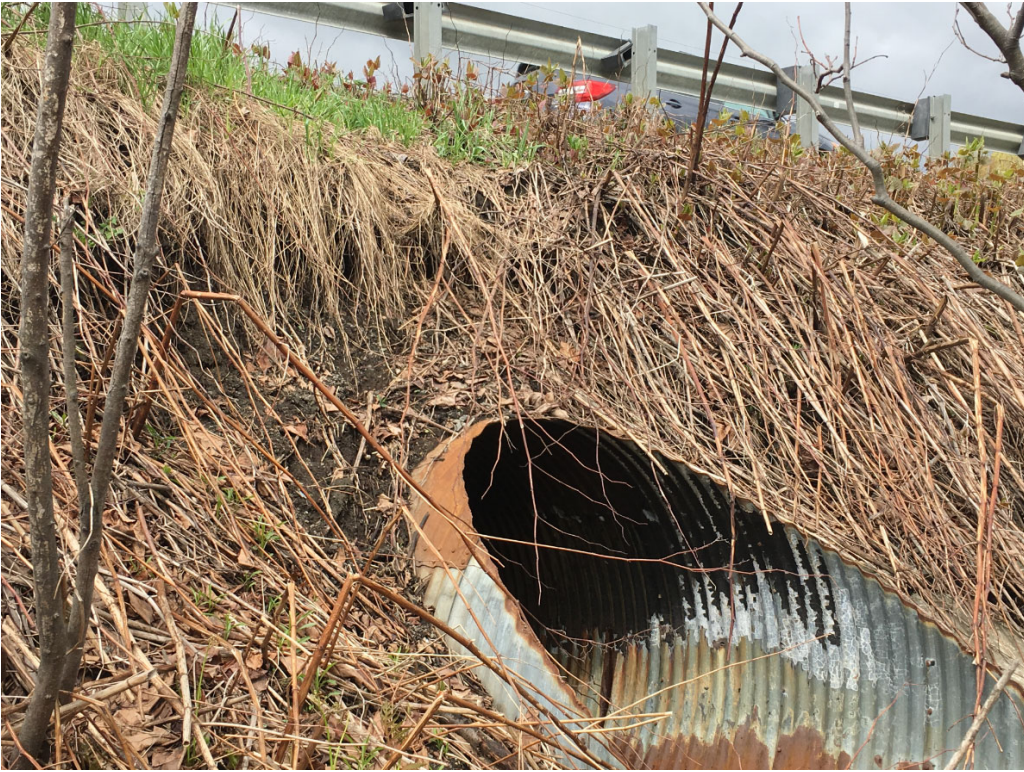
Picture 7: Scour Hole Above Bridge 94

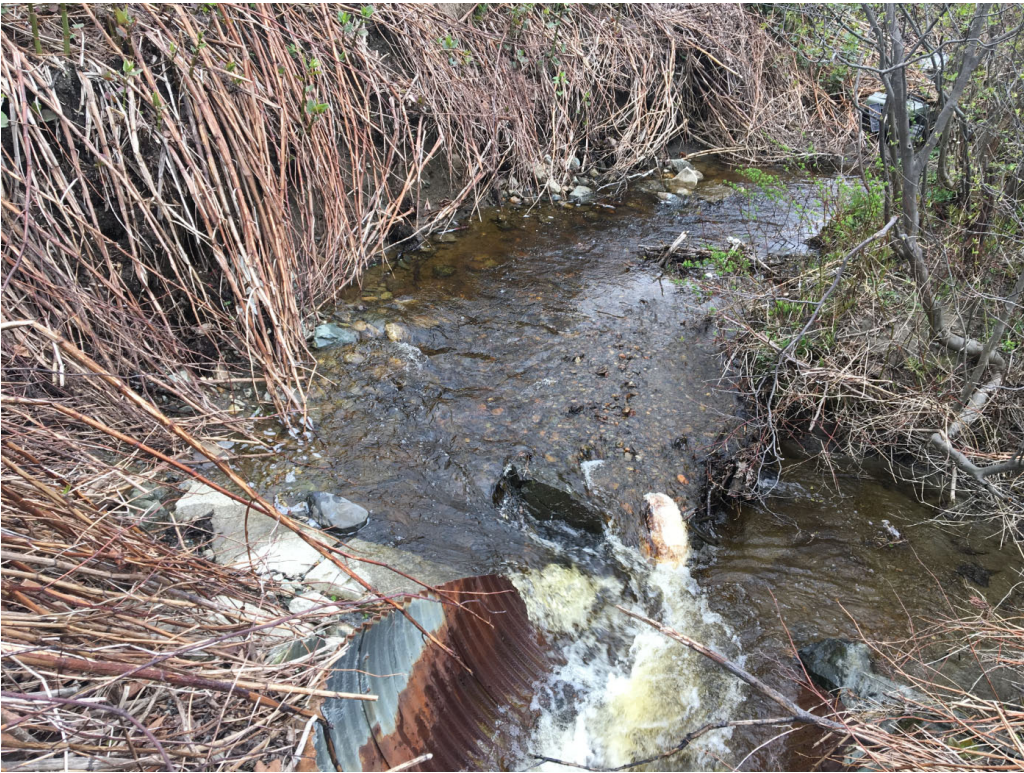
Picture 8: Scour Along Banks

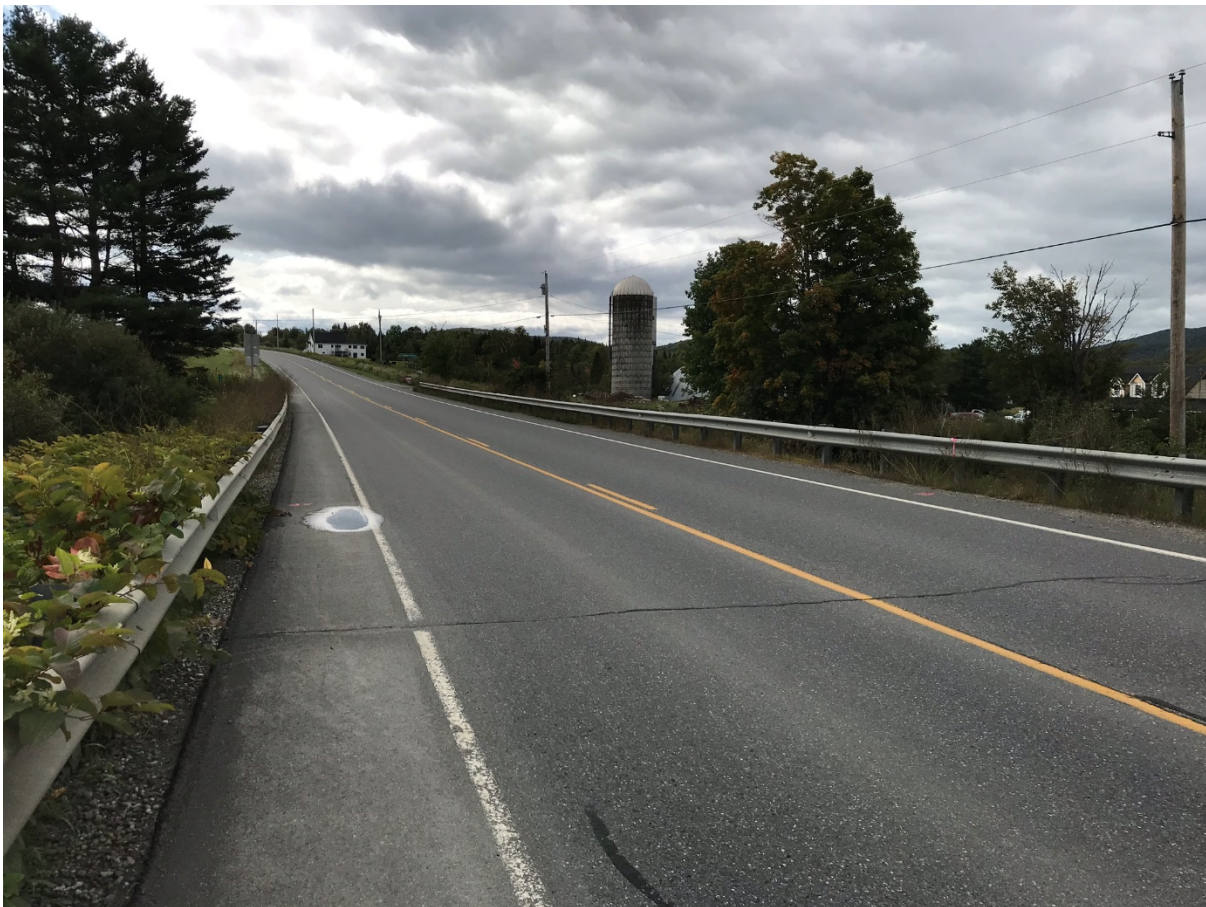
**Figure 3.1:** Facing south along VT Route 12; note overhead utilities to west of roadway. These utilities are not anticipated to interfere with potential boring operations.

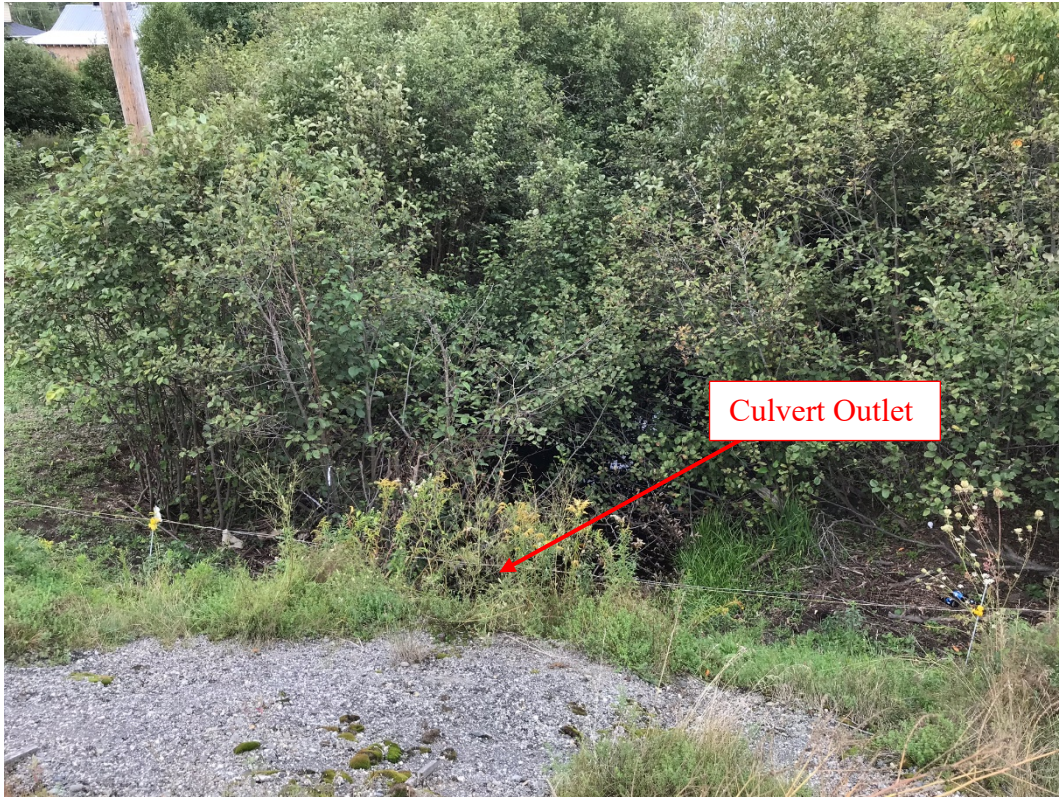
**Figure 3.2:** Facing downstream; note vegetated embankments adjacent to culvert outlet.

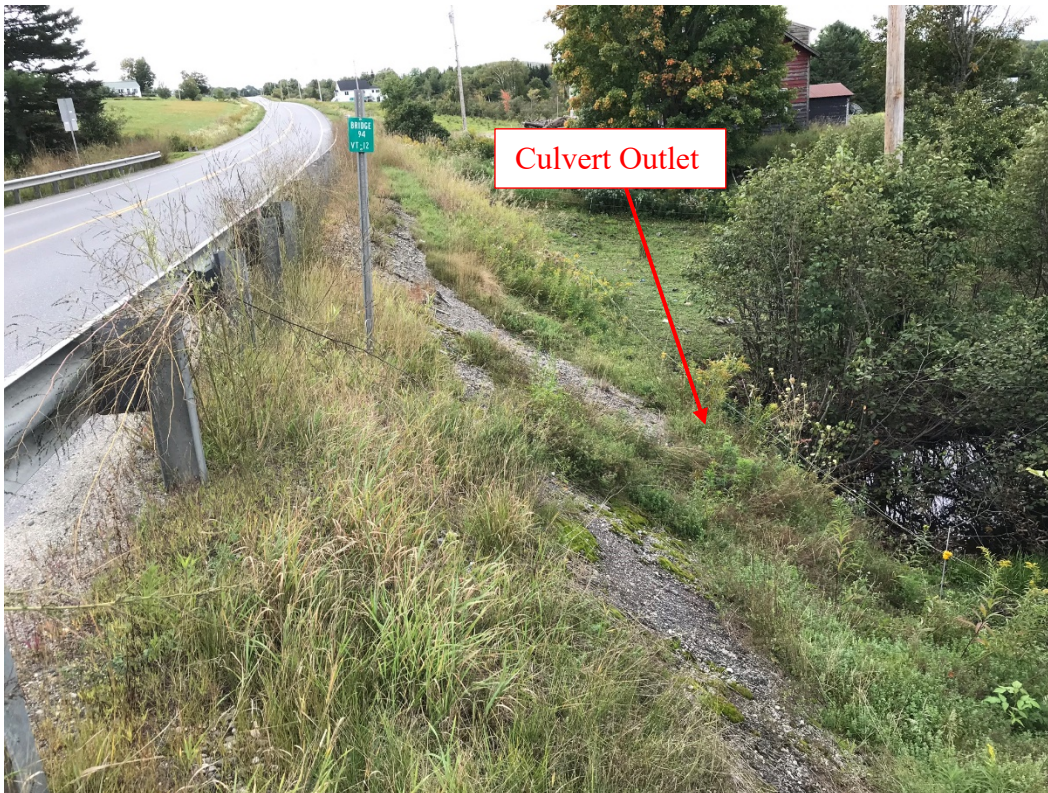
**Figure 3.3:** Facing culvert outlet; note sloping embankment that may preclude drilling from directly adjacent to culvert outlet.
