STATE OF VERMONT
AGENCY OF TRANSPORTATION

Scoping Report

FOR
WORCESTER BF 0241(56)

VT ROUTE 12, BRIDGE 87 OVER HARDWOOD BROOK

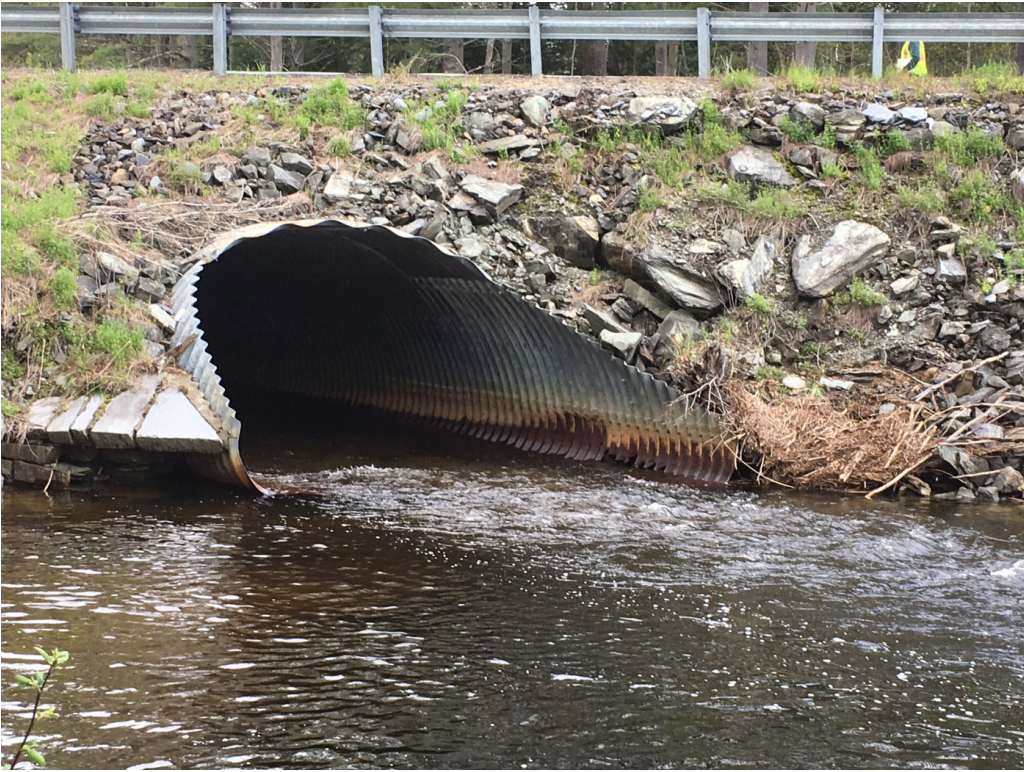
Picture 3: Culvert Outlet

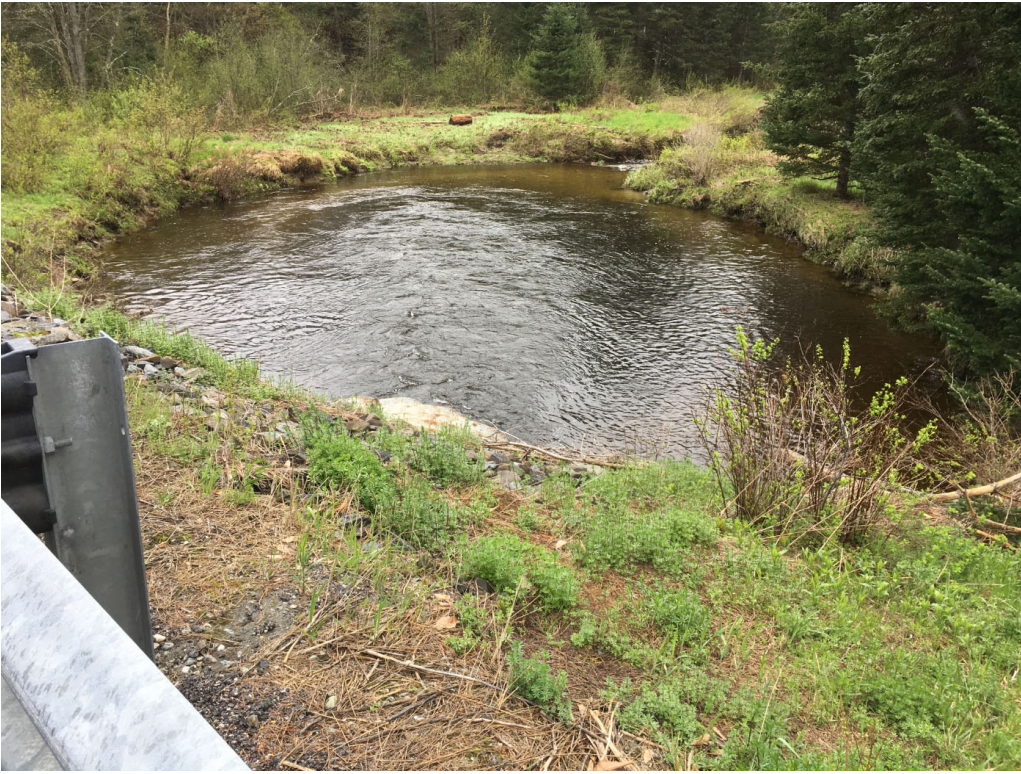
Picture 5: Looking Downstream

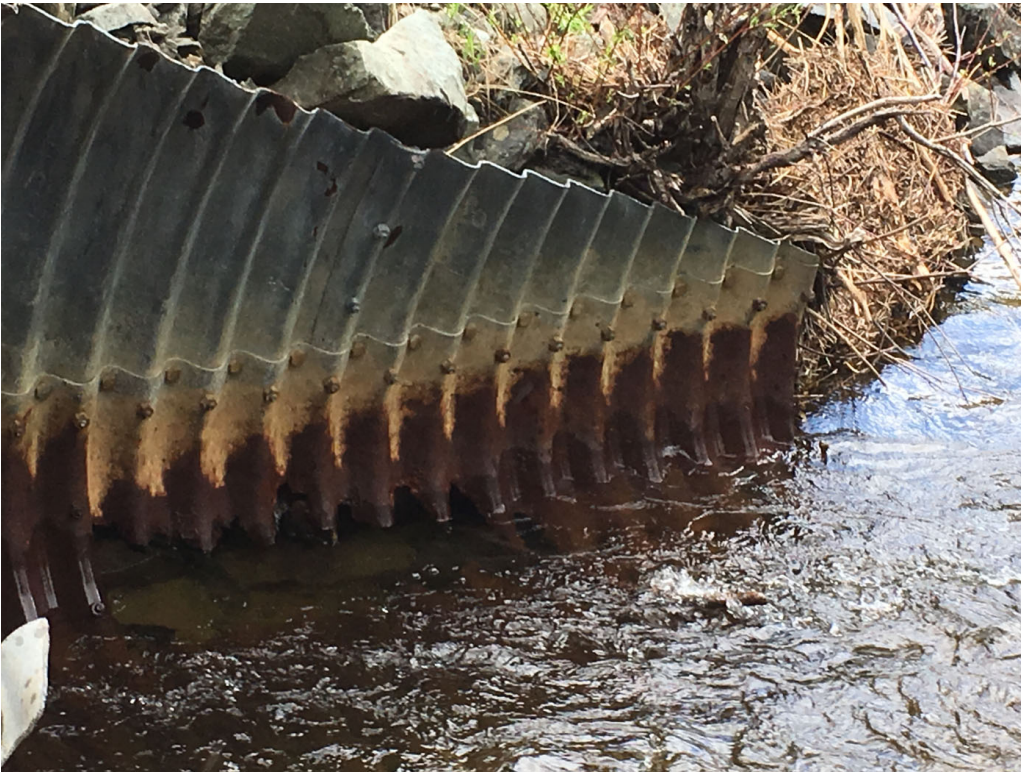
1. While the culvert is in fair condition, several maintenance issues exist:
 - a. Barrel: On the outlet end, there is a large hole at the water line.
 - b. Invert: The invert of the culvert has deep pitting and heavy rust scaling in random spots. It is expected that holes will start to form in the near future.
2. The existing culvert does not meet the calculated or measured bank full width. There is a large scour hole at the outlet, indicative of an undersized structure.

This alternative is not recommended. The culvert is in approaching poor condition and will continue to deteriorate if no action is taken. A large hole has developed in the outlet end near the

Picture 6: Hole at Outlet Waterline

All rehabilitation options would employ the use of hydroblasting or hydrodemolition to appropriately clean the existing pipe interior prior to rehabilitation. In addition to cleaning, some grouting would be needed to plug holes in the pipe and fill all voids on the outside of the pipe. Curing in dry conditions would be required in most cases, necessitating a re-routing of the stream flow during the work and for a prescribed curing period (usually 24 hours). A headwall with beveled inlets would be recommended for all rehabilitation alternatives.

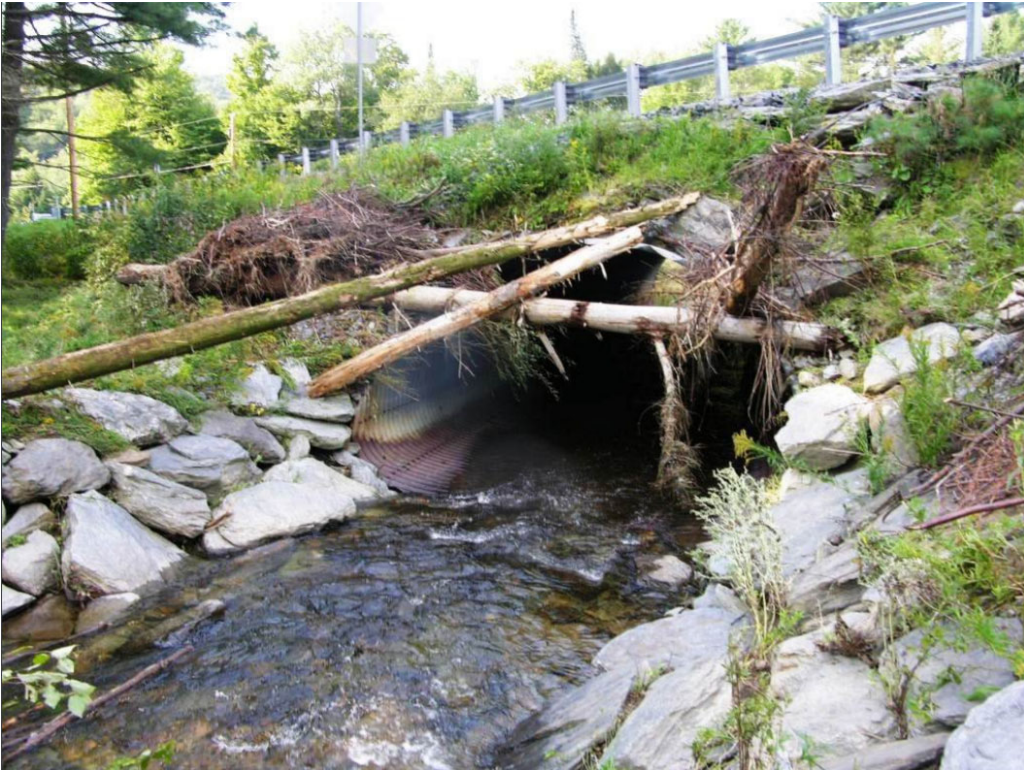
Picture 7: Debris Jam After 2011 Flood Event

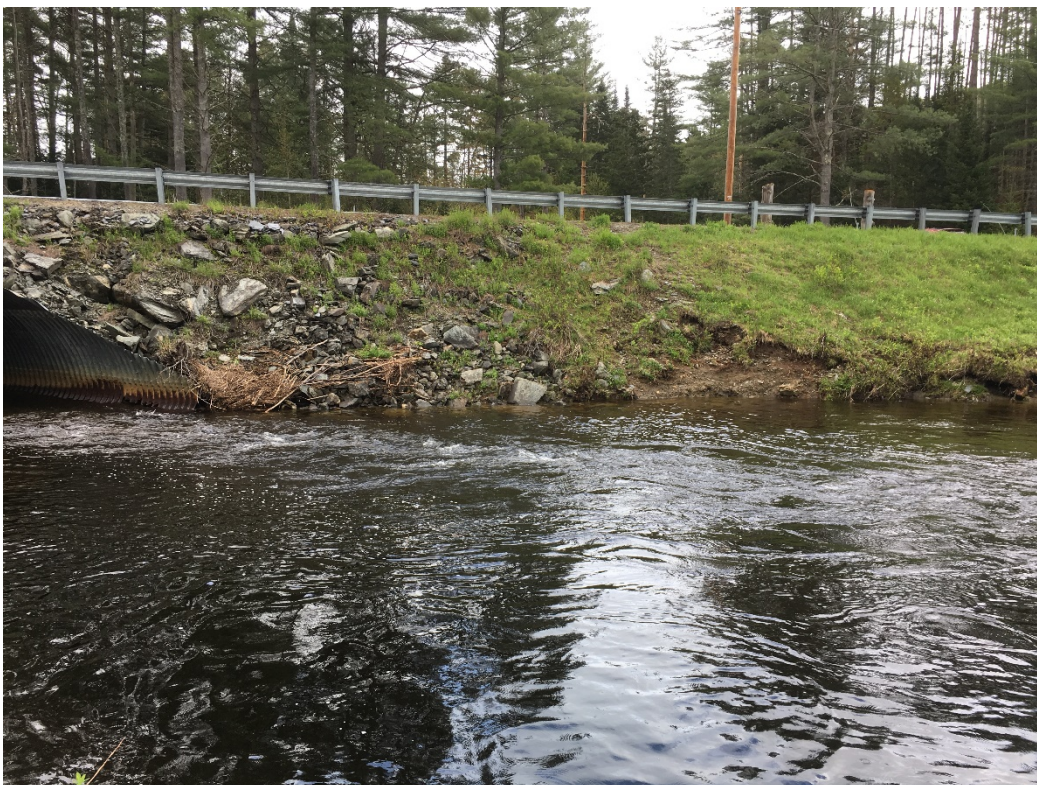
Figure 3.2: *Sloughing of slope near the outlet. [Structures photo dated May 2019]*
