**STATE OF VERMONT
AGENCY OF TRANSPORTATION**

Scoping Report

Worcester BF 0241(59)

VT Route 12, BRIDGE 84 Over the North Branch of Winooski River

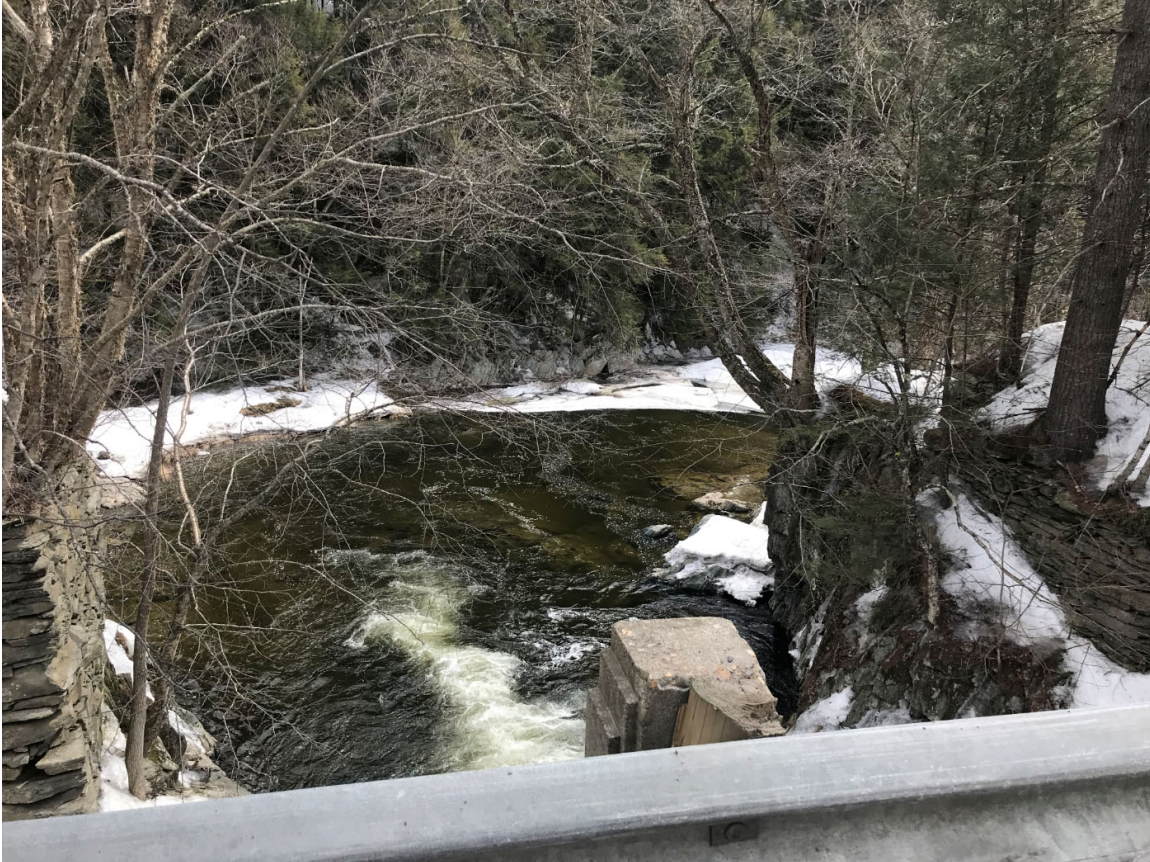
Photo 4: Looking Downstream from Bridge 84 (note old bridge abutments)

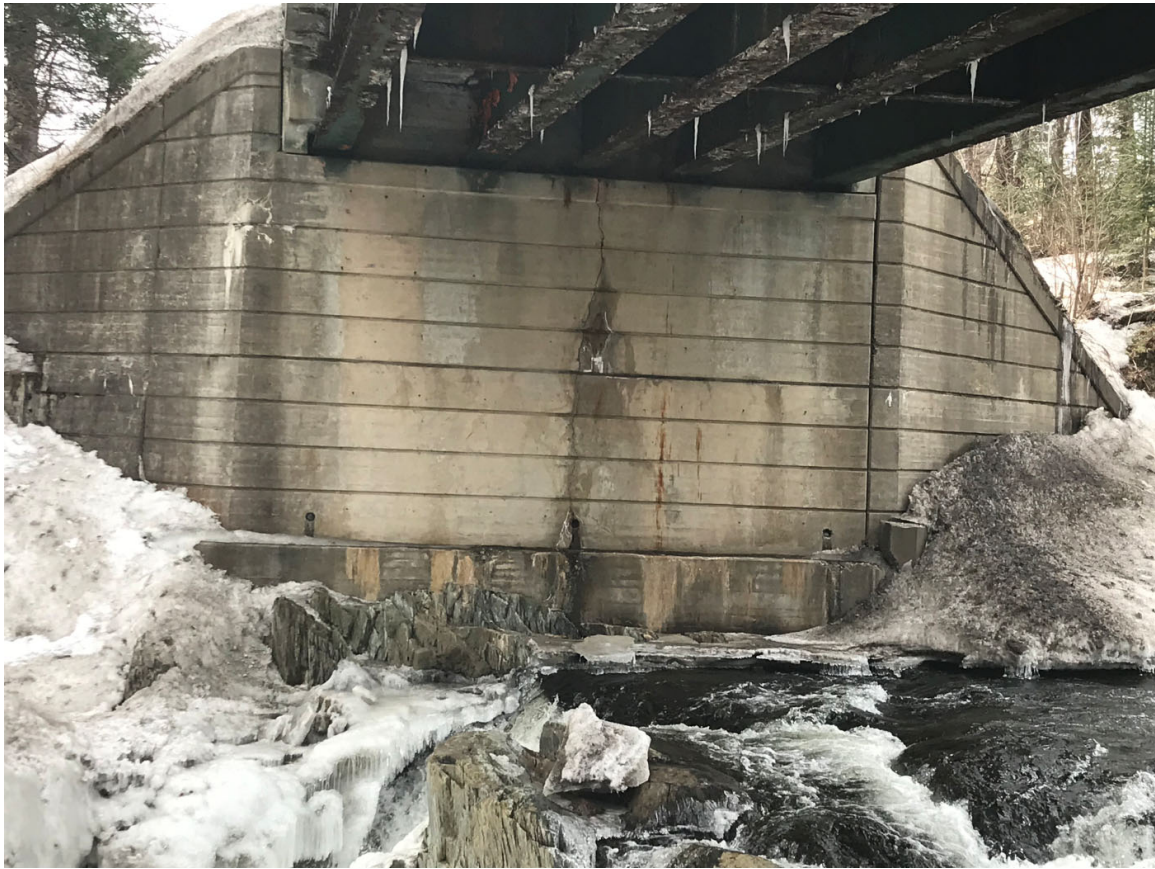
Photo 5: Southern Abutment

- Southern Abutment: The reinforced concrete abutment has a full height vertical crack.
- VT Route 12 through the project area and over the bridge is substandard in width by 8 feet.

- There is a full height vertical crack in the northern abutment. This crack should be stabilized and repaired.
- The existing bridge seats would be cut down and new bridge seats would be poured to accommodate the new superstructure. This would include replacing the deteriorating backwall at both abutments.
- A silane application should be applied to all exposed substructure concrete as part of the project.

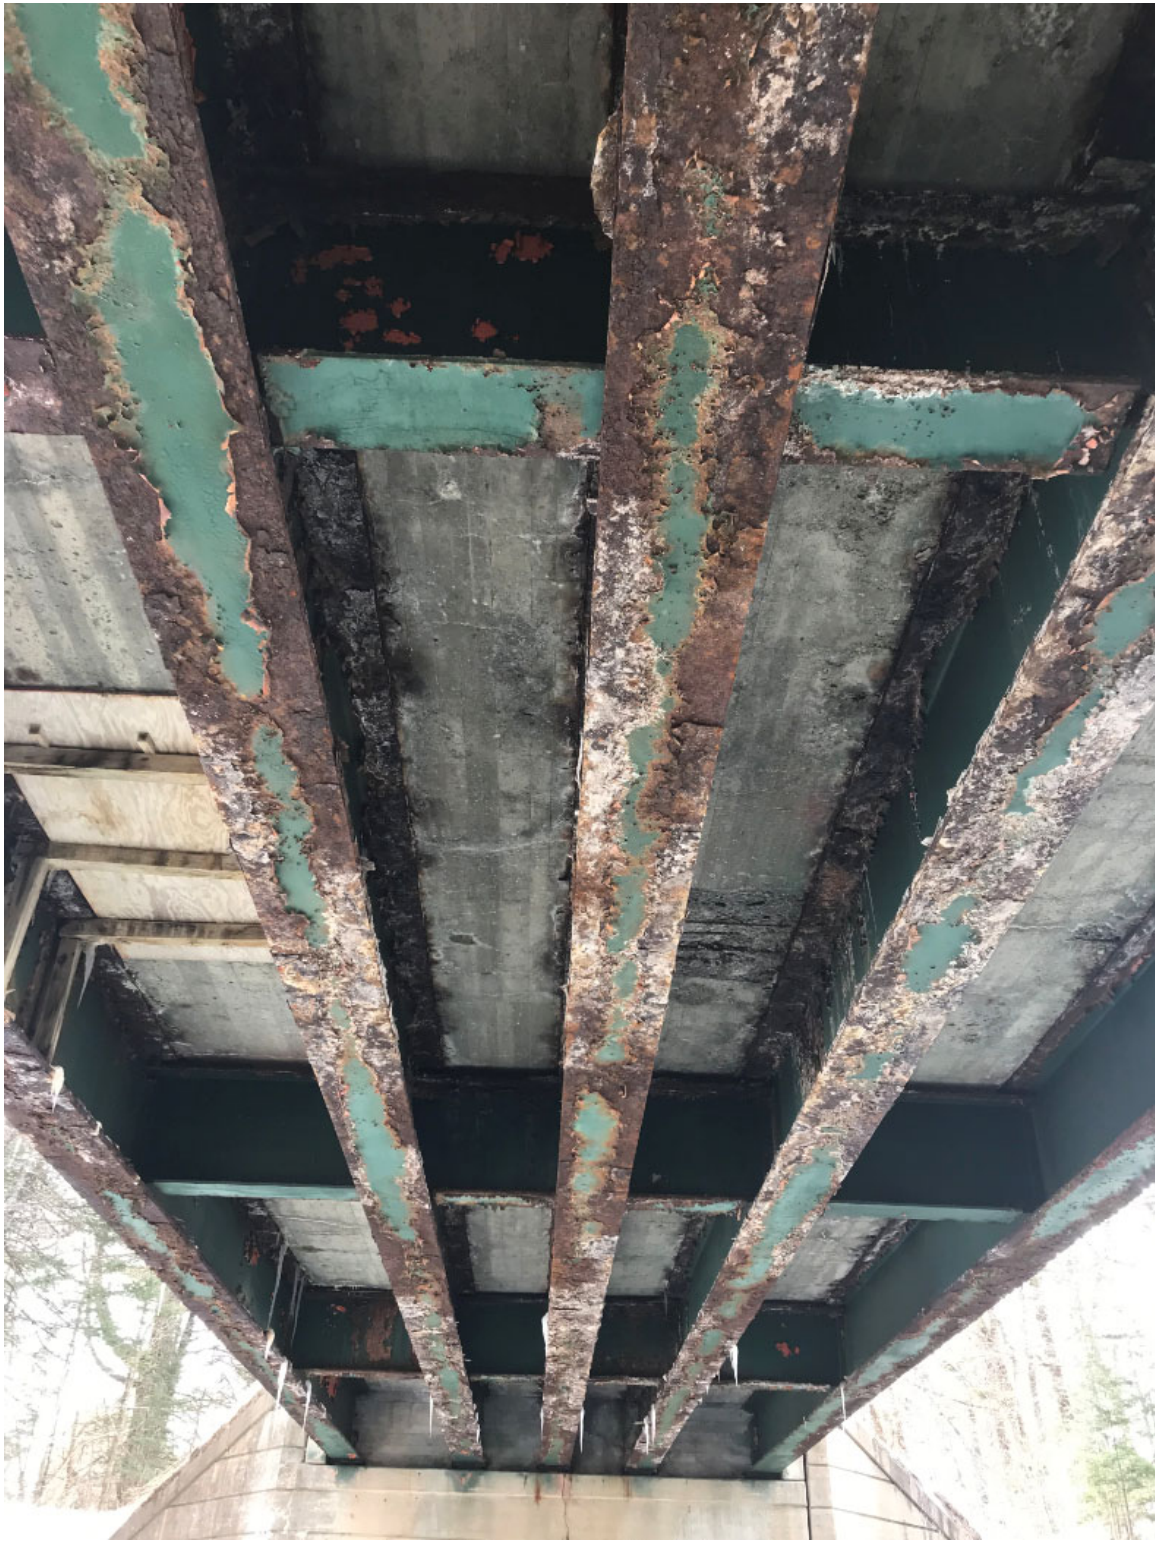
- The deck is in poor condition. The concrete is showing signs of significant distress with widespread rust staining, concrete scaling, saturation leakage and efflorescence leakage. There is one moderate size spall in bay #2 near the midspan. There is a wood catch form in Bay #4 where a previous spall has been covered. The poor deck condition radiates to the asphalt above which is also in poor condition with multiple patches, potholes, depressions and cracking. The fascia's are in poor condition with multiple areas of spalling with exposed thinning rebar, cracking and saturation leakage present.

- While the superstructure is rated as being in satisfactory condition, the paint system has failed. The Rolled beams have heavy paint distress with continuous paint failure with paint starting to peel, flake and bubble. Five (5) green painted rolled beams are ok condition with moderate rust scaling and neutral camber

Photo 7: Spalling in deck (Note deck repairs and paint failure at beams)

- The existing deck would be removed, and a new cast-in-place deck would be poured.
- The existing rolled beams are rusting and have areas of minor section loss. This alternative would include cleaning and painting the existing beams.
- There is a full height vertical crack in the northern abutment. This crack should be stabilized and repaired.
- The backwalls have areas of moderate concrete scaling with localized heavy efflorescence leakage present. New backwalls should be poured.
- A silane application should be applied to all exposed substructure concrete as part of the project.

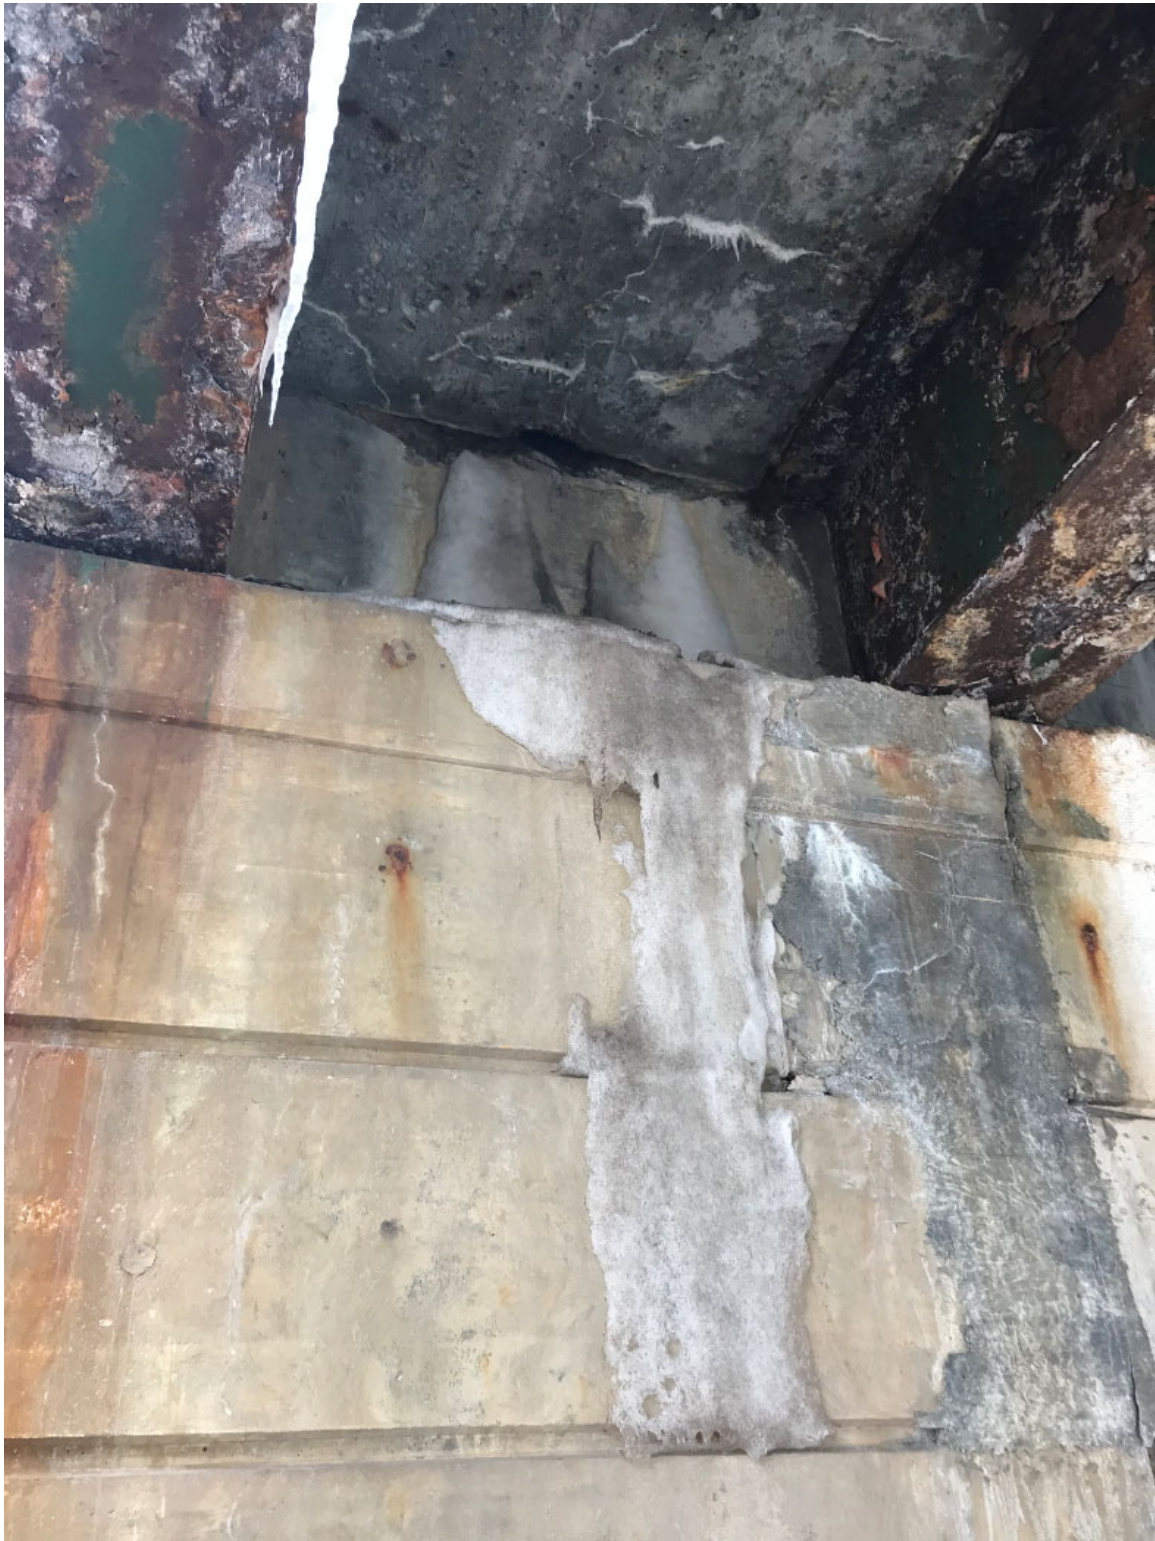
- The substructures are in satisfactory condition, with the following maintenance needs:
 - Backwall: The reinforced concrete curtain walls have areas of moderate concrete scaling with heavy efflorescence leakage present in bays 1 and 3.

4/12/2017 – This structure needs to have a full deck replacement with extensive cleaning and painting of the beams. Due to continued saturation of the abutment 2 backwall, concrete repairs should be considered as well. ~JW/SP

Photo 8: Backwall Leakage

4/9/2018 – Structure is in poor condition due to the deck. Deck will need replacement soon. Beams should be cleaned and painted. Spalling in the backwall on abutment #2 should be cleaned and patched. Should consider replacing the deck and paving soon. ~FRE/SMP

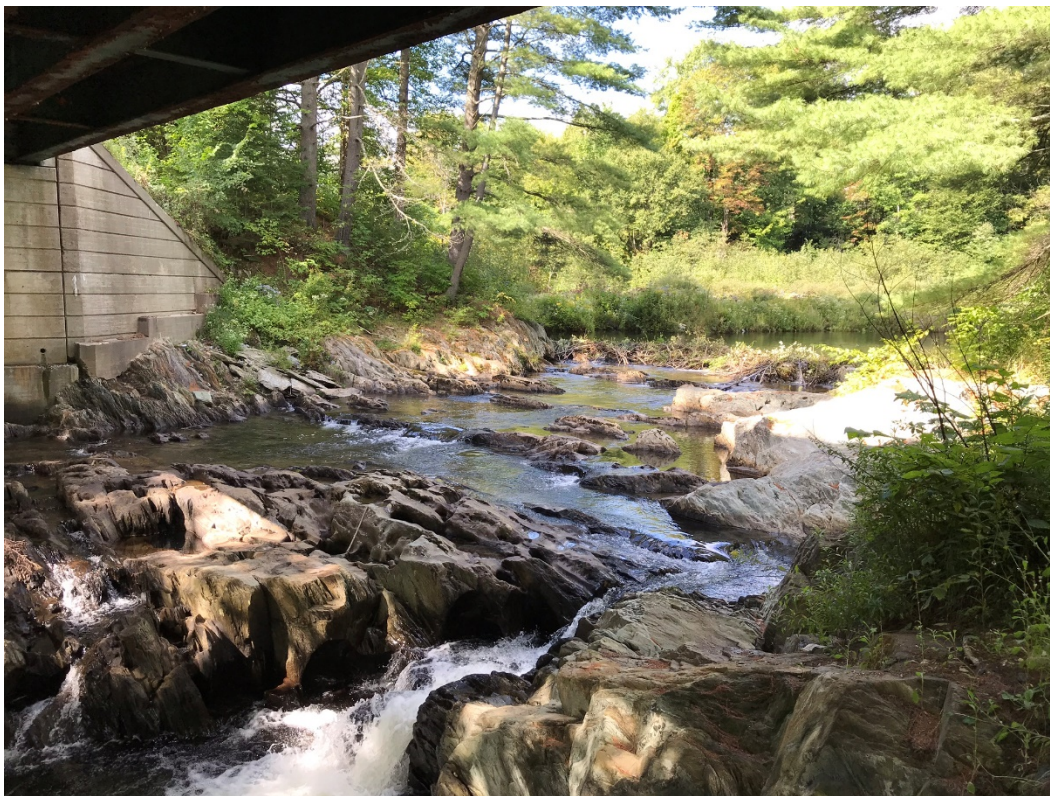
Figure 3.3: Facing upstream; note exposed bedrock throughout including at wingwall location.

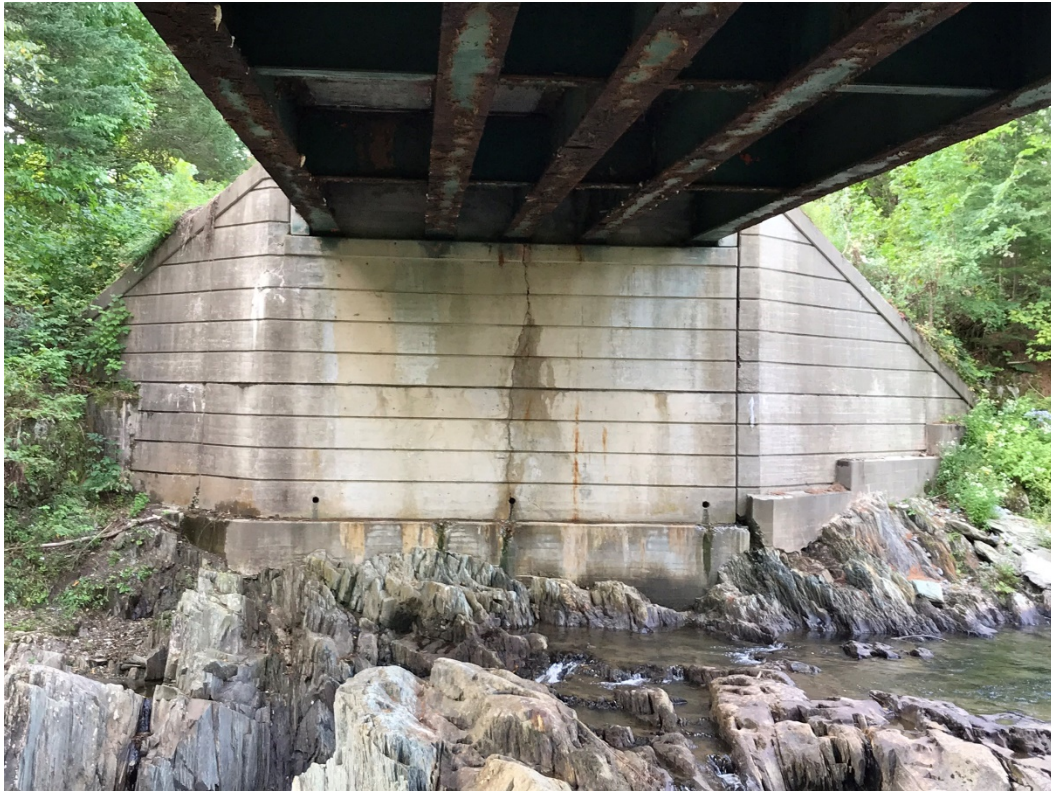
Figure 3.4: *Facing southern abutment; note exposed bedrock at bottom of footing elevations for abutment and wingwalls.*

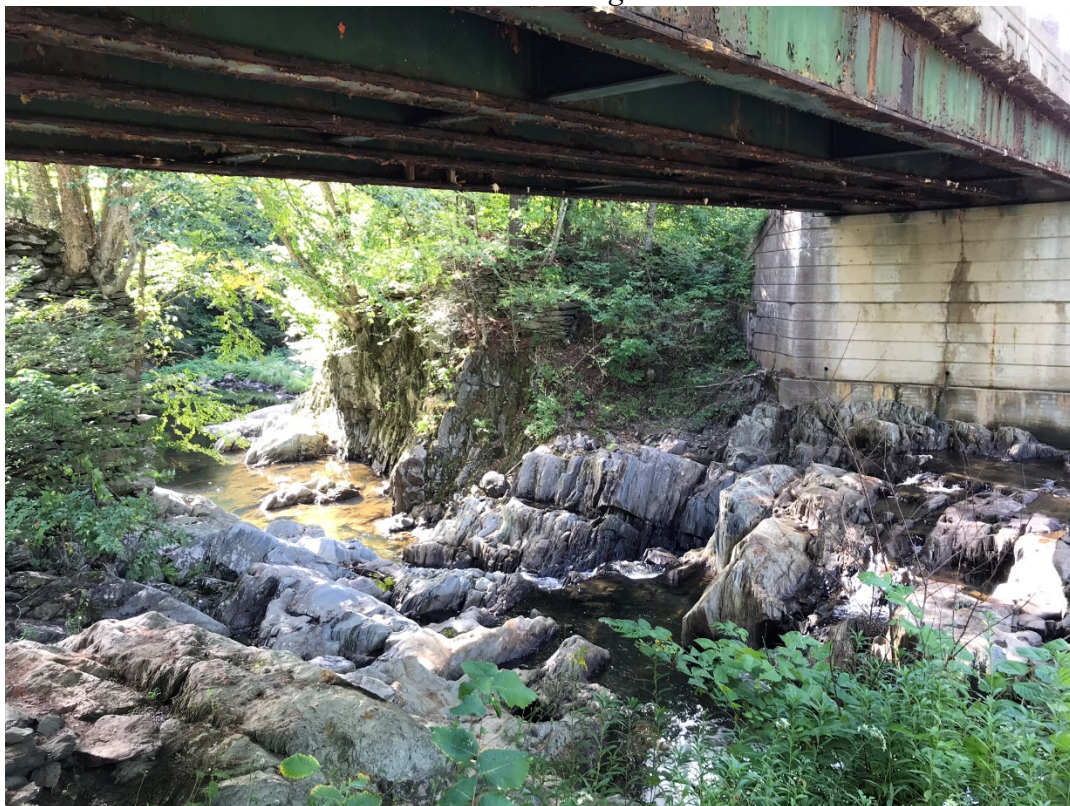
Figure 3.5: *Facing downstream; note exposed bedrock throughout.*

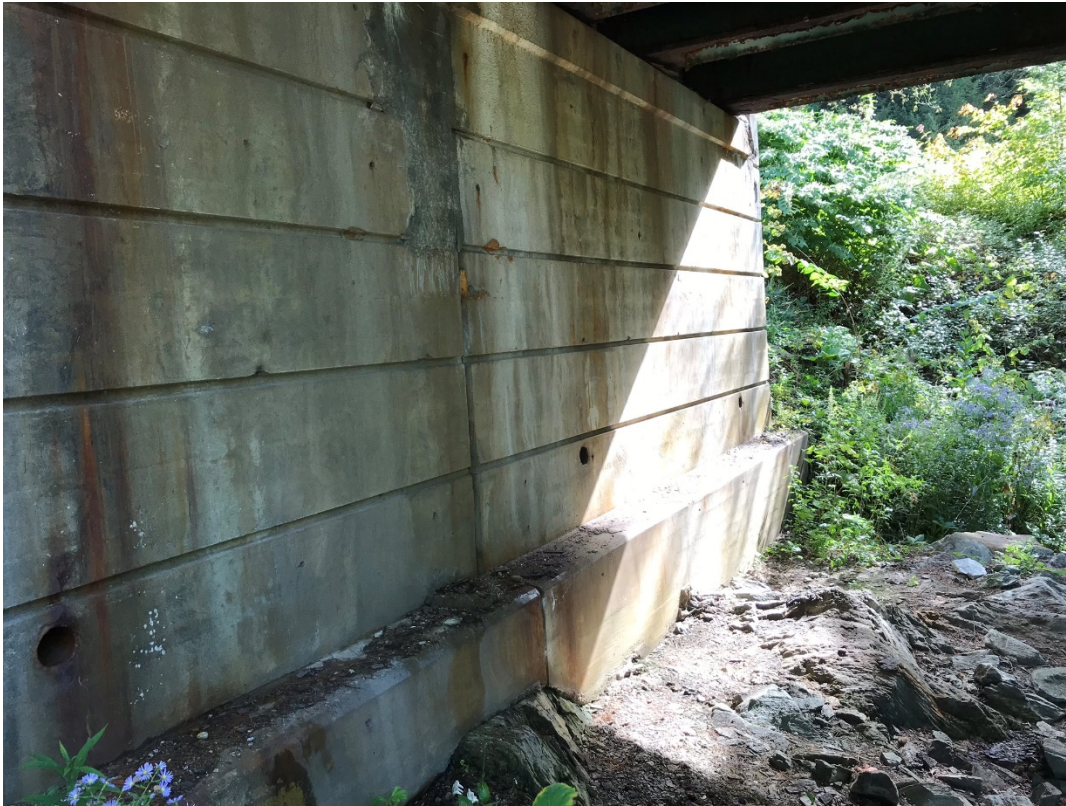
Figure 3.6: Facing northern abutment outlet; note exposed bedrock at bottom of footing elevation for abutment.

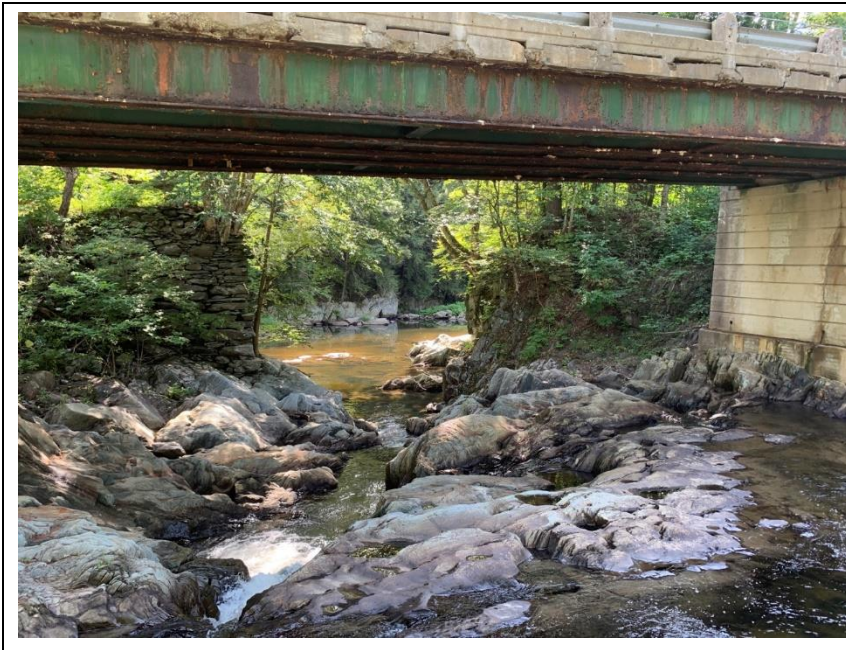
Upstream of structure looking downstream. Cracks in abutment may provide bat roosting.
September 10, 2019

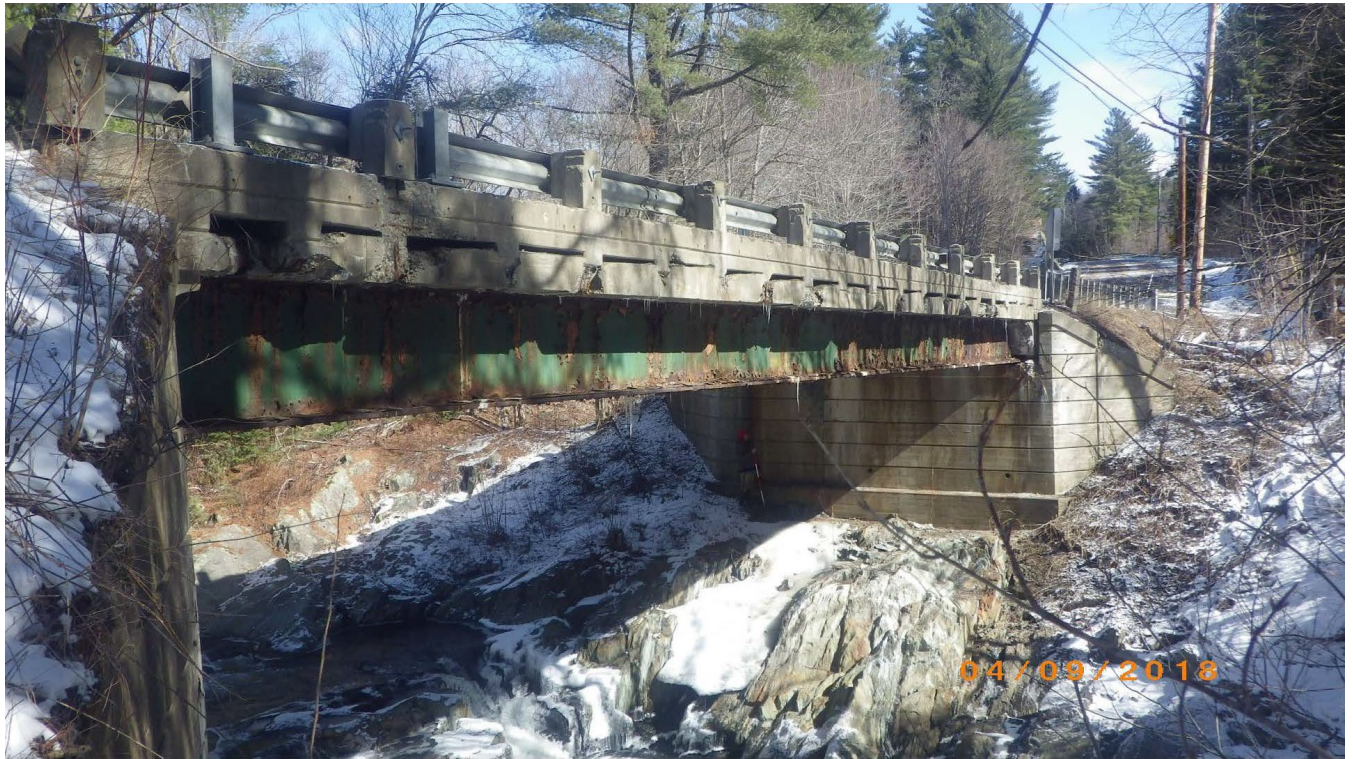
Figure 3: Note the bridges original Art Deco detailing and poor substructure.

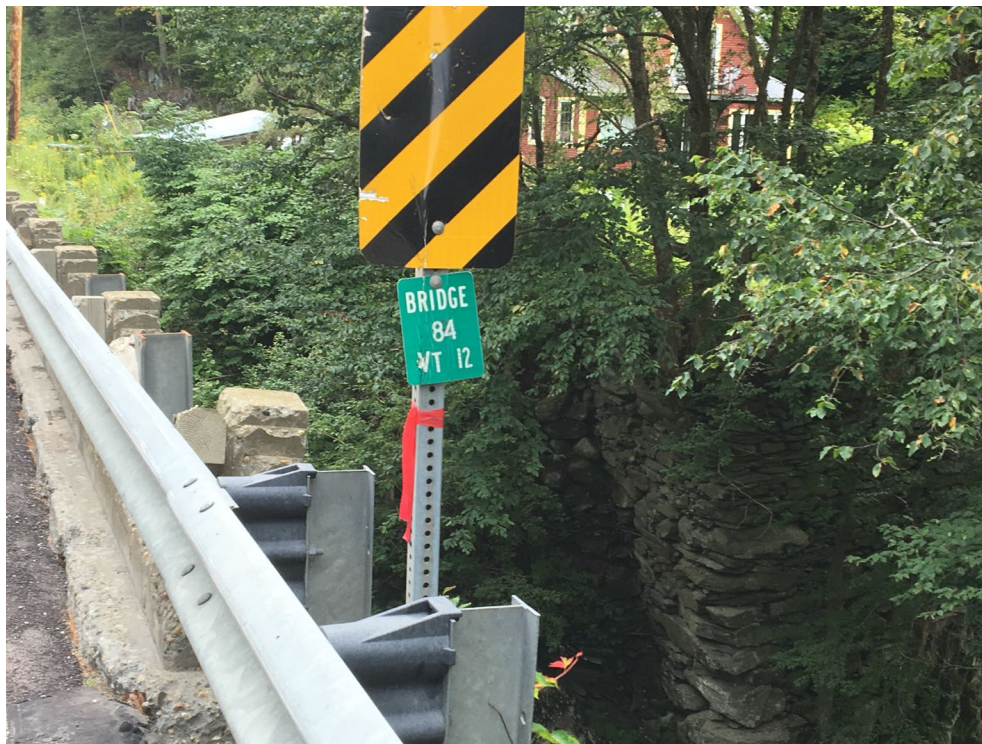
Figure 4: Early dry laid abutments from a previous structure are viewable in the rightmost portion of this image. This is also visible in Figure 2.
