STATE OF VERMONT
AGENCY OF TRANSPORTATION

Final Scoping Report

Springfield IM 091-1(83)

**I-91 Bridges 25 N&S over Route 5, Bridges 27 N&S over the Toonerville Rail Trail
and Related Considerations for Adjacent Bridges 26 N&S and 28 N&S**

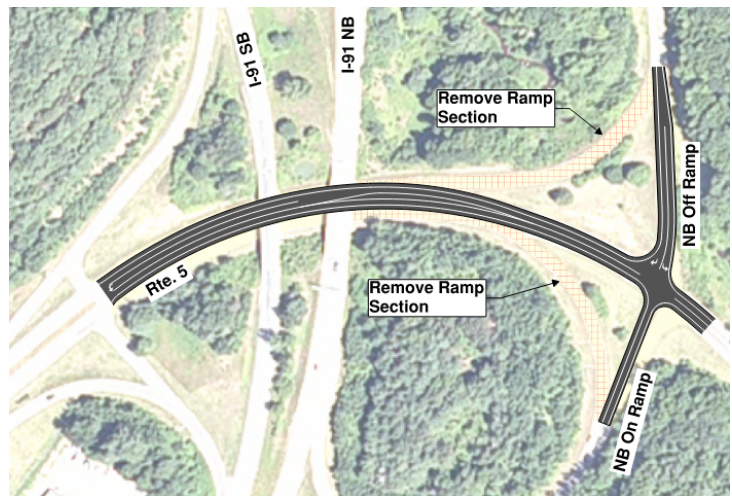
Just north of Bridges 27N & 27S is the Exit 7 interchange which encompasses Bridges 28 N & S. This interchange has multiple freeway movements including weaves, merge, and diverge areas that increase the potential for driver conflict and therefore results in safety concerns. With the replacement of Bridges 28 N&S, as recommended in the 2020 Bridges 28 Scoping Report, there is the opportunity to remove some of these conflict points by removing the slip lanes to and from Route 5. This scenario results in t-intersections with

the ramps and Route 5, allowing for a narrower Route 5 and ultimately resulting in shorter Bridges 28N and 28S. In addition, the elimination of slip lanes and teeing of the intersection allows for relocation of the Toonerville Rail Trail along Route 5 by providing safer and fewer crossings at the ramps. The new intersections would operate at an acceptable level of service upon opening while also improving safety. Signal warrants are not anticipated to be met and, even under stop conditions during the peak hour, queuing on the ramp is anticipated to be minimal. Additional benefits of removing the slip lanes and narrowing Route 5 are the overall amount of pavement is reduced, stormwater impacts are lessened, and future maintenance costs are reduced. With these numerous benefits, we recommend removing the slip lanes and narrowing Route 5 as the baseline condition and therefore have assumed this for all maintenance of traffic strategies discussed later.

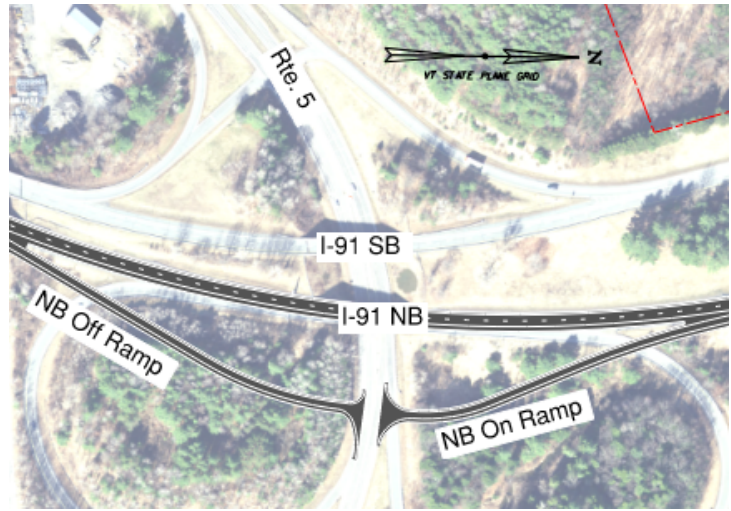
Another opportunity to reduce weave and merge conflicts and improve safety is to remove the northbound clover leaf ramps and replace with diamond interchange ramps. The incorporation of diamond ramps removes the weaving area between the on ramp and off ramp traffic on I-91 northbound resulting in a bridge 12' narrower than the existing. This is not anticipated to reduce the level of service on the mainline or ramps and the newly configured intersection is anticipated to perform acceptably.

A few of the maintenance of traffic alternatives discussed below incorporate the diamond interchange option. Additional benefits to removing the clover leaf ramps are reduced impervious areas by removing existing pavement along the clover ramps and removing two 11' x 11' concrete box culverts, one 430' long and the other 235' long, currently carrying Spencer Brook (Culverts 28-1G and 28-1C).

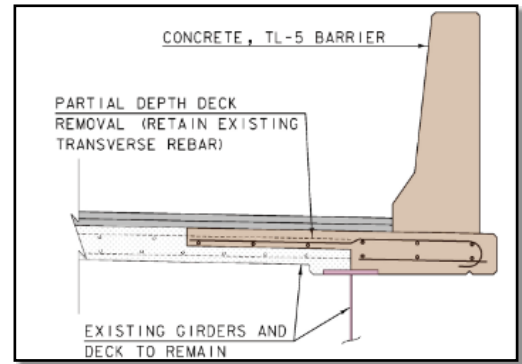
- Remove and replace the waterproofing membrane and pavement.
- Remove and replace the deck overhangs, curbs, and rail system as shown in the detail to the right. Overhang removal, with partial removal into the first girder bay, will be necessary to properly reinforce a TL-5 barrier.
- Patch the remaining portions of the concrete deck (approximately 15% of deck estimated to be patched based on visible full-depth patches, cracking, and moisture).
- Replace the bridge joints with asphaltic plug joints at the southern abutment and compression or strip seals at the northern abutments.
- Replace all abutment bearings.
- Patch the abutments and wingwalls (<10% of total surface area anticipated).
- Patch the piers (minimal patching anticipated).

Based on the repairs listed above, it is reasonable to assume the existing substructure and beams can safely carry anticipated traffic loads for an additional 20 to 25 years, without significant maintenance during that period. Although field painting the girders is not listed above, nor included in cost estimates presented later in this section, this work will likely be necessary within the next 20 years.

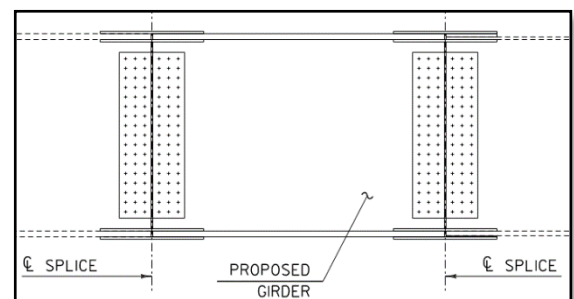
This deck replacement option involves the removal of the existing pin and link system, used to suspend the majority of the central bridge span, with four continuous field splices per girder line (two field splices per pin and link location as shown to the right).

Progression of this work can occur from the top of the deck using strong backs or from beneath the deck using temporary towers and jacks. Each of these construction approaches have advantages and disadvantages. Top-down construction will eliminate channel impacts but require additional attention to sequence of work and overall fit-up, whereas temporary towers may eliminate risk and sensitivity to operations but requires in-water work. To avoid the cost and impacts associated with temporary access within the channel, a top-down approach is assumed for the following discussion.

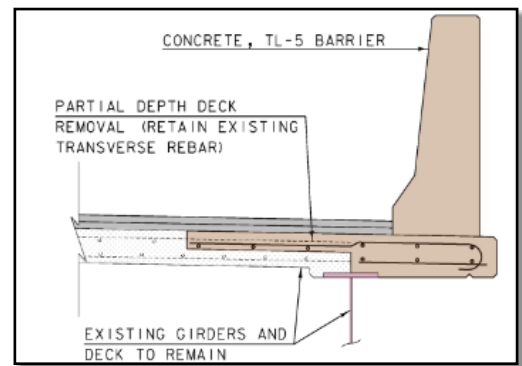
- Remove and replace the waterproofing membrane and pavement.
- Remove and replace the deck overhangs, including curbs and rail system as shown in the detail to the right. Overhang removal, with partial removal into the first girder bay, will be necessary to properly reinforce a TL-5 barrier.
- Patch the remaining portions of the concrete deck (approximately 10% of deck estimated to be patched based on visible full-depth patches, cracking, and moisture).
- Replace the asphaltic plug joints.
- Clean the bridge seats and correct the infiltrating backfill fines.

- Patch the abutments and wingwalls (<5% of total surface area anticipated).
- Address the failing metal bin retaining walls by raising the trail grade or strengthening the wall system. Raising the trail grade along the walls will bury the walls within approximate 3:1 slopes and render the walls unnecessary. Alternatively, the bin walls could be faced with structural precast and/or cast in-place concrete and restrained with soil anchors; however, anchors will need to be carefully placed to avoid conflicts with abutment piles. Estimated costs for raising the trail grade or strengthening the wall are \$150,000 and \$800,000 respectively. Since raising the trail grade is more cost effective and results in less long-term maintenance, this cost is carried forward for all options that preserve and reuse a portion of the existing bridges.

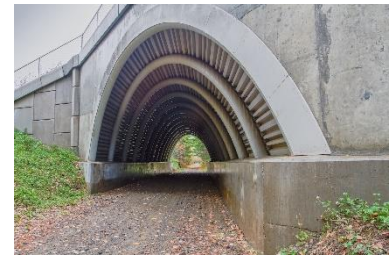
Several buried structure types are available to meet the needs of this project. However, precast concrete frames and concrete-filled fiberglass tube structures will best meet project need and provide long-term, low-maintenance solutions. Precast structures are typically detailed on the Plans and designed by the vendor, whereas concrete-filled fiberglass tube structures are fully designed and detailed on the Plans. The final structure type should be determined in future project phases.

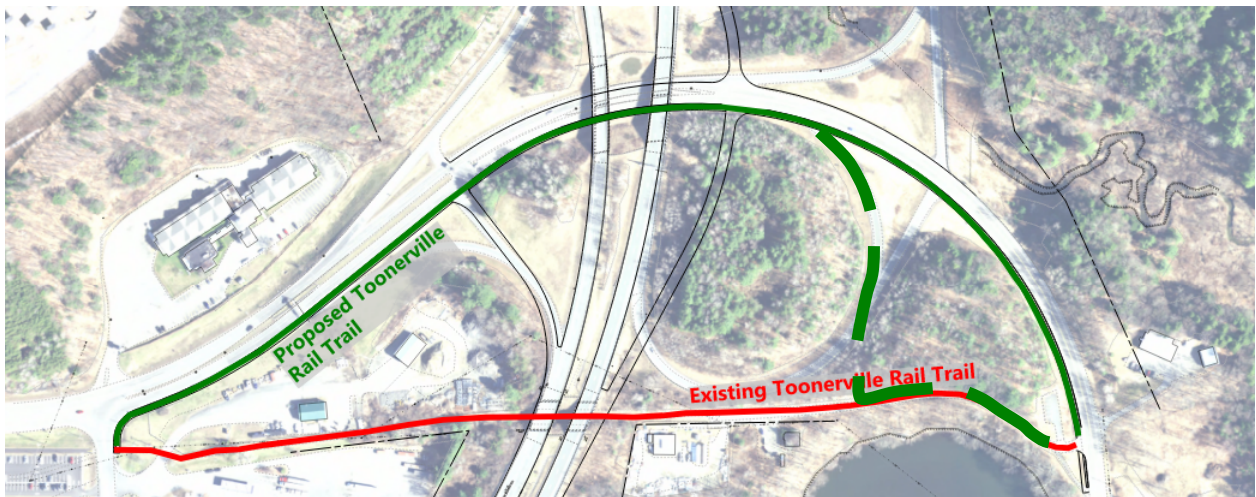
Toonerville Rail Trail Relocation Figure

Both of the trail relocations would not significantly increase the length of the trail, would maintain the same trail connection points, and would allow Bridges 27 N&S to be removed while only increasing the length of Bridges 28 N&S by 10-15 feet. Diverting the trail onto the disinvested on-ramp would beneficially limit the amount of new trail construction, as the existing ramp pavement could be partially left in place and reused for the trail. Additionally, trail users would be placed further from the roadway to provide greater buffer from traffic. In order for the ramp clover to be reused, the diamond interchange ramps will need to be constructed, southbound slip lane removed, and pedestrian safety improvements implemented – this will likely require a prolonged closure of the trail. The final path location should be determined in future project phases based on community input and limitations of closure periods for the trail.

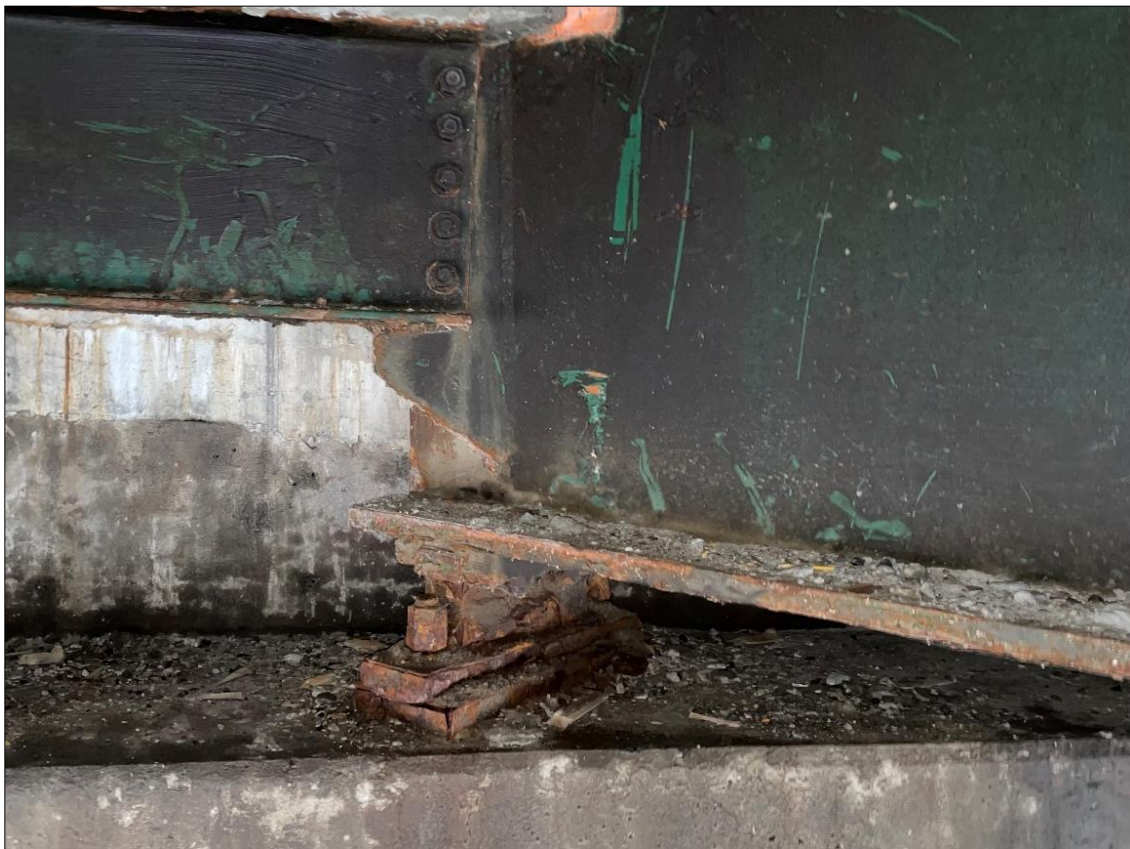
Bridge 25S Southern Abutment and Bridge Seat

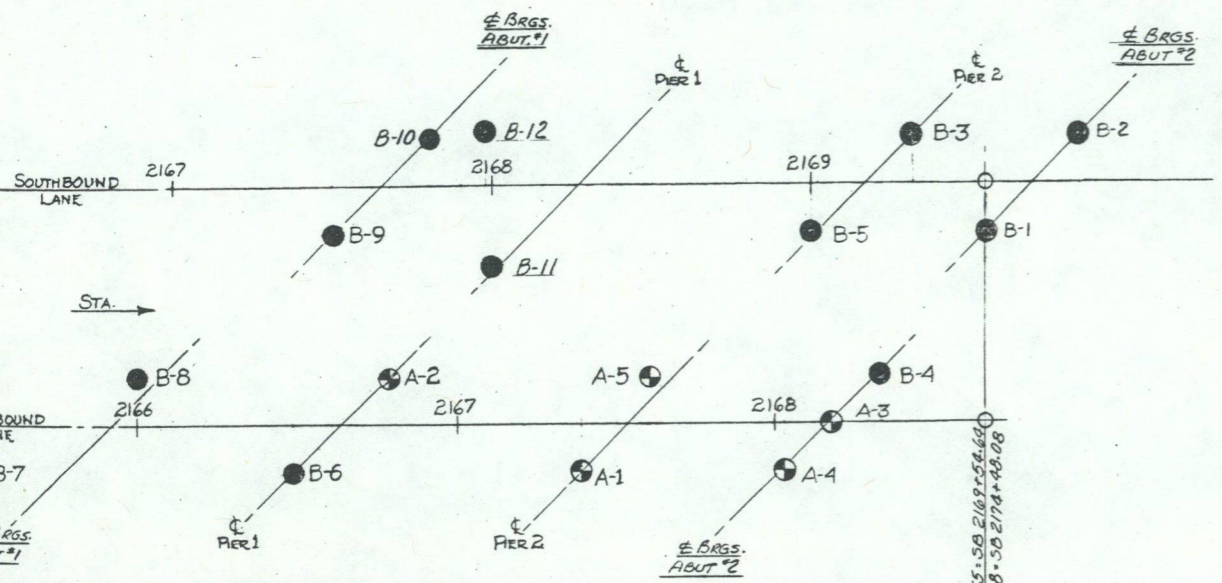
BORING LOCATIONS
Scale 1"=30'
Key: ● Wash Boring
⊙ Auger Boring

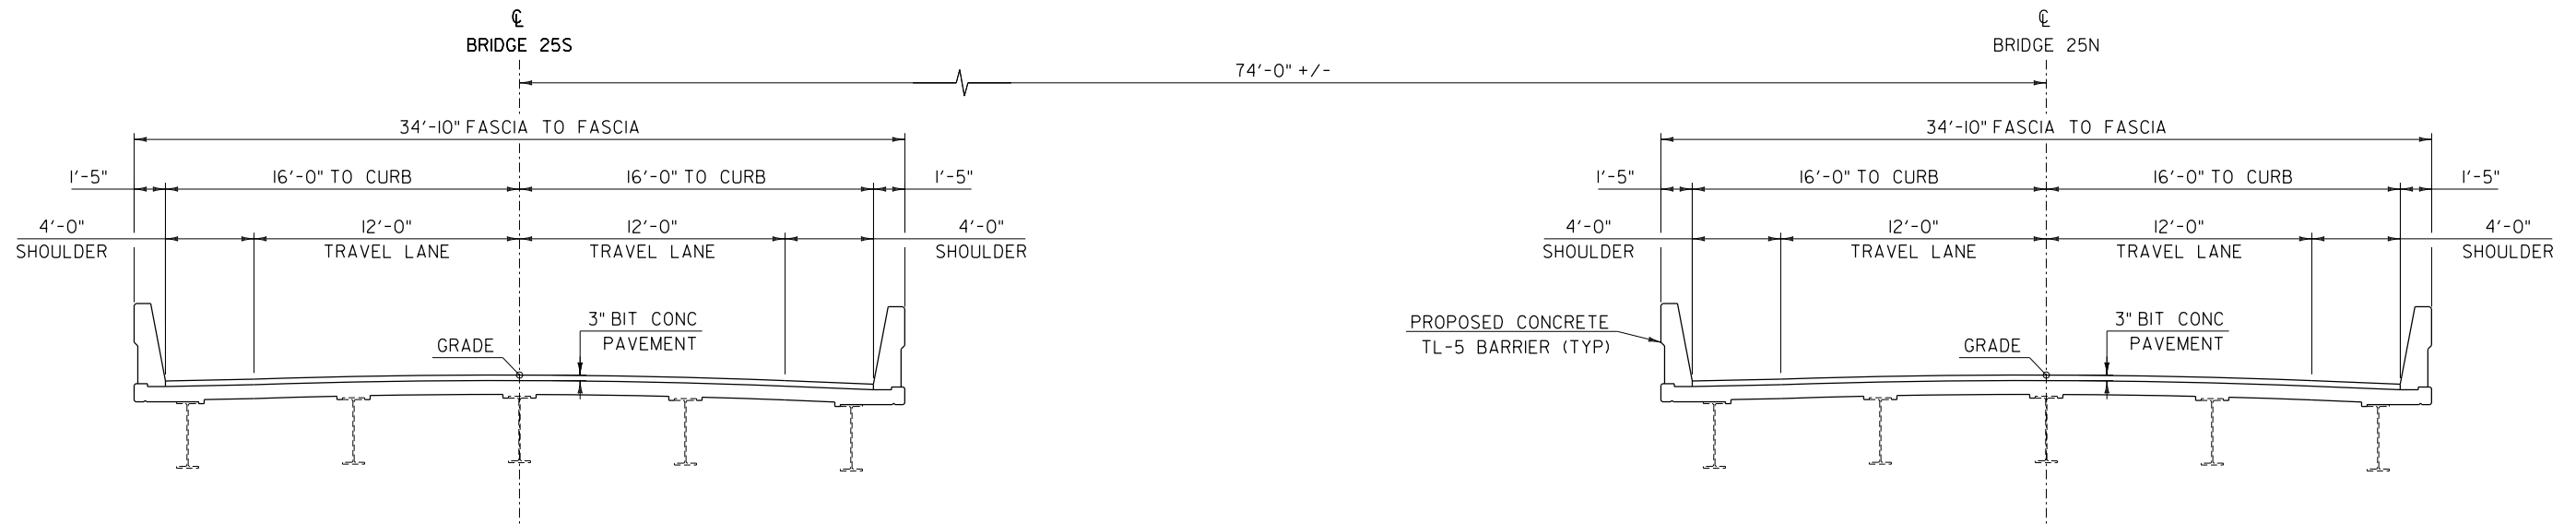
BRIDGE 25 N/S TYPICAL SECTION - DECK REPLACEMENT
SCALE 1/4" = 1'-0"

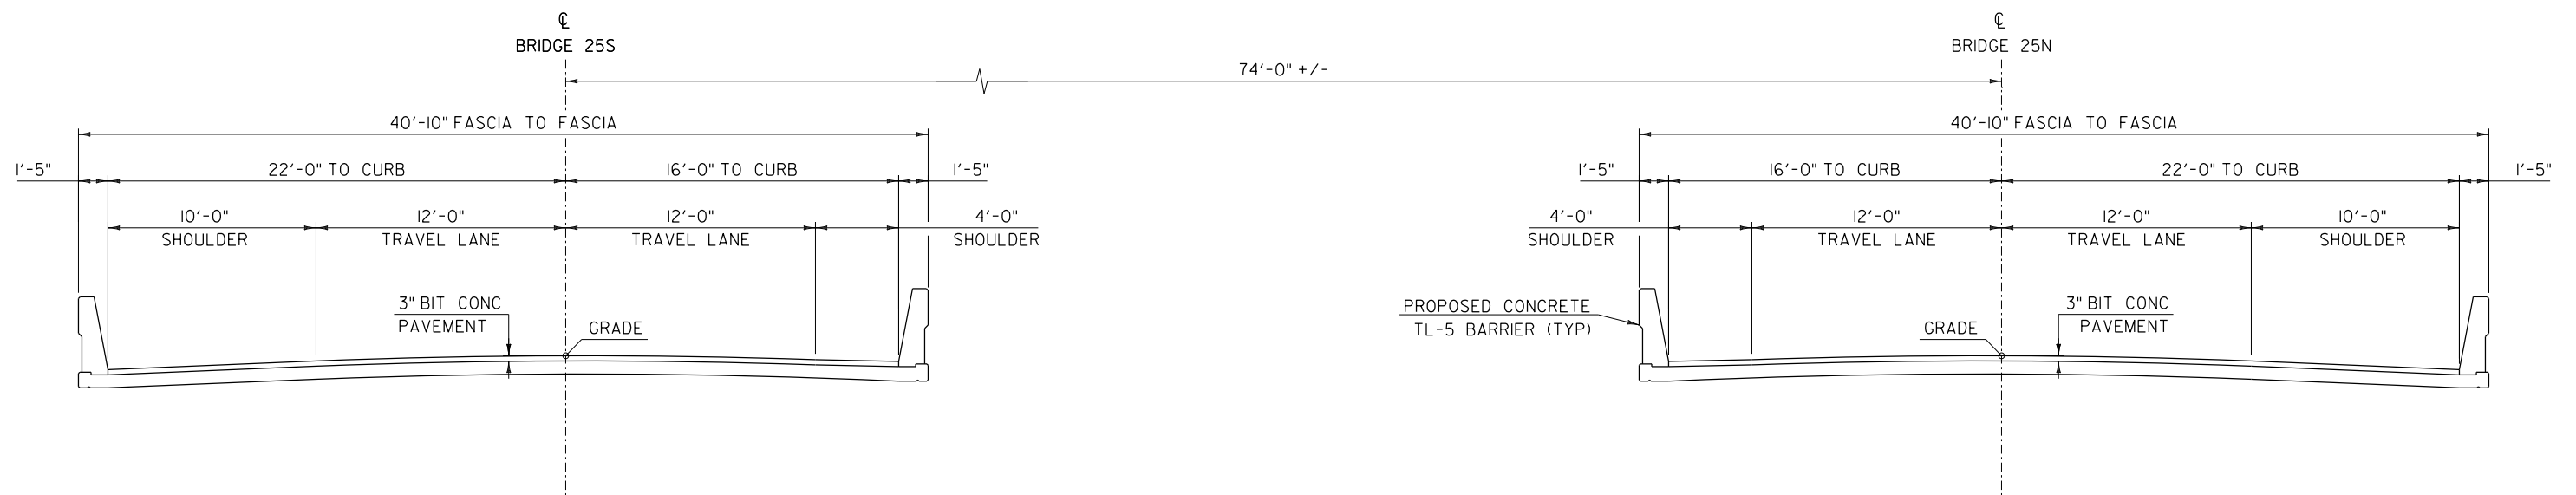
BRIDGE 25 N/S TYPICAL SECTIONS - BRIDGE REPLACEMENT
SCALE 1/4" = 1'-0"

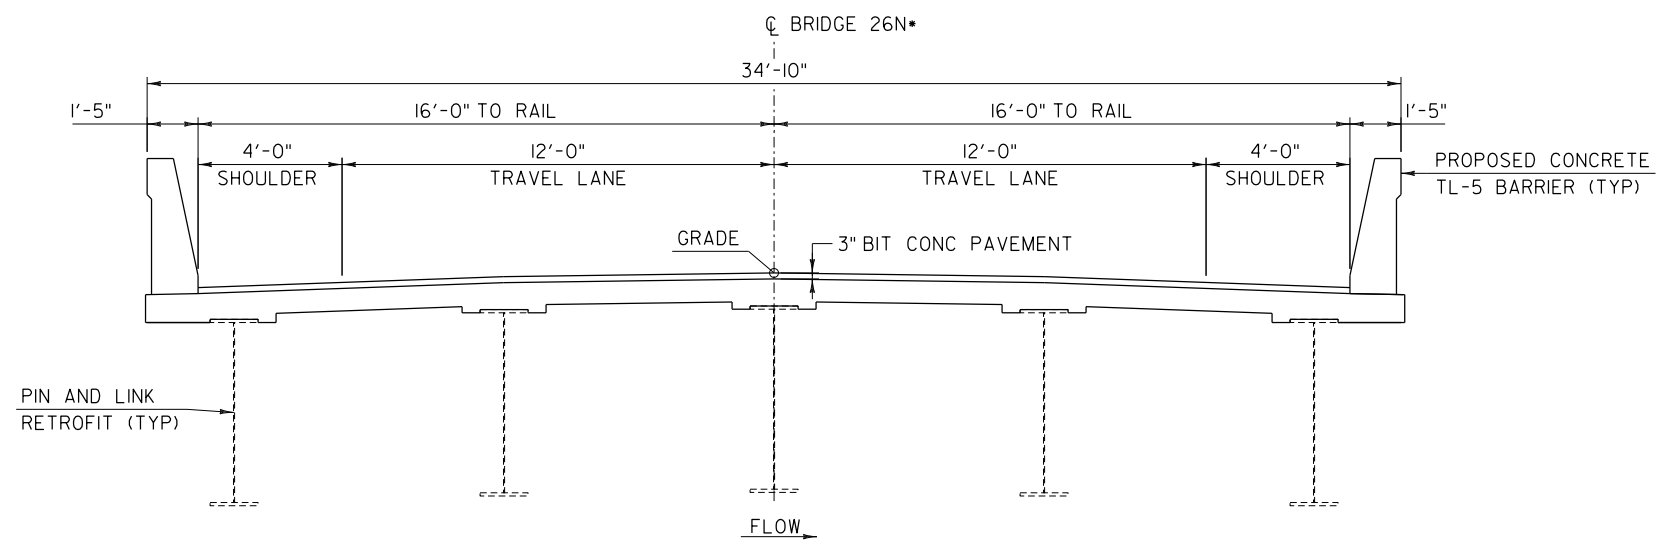
BRIDGE 26 N TYPICAL SECTION - DECK REPLACEMENT AND STEEL RETROFIT

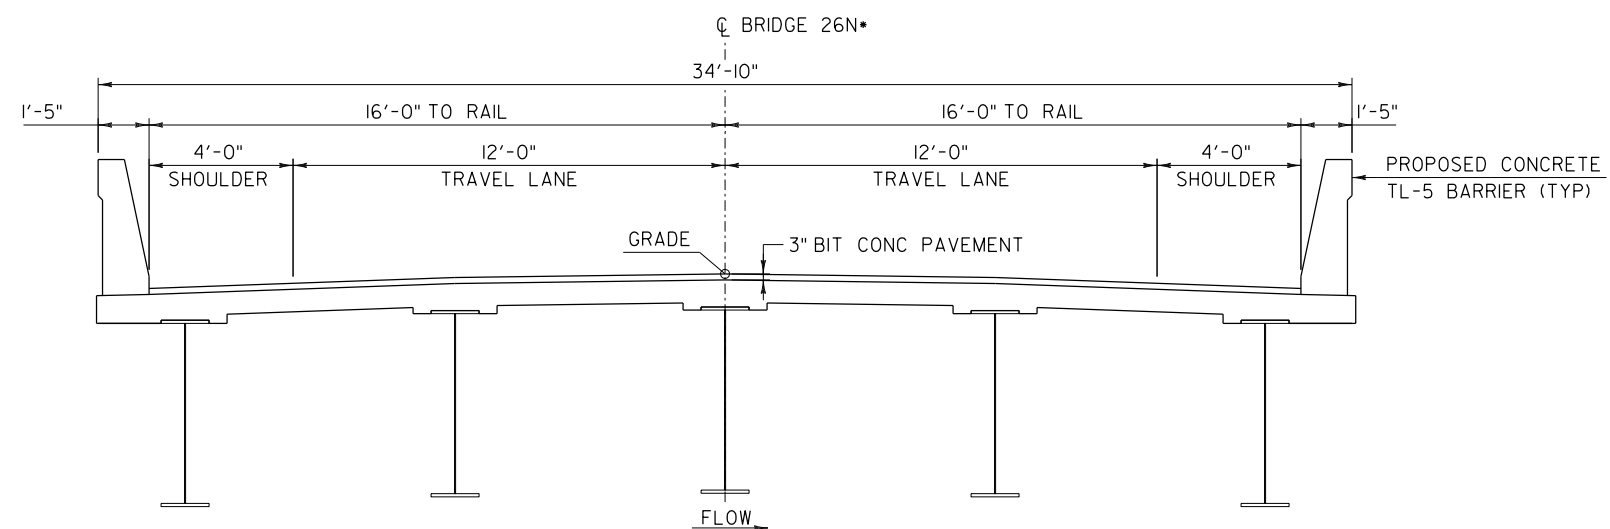
BRIDGE 26 N TYPICAL SECTION - SUPERSTRUCTURE REPLACEMENT

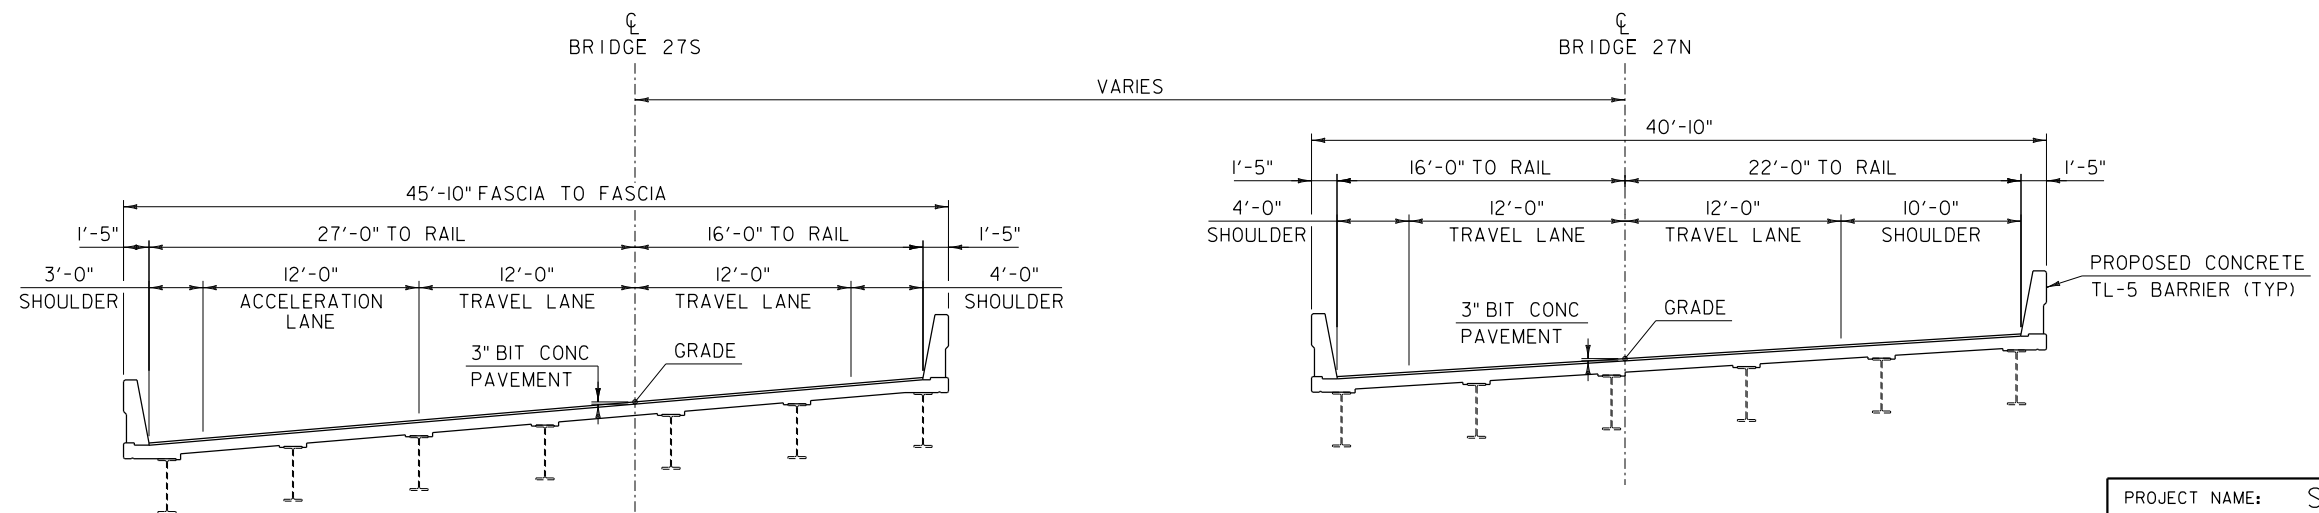
BRIDGE 27 N/S TYPICAL SECTION - DECK REPLACEMENT

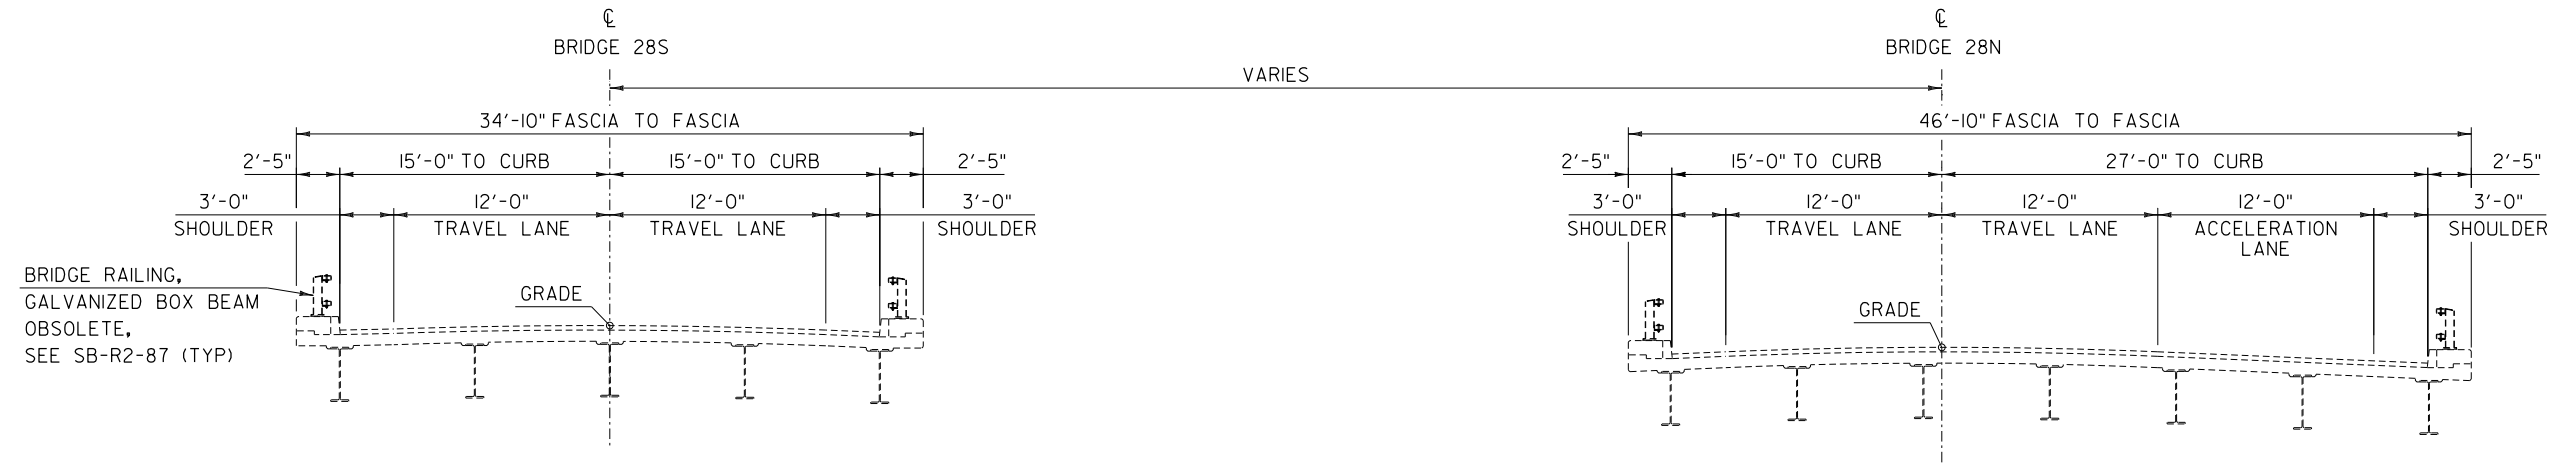
EXISTING BRIDGE 28 N/S TYPICAL SECTION

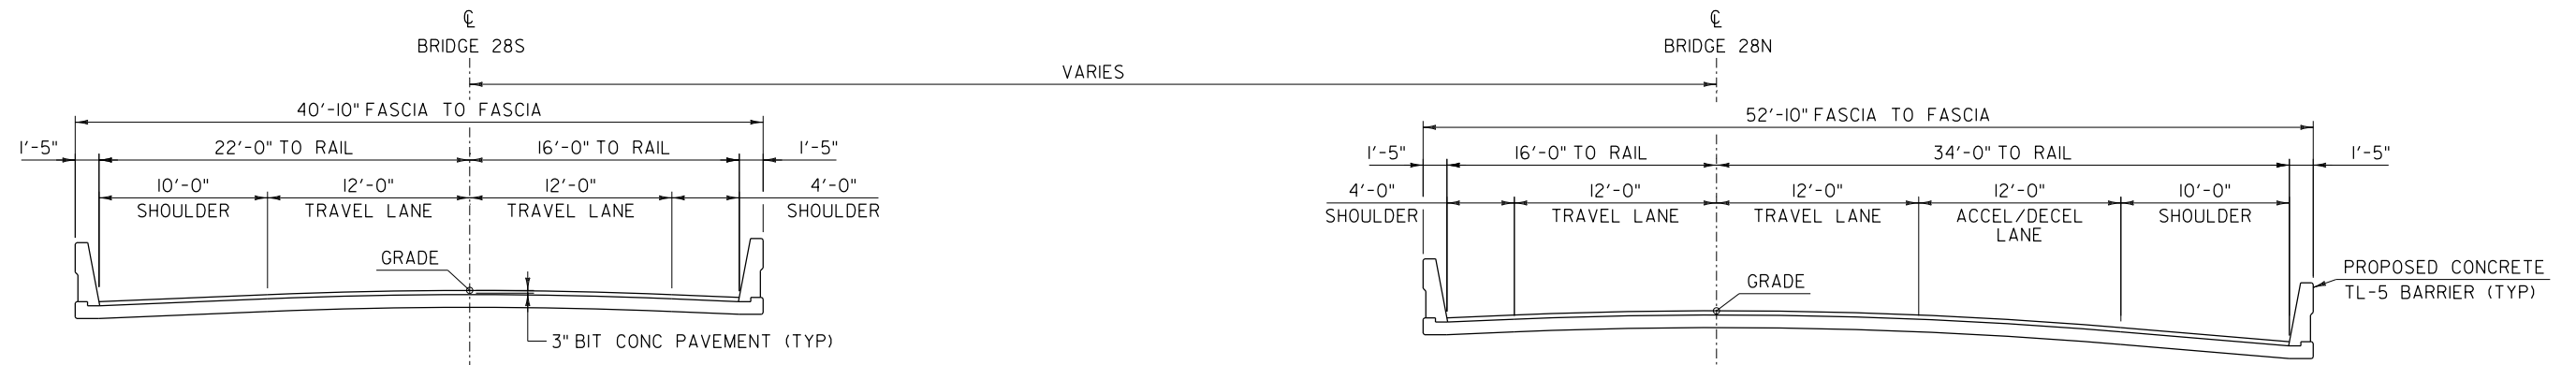
BRIDGE 28 N/S TYPICAL SECTIONS - BRIDGE REPLACEMENT (CLOVER)

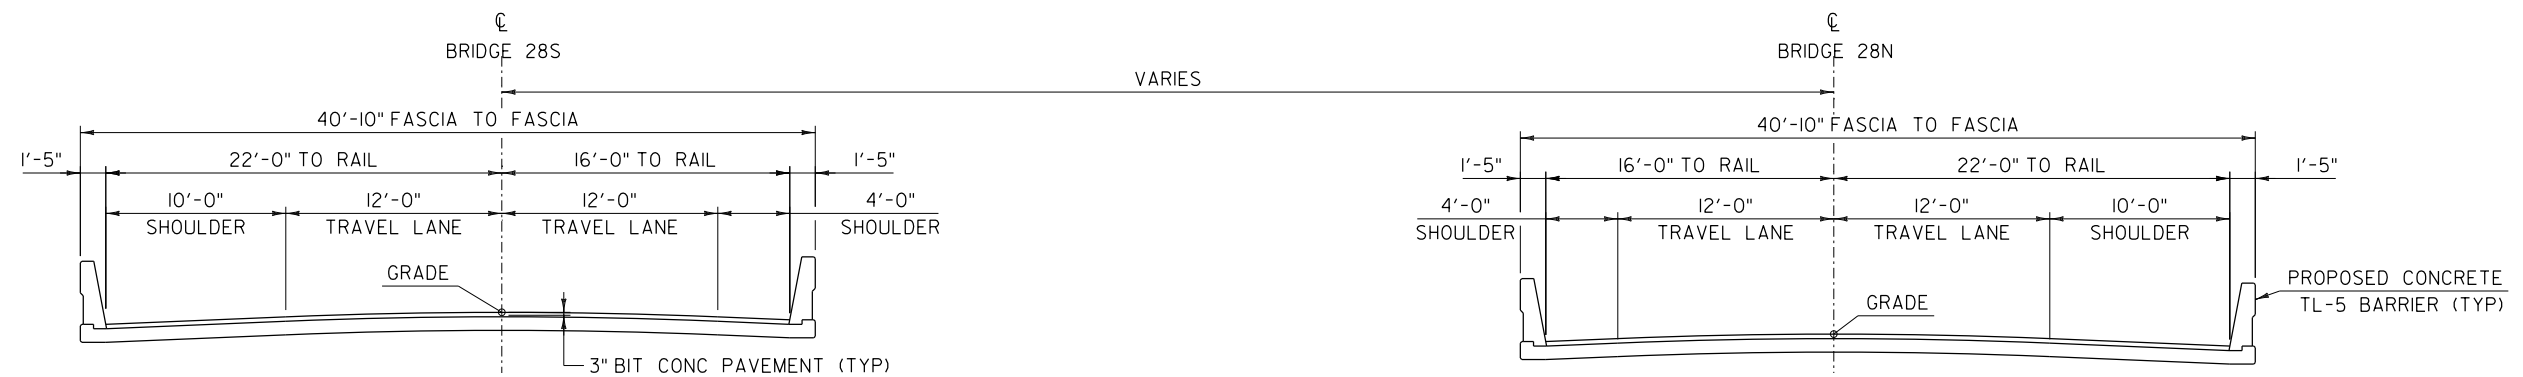
BRIDGE 28 N/S TYPICAL SECTION - BRIDGE REPLACEMENT (DIAMOND)

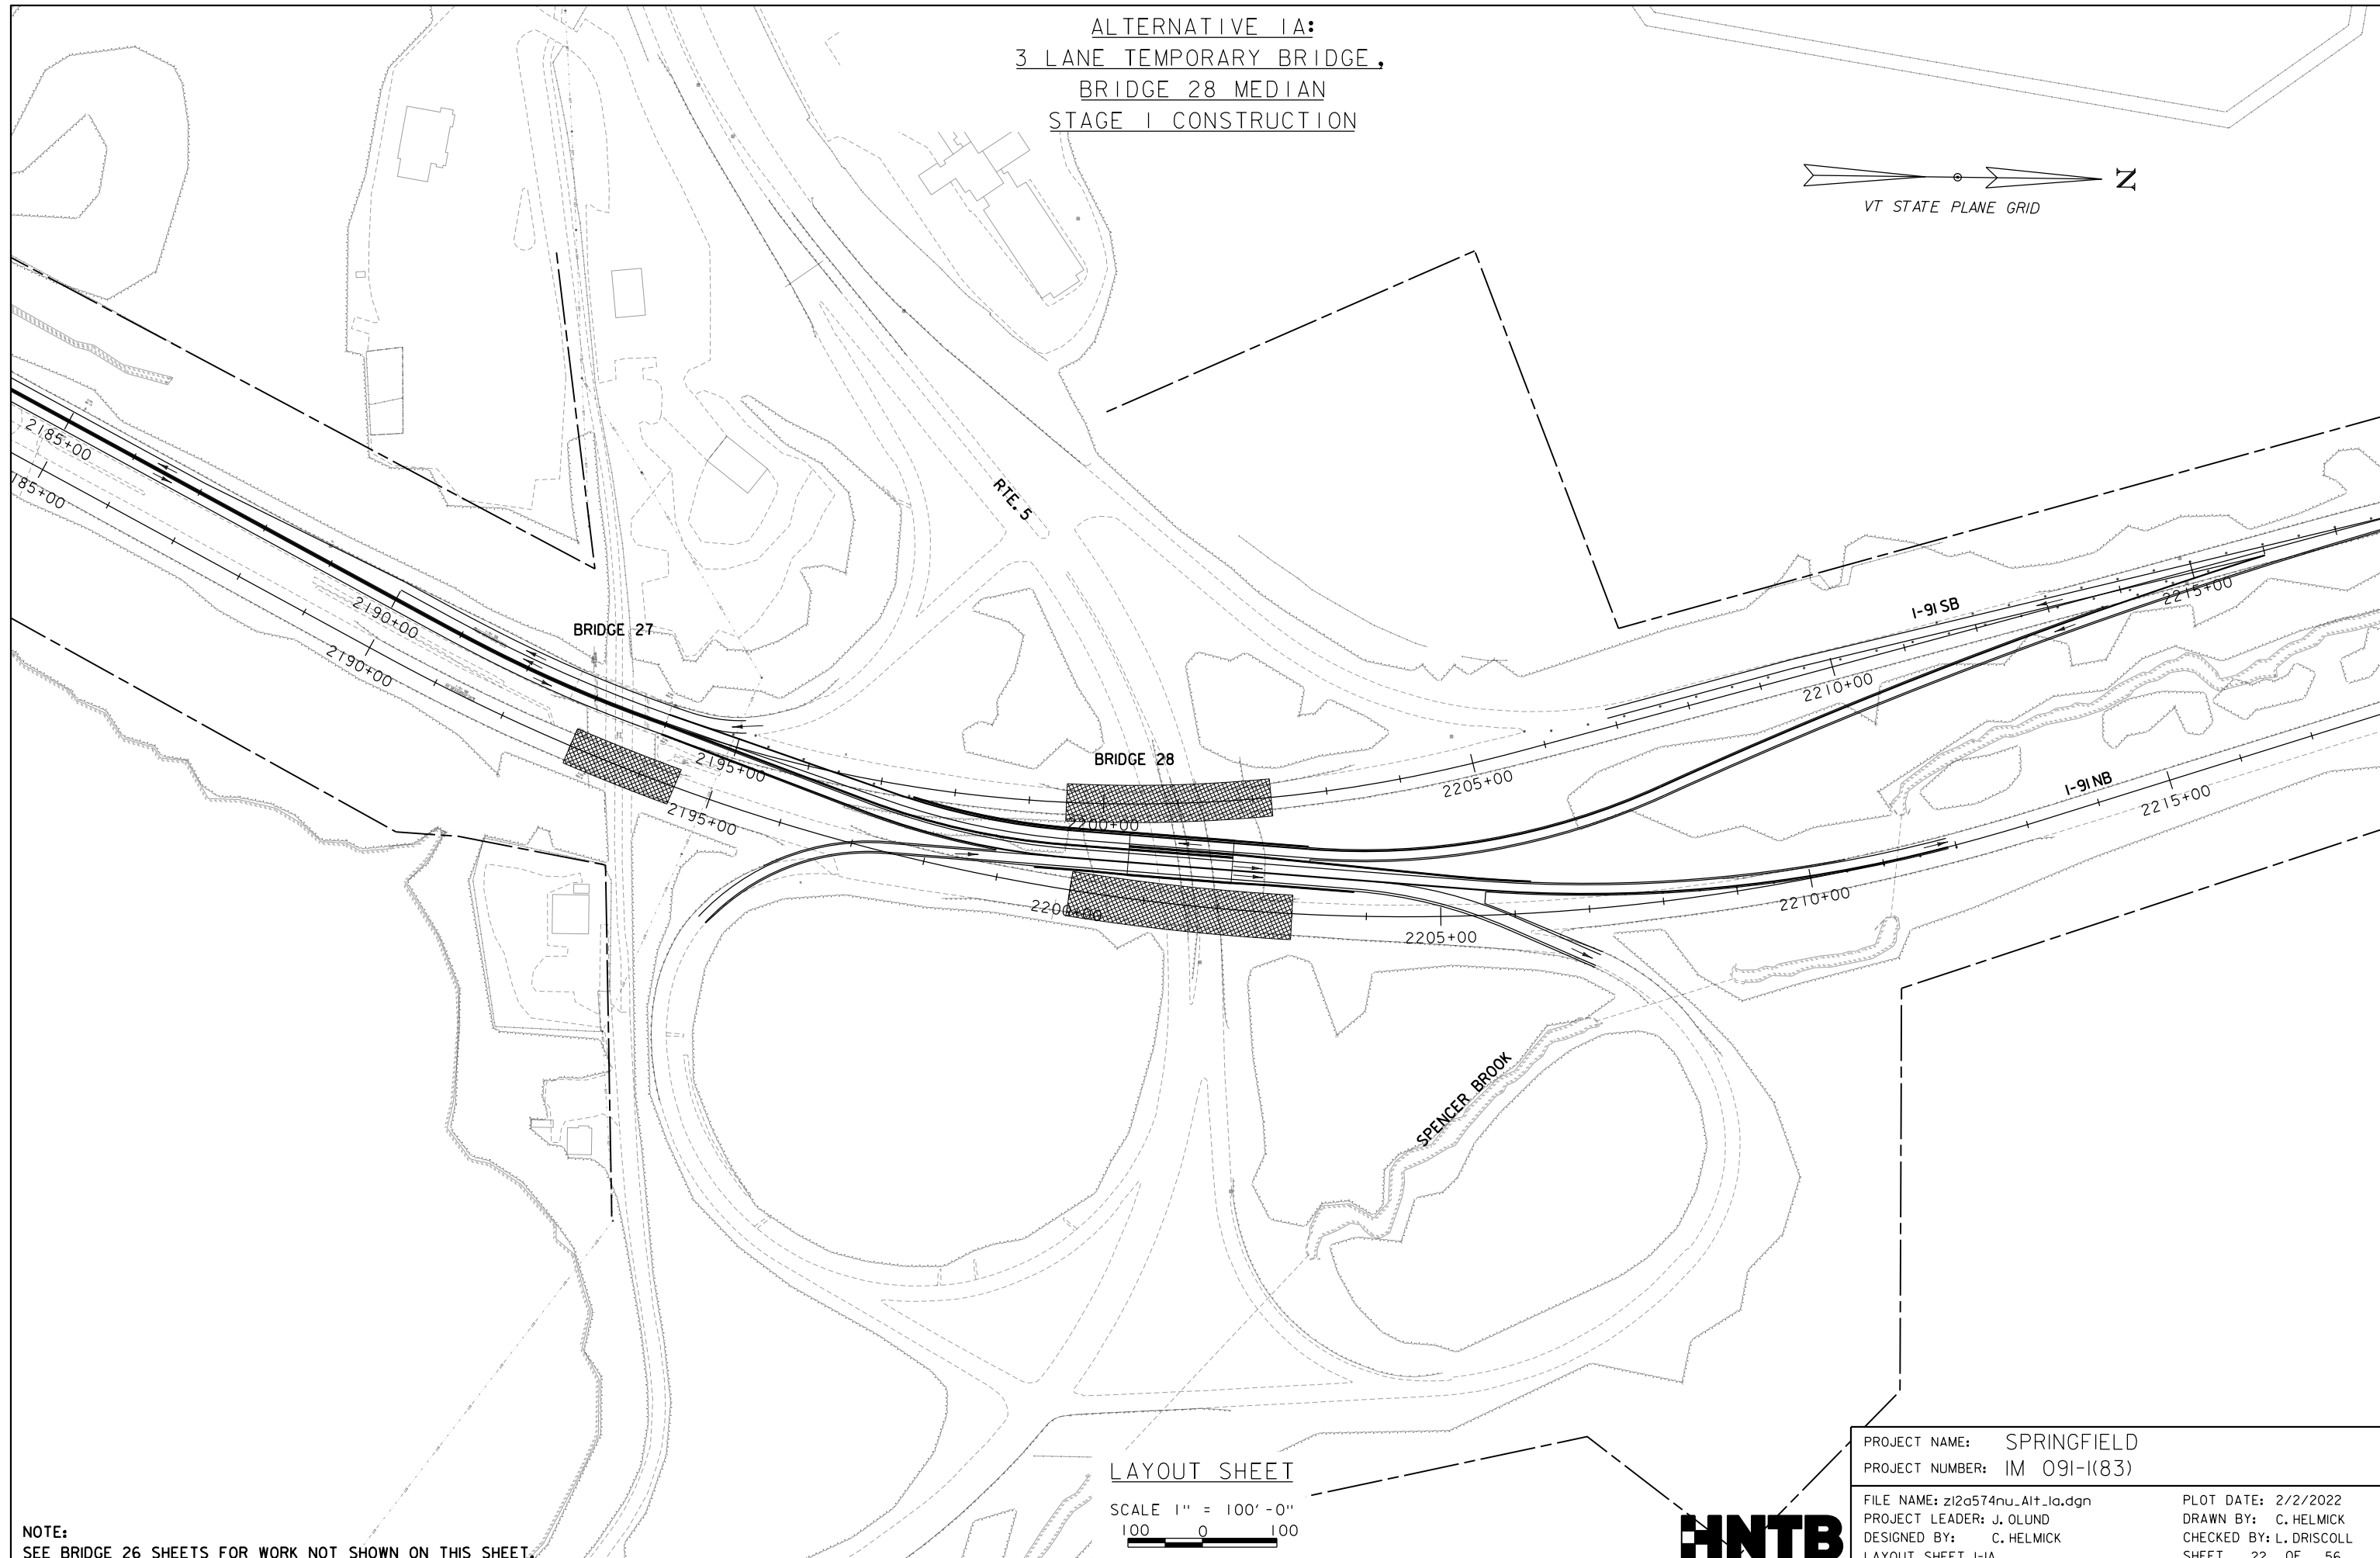
ALTERNATIVE 1A:
3 LANE TEMPORARY BRIDGE,
BRIDGE 28 MEDIAN
STAGE I CONSTRUCTION

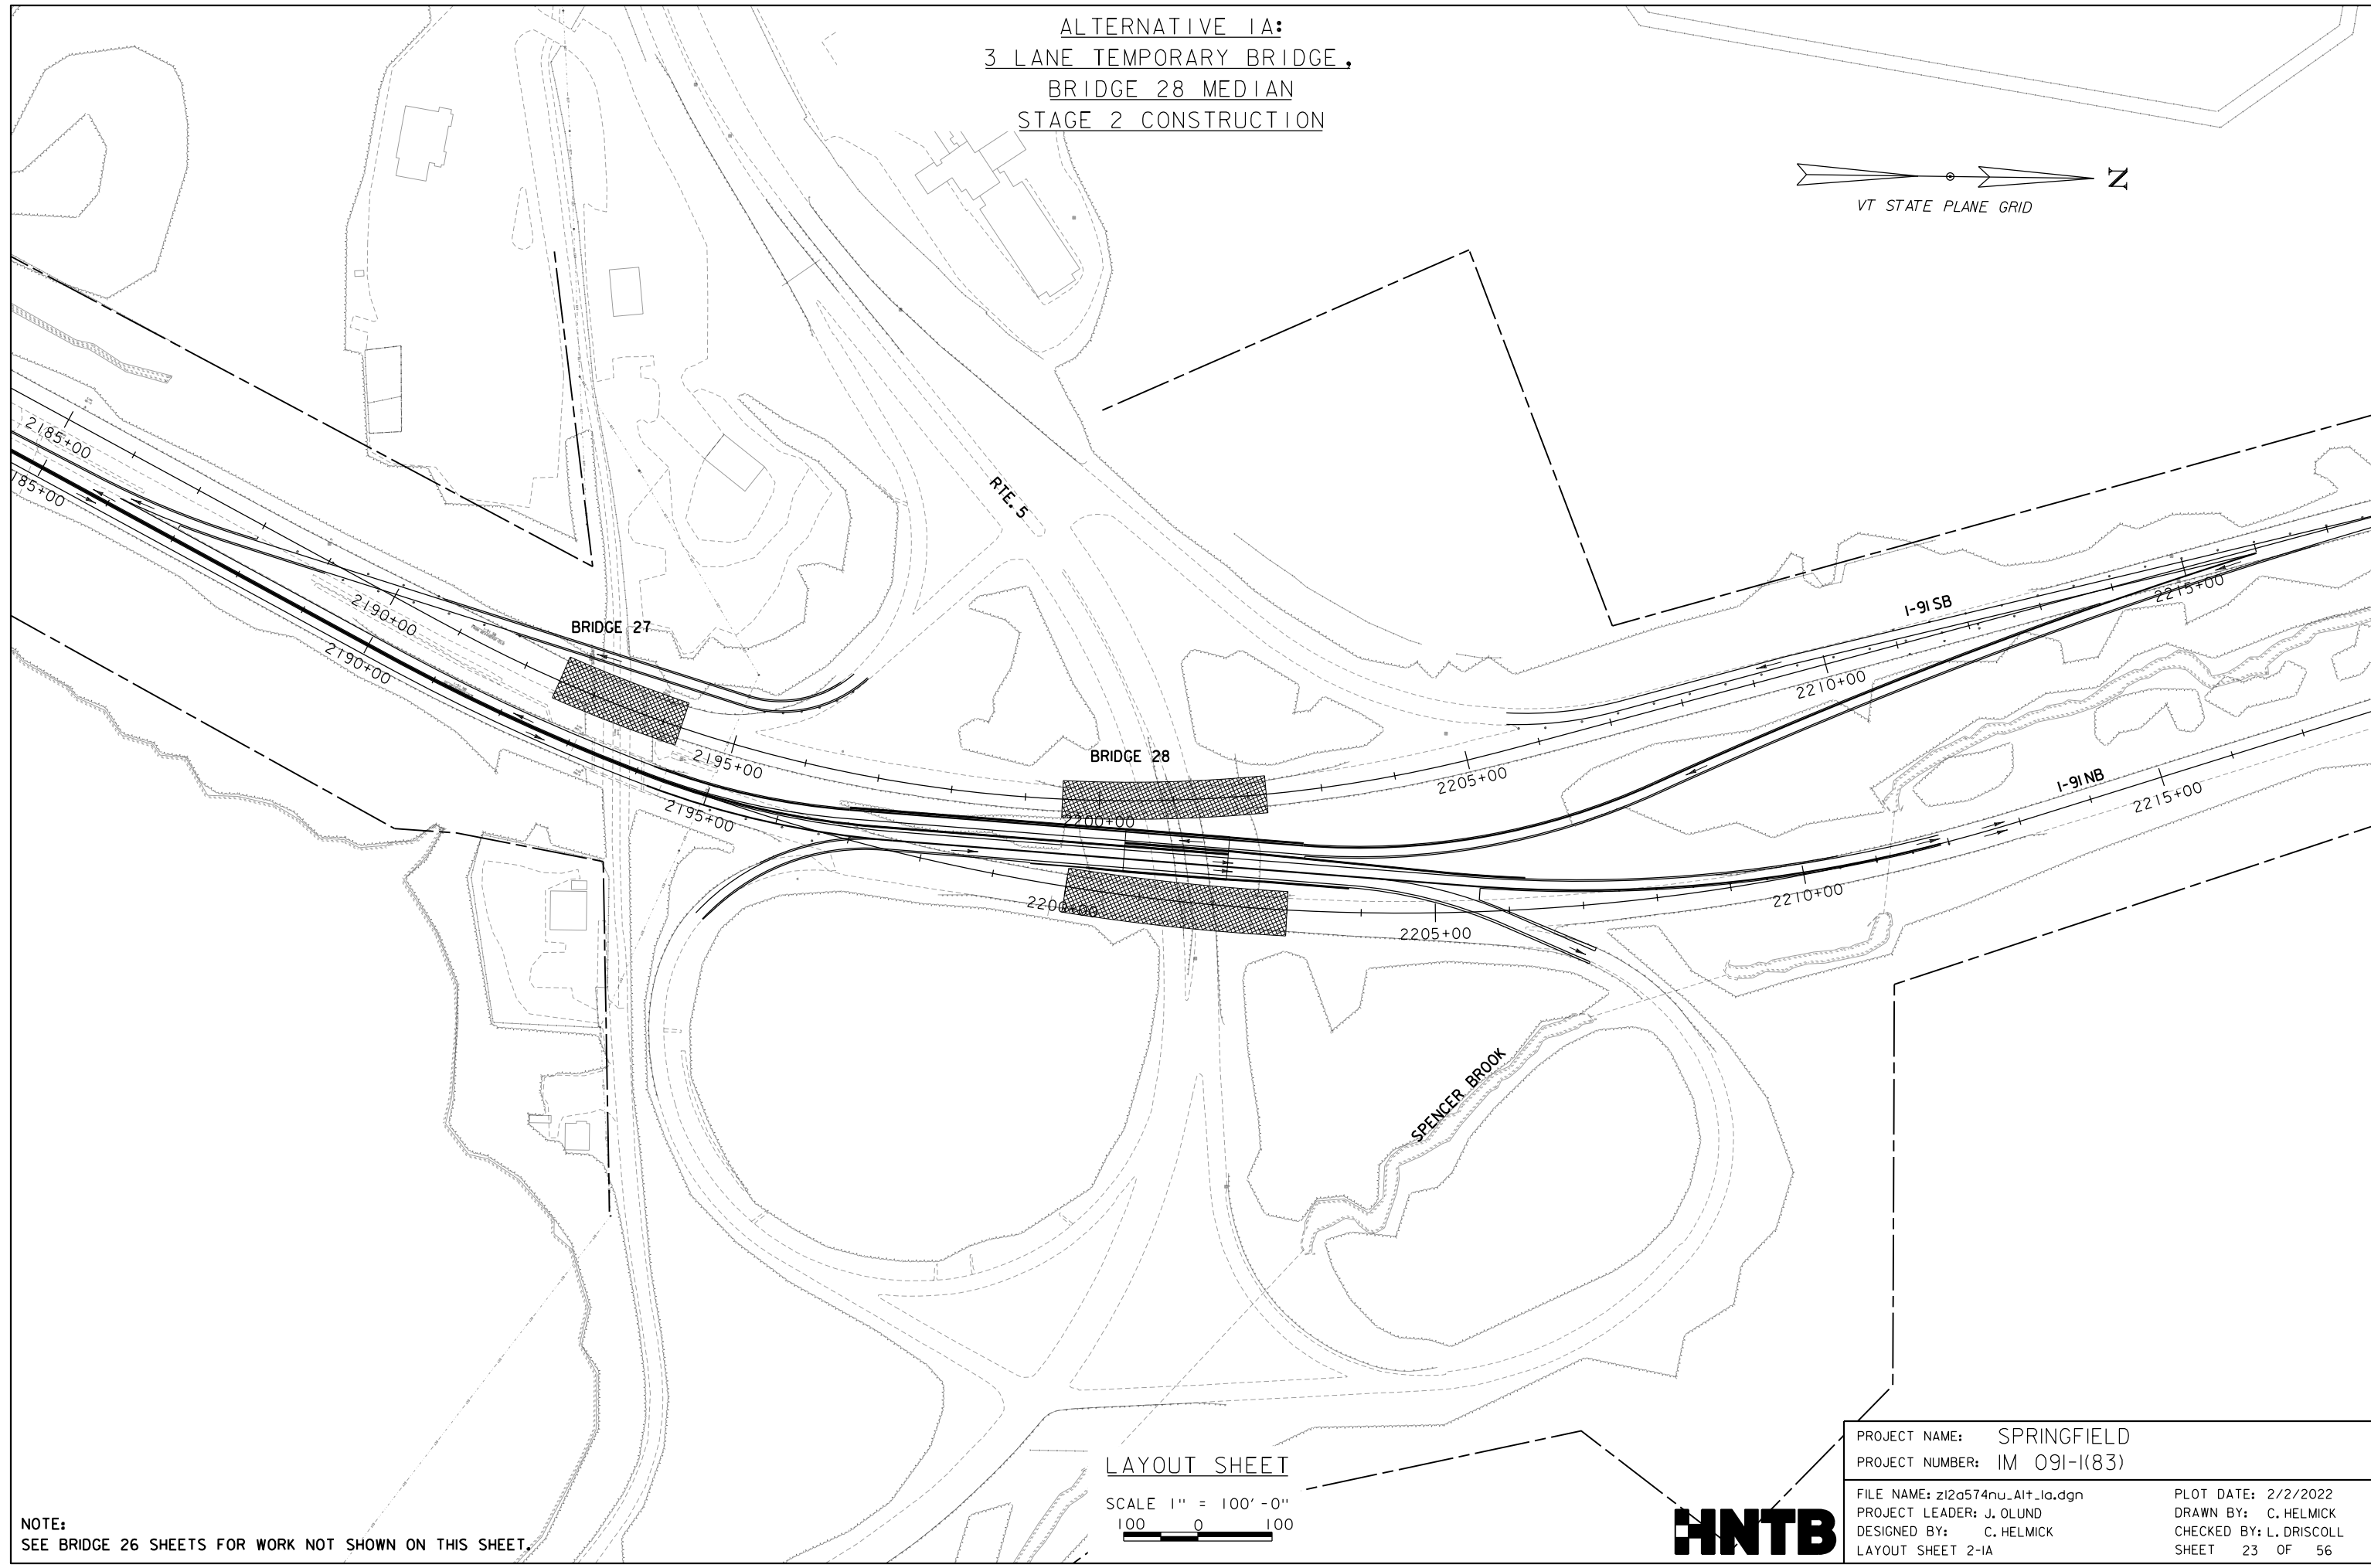
ALTERNATIVE 1A:
3 LANE TEMPORARY BRIDGE,
BRIDGE 28 MEDIAN
STAGE 2 CONSTRUCTION
