STATE OF VERMONT
AGENCY OF TRANSPORTATION

Final Scoping Report

Springfield IM 091-1(83)

**I-91 Bridges 25 N&S over Route 5, Bridges 27 N&S over the Toonerville Rail Trail
and Related Considerations for Adjacent Bridges 26 N&S and 28 N&S**

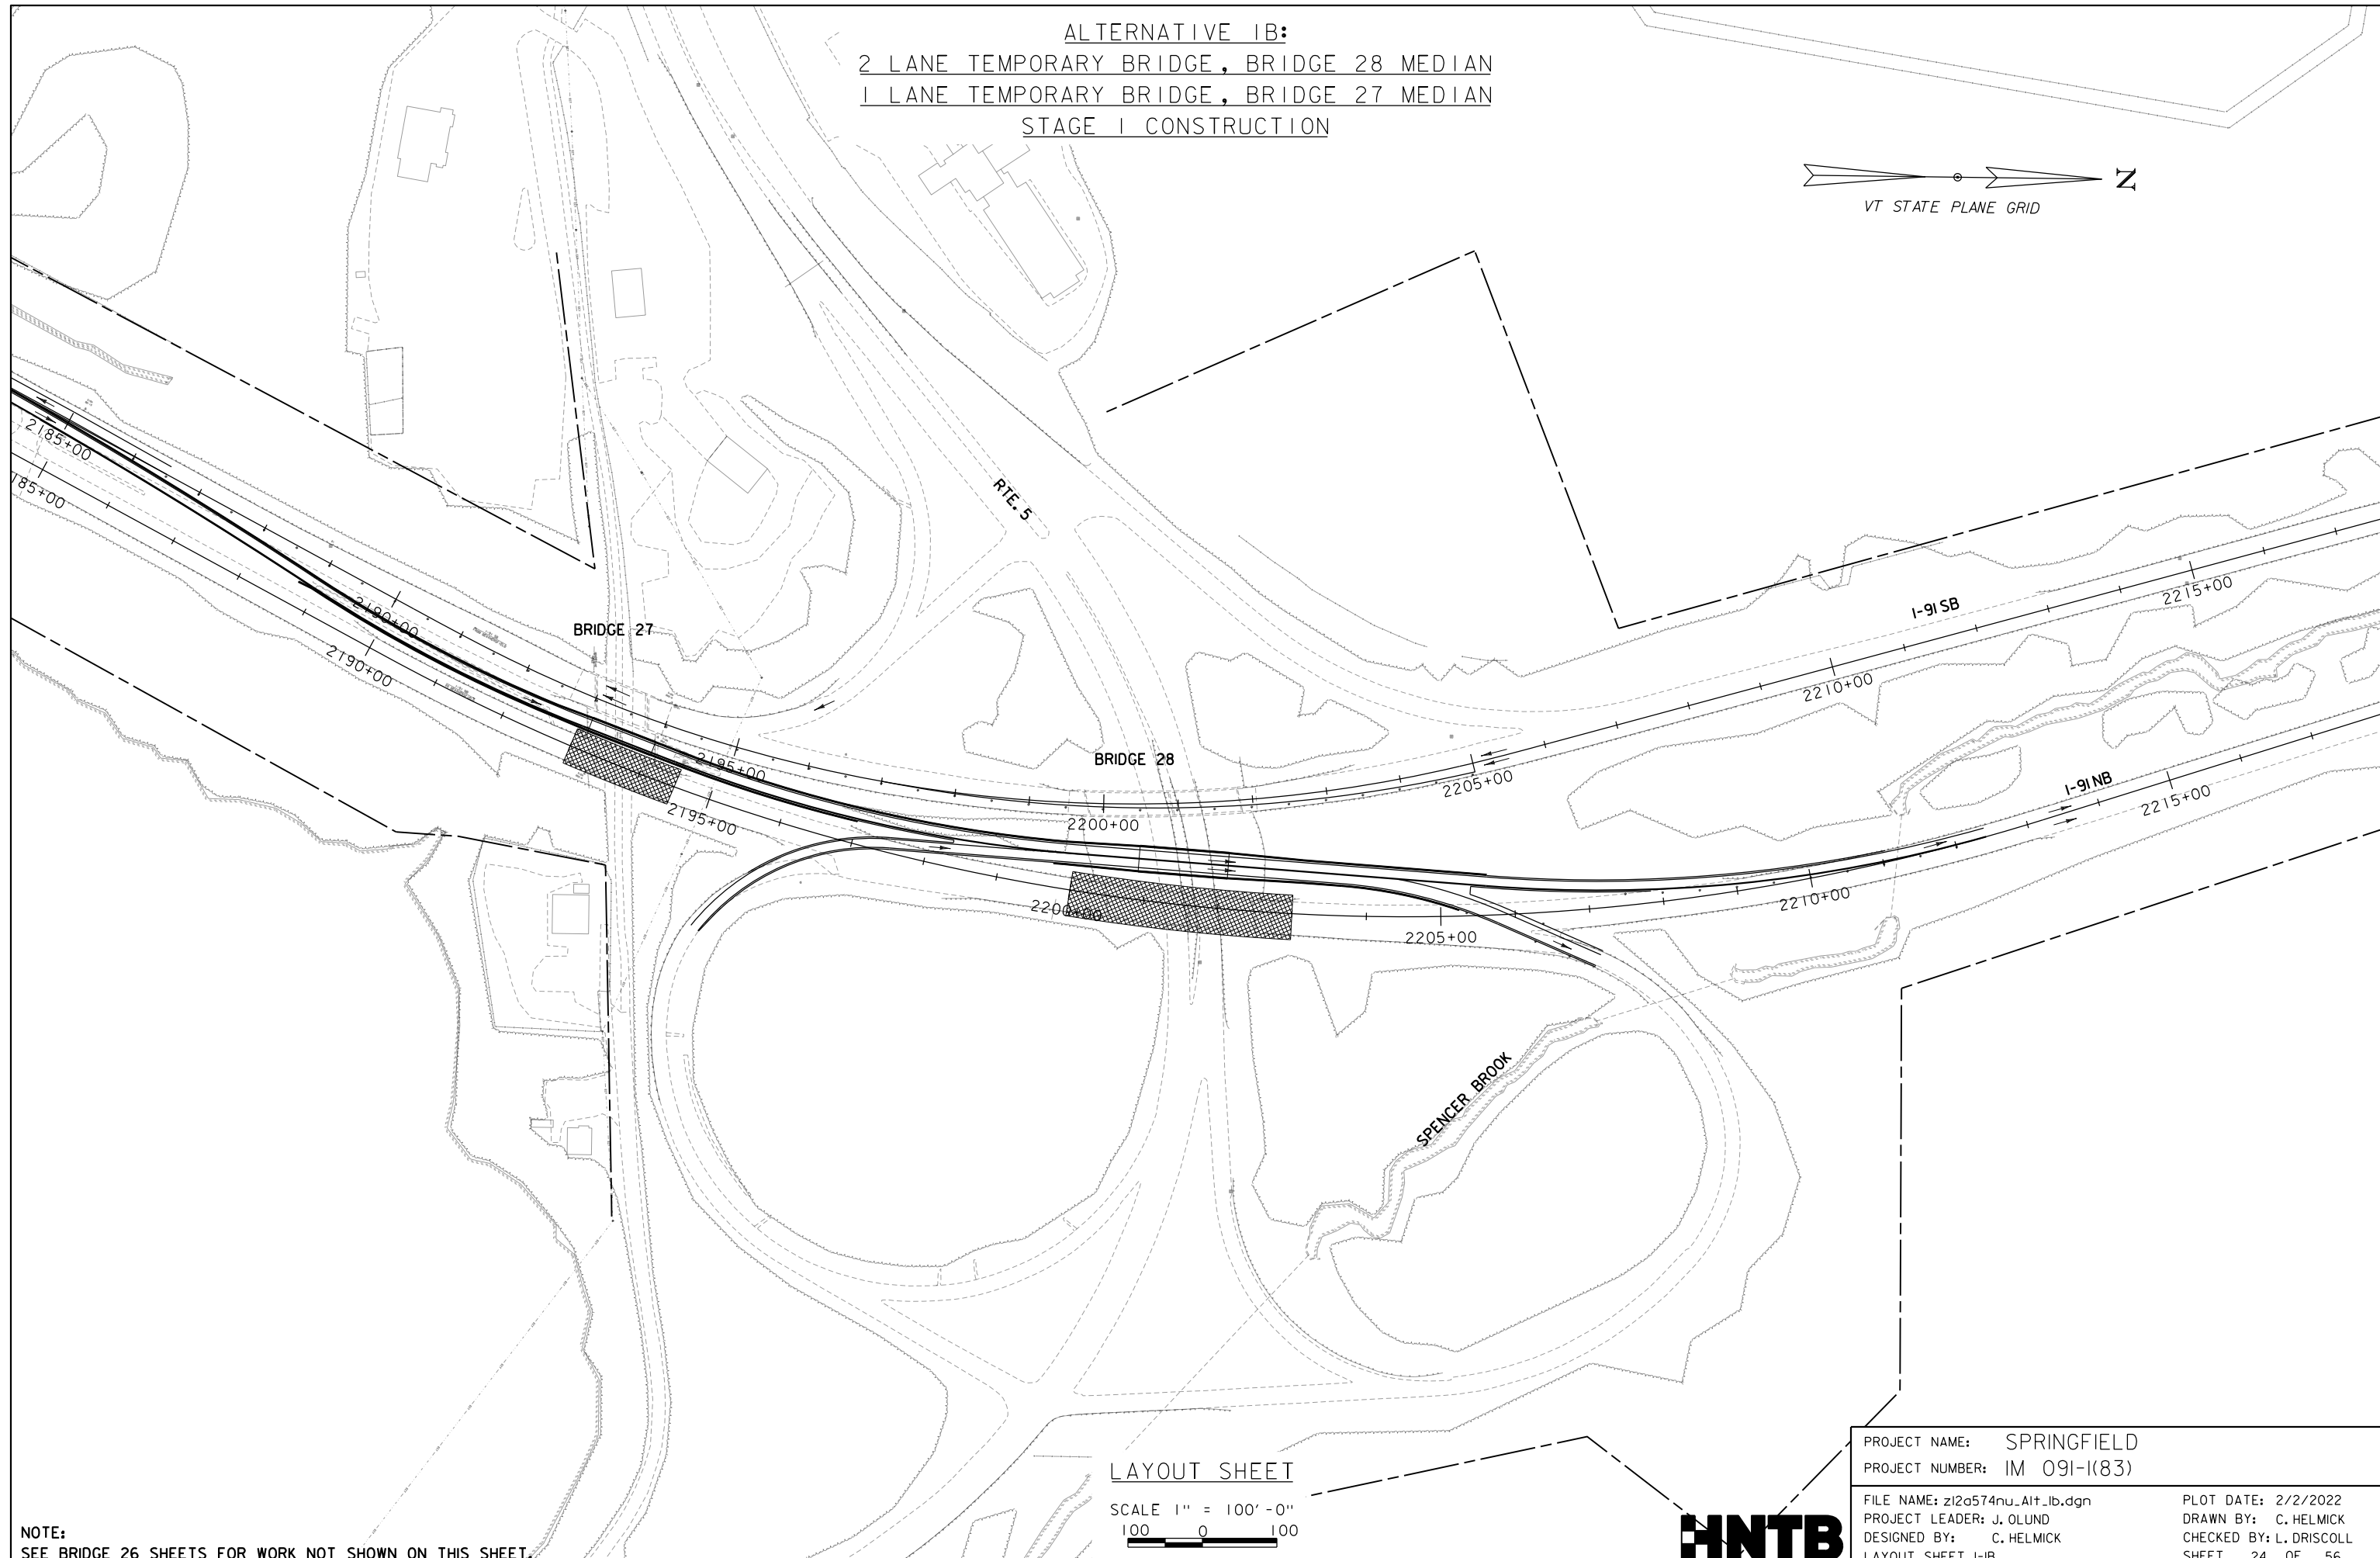
ALTERNATIVE 1B:
2 LANE TEMPORARY BRIDGE, BRIDGE 28 MEDIAN
1 LANE TEMPORARY BRIDGE, BRIDGE 27 MEDIAN
STAGE I CONSTRUCTION

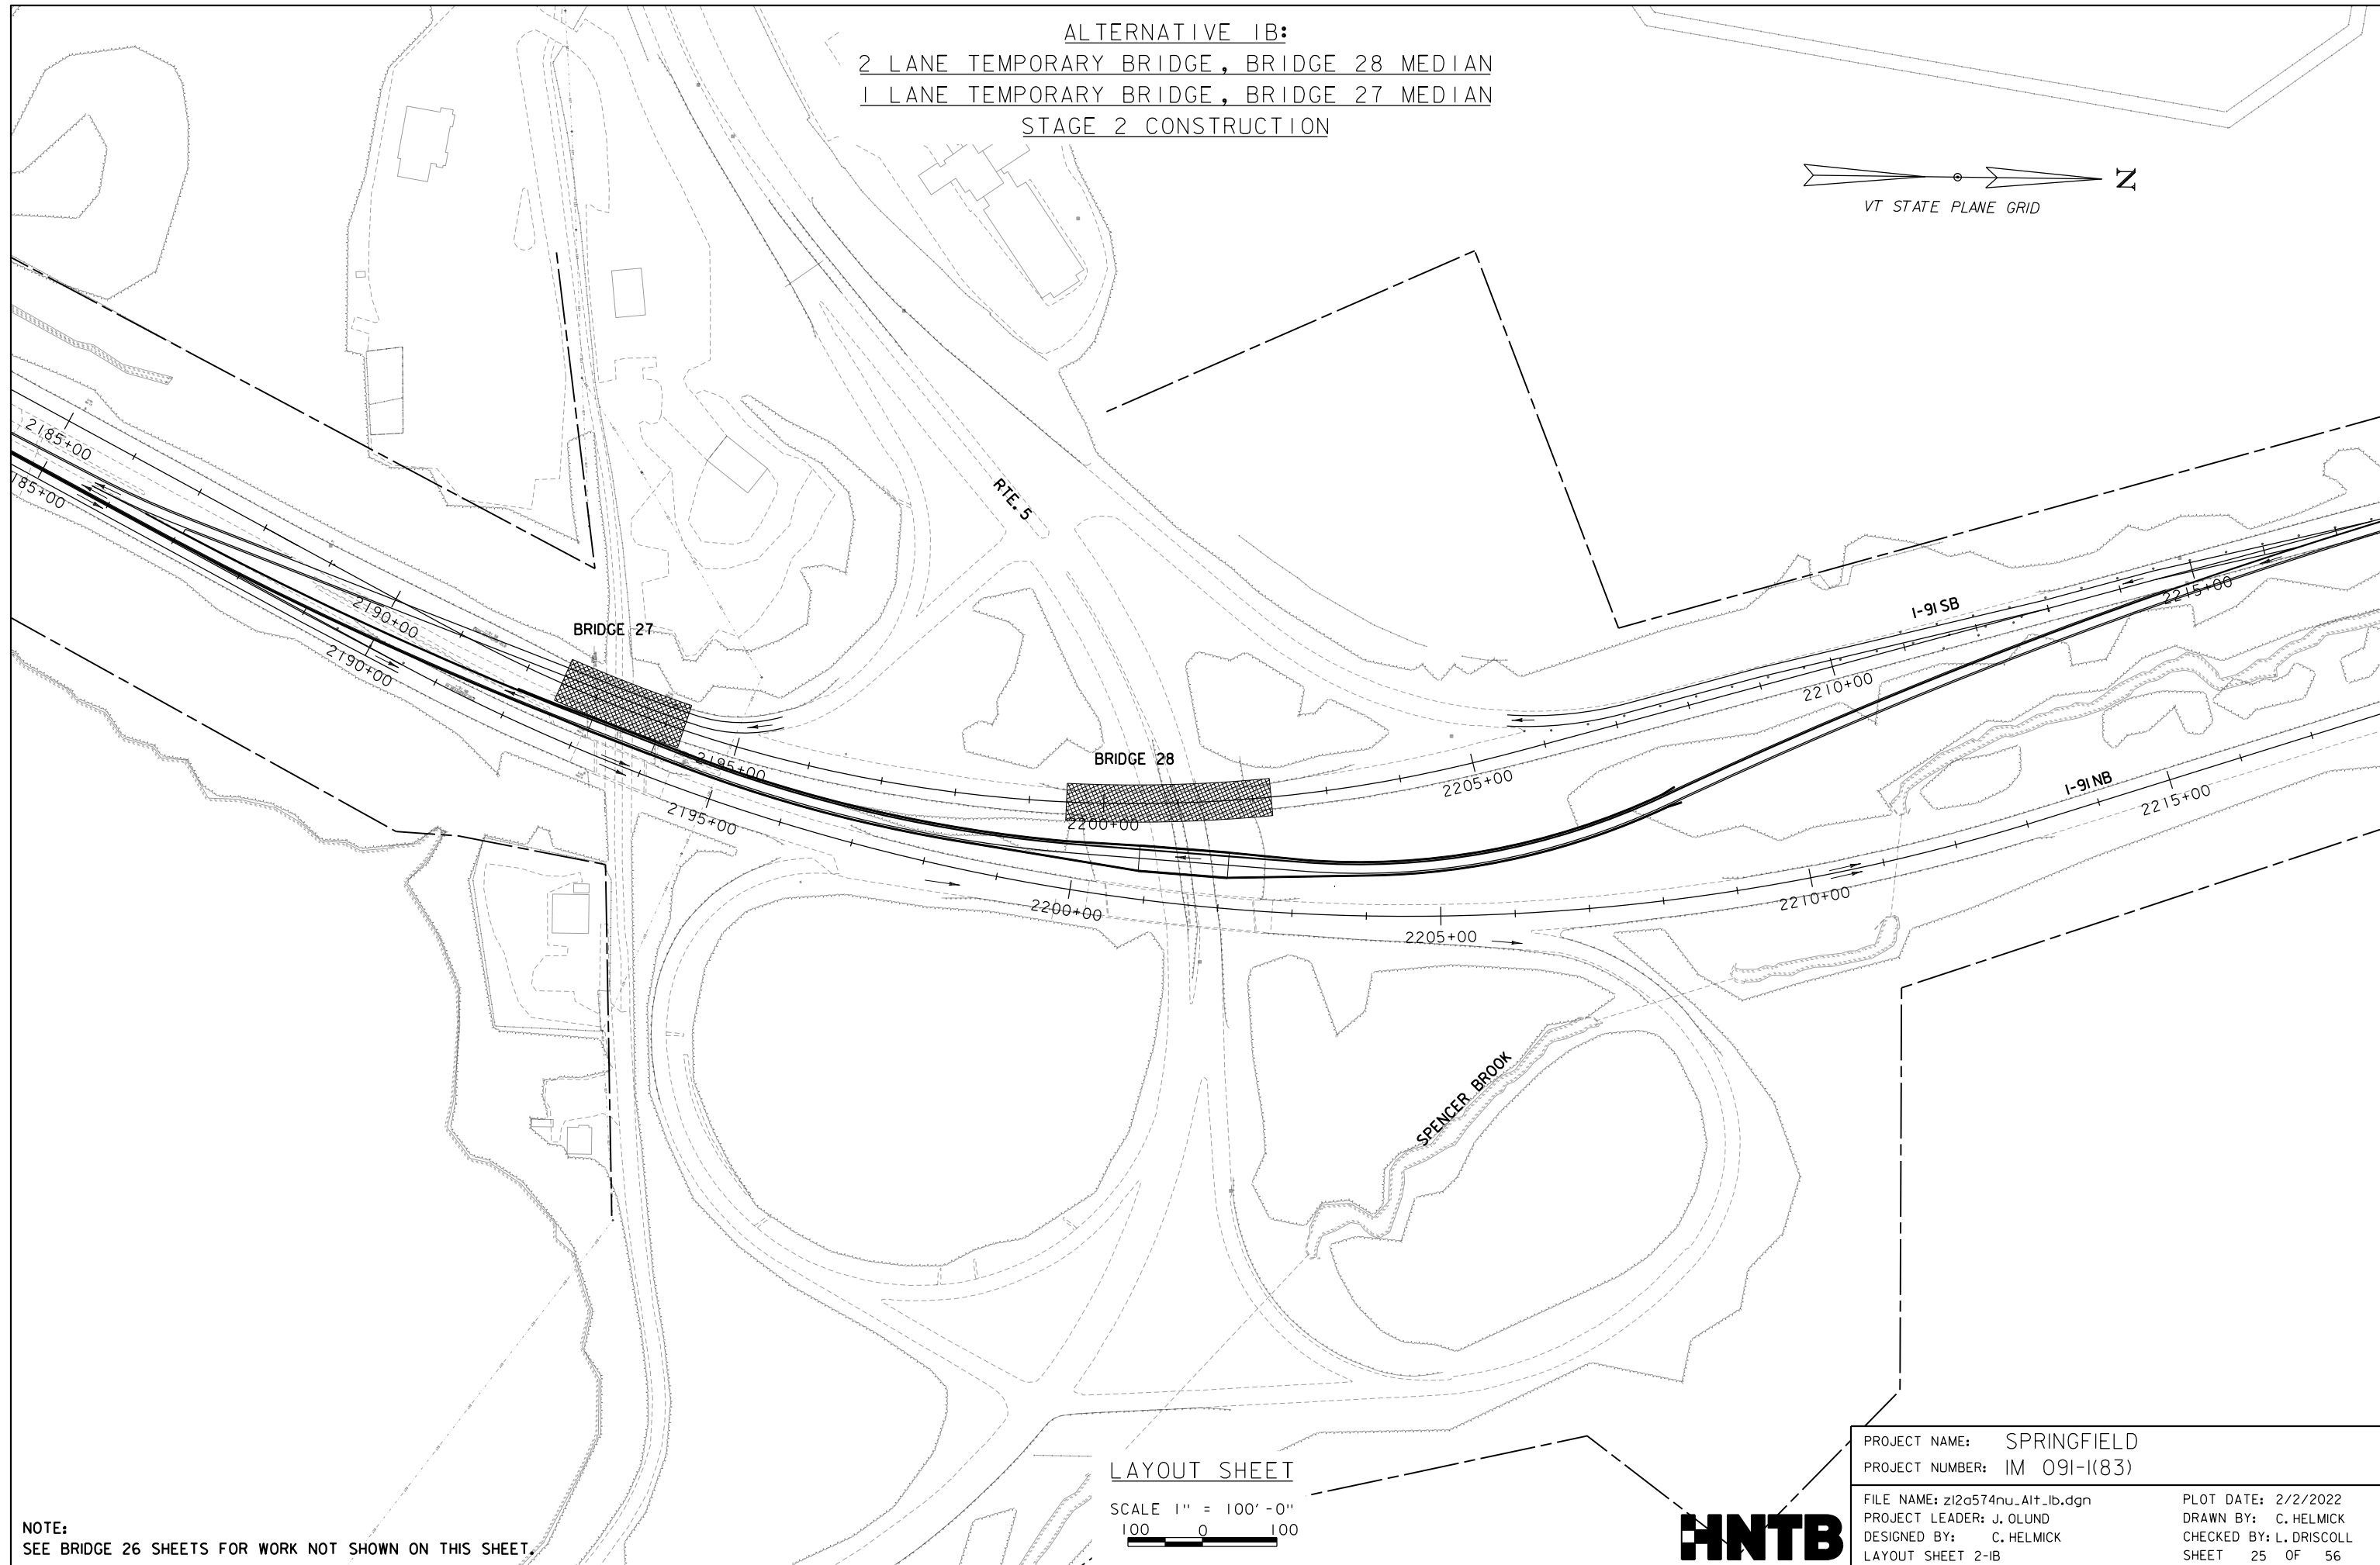
ALTERNATIVE 1B:
2 LANE TEMPORARY BRIDGE, BRIDGE 28 MEDIAN
1 LANE TEMPORARY BRIDGE, BRIDGE 27 MEDIAN
STAGE 2 CONSTRUCTION

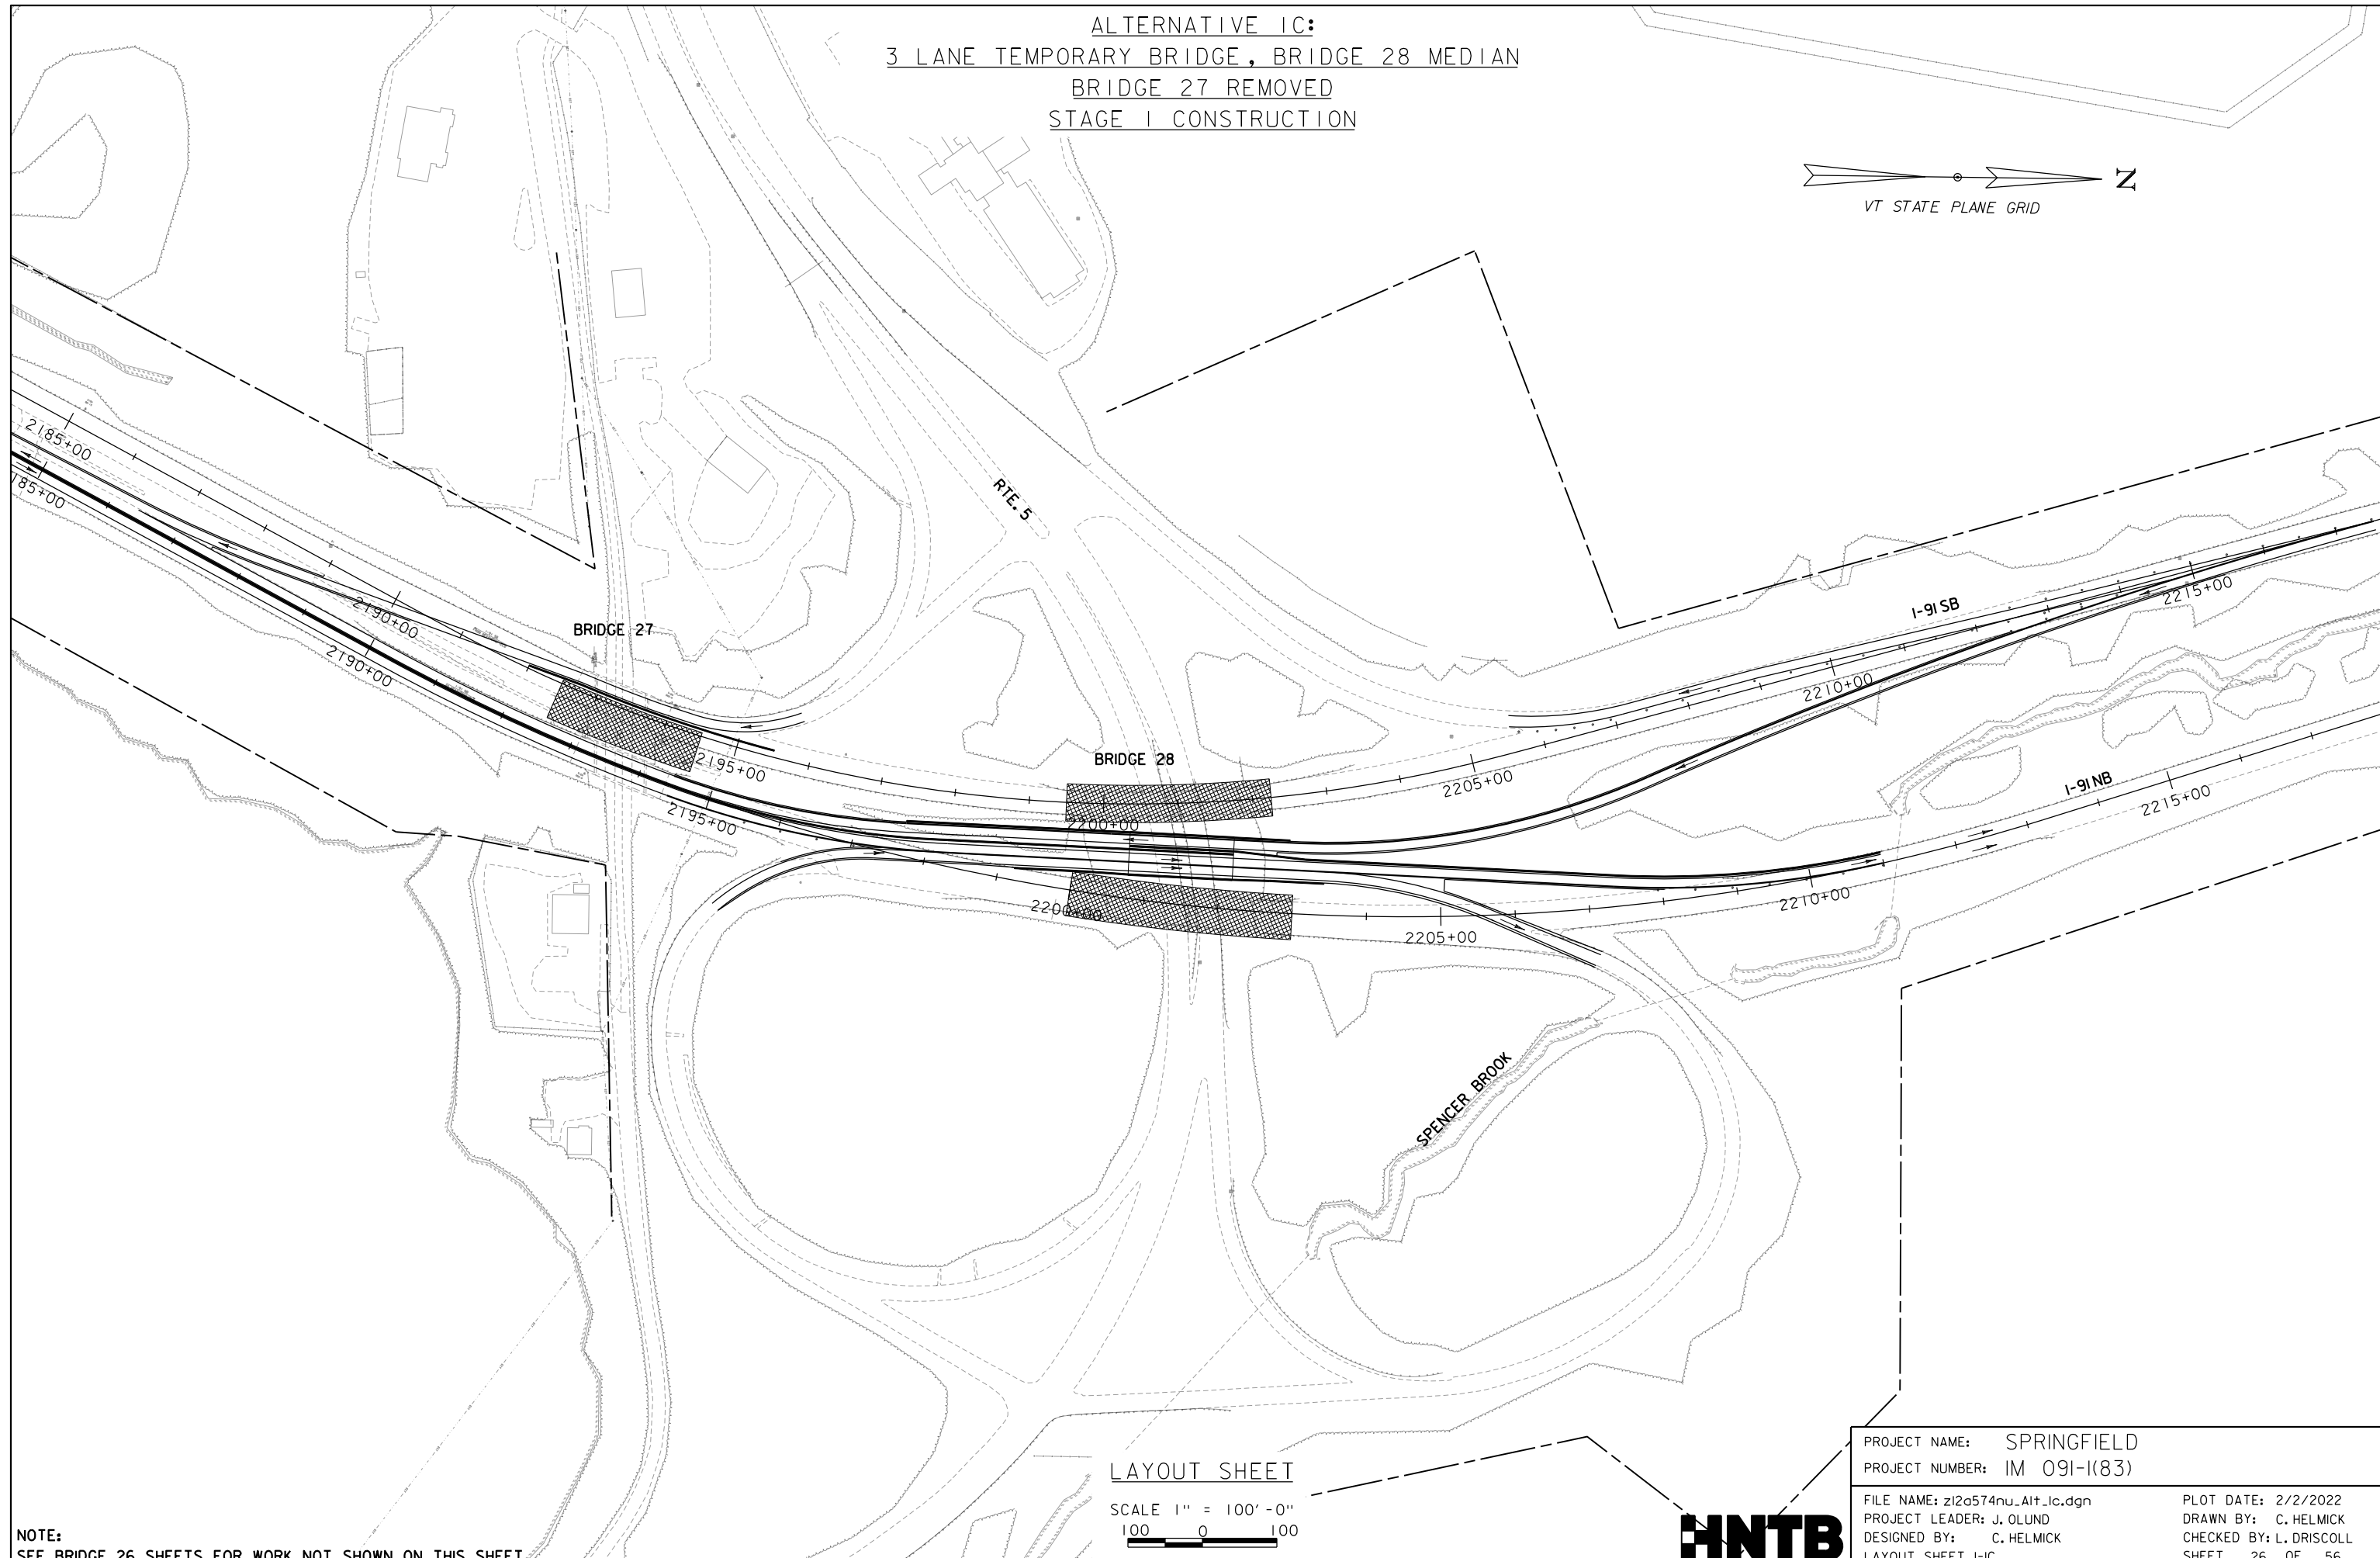
ALTERNATIVE 1C:
 3 LANE TEMPORARY BRIDGE, BRIDGE 28 MEDIAN
 BRIDGE 27 REMOVED
 STAGE I CONSTRUCTION

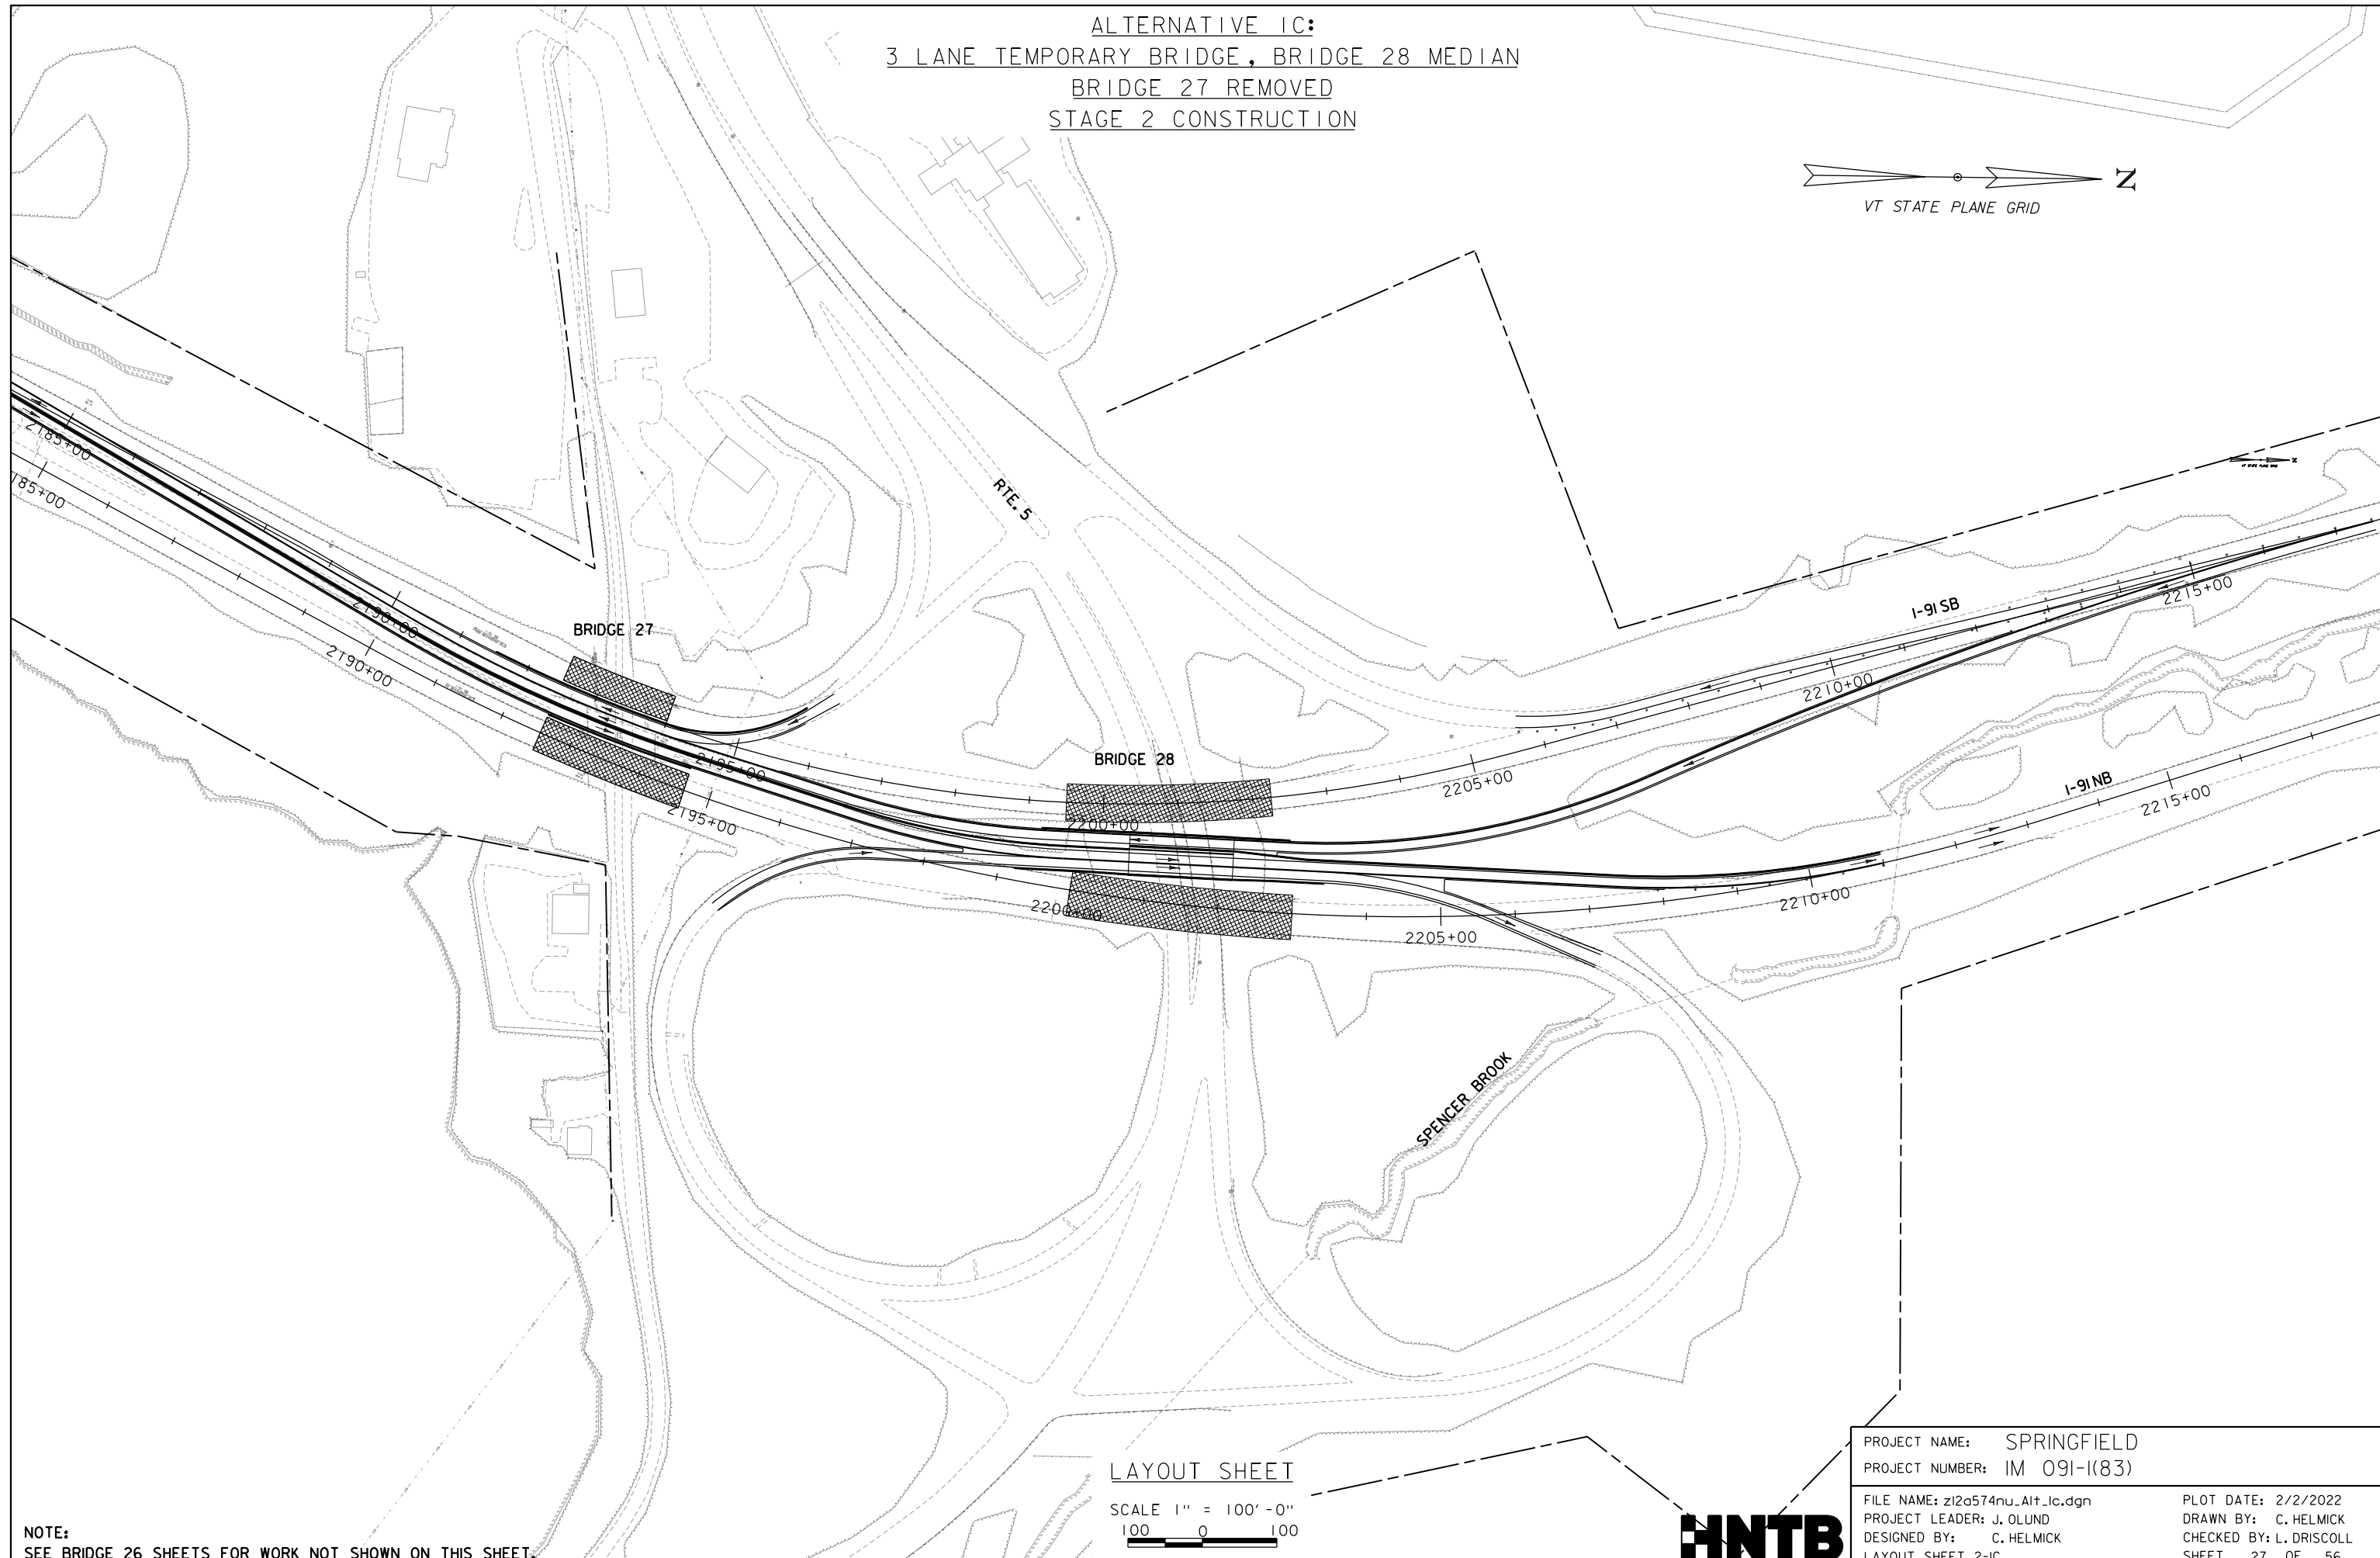
ALTERNATIVE 1C:
 3 LANE TEMPORARY BRIDGE, BRIDGE 28 MEDIAN
 BRIDGE 27 REMOVED
 STAGE 2 CONSTRUCTION

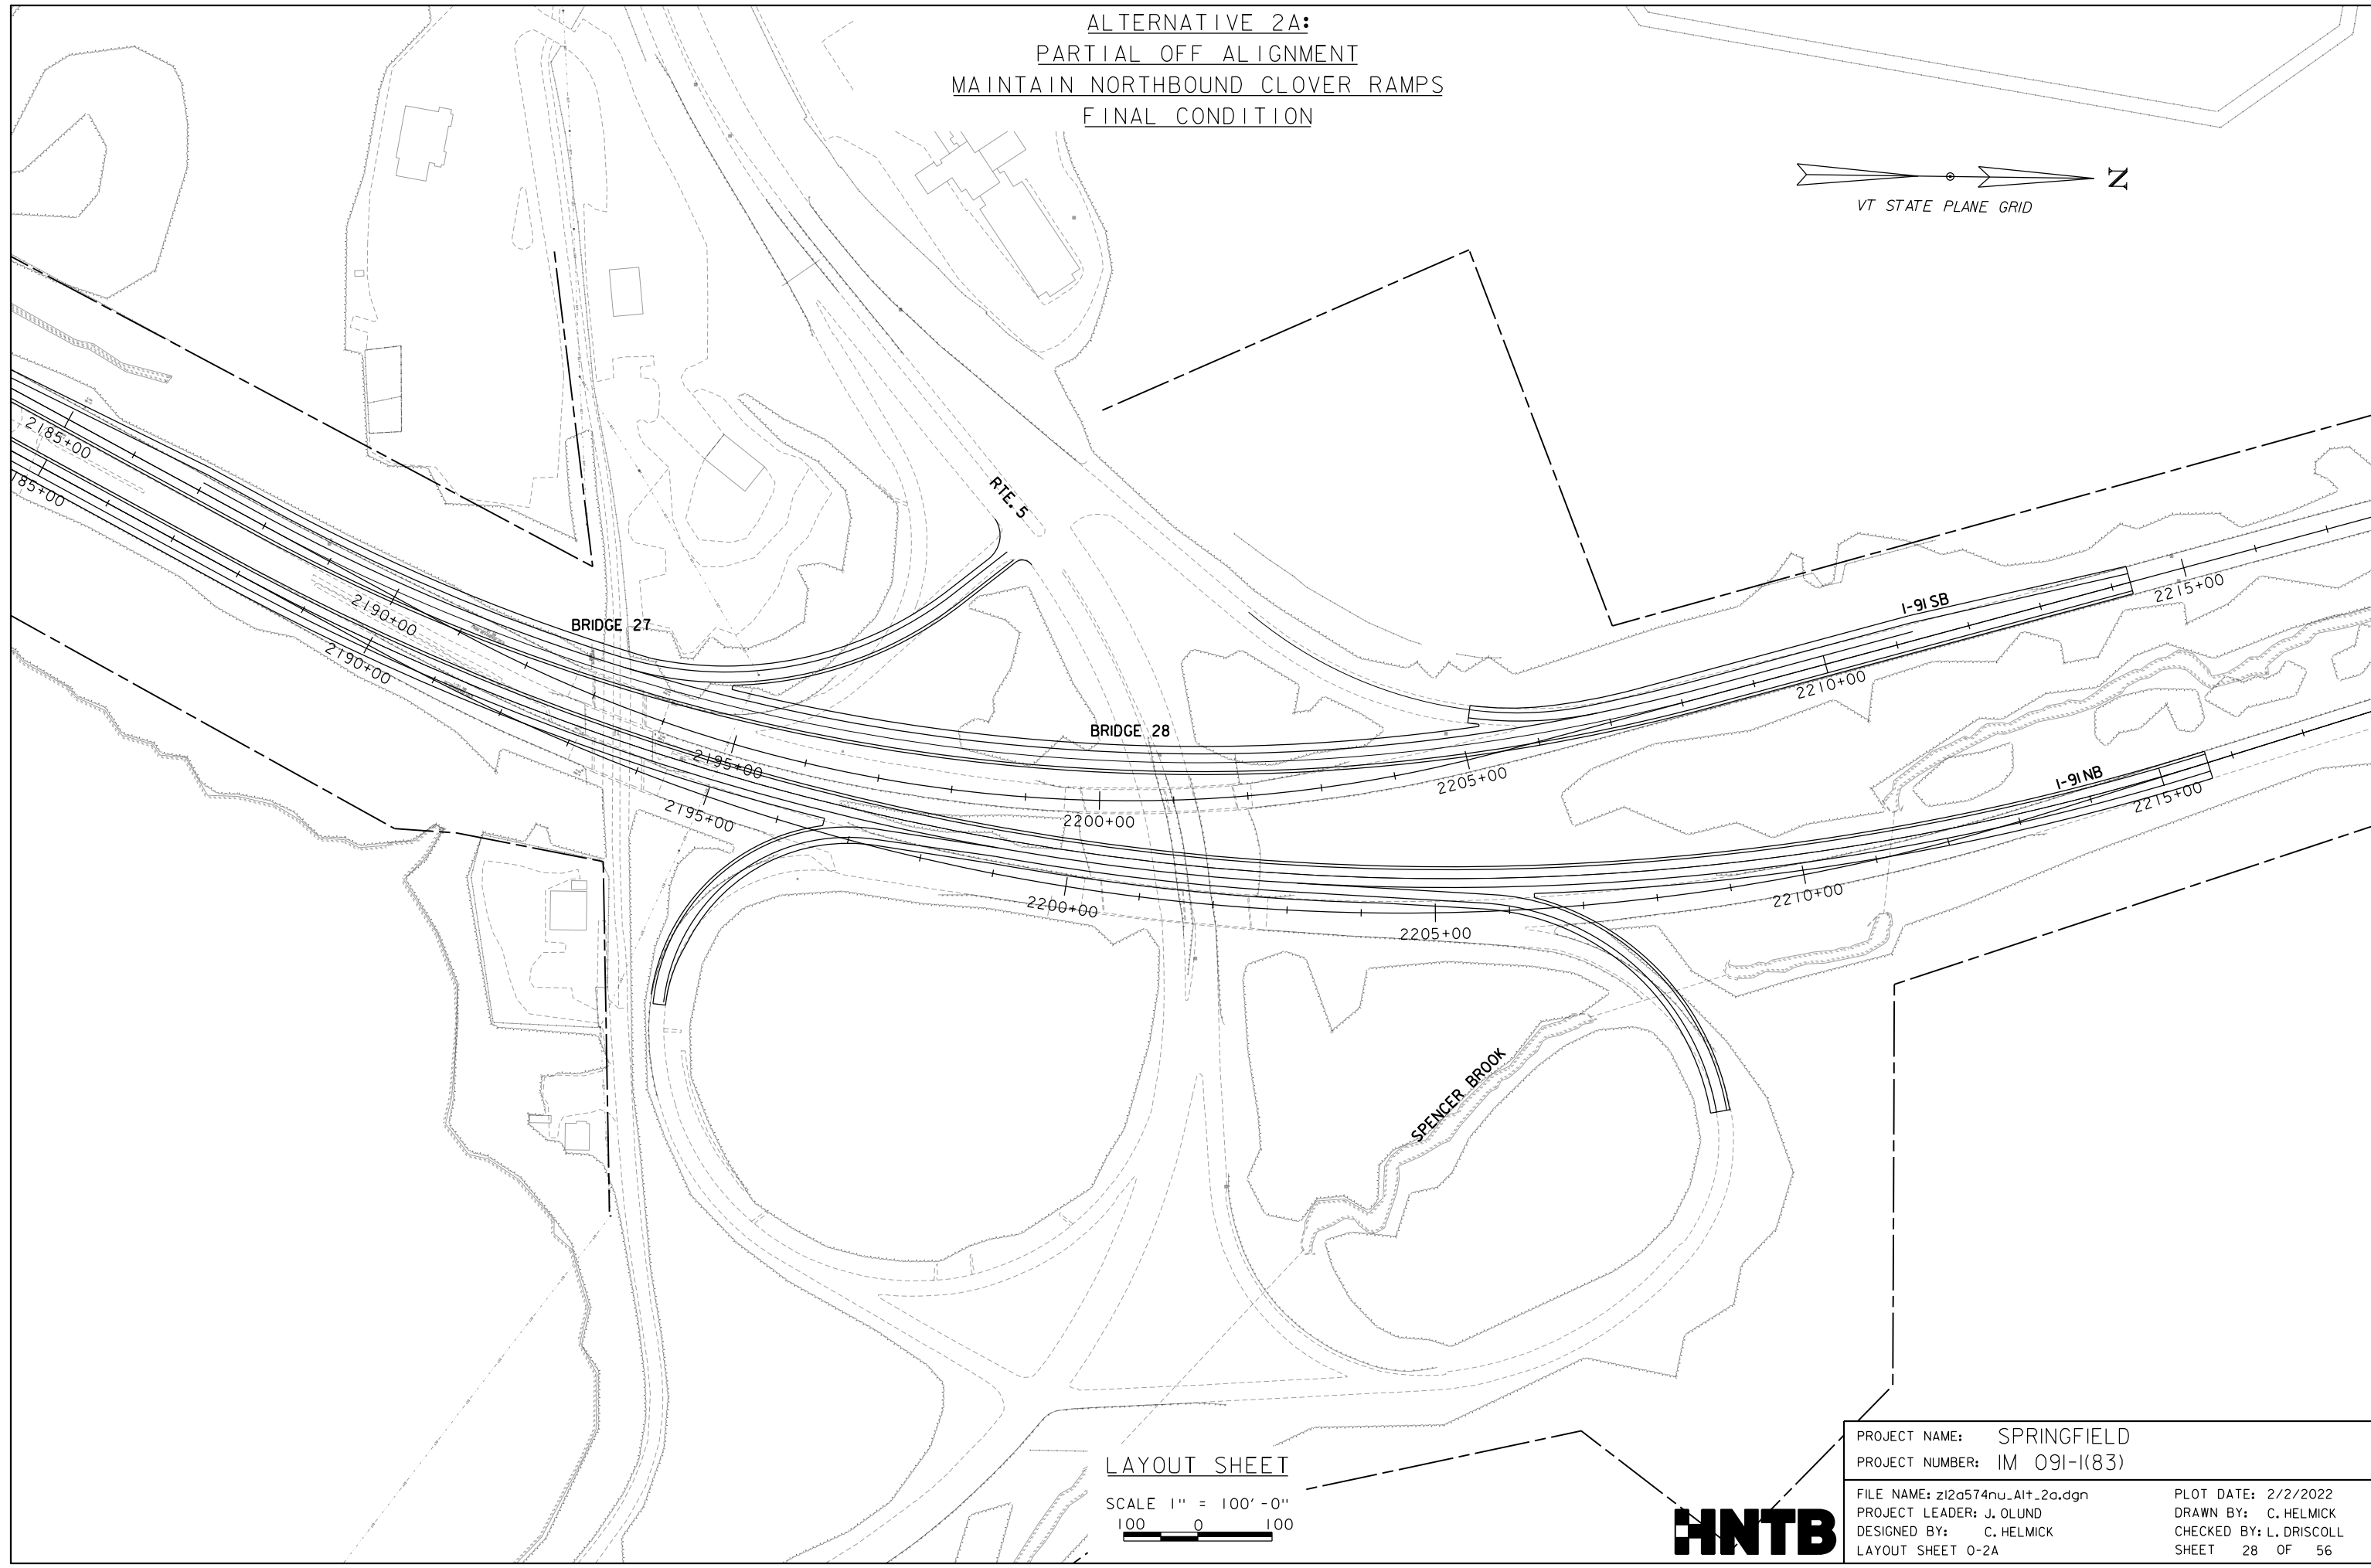
ALTERNATIVE 2A:
PARTIAL OFF ALIGNMENT
MAINTAIN NORTHBOUND CLOVER RAMPS
FINAL CONDITION

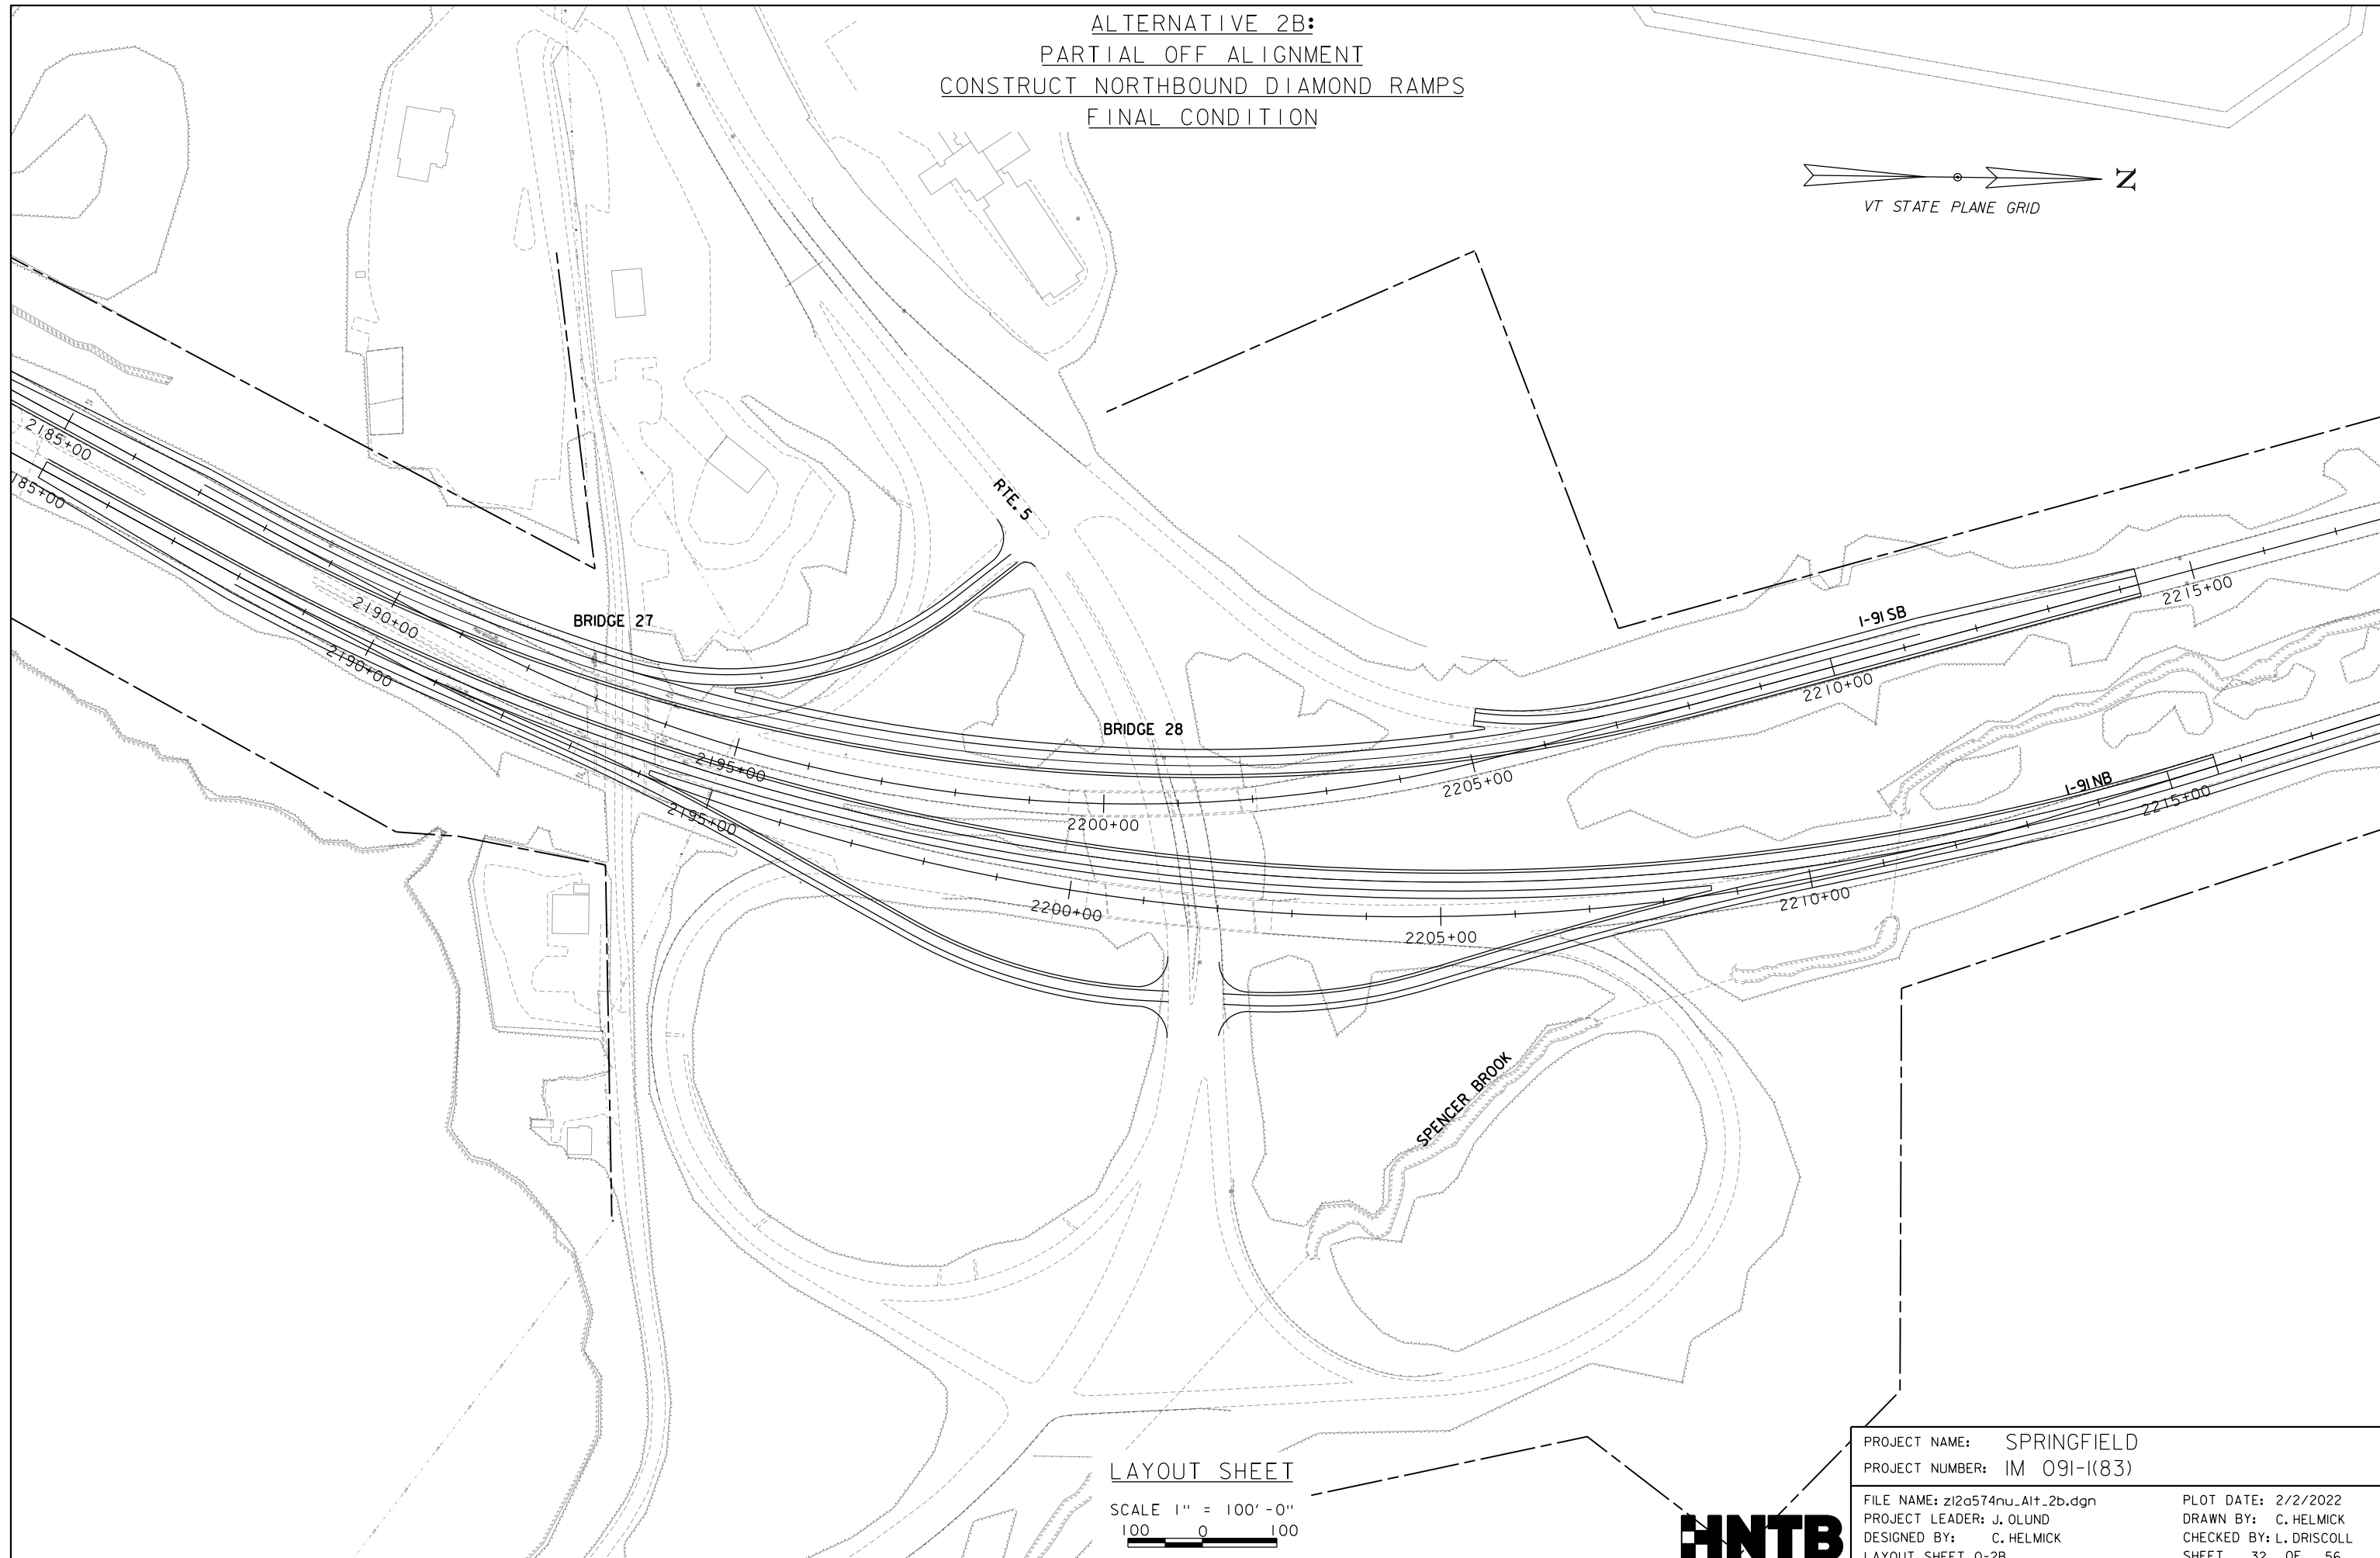
ALTERNATIVE 2B:
PARTIAL OFF ALIGNMENT
CONSTRUCT NORTHBOUND DIAMOND RAMP
FINAL CONDITION
