STATE OF VERMONT
AGENCY OF TRANSPORTATION

Final Scoping Report

Springfield IM 091-1(83)

**I-91 Bridges 25 N&S over Route 5, Bridges 27 N&S over the Toonerville Rail Trail
and Related Considerations for Adjacent Bridges 26 N&S and 28 N&S**

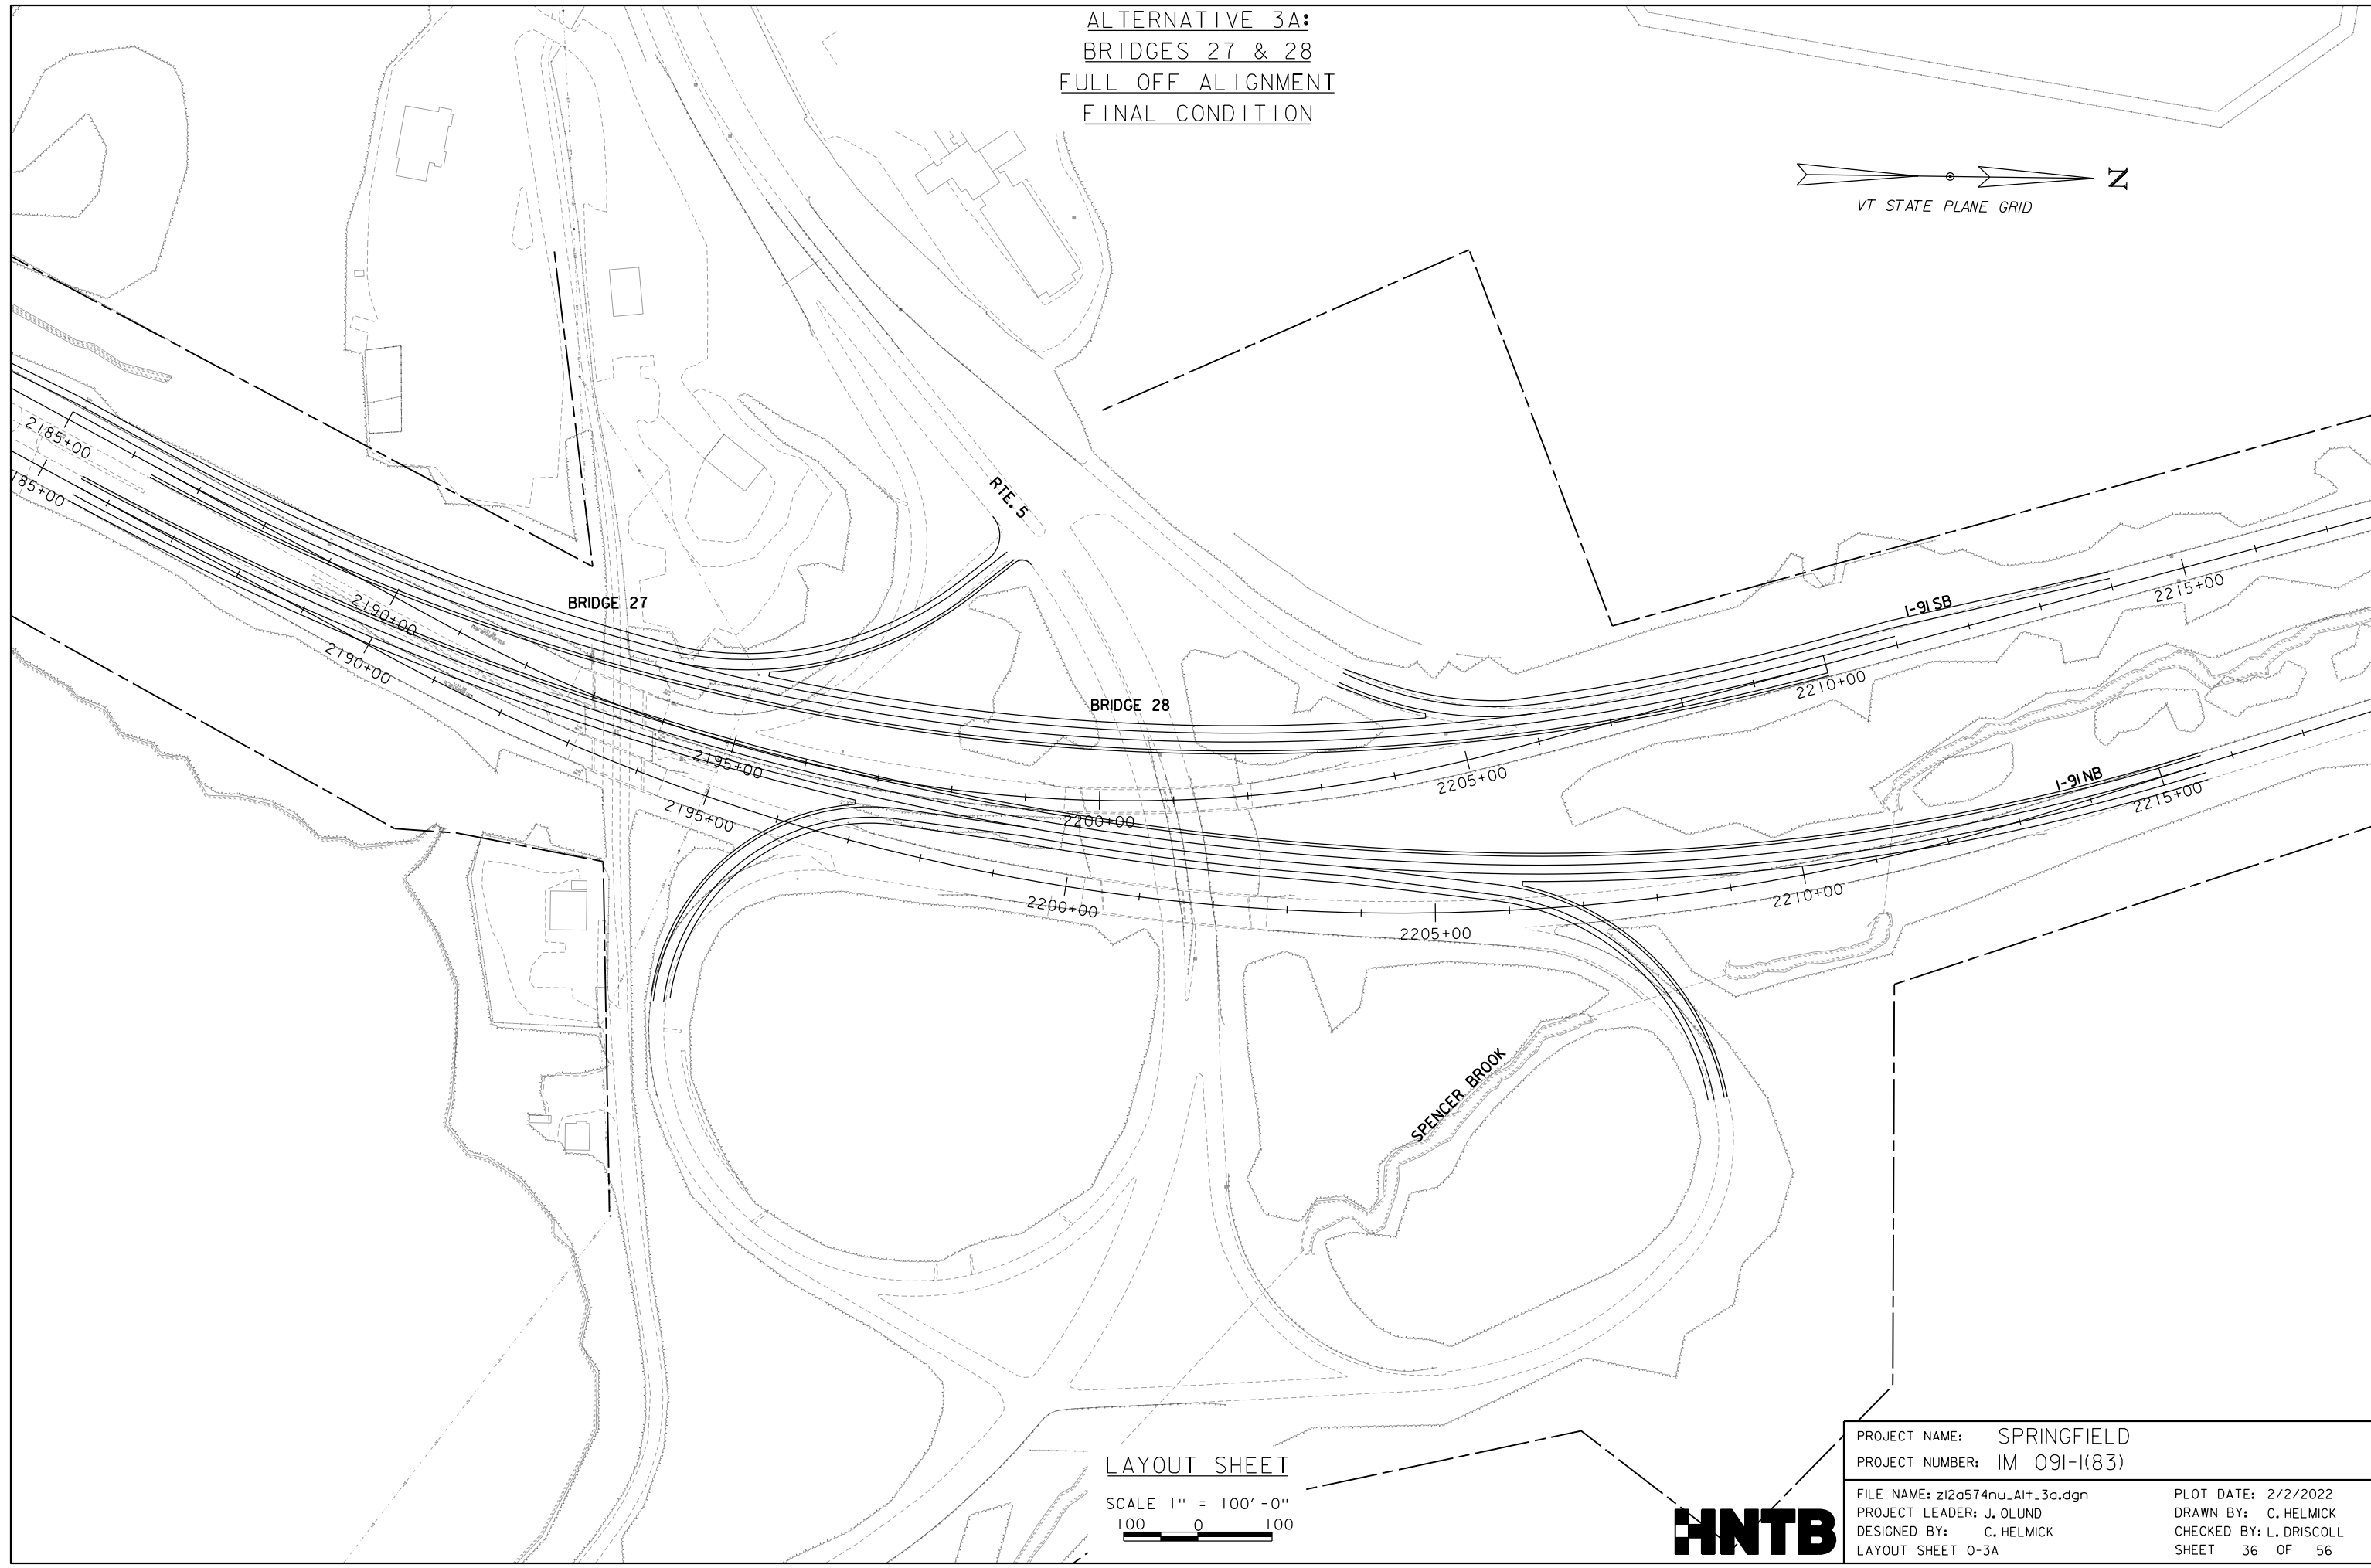
ALTERNATIVE 3A:
BRIDGES 27 & 28
FULL OFF ALIGNMENT
FINAL CONDITION

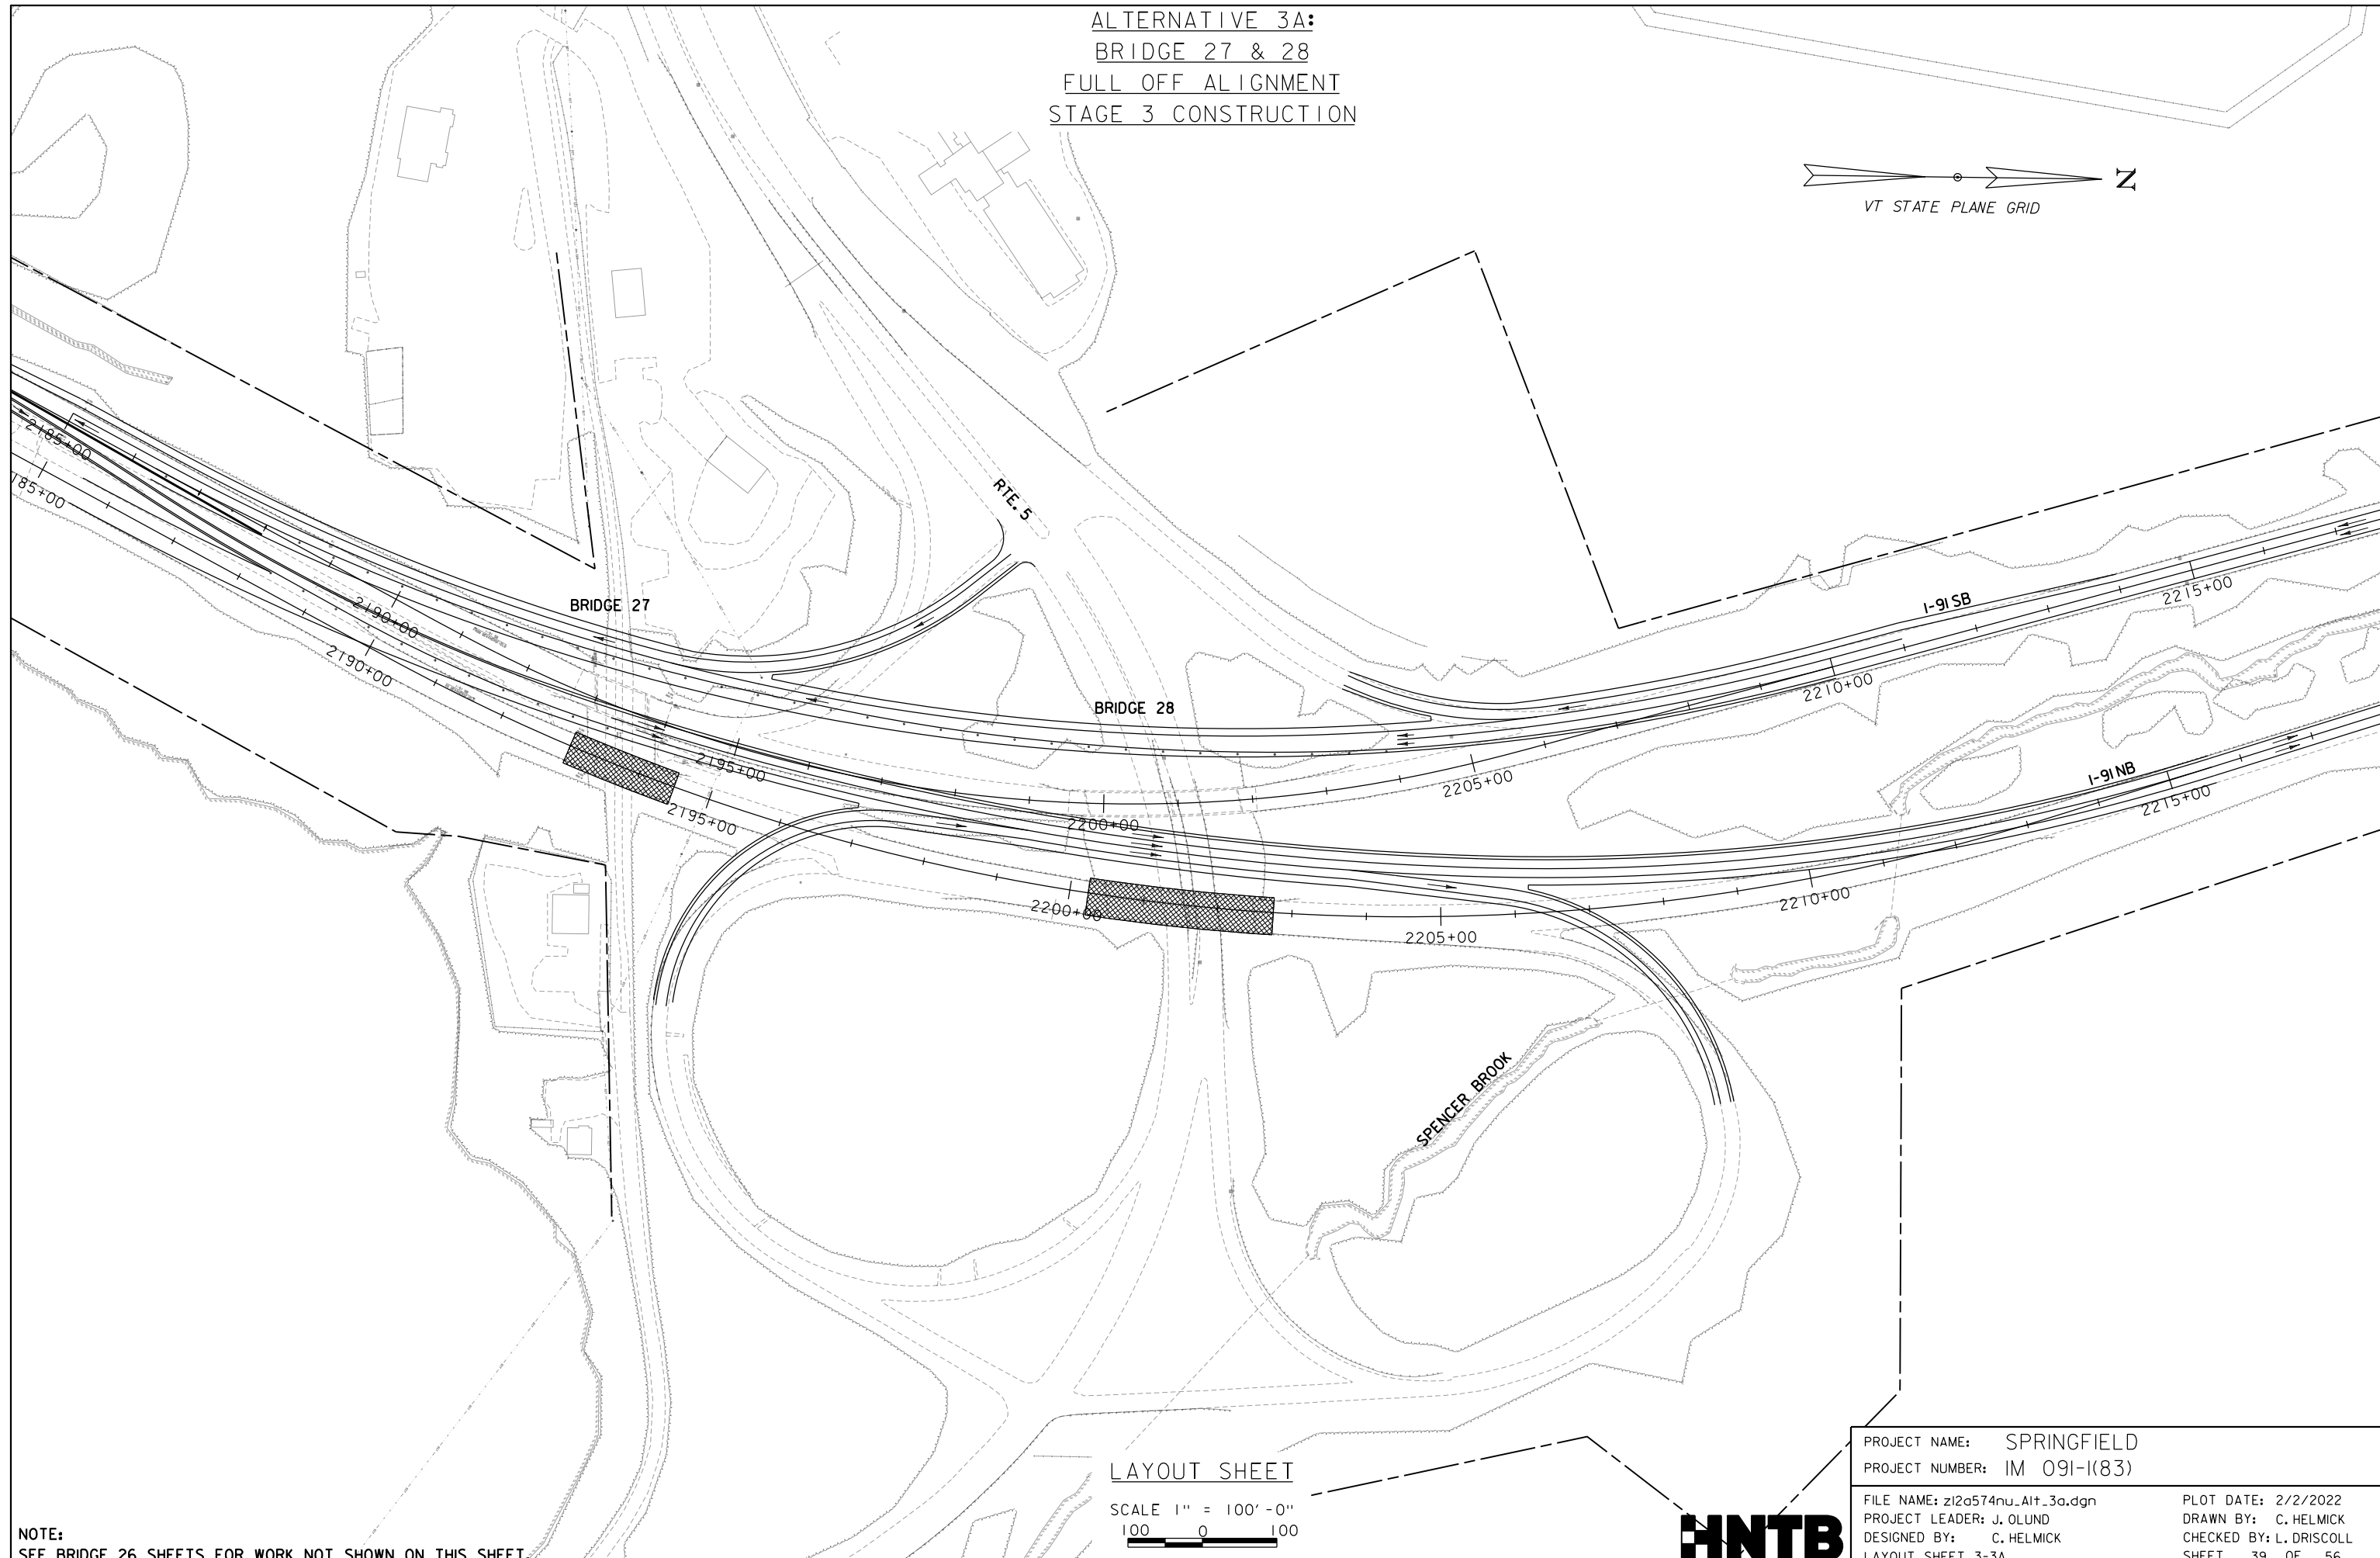
ALTERNATIVE 3A:
 BRIDGE 27 & 28
 FULL OFF ALIGNMENT
 STAGE 3 CONSTRUCTION

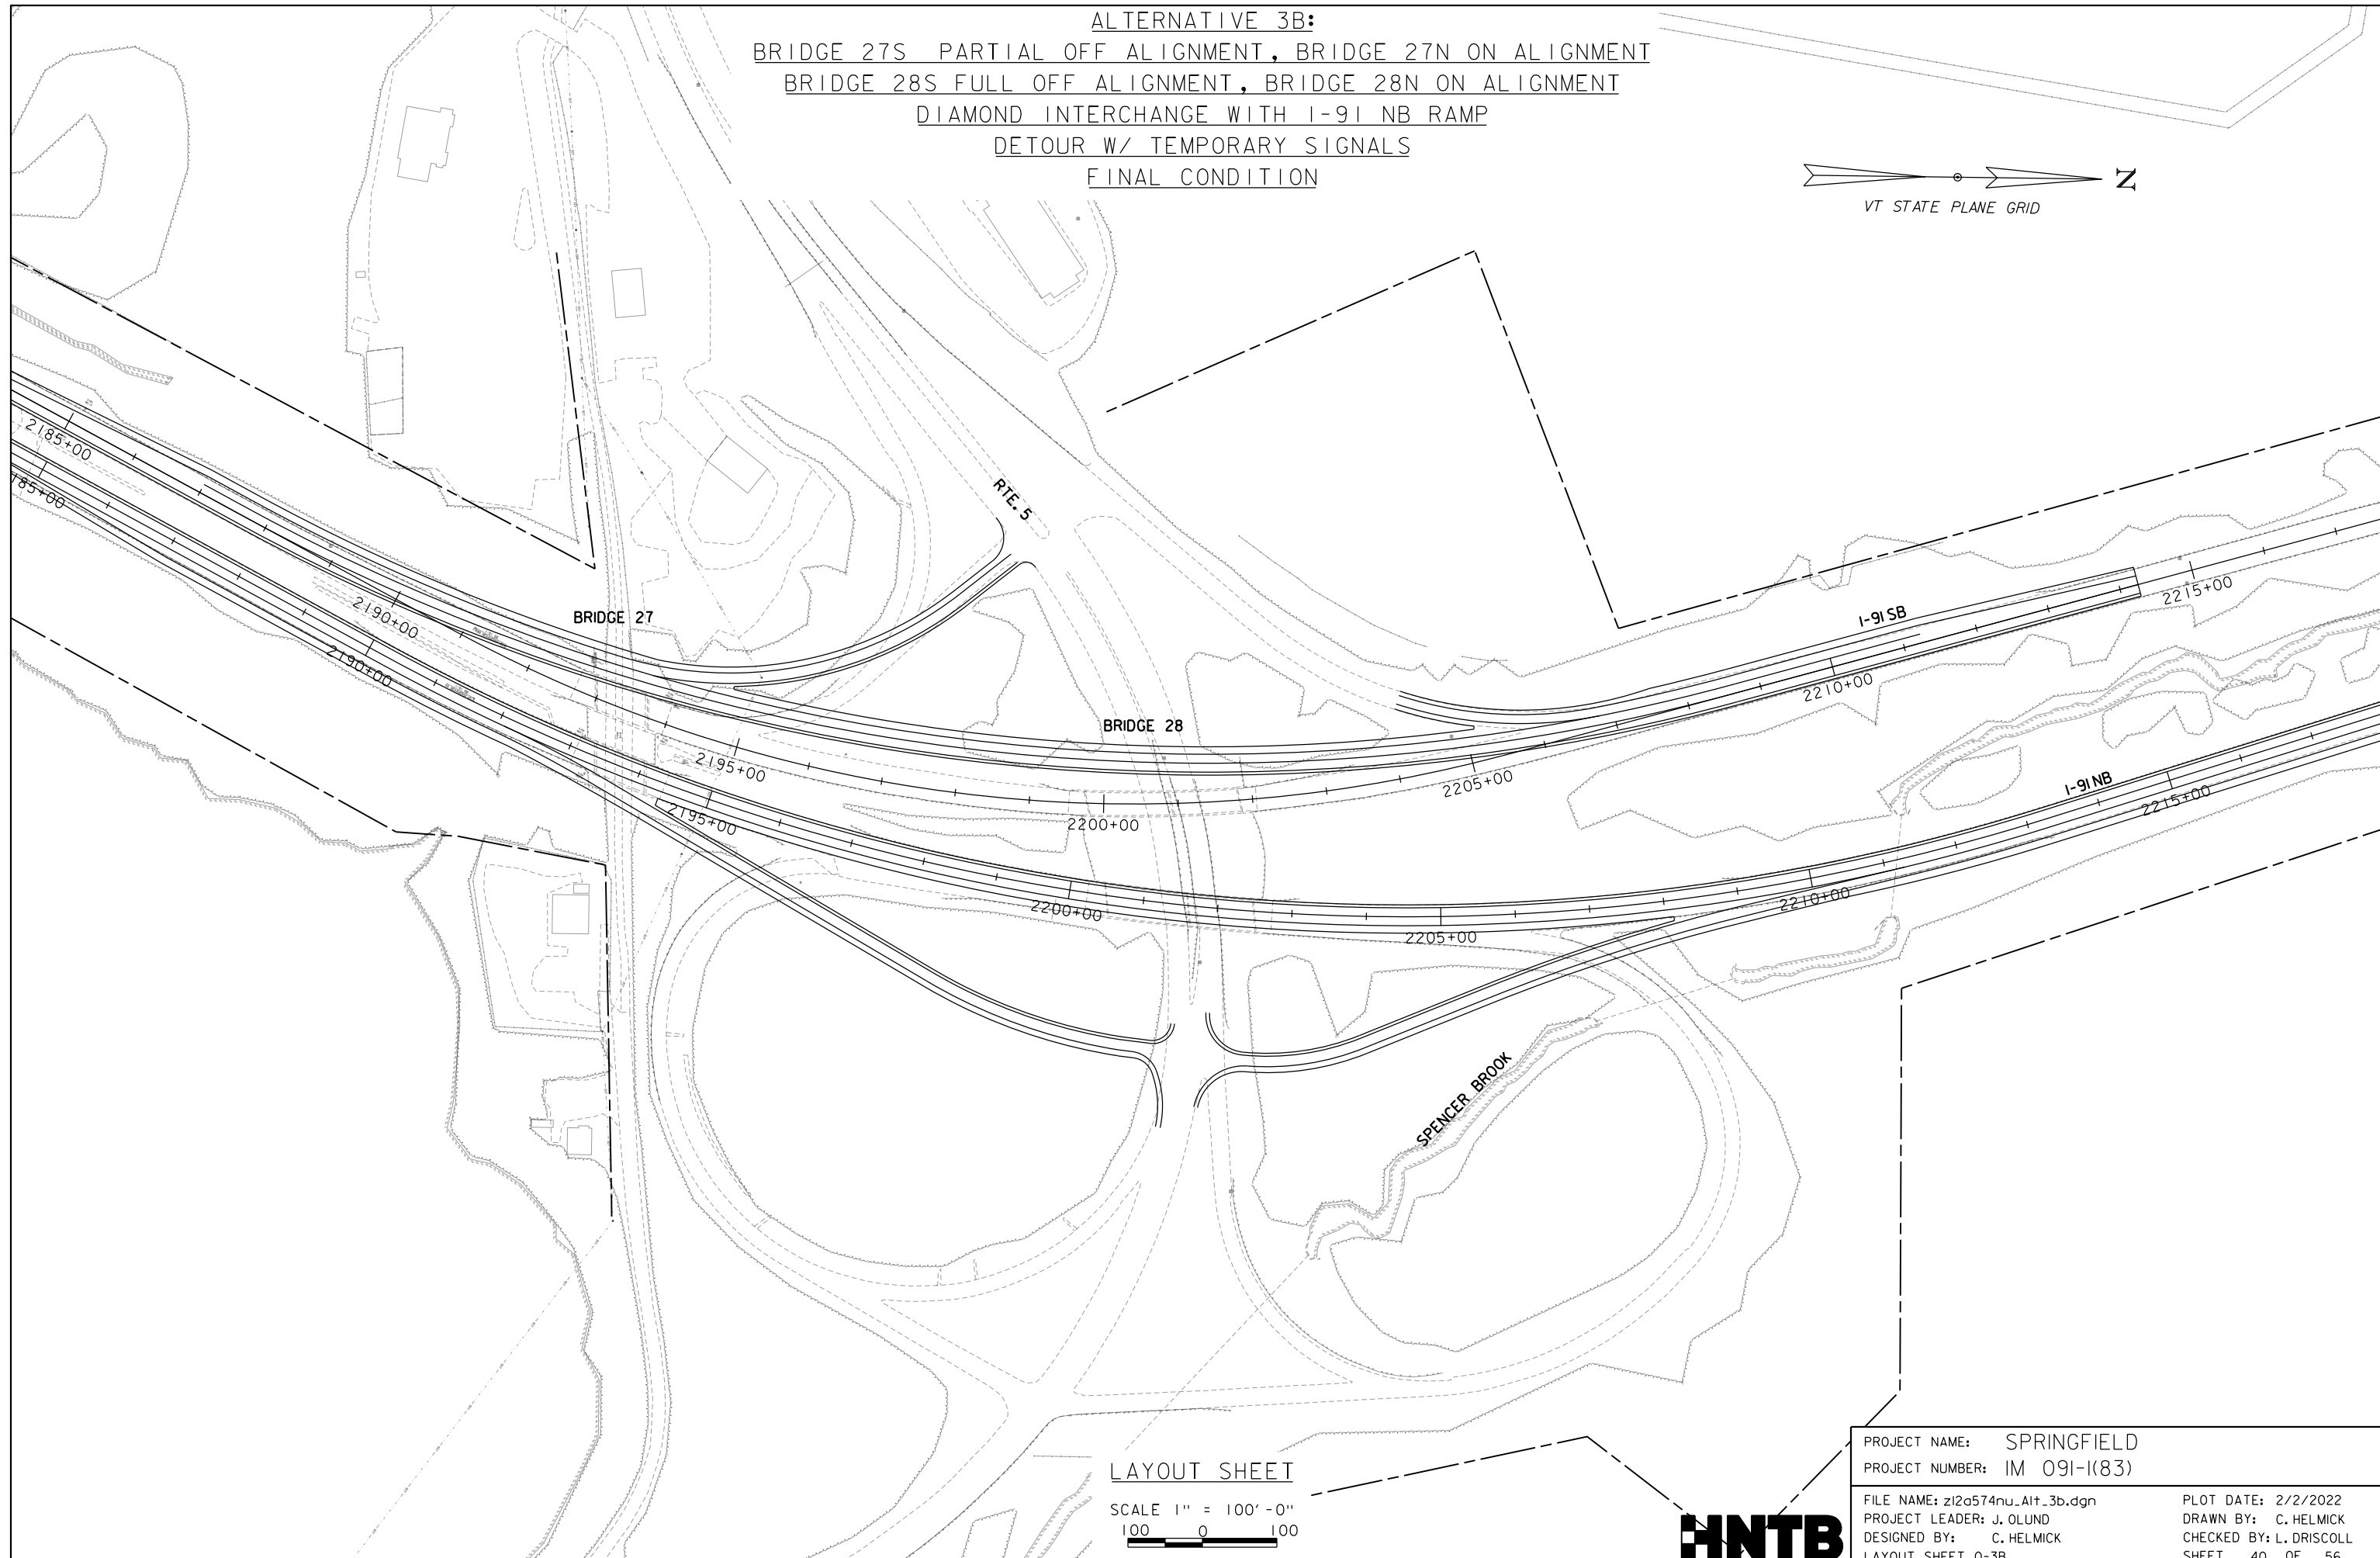
ALTERNATIVE 3B:
 BRIDGE 27S PARTIAL OFF ALIGNMENT, BRIDGE 27N ON ALIGNMENT
 BRIDGE 28S FULL OFF ALIGNMENT, BRIDGE 28N ON ALIGNMENT
 DIAMOND INTERCHANGE WITH I-91 NB RAMP
 DETOUR W/ TEMPORARY SIGNALS
 FINAL CONDITION

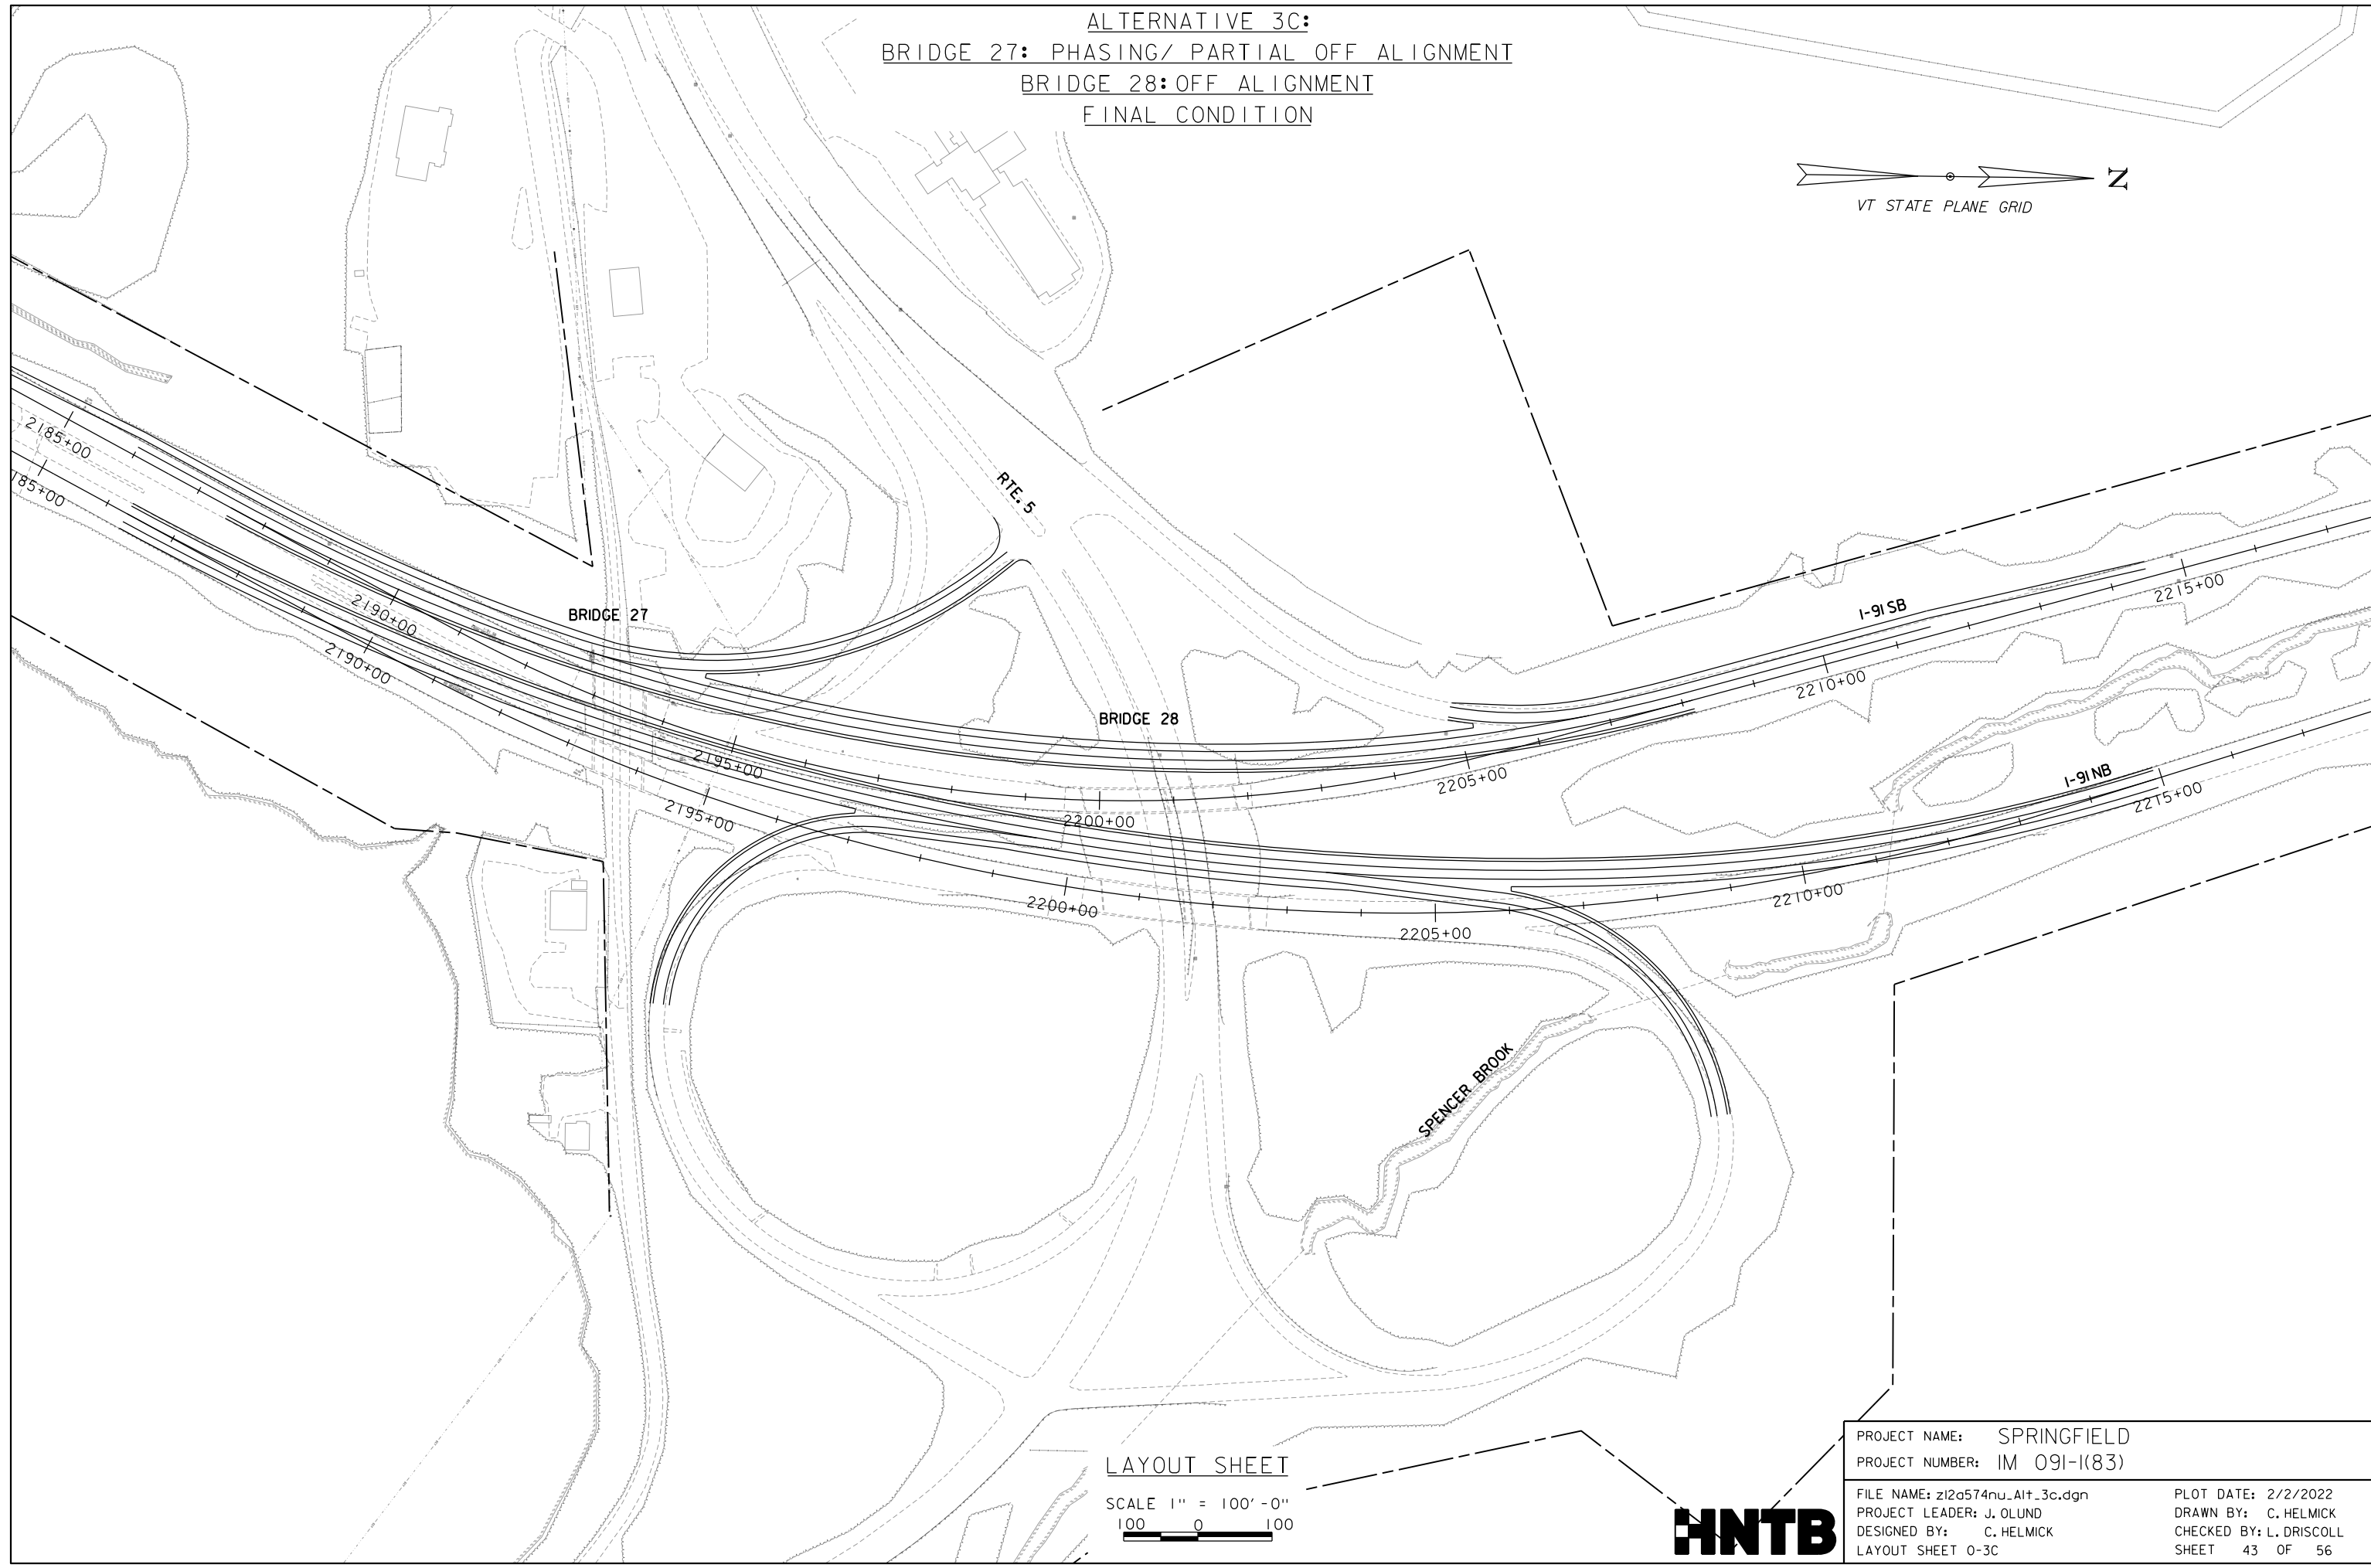
ALTERNATIVE 3C:
BRIDGE 27: PHASING/ PARTIAL OFF ALIGNMENT
BRIDGE 28: OFF ALIGNMENT
FINAL CONDITION

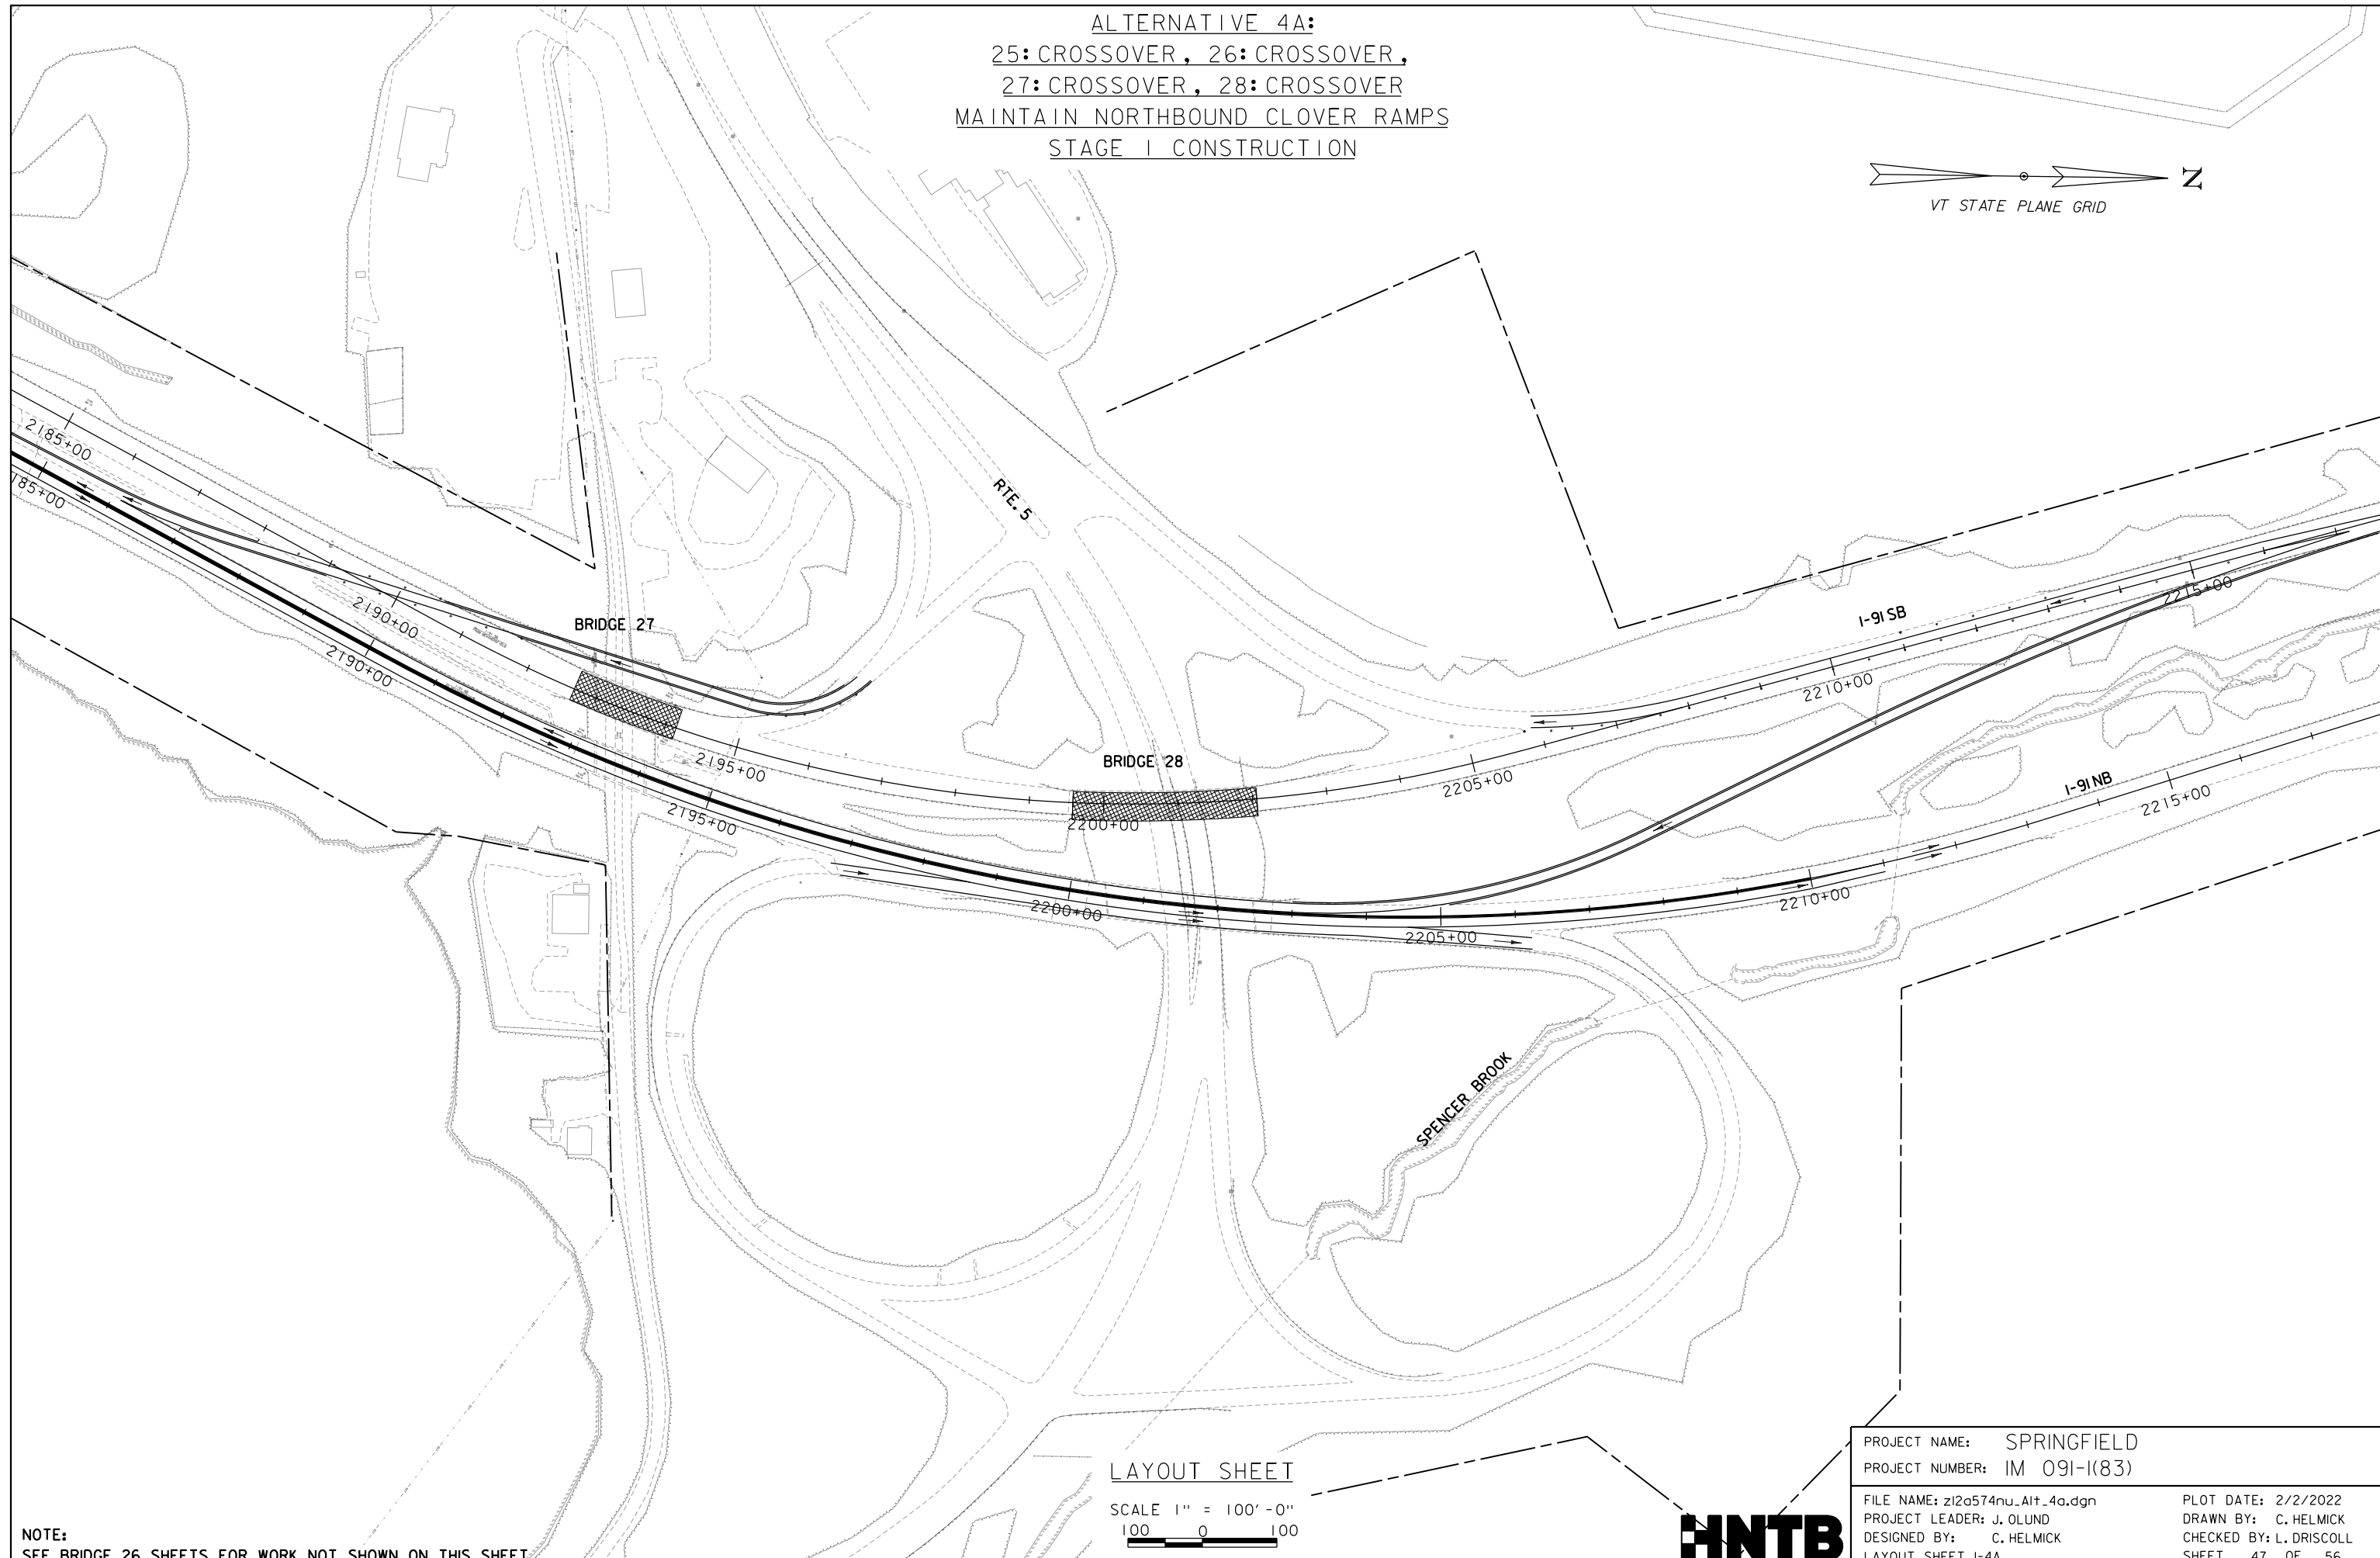
ALTERNATIVE 4A:
 25: CROSSOVER, 26: CROSSOVER,
 27: CROSSOVER, 28: CROSSOVER
 MAINTAIN NORTHBOUND CLOVER RAMPS
 STAGE I CONSTRUCTION

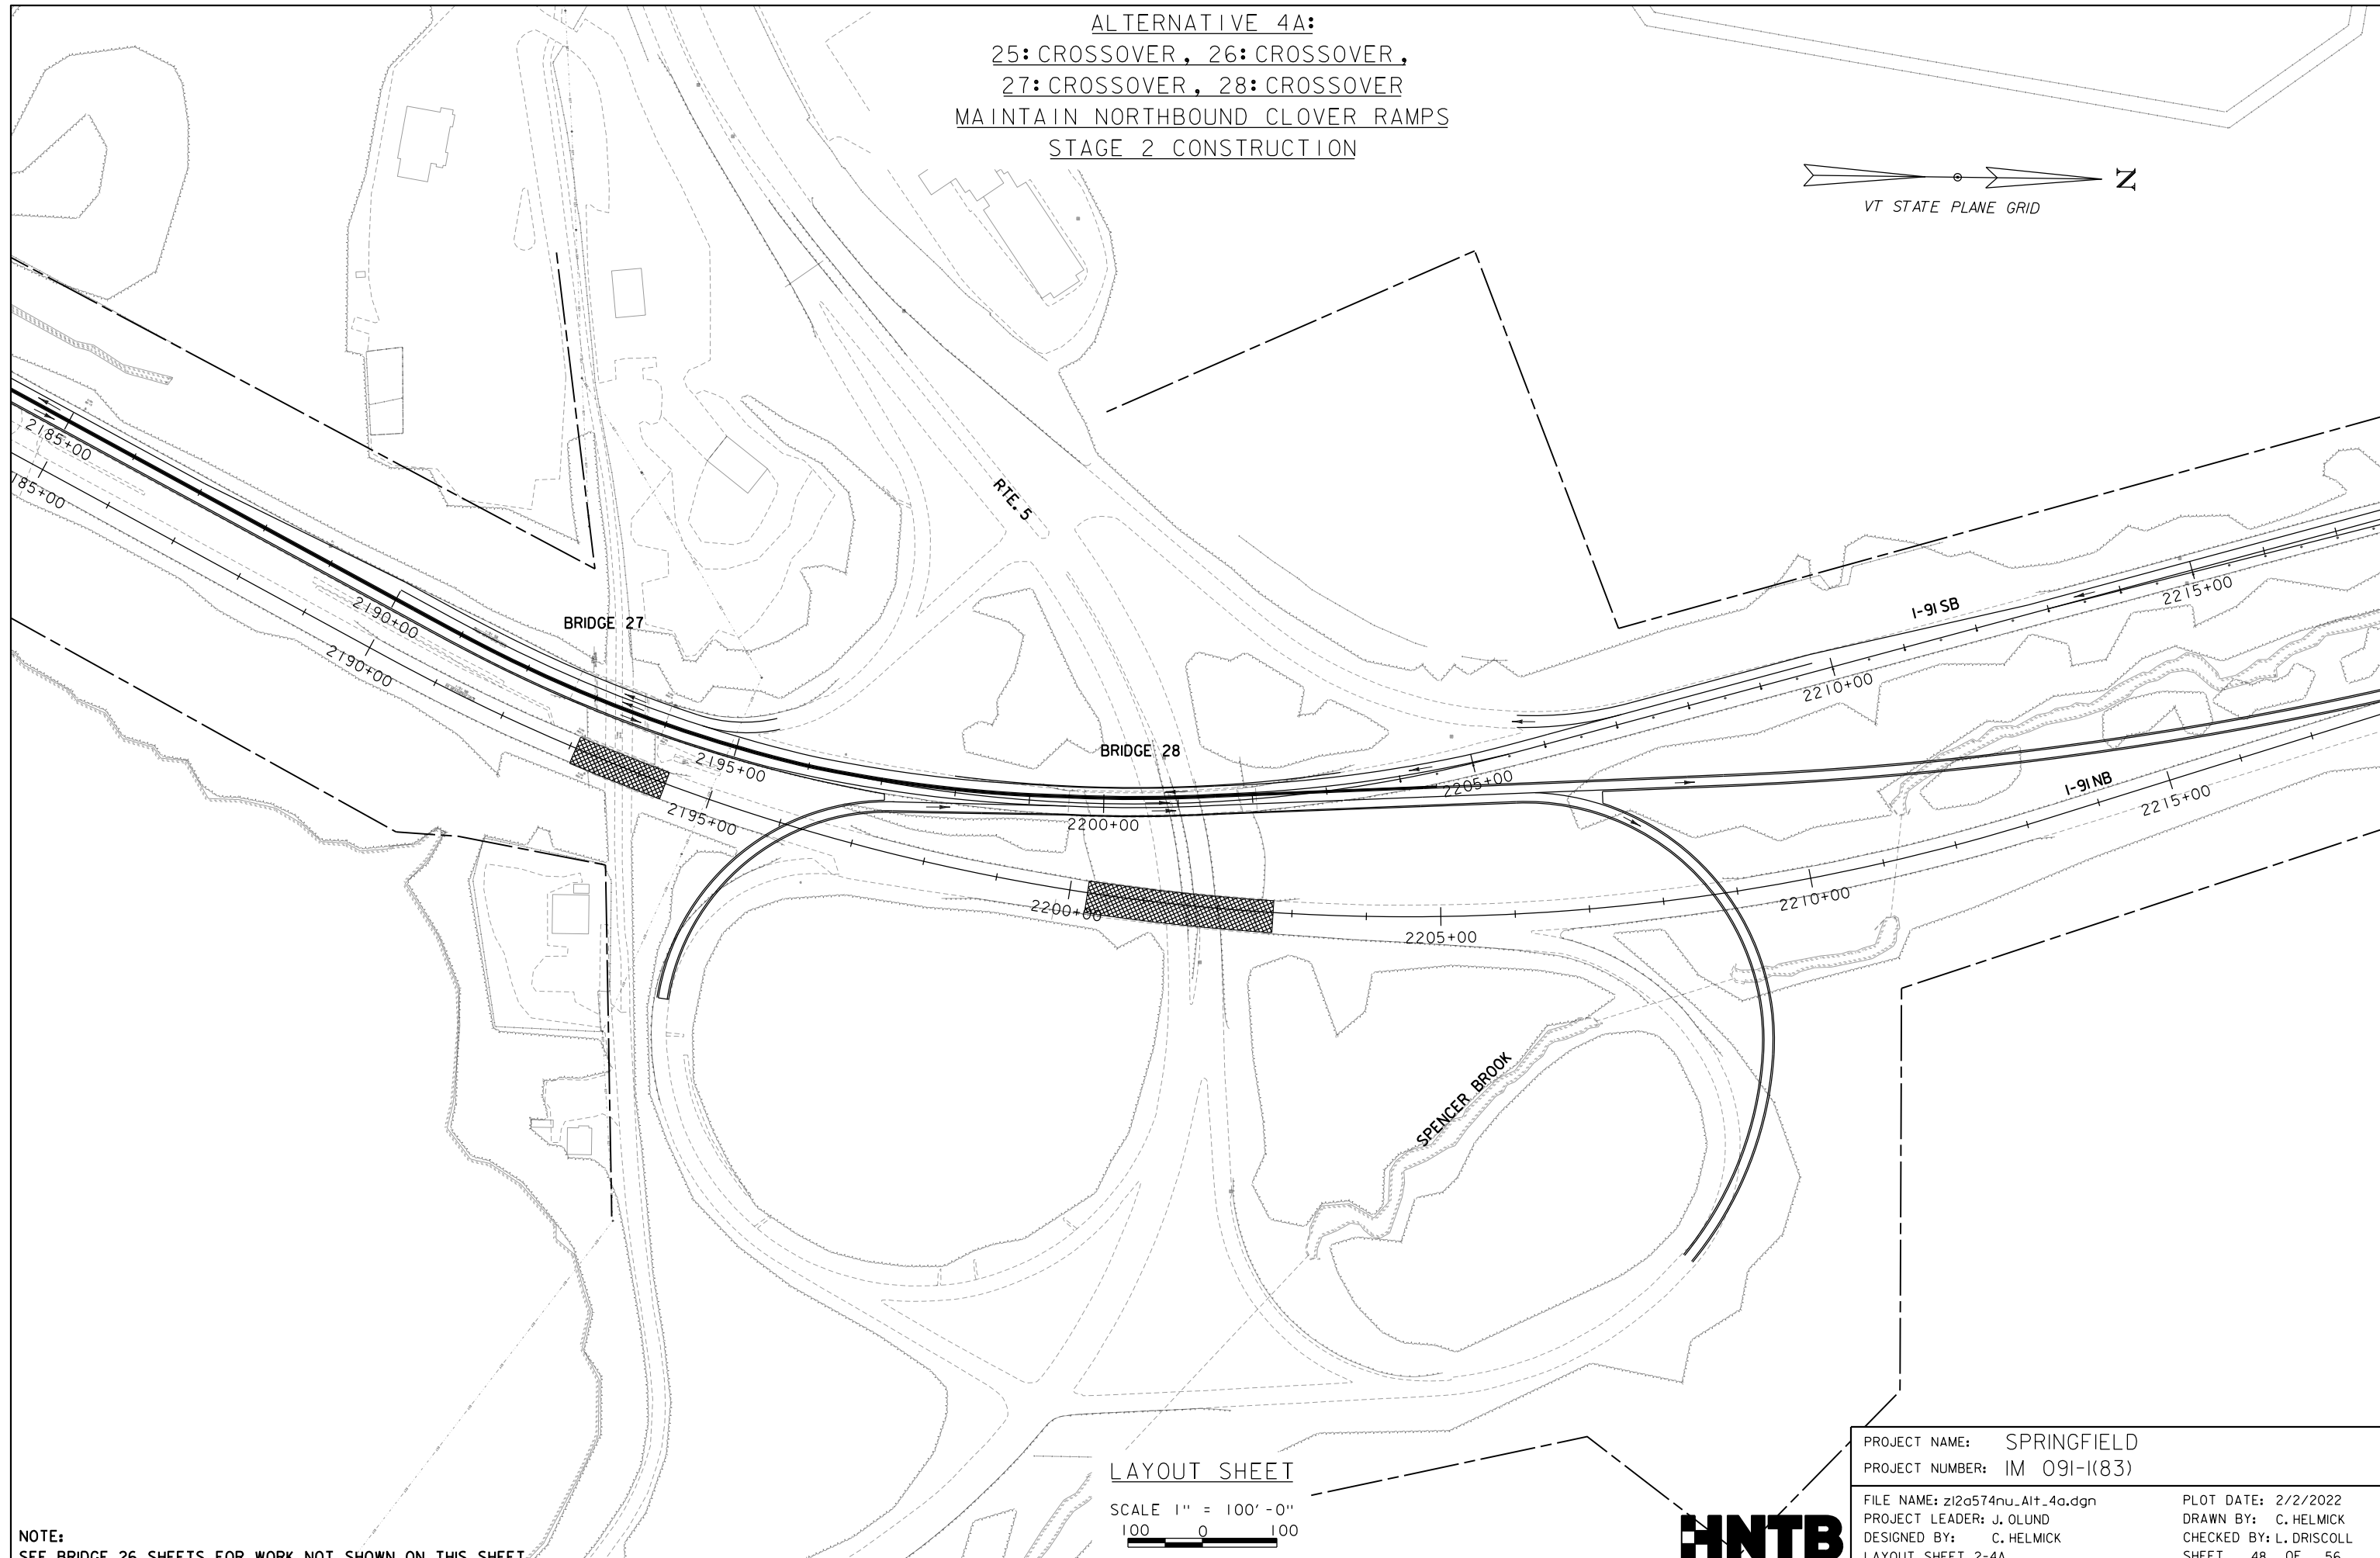
ALTERNATIVE 4A:
 25: CROSSOVER, 26: CROSSOVER,
 27: CROSSOVER, 28: CROSSOVER
 MAINTAIN NORTHBOUND CLOVER RAMPS
 STAGE 2 CONSTRUCTION
