STATE OF VERMONT
AGENCY OF TRANSPORTATION

Final Scoping Report

Springfield IM 091-1(83)

**I-91 Bridges 25 N&S over Route 5, Bridges 27 N&S over the Toonerville Rail Trail
and Related Considerations for Adjacent Bridges 26 N&S and 28 N&S**

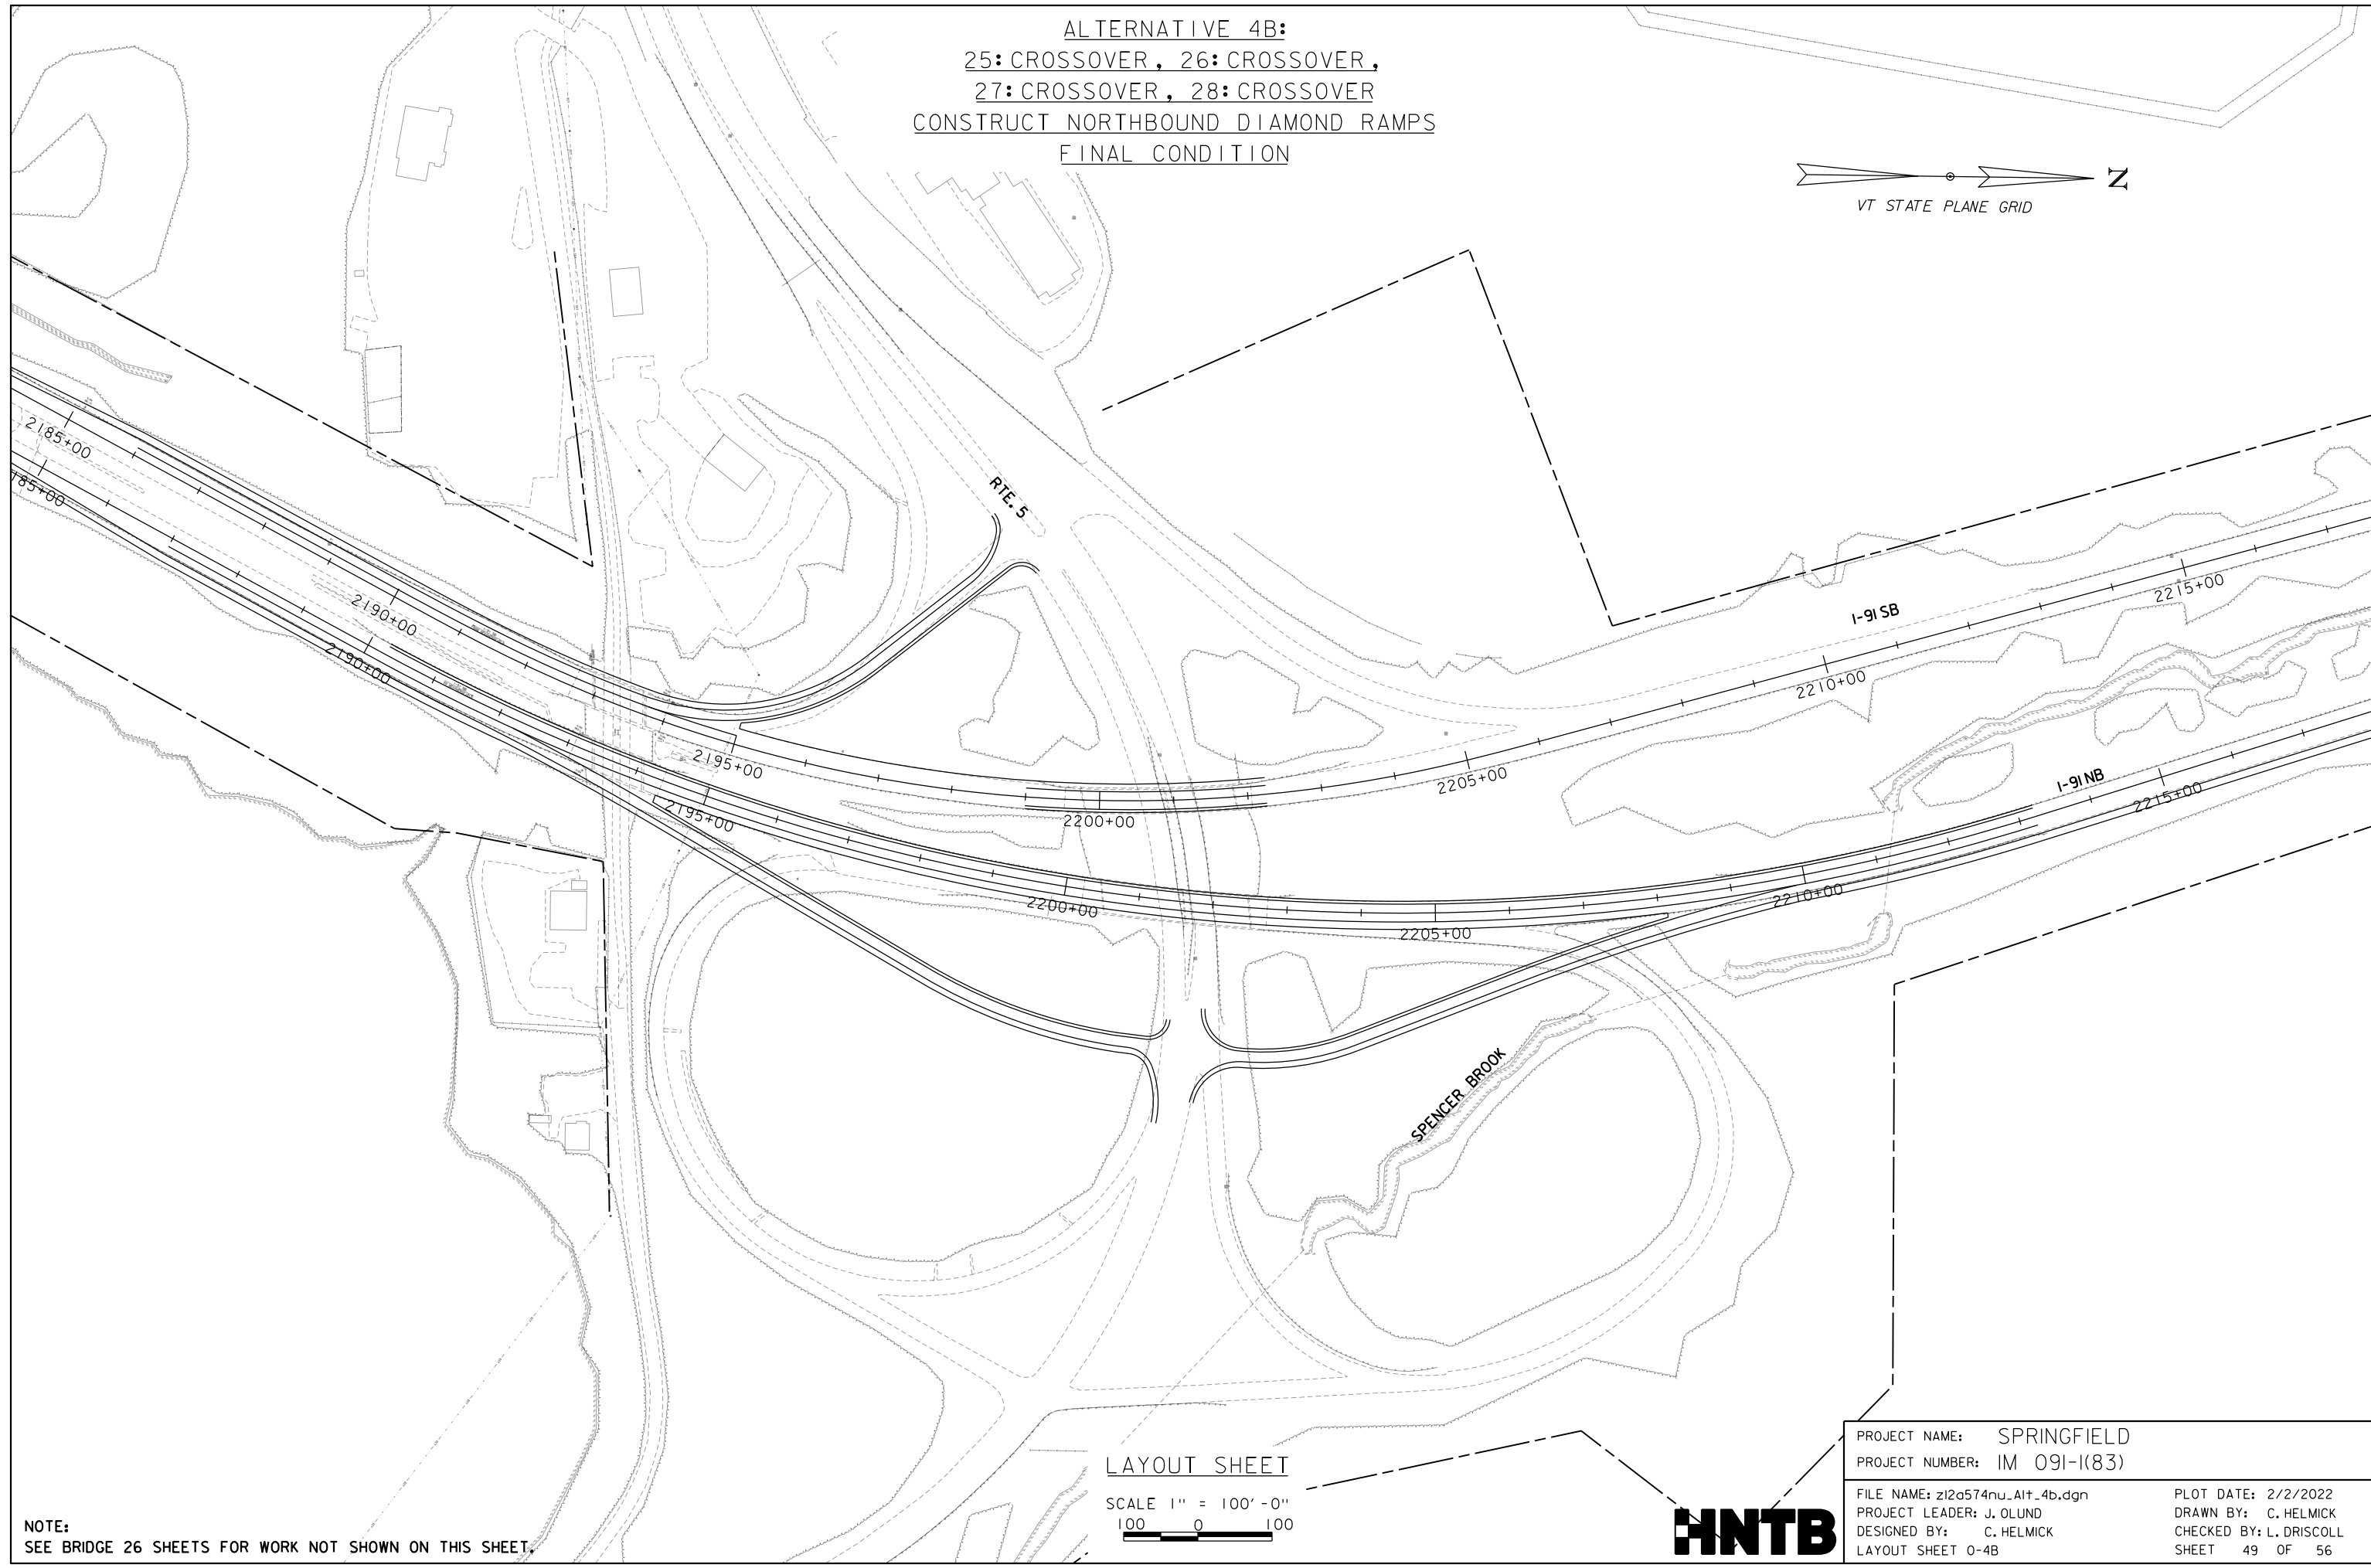
ALTERNATIVE 4B:
 25: CROSSOVER, 26: CROSSOVER,
 27: CROSSOVER, 28: CROSSOVER
 CONSTRUCT NORTHBOUND DIAMOND RAMP
 FINAL CONDITION

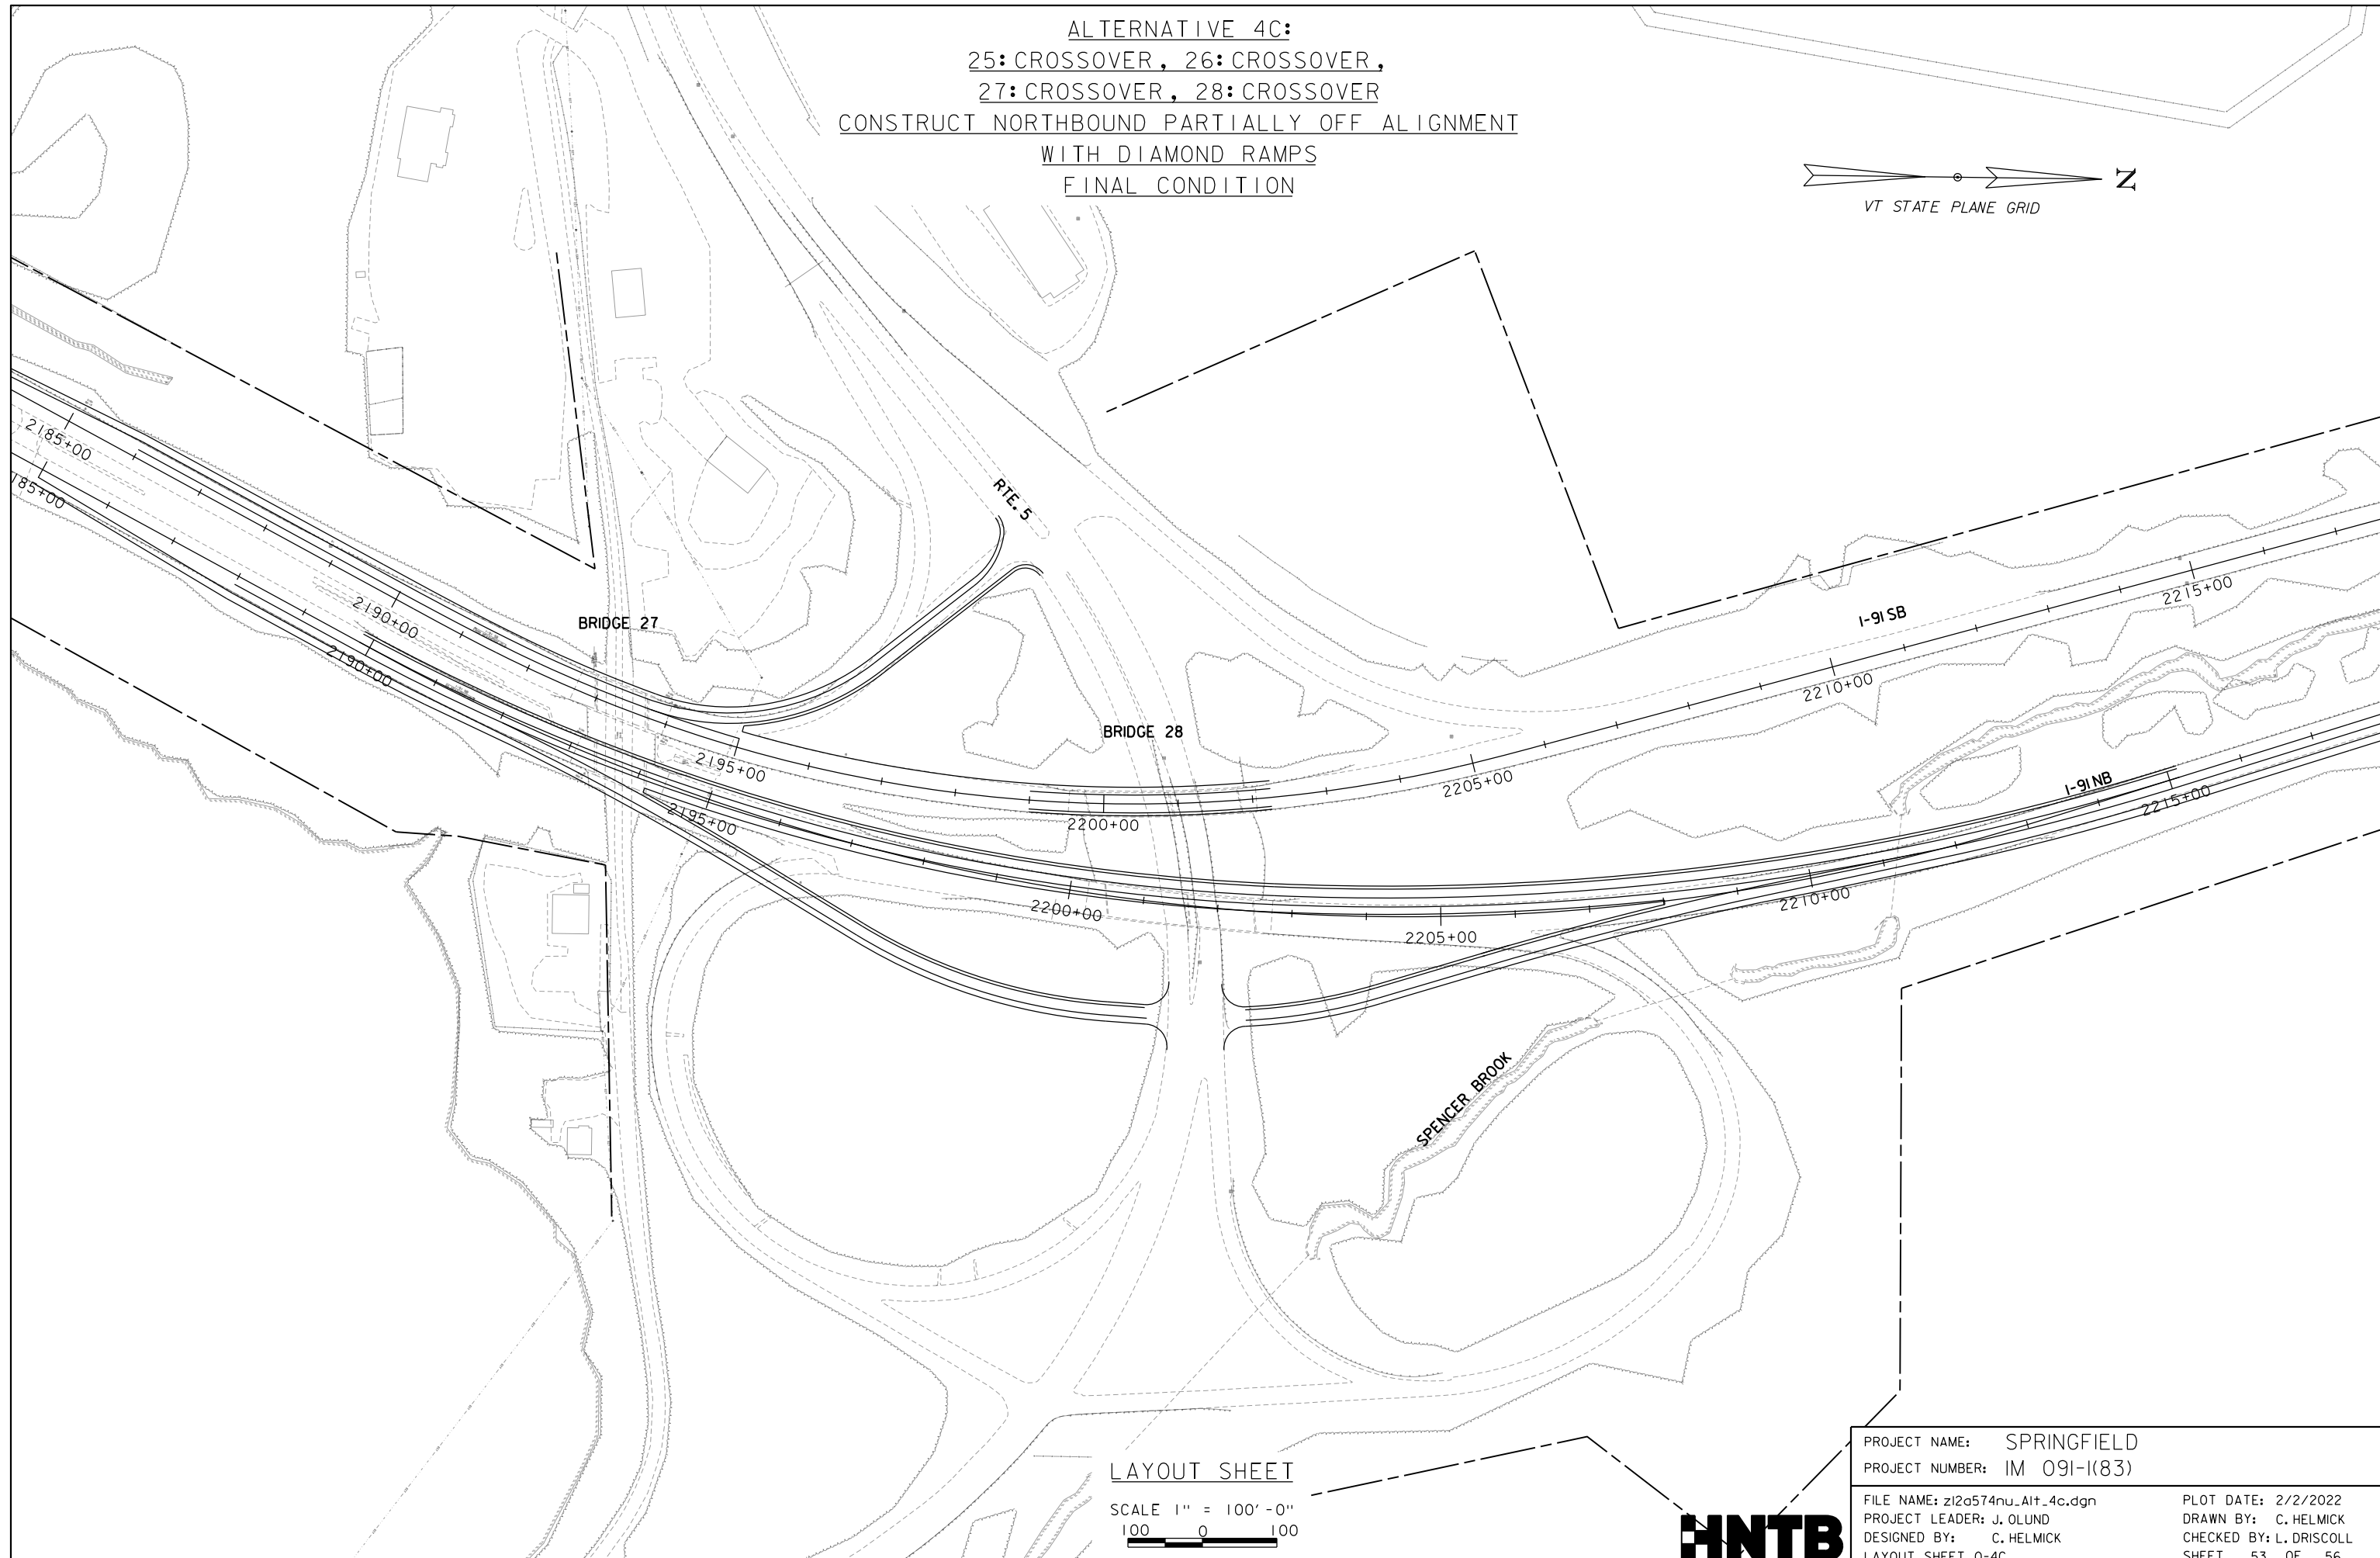
ALTERNATIVE 4C:
 25: CROSSOVER, 26: CROSSOVER,
 27: CROSSOVER, 28: CROSSOVER
 CONSTRUCT NORTHBOUND PARTIALLY OFF ALIGNMENT
 WITH DIAMOND RAMPS
 FINAL CONDITION

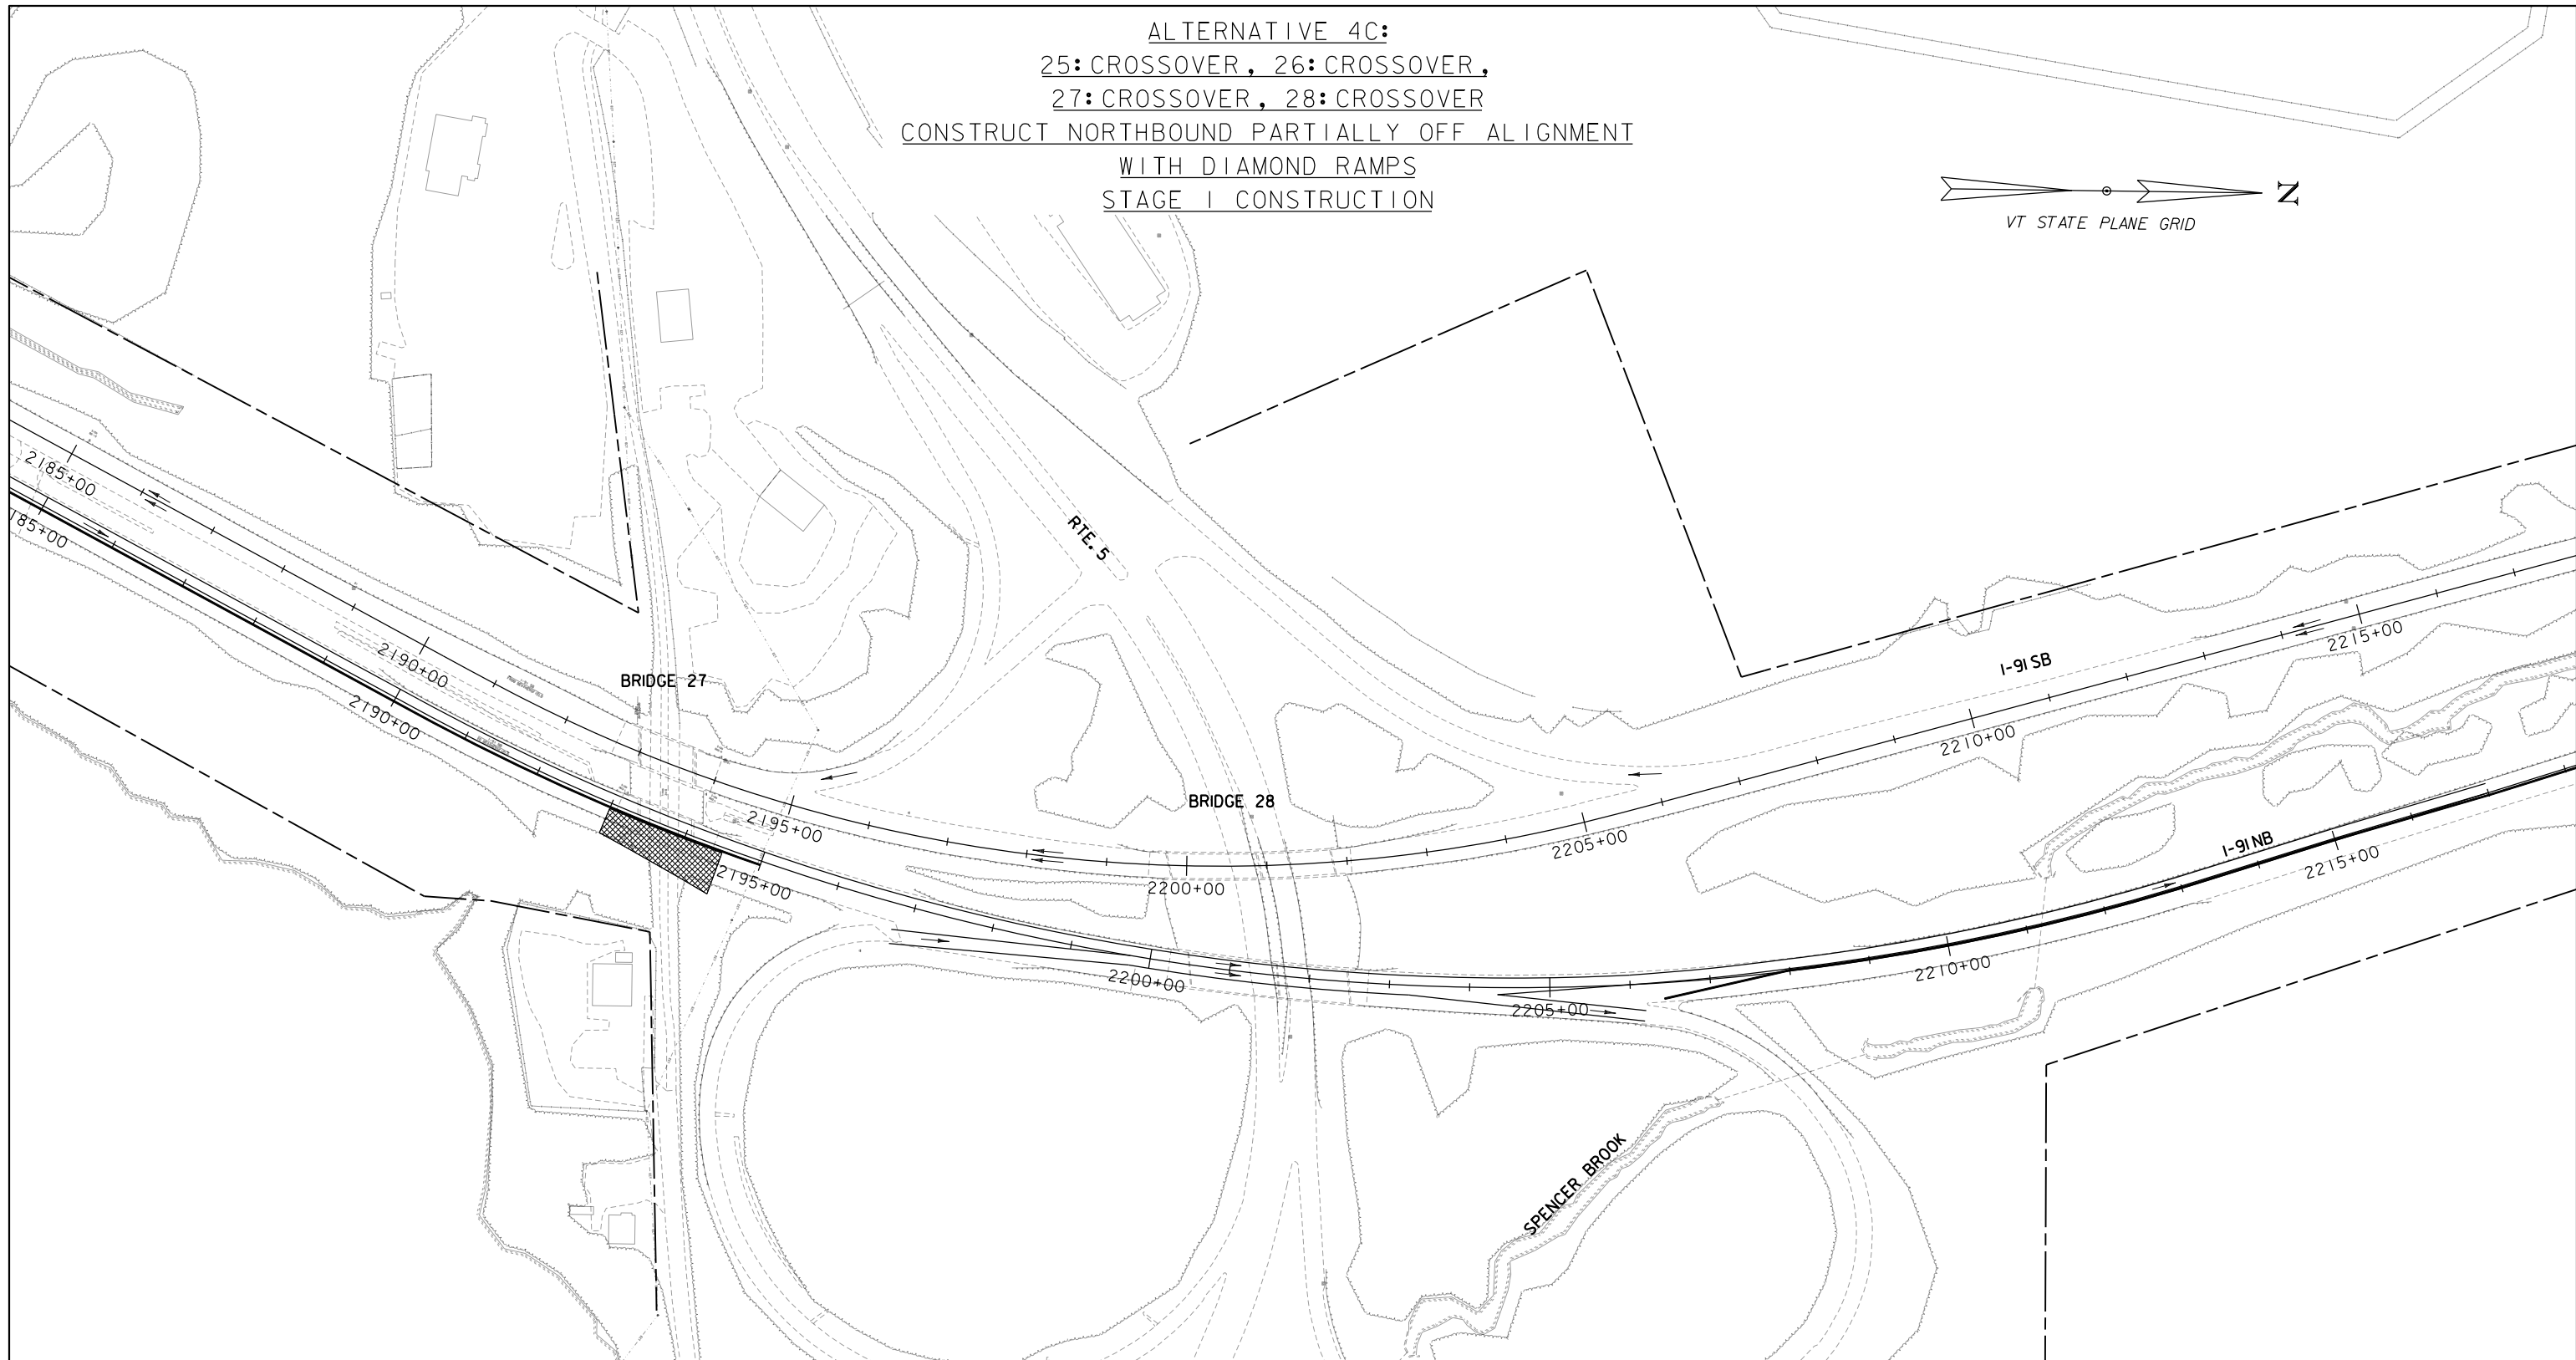
ALTERNATIVE 4C:
 25: CROSSOVER, 26: CROSSOVER,
 27: CROSSOVER, 28: CROSSOVER
 CONSTRUCT NORTHBOUND PARTIALLY OFF ALIGNMENT
 WITH DIAMOND RAMPS
 STAGE I CONSTRUCTION
