**STATE OF VERMONT  
AGENCY OF TRANSPORTATION**

**Scoping Report**

**FOR  
Readsboro BF 0102(16)  
VT ROUTE 100, BRIDGE 25 OVER THE DEERFIELD RIVER**

October 18, 2013

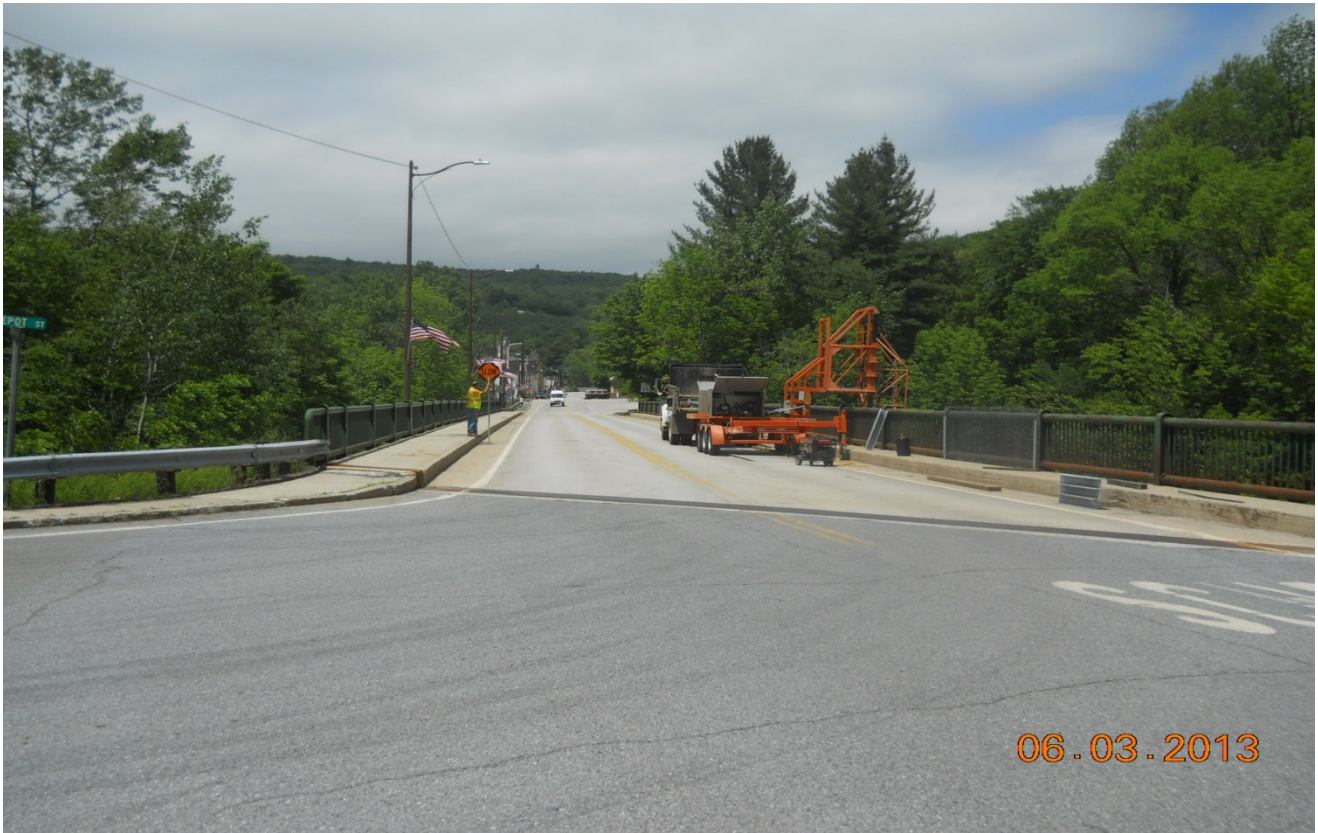
Bridge 25 Looking West

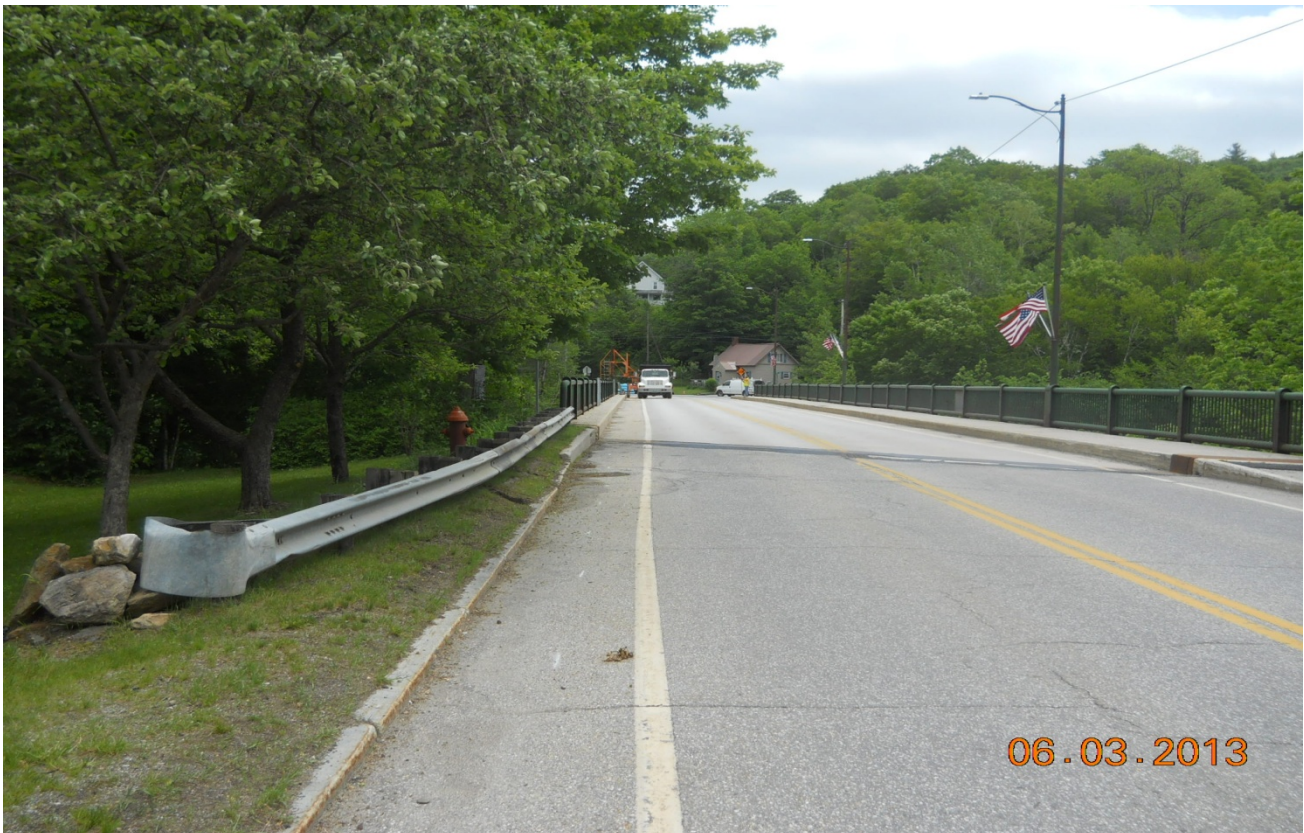
Bridge 25 Looking East

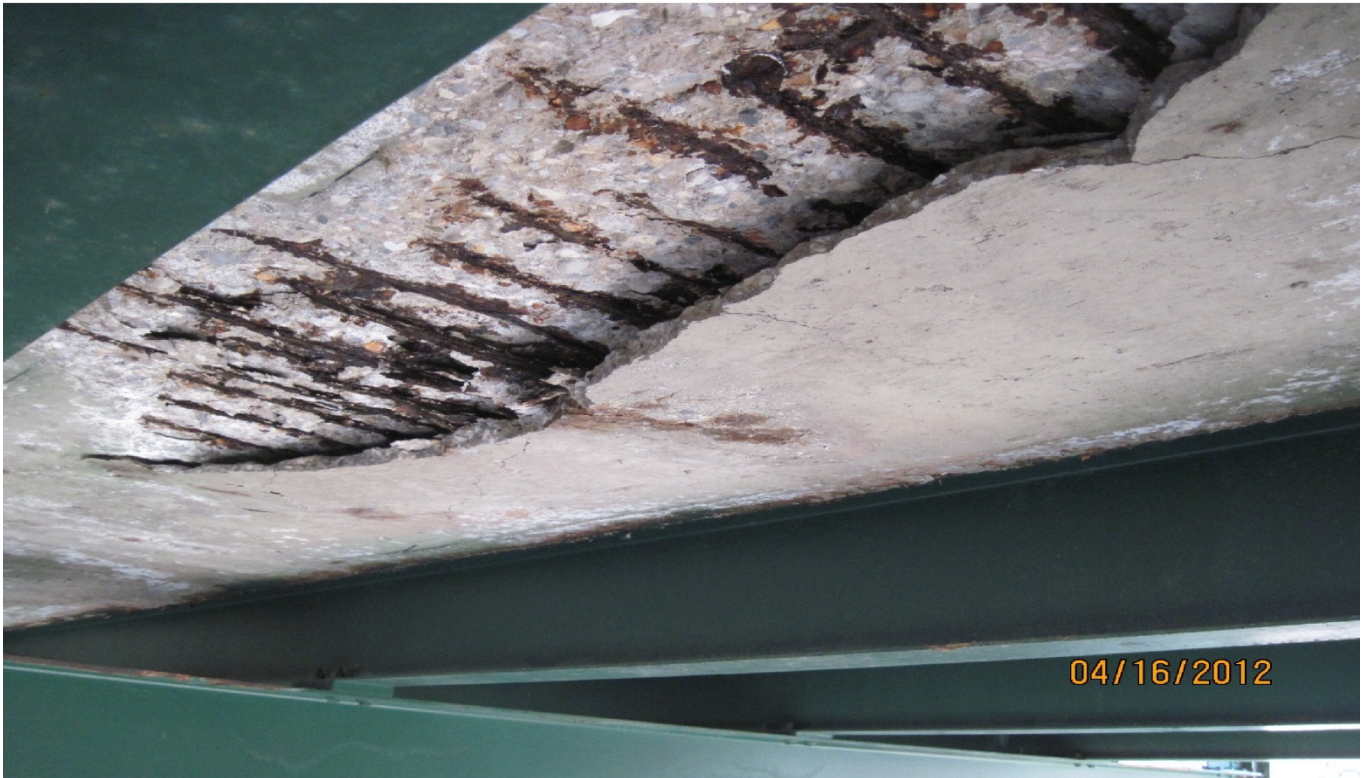
Delaminating Deck

| 1. Deck Repair Needed | <b>Large and thick delams w/ broken rebar</b> |

Inspector(s) Comments : Large delaminations in bays 2 or 3 of spans 2 and 3 are in need of added support to prevent local break through. Stringer beams 1 thru 3 of span 3 are in need of reinforcement along the lower web areas. Connection plates on the south side of the both end floor beams are in need of repairs.

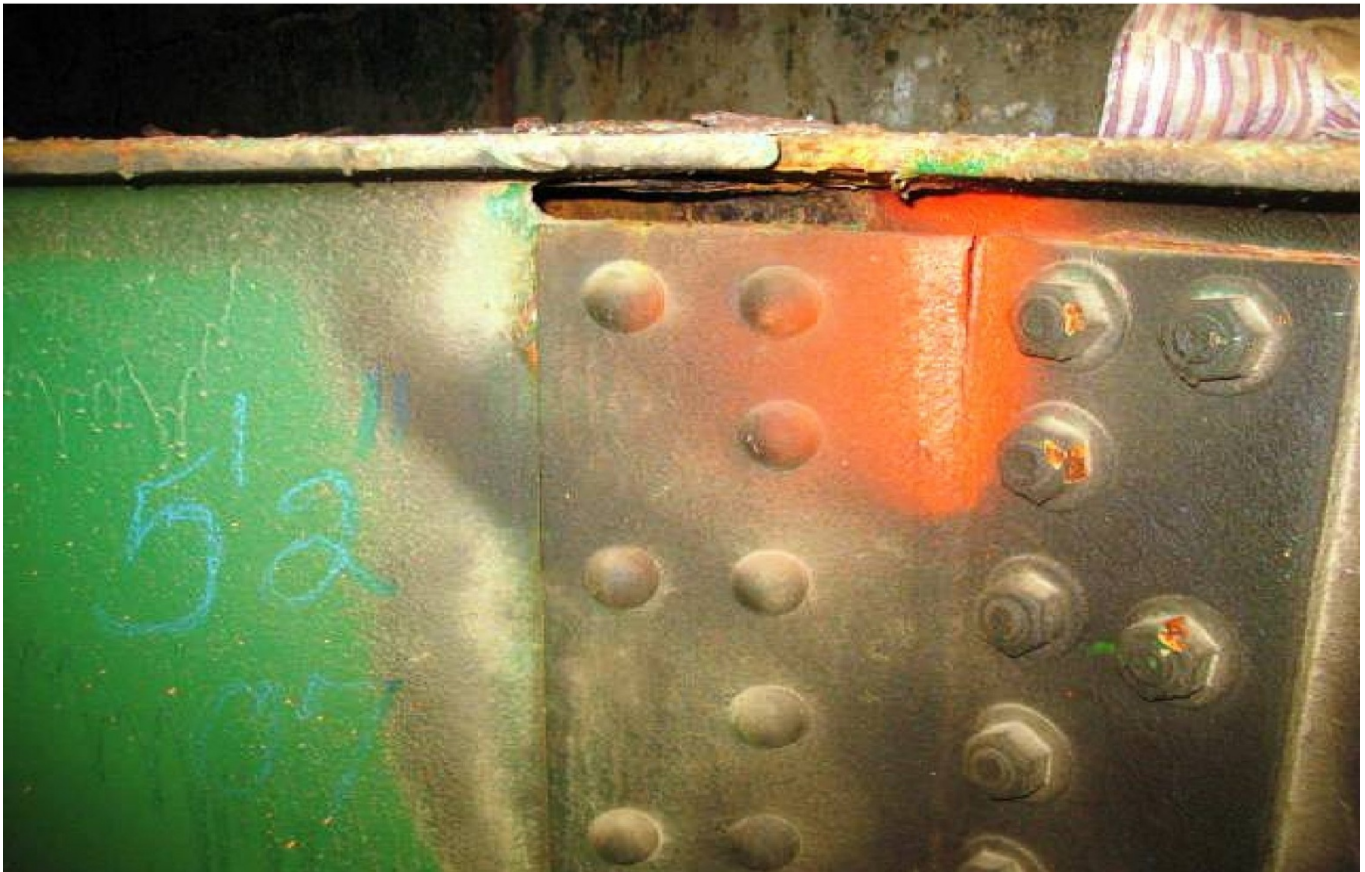
Secondary Member Crack

| 1. Repair Stringer Beam | <b>Holes in lower web.</b> |

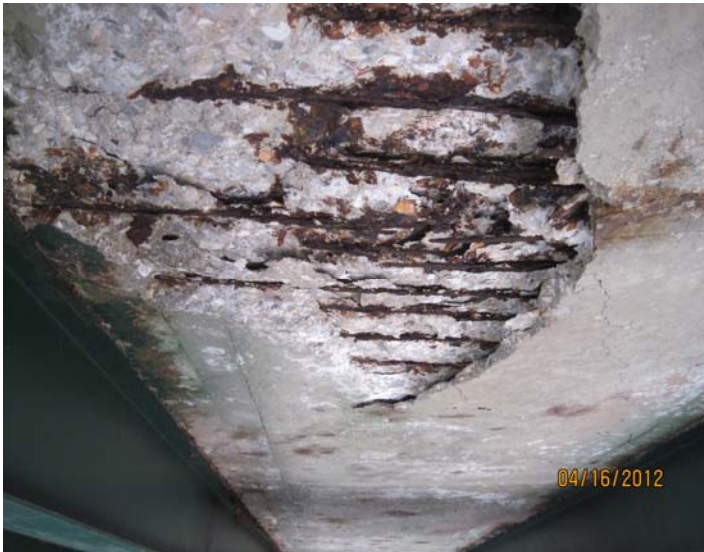
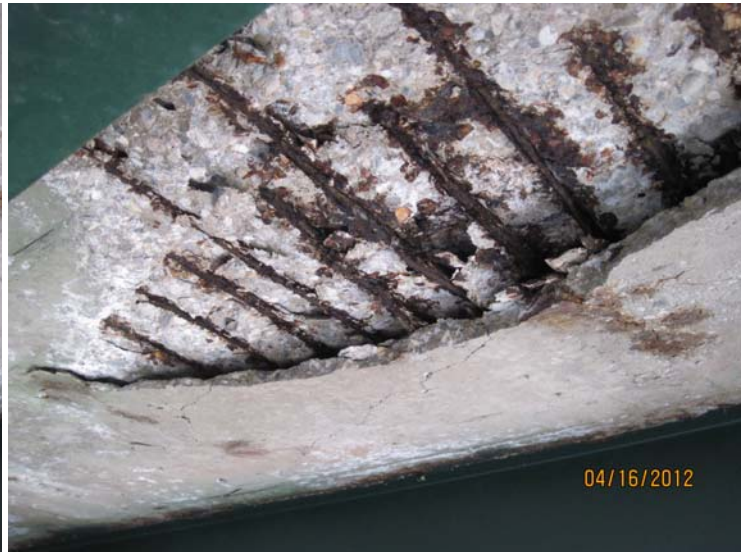
“04/16/2012 This inspection is a Servi-lift inspection (fracture critical inspection) that was postponed due to Tropical Storm Irene during 2011. Please refer to the inspection report dated on 06/08/2011 for other information missing from this report. Stringer beams 1-3 of span No.3 are in need of web reinforcement. Floor beam #7 needs repair to a crack on south end connection plate. The south end connection plate of floor beam No.1 of span No.1 needs repair to a vertical crack. Local failures may occur anytime and anywhere along both sides of the centerline of all three span areas (especially bays 2 and 3) without notice. Please refer to Critical Maintenance Report dated on 04/16/2012. PLB

04/16/2012

06/08/2011 The deck is in need of full replacement. The bridge guard rails on both sides are in need of painting and repairs. Miscellaneous steel repairs are needed on a few members throughout. PLB”

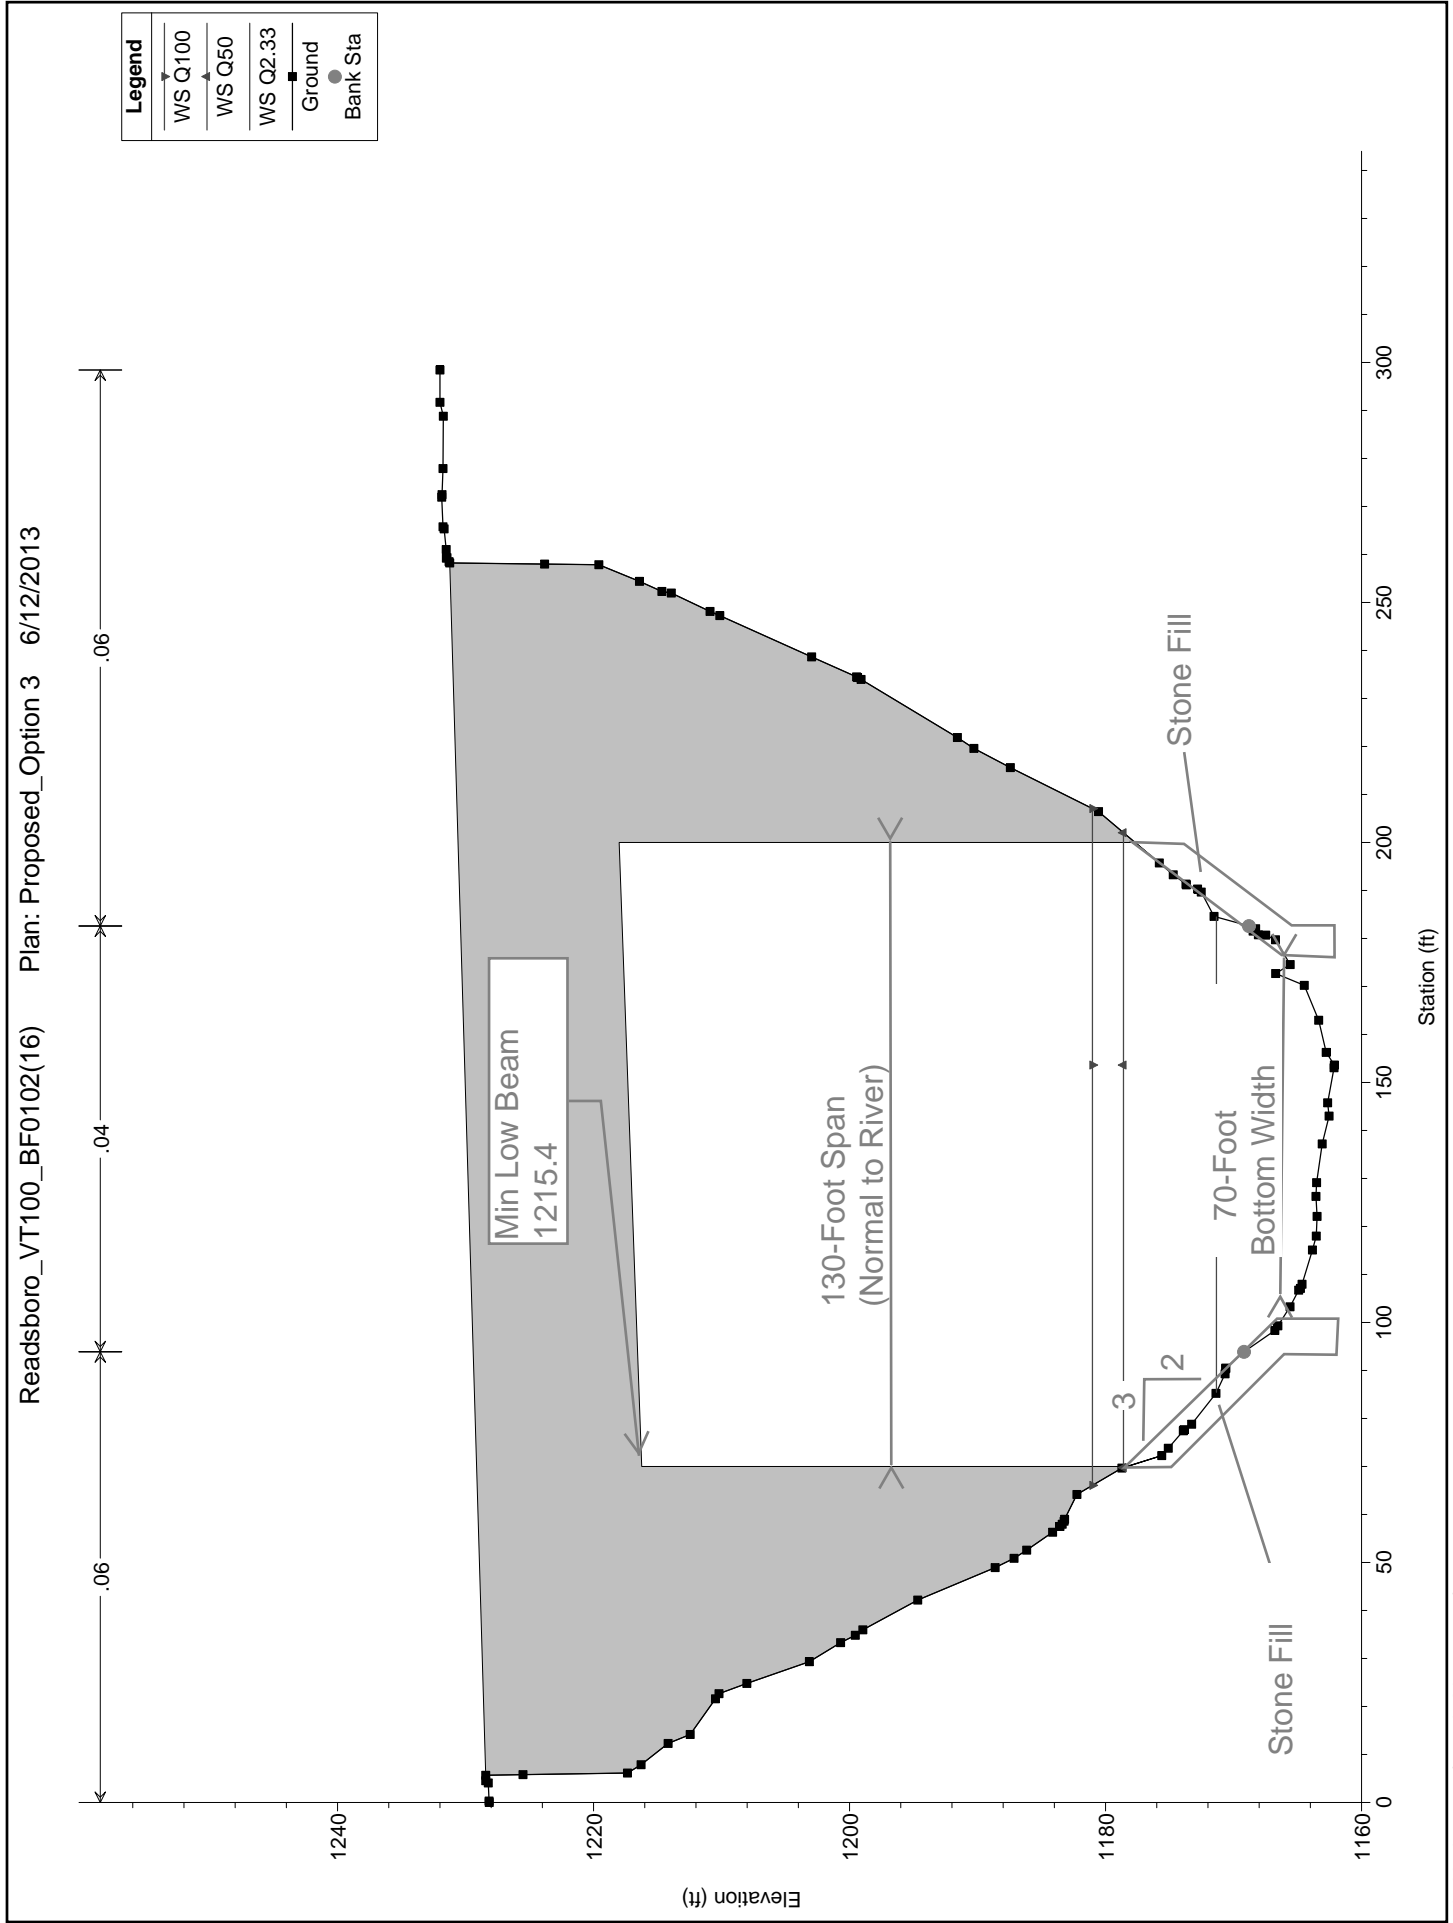
Figure 1: 175-Foot Singe Span Normal to Road (130-foot Normal to River)

Based on our analysis, the designer has flexibility on the bridge design to meet eh hydraulic standards. One option would be to use a replacement bridge having a single 175-foot clear span (130-foot normal to the stream channel) between the abutment faces. For this option with a low

beam elevation of 1215.4, this analysis predicted a freeboard of 29.8 for the  $Q_{500}$  event. The designer would have flexibility on the low beam elevation given the significant freeboard. The proposed opening is narrower than the existing structure but has a wider center clear span and will not constrict the stream channel's bank full width based on the current BFW conditions. This proposed structure option will also provide approximately 37.0 feet of freeboard at the  $Q_{50}$  design storm event and meet the hydraulic design standard.

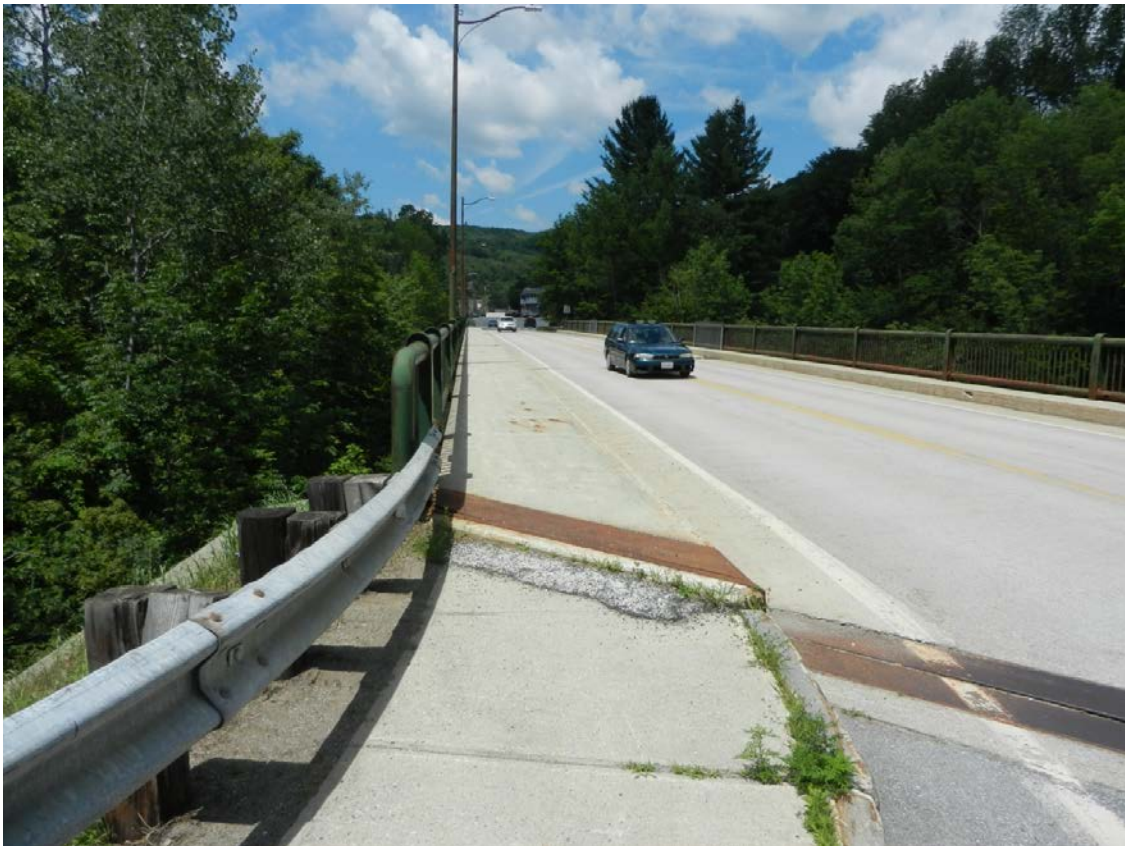
**Figure 1.** Looking North on VT-100

Overhead power is non-existent on the bridge, and will not interfere with boring operations. For borings completed on and through the bridge deck, the wide sidewalk allows for more width to locate the drilling rigs while maintaining one-way traffic.

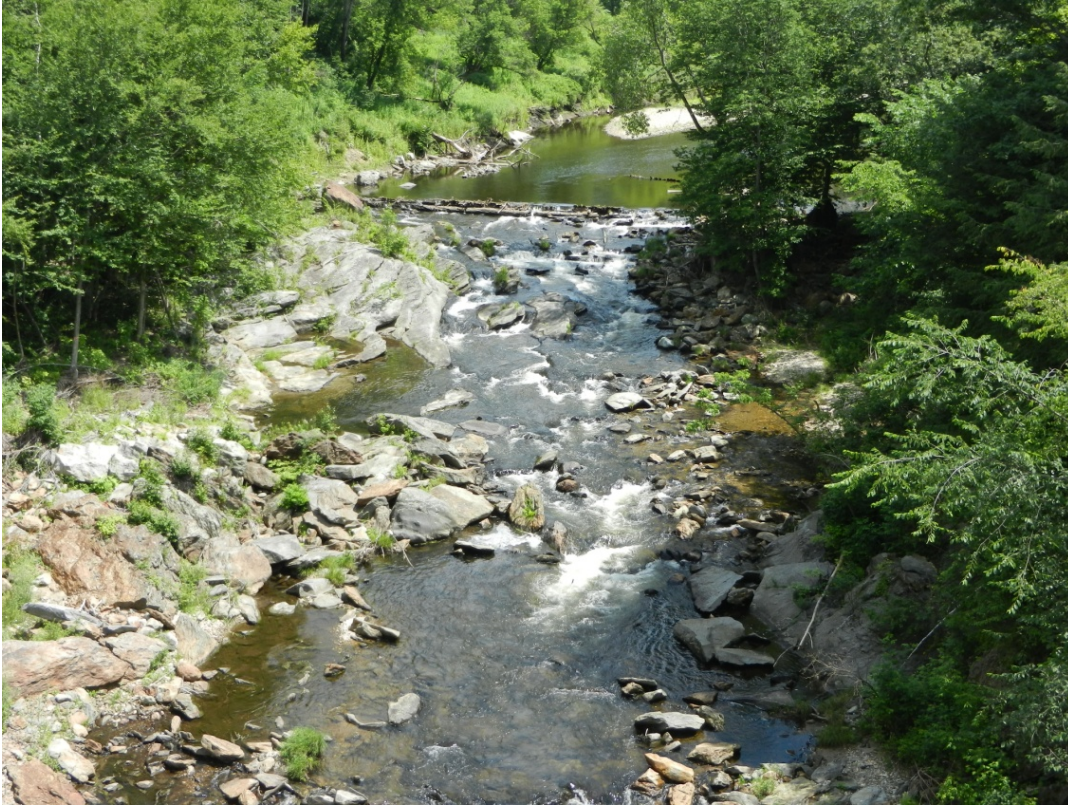
**Figure 2.** Bedrock visible upstream

Figure 2 shows visible bedrock upstream of the bridge; however it should be noted the bedrock elevation at this site is variable. Based on the existing plans, and nearby borings, although bedrock is visible up and downstream of the bridge, it could be vary significantly across the width of the bridge. Additionally, large boulders in the area can be misleading as to the presence of bedrock.

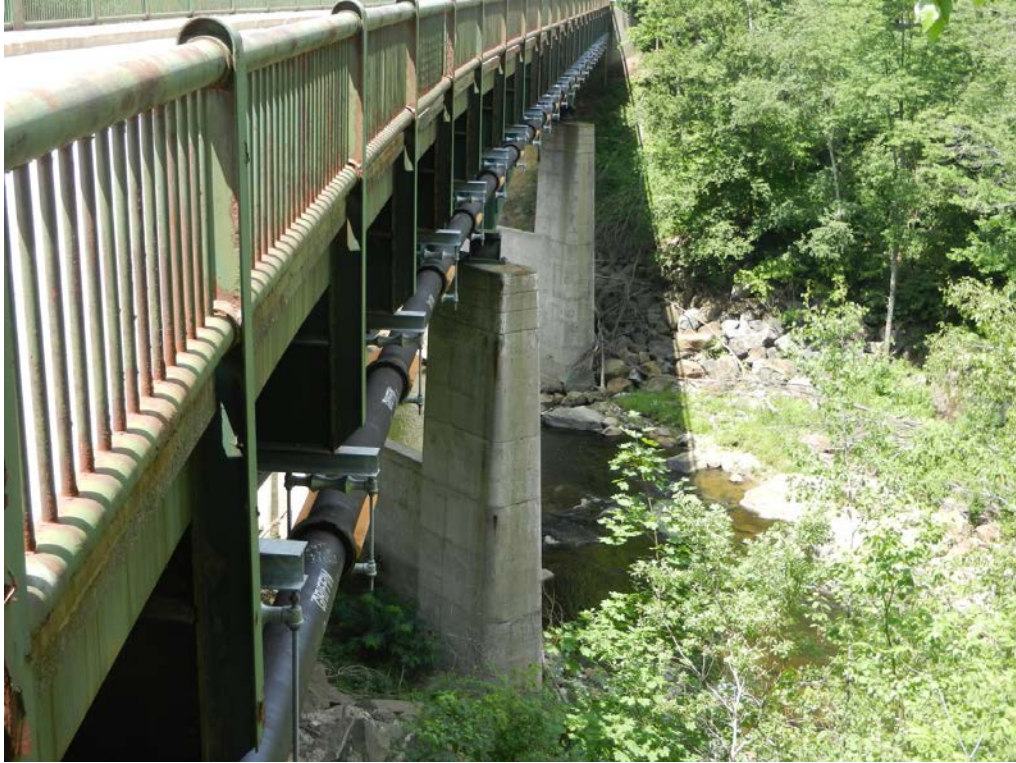
**Figure 3.** Upstream side of the bridge, looking North on VT-100

Figure 3 shows the tall piers, steep banks, and presence of cobbles and boulders, all of which contribute to difficult boring operations. With the large size and scope of this project, an in-depth geotechnical investigation is necessary. Two borings should be completed at each abutment, and due to the irregularities in bedrock elevation, a minimum of two at each additional substructure unit. With bedrock visible in the river, the subsurface exploration could be done in phases to help gain more information for design decisions. A series of hand steel soundings could be conducted near existing piers as well, to help ascertain the bedrock profile.

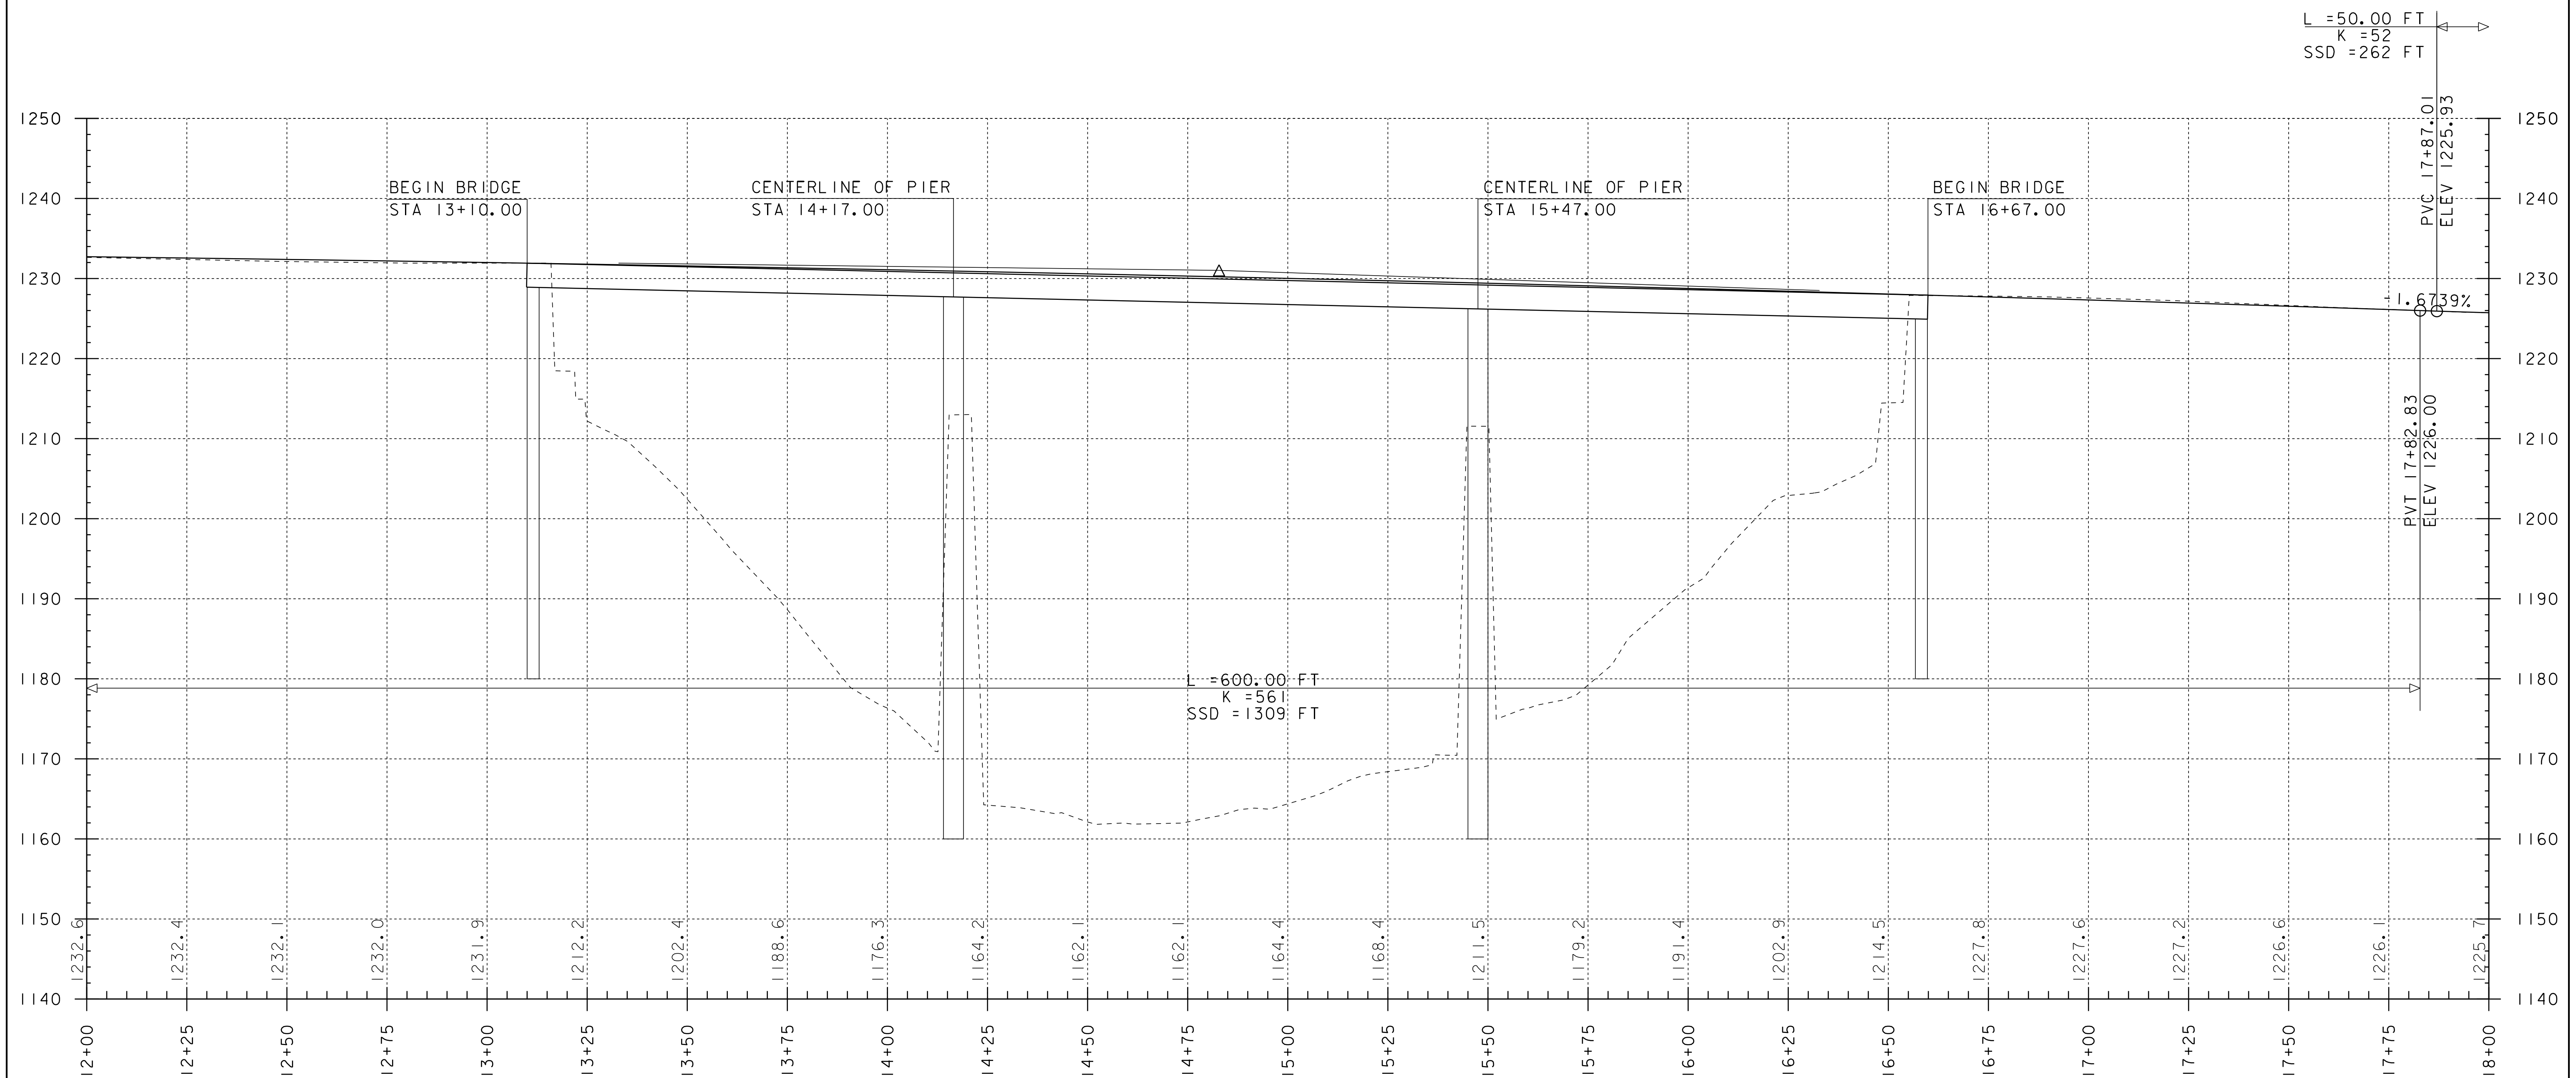
THREE SPAN BRIDGE VT 100 PROFILE I  
 SCALE: HORIZONTAL 1"=20'-0"  
 VERTICAL 1"=10'-0"

GRADES SHOWN TO THE NEAREST TENTH ARE EXISTING GROUND ALONG  $\phi$   
 GRADES SHOWN TO THE NEAREST HUNDREDTH ARE FINISH GRADE ALONG  $\phi$

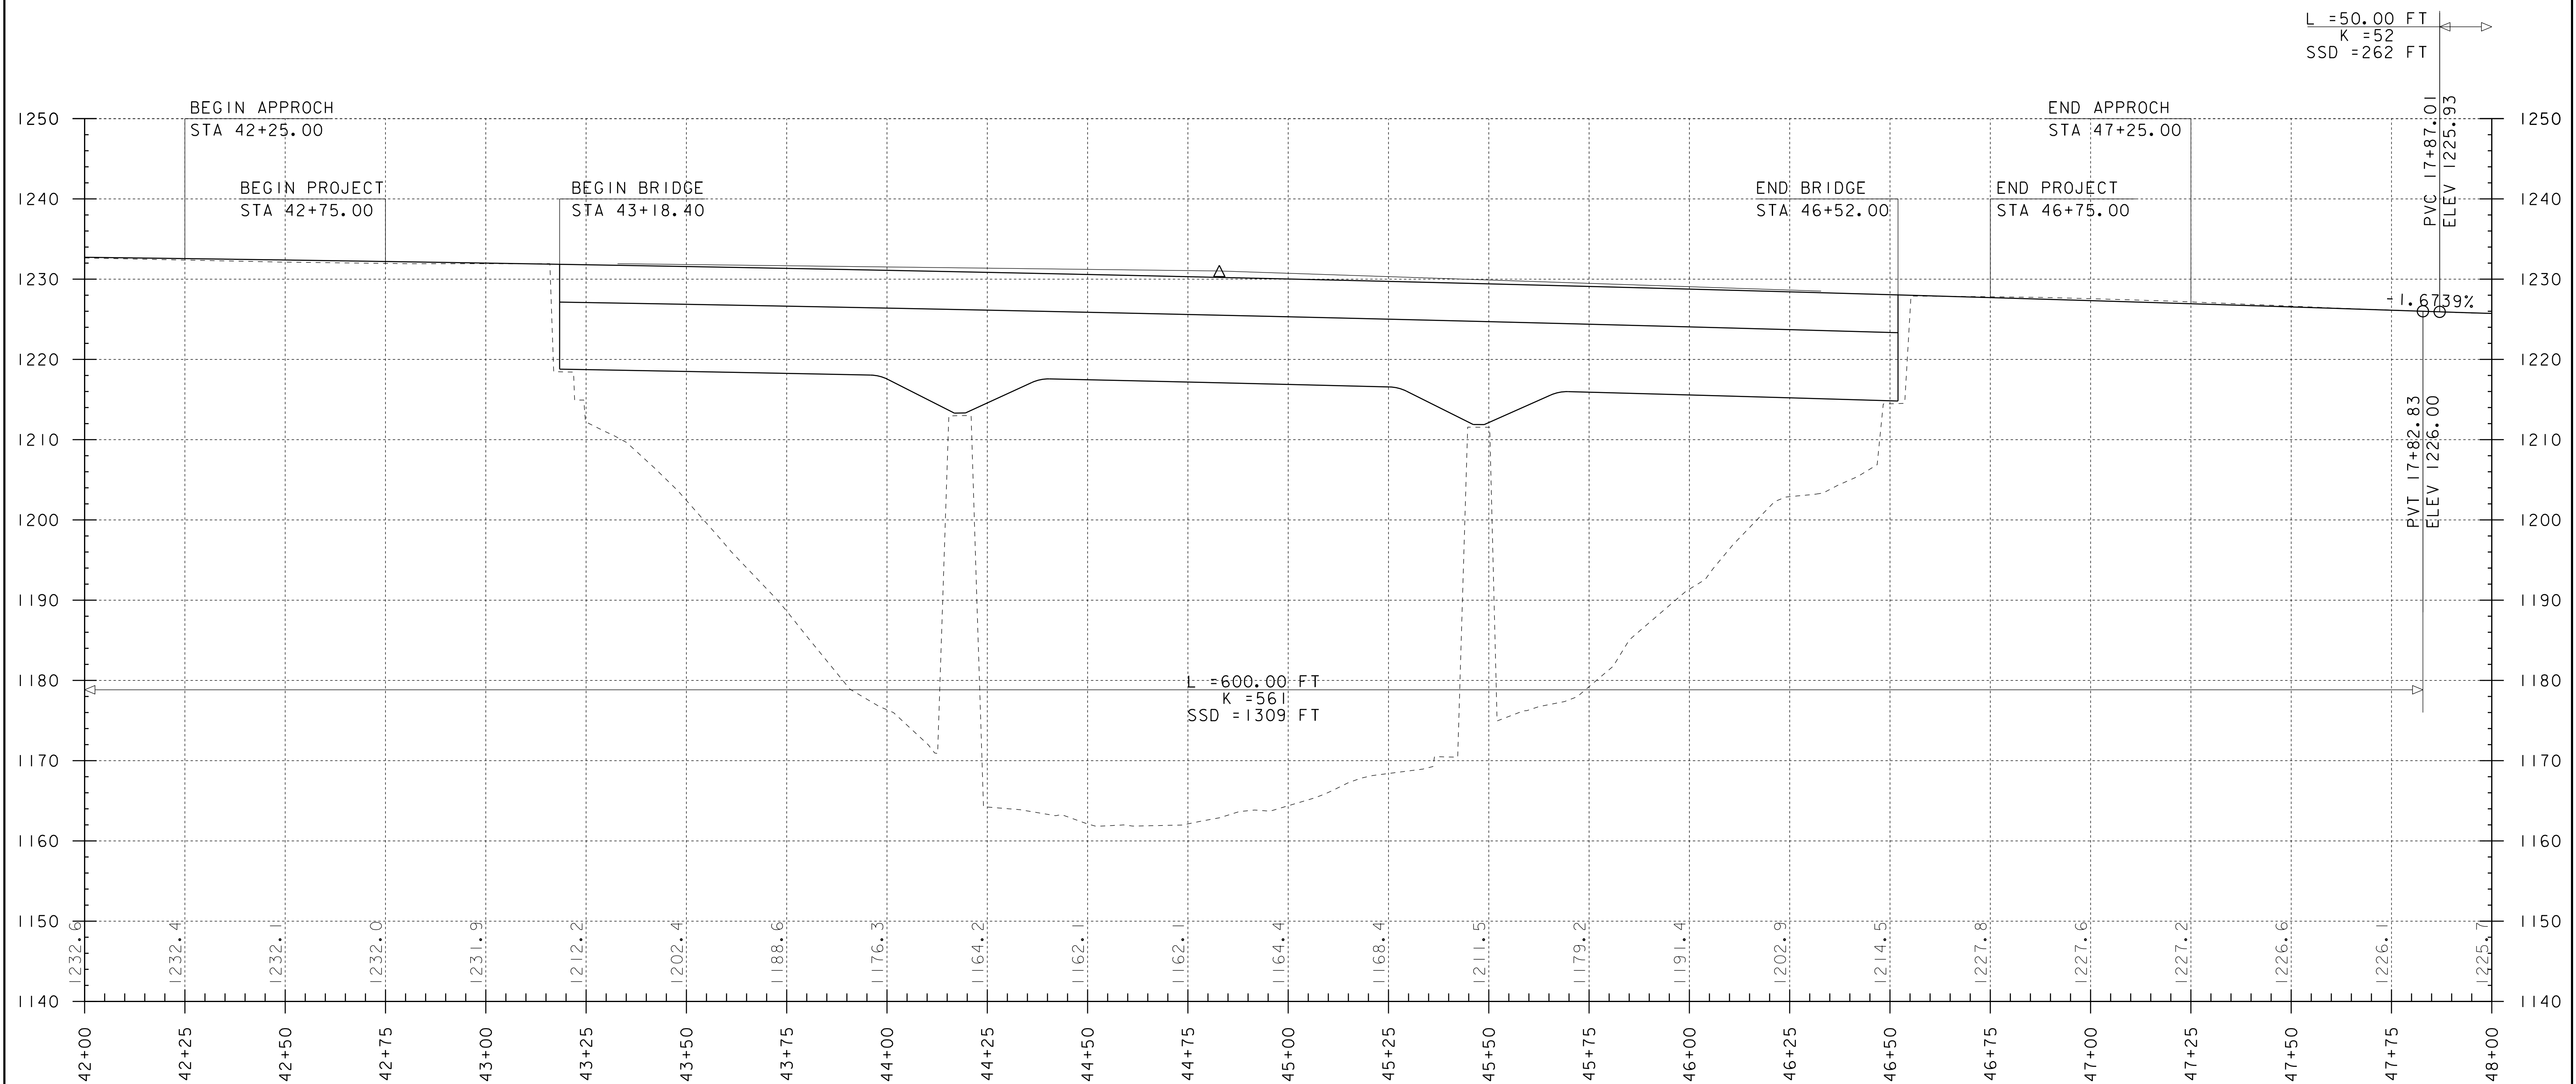
**DECK AND SUPERSTRUCTURE REPLACEMENT PROFILE**

GRADES SHOWN TO THE NEAREST HUNDREDTH ARE FINISH GRADE ALONG  $\phi$
