**STATE OF VERMONT  
AGENCY OF TRANSPORTATION**

**Scoping Report  
FOR  
Worcester BF 0241(57)**

**VT ROUTE 12, BRIDGE 89 OVER NORTH BROOK**

July 31, 2020

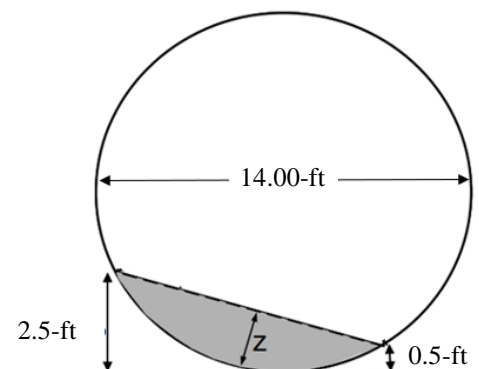
Option 1: Typical Section

Option 1: Rehabbed Existing Culvert (Slip Lined w/ Fish Baffles)

- This analysis assumed that the culvert is to be slip lined with a 14.0-ft CMP.
- Assumes that a rock weir will be required.
- The analysis assumed that fish baffles to be installed at 14.5-ft spacing with minimum and maximum height of 0.5-feet and 2.5-feet, respectively (as seen in Option 1).
- The installation of fish baffles would allow for adequate fish passage for Adult Brook Trout.
- The HW/D ratio would increase to 0.85 and 0.98 during the 2% and 1 % AEP, respectively. Headwater depths of 12.02-ft and 13.69-ft were determined during the design and check storm event, respectively.

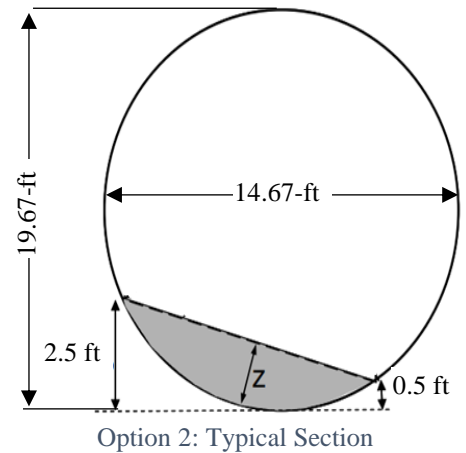
**Option 2: Rehabbed Existing Culvert (Spray Lined w/ Fish Baffles)**

- This analysis assumed that the culvert is to be lined with a 2.0-inch thick liner which would provide a 14.67-ft span by 19.67-ft rise.
- Assumes that a rock weir will be required.
- The analysis assumed that fish baffles to be installed at 7.5-ft spacing with minimum and maximum height of 0.5-feet and 2.5-feet, respectively (as seen in Option 2)
- The installation of fish baffles would allow for adequate fish passage for Adult Brook Trout
- The HW/D ratio would increase to 0.59 and 0.65 during the 2% and 1 % AEP, respectively. Headwater depths of 11.65-ft and 12.87-ft were determined during the design and check storm event, respectively.

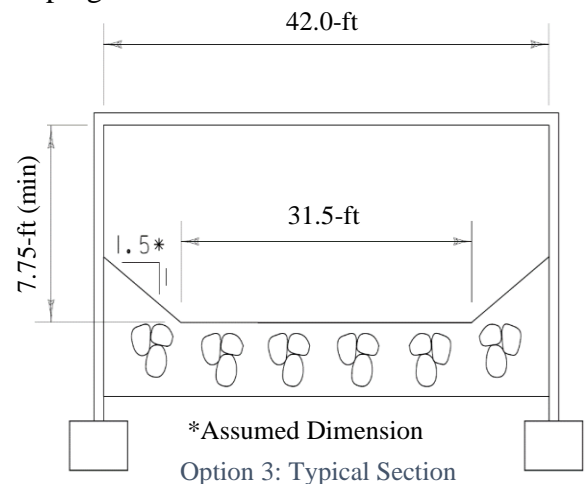
**Option 3: Bridge (3 sided), 42-foot span x 7.75-foot clear height w/sloping fill**

- There is approximately 1.4-feet of freeboard at the design AEP, providing a minimum waterway area of 275.6 sq. ft ±.
- E-Stone, Type IV will need to be used to grade the channel through this structure
- Stone Fill, Type IV shall be used to protect any disturbed channel banks or roadway slopes at the structure's inlet and outlet
- Does not increase the 100-year base flood elevations
- Assumes no changes to the existing structure alignment/skew

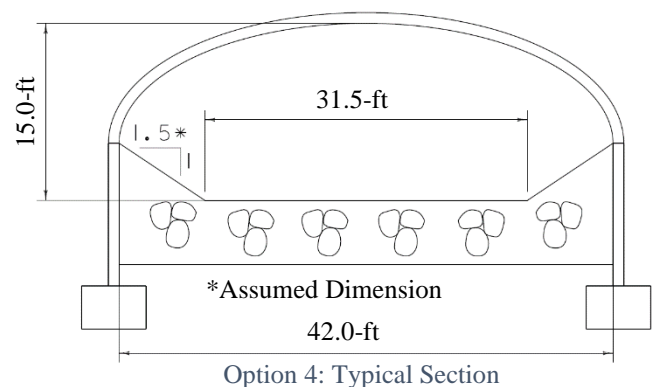
**Option 4: Arch Bridge, 42-foot span x 15.0-foot clear height w/sloping fill**

- There is approximately 8.6-feet of freeboard at the design AEP, providing a minimum waterway area of 450.6 sq. ft ±.
- E-Stone, Type IV will need to be used to grade the channel through this structure
- Stone Fill, Type IV shall be used to protect any disturbed channel banks or roadway slopes at the structure's inlet and outlet
- Does not increase the 100-year base flood elevations
- Assumes no changes to the existing structure alignment/skew

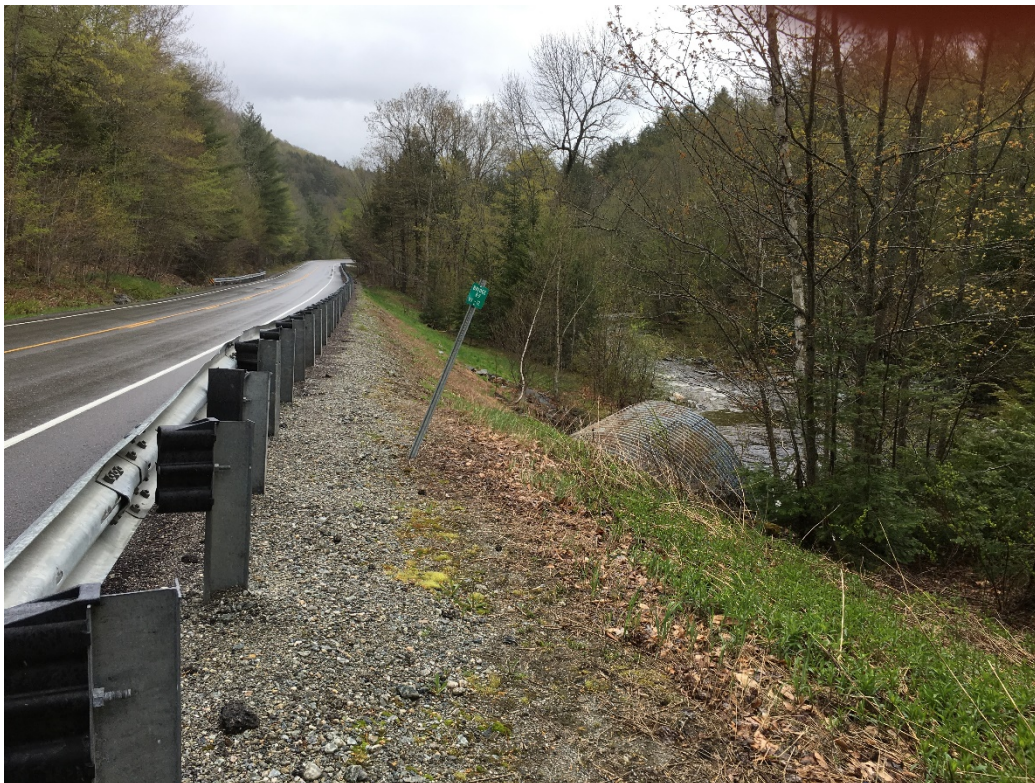
**Figure 3.3:** *Space to perform borings outside of the roadway. [Structures photo dated April 2019]*

No overhead utilities are present at the site. Based on photos from the site there appears to be exposed bedrock at both the inlet and the outlet of the culvert as shown in Figures 3.1 and 3.2, respectively. It looks as if there is access near the inlet and outlet for a drill rig in order to perform borings outside of the roadway, as shown in Figure 3.3.

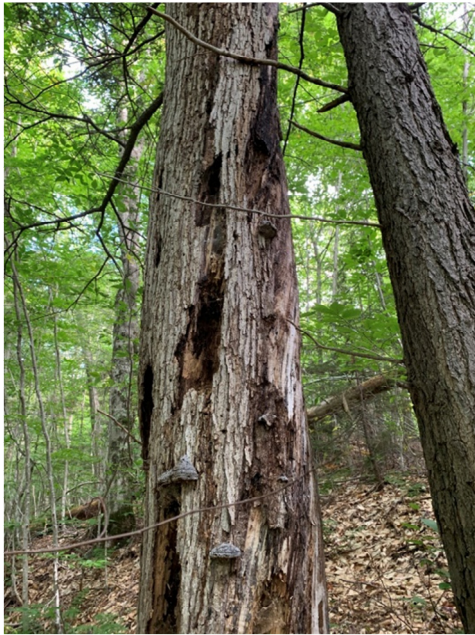
Potential Bat Roost Tree  
September 10, 2019

The USFWS IPaC mapping indicates that the project area is within the Northern Long Eared Bat's (NLEB's) habitat range. The NLEB is a federally listed threatened species. Suitable habitats for NLEB's per guidance from USFWS are: trees  $\geq 3$  inches in diameter that have holes, crevices, cracks or peeling bark. Several trees that fit this description have been identified in the immediate vicinity of the project. As the project moves forward, additional investigation is warranted to avoid impacts to potential roosting habitat.

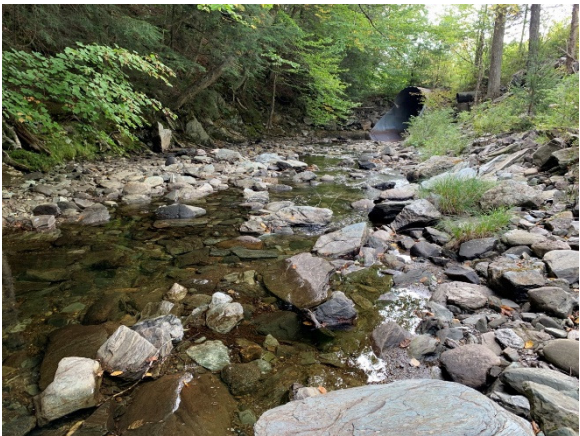
<p>Upstream looking at culvert inlet</p>
Photo Date: 9/16/19	Photo Date: 9/16/19

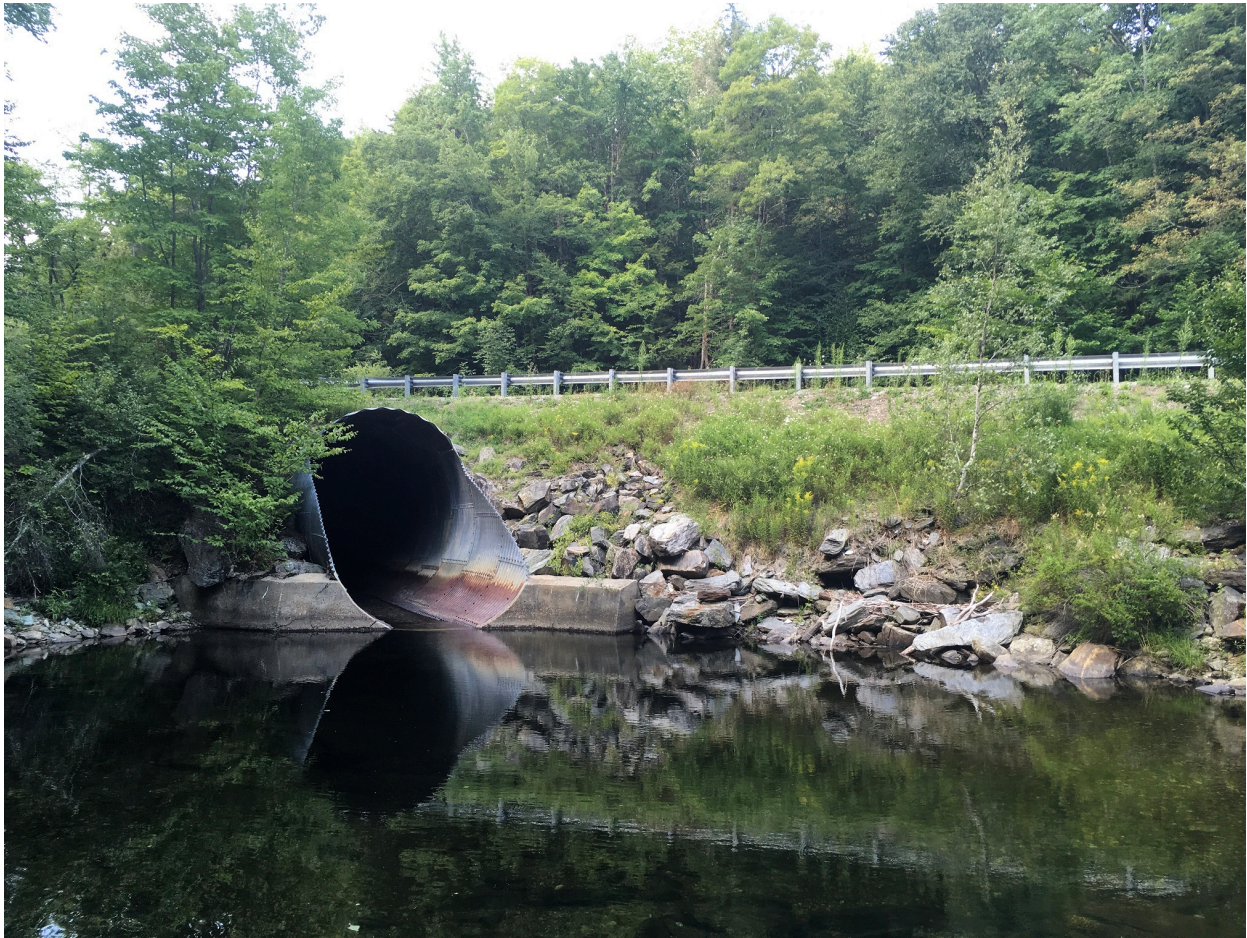
**Photo of culvert from west side of the road**

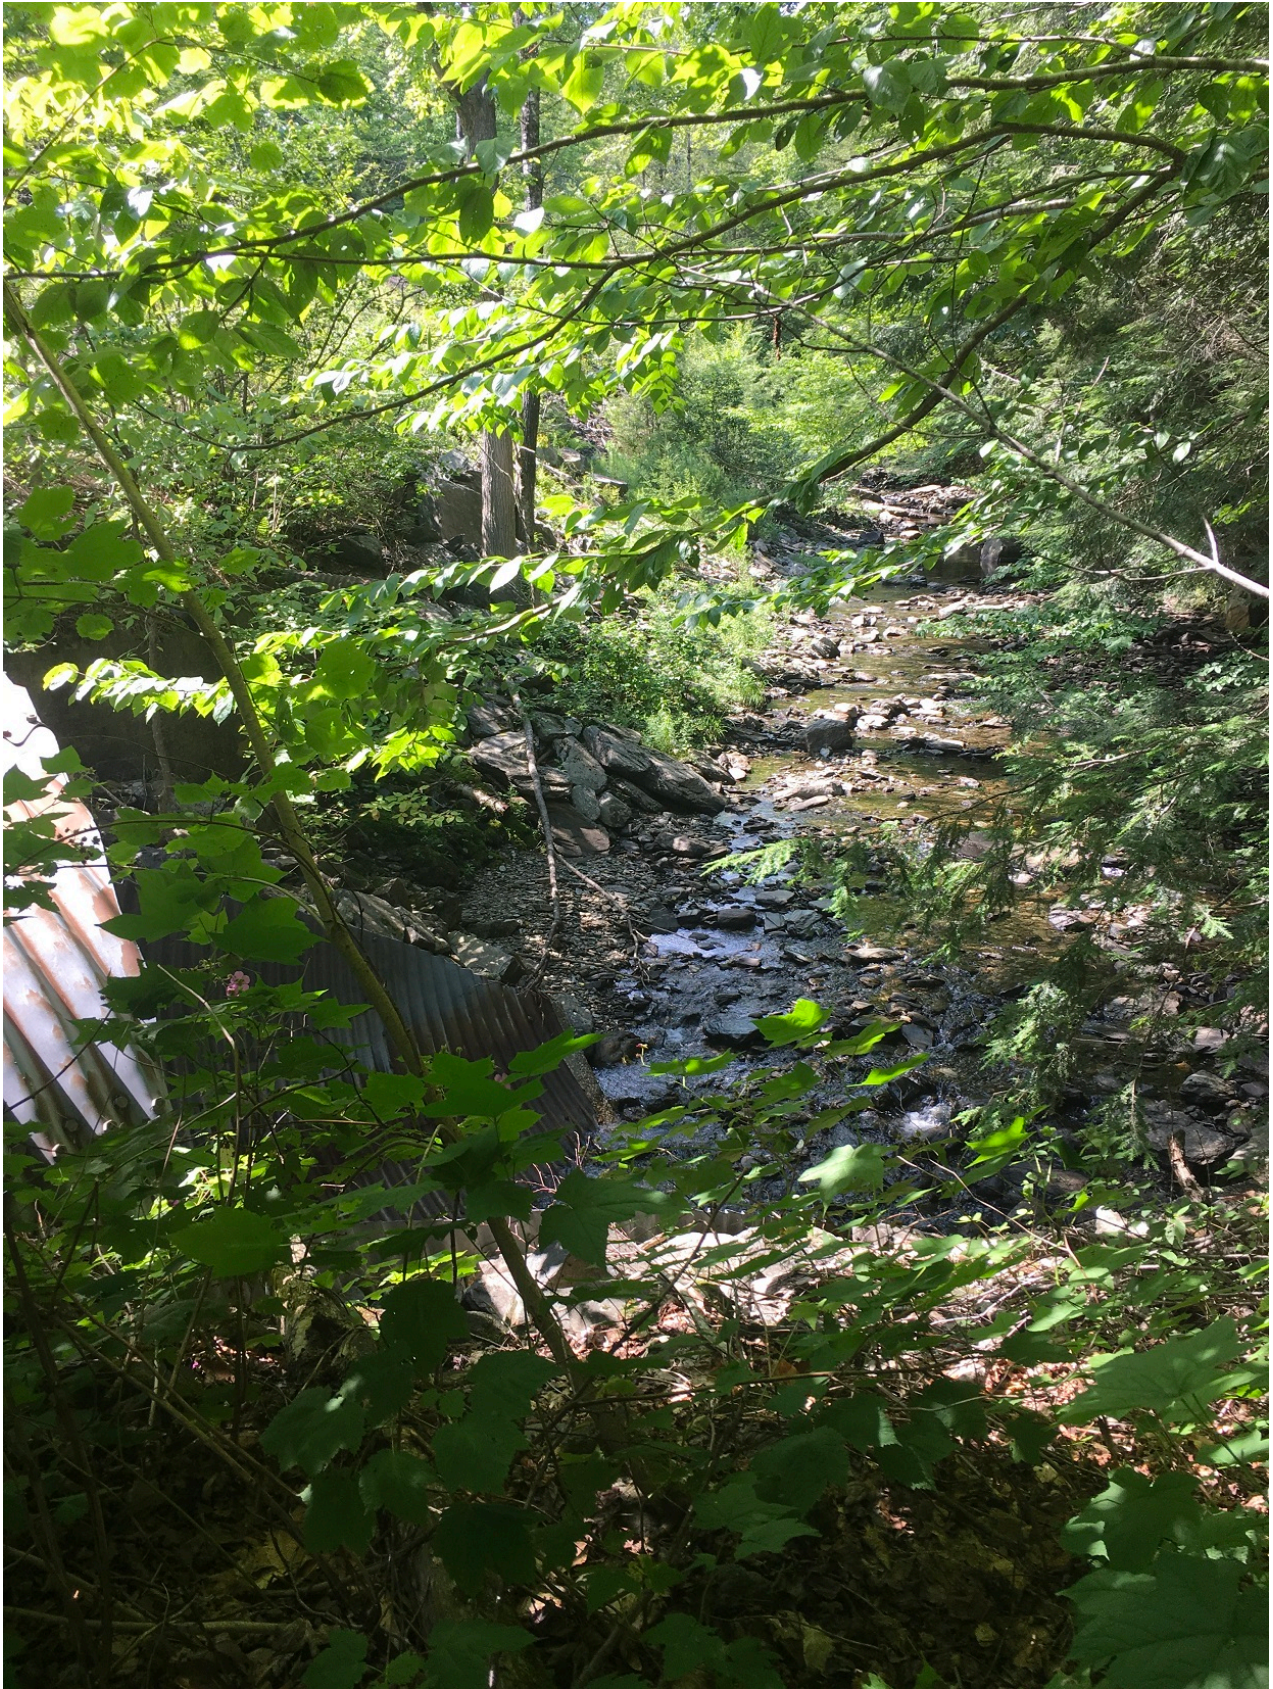
**Eastern inlet of culvert**

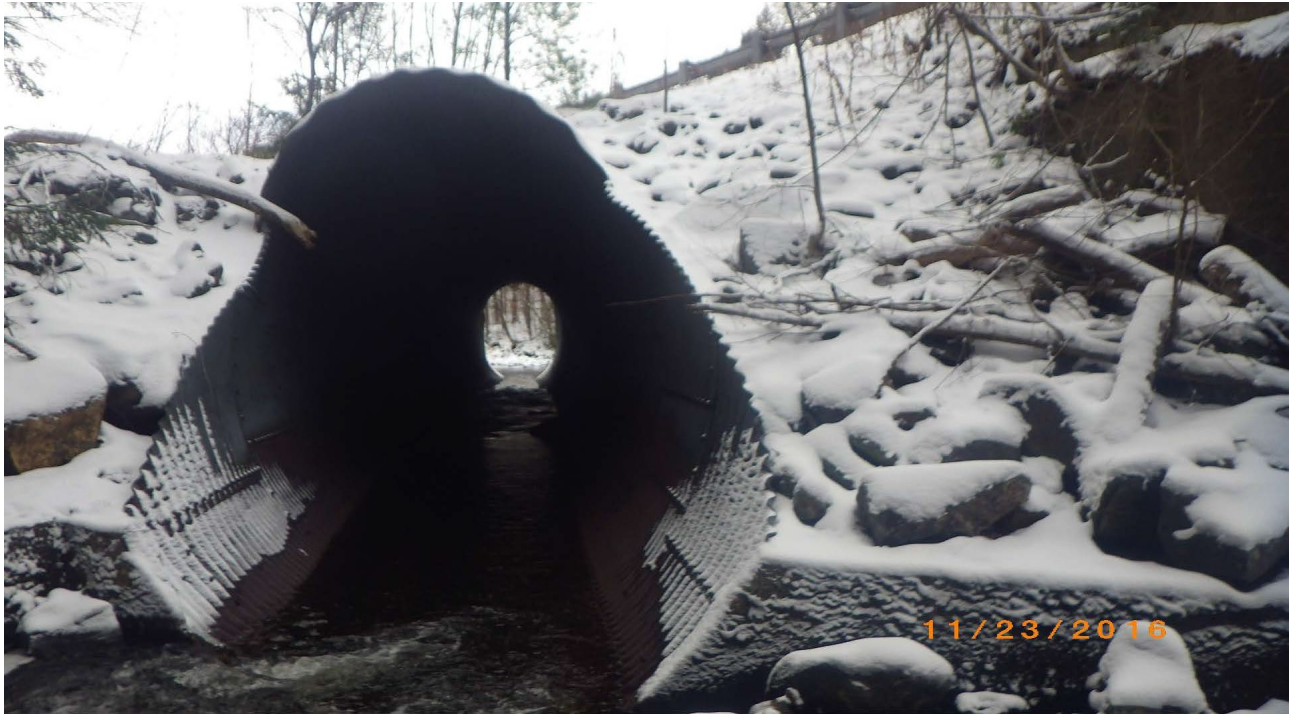
Culvert 89 is a metal culvert over the North Brook on VT 12 in Worcester (Figure 2), adjacent to the 4(f) resource, the CC Putnam State Forest. Built in 1964, this culvert meets the 50-year criteria for eligibility for the National Register. However, because of the condition of the culvert and the fact that it displays common materials, design, and construction, VTrans has determined that it is not historic as it does not possess any qualities of significance necessary for inclusion in the National Register of Historic

Figure 2: Culvert 89 in Worcester on VT-12.
