Town: 206 - SPRINGFIELD

District 2, 27 - WINDSOR County

IDENTIFICATION	
(1) State Names	50 - Vermont
(8) Structure Number	200091025N14182
(5) Inventory Route	1
(2) Highway Agency District	2 - District 2
(3) County Code	27 - WINDSOR

Team Lead: Stephen Piro, Inspection Date: 05/24/2022

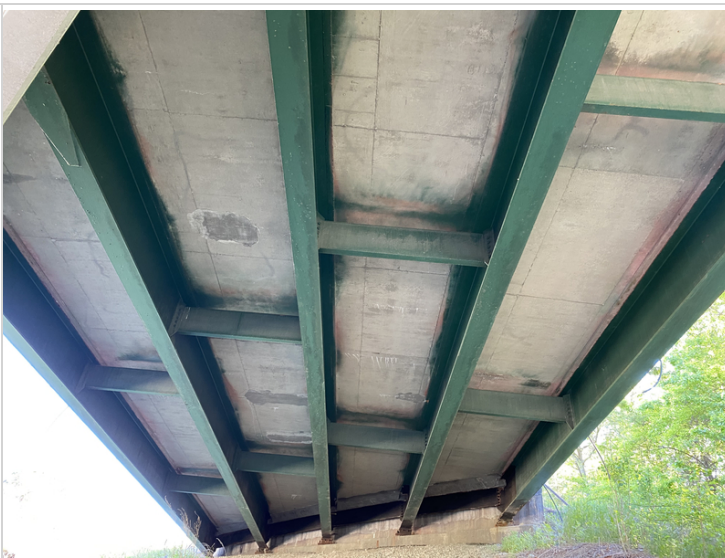
Span #3 Deck

Reinforced concrete deck is in okay condition having multiple areas of concrete patches scattered throughout the bays and spans. Other various light transverse cracking with light efflorescence leakage is present throughout the deck.

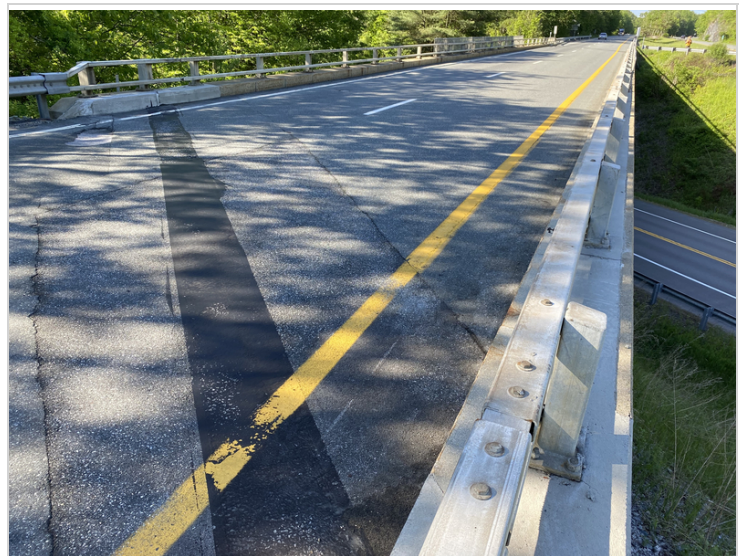
Deck Wearing Surface from Abutment #2

Asphalt is in satisfactory condition with some light wearing on deck in the travel lanes. Small pothole has formed near the southern end of span #2 in the main travel lane with other various cracking and depressions forming in nearby area in both travel lanes.
