Town: 206 - SPRINGFIELD

District 2, 27 - WINDSOR County

IDENTIFICATION	
(1) State Names	50 - Vermont
(8) Structure Number	200091026N14182
(5) Inventory Route	1
(2) Highway Agency District	2 - District 2
(3) County Code	27 - WINDSOR

(4) Place Code	69550
(6) Features Intersected	BLACK RIVER
(7) Facility Carried	I 00091 ML
(9) Location	0.4 MI S EXIT 7
(11) Mile Point	41.251 mi
(12) Base Highway Network	Yes

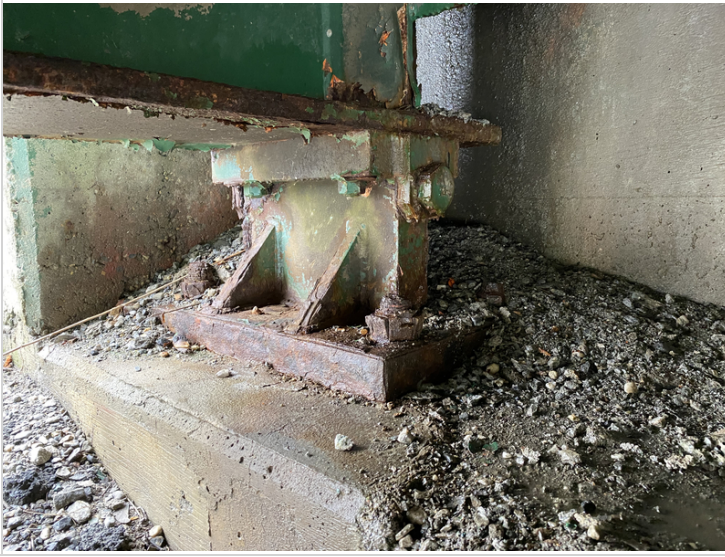
Bearing #5 at Abutment #1 with Heavy Debris Build Up

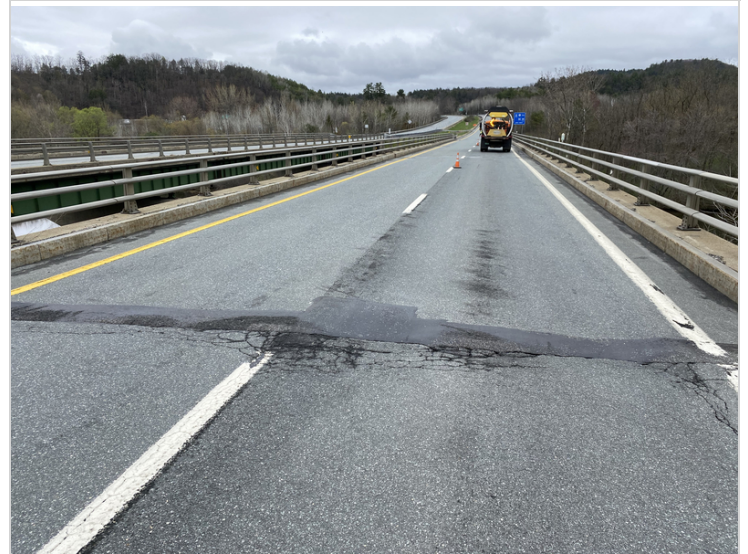
Deck Wearing Surface from Abutment #1

Asphalt is in fair condition having minor wearing in wheel paths and some heavier deterioration scattered throughout. Areas surrounding joints have moderate to heavy map cracking with pot holes starting to form and multiple asphalt patches.

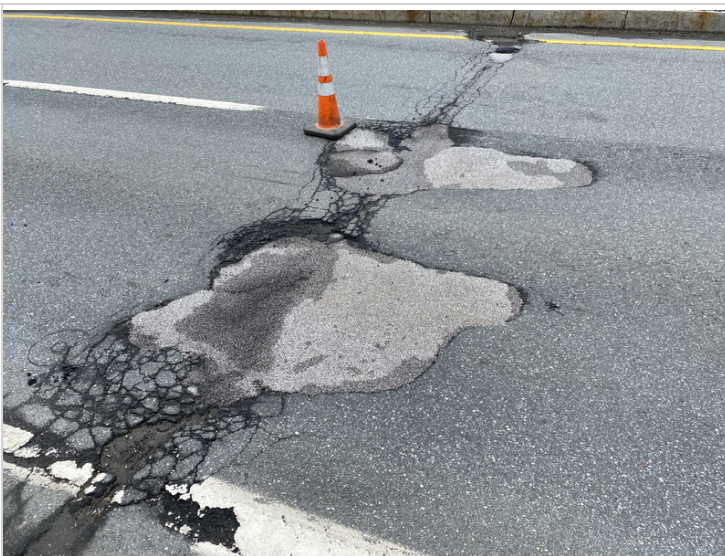
Heavy Break Up / Patches over Pin Section #2 in Span #2

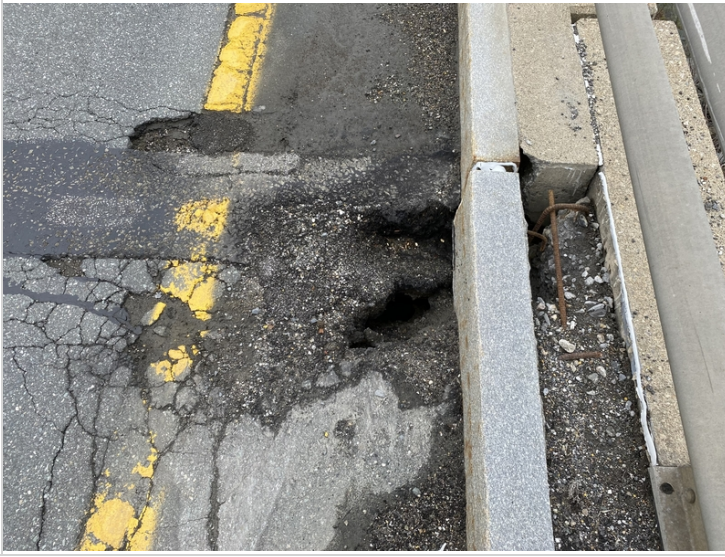
Full Depth Hole over West Shoulder at Abutment #2

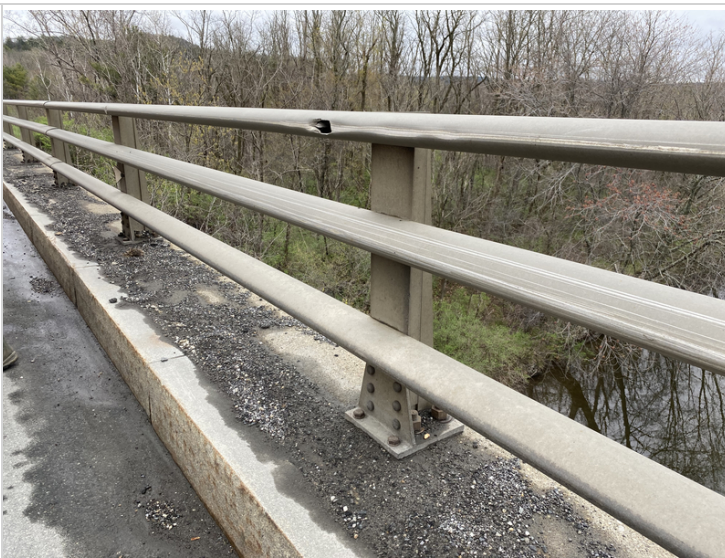
Three (3) tier aluminum tear drop rail is in satisfactory condition having some minor scrapes and gouges along the face of rail. A few areas have large scrapes which make tears in face of rail. Newer transition rail has been installed at the four (4) corners of the structure.

Typical Bridge Rail Scrapes

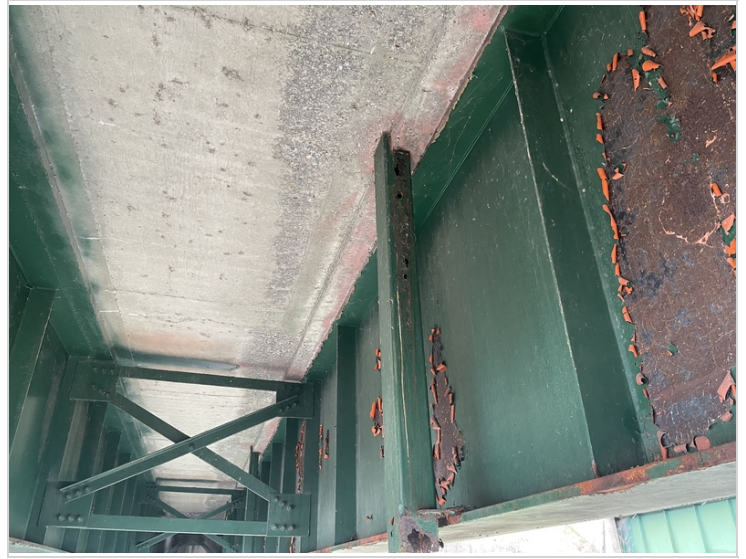
Span #2 Bay #1 Deck Drain Downspout

Weep tubes are present along both fascia's and are in satisfactory condition hanging out away from superstructure. Additional fifteen (15) steel spout box drains are present along both fascia's that are paved over along deck. Drains have section loss scattered throughout with perforations forming along the downspouts.

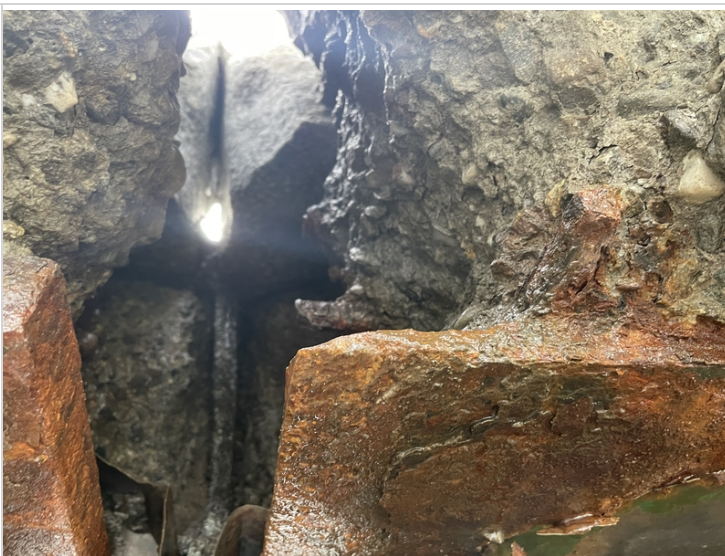
Pin Assembly Girder #1 In Span #2 Second Section Hole Through Curb

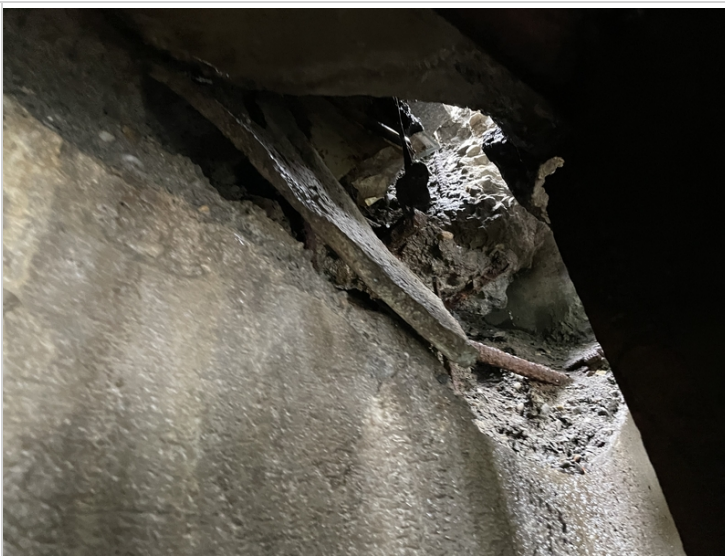
Hole Through Abutment #2 Backwall East Side

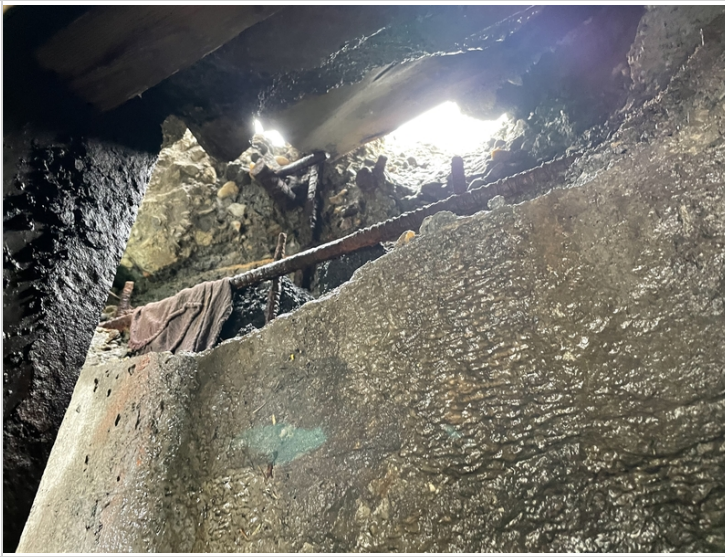
Hole Through Abutment #2 Backwall West Side

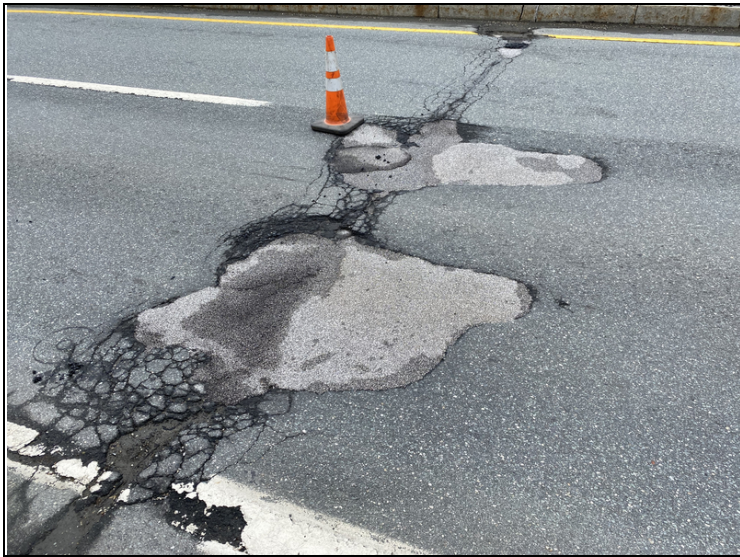
Heavy Break Up / Patches over Pin Section #2 in

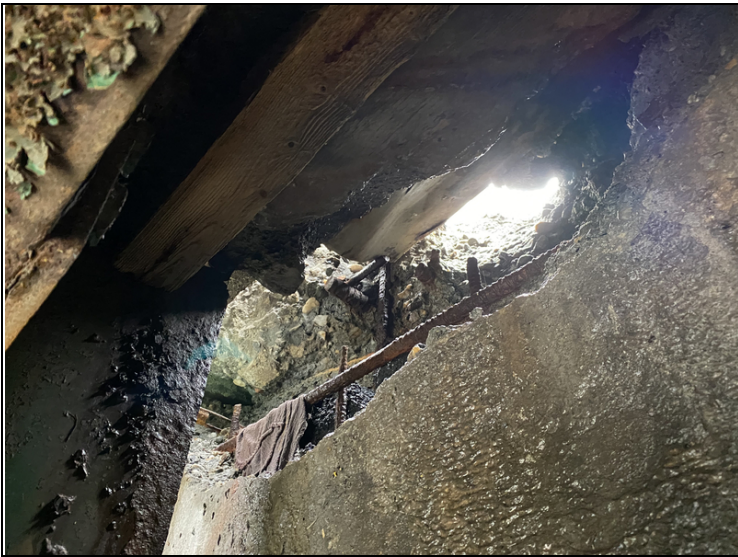
Full Depth Hole West Side of Abutment #2 ion

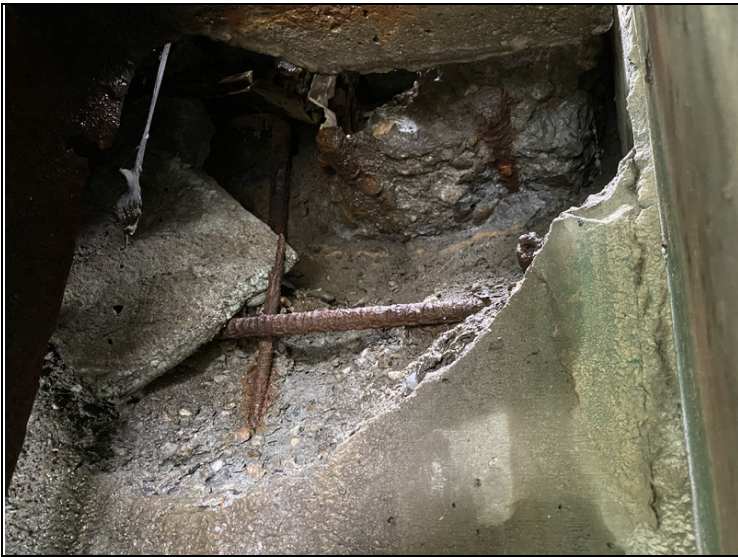
Spalling along Abutment #2 East Backwall
