Town: 206 - SPRINGFIELD

IDENTIFICATION	
(1) State Names	50 - Vermont
(8) Structure Number	200091028N14182
(5) Inventory Route	1
(2) Highway Agency District	2 - District 2
(3) County Code	27 - WINDSOR

(4) Place Code	69550
(6) Features Intersected	I 91 OVER US 5
(7) Facility Carried	I 00091 ML
(9) Location	I 91 EXIT 7
(11) Mile Point	41.681 mi
(12) Base Highway Network	Yes

Team Lead: Martin Kelley, Inspection Date: 05/25/2022

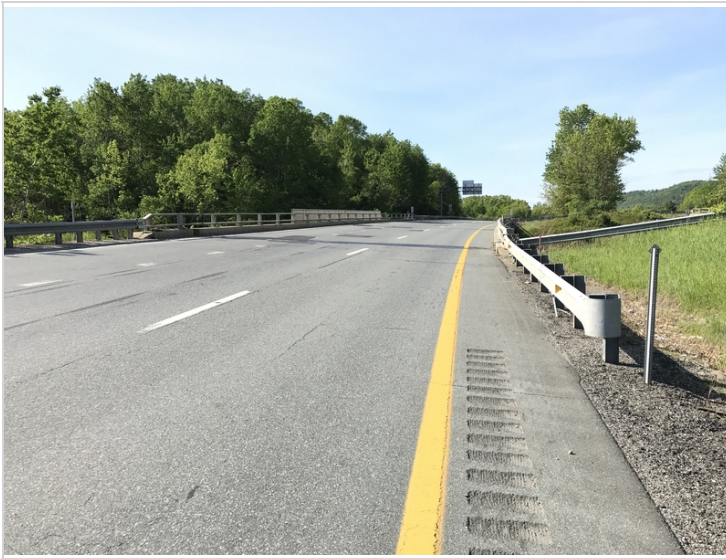
Northern Approach

Galvanized steel beam rail is in satisfactory condition having areas of flattened out rail with minor scrapes and dents. Older sections of rail have freckling surface rust and rusting along scrapes.

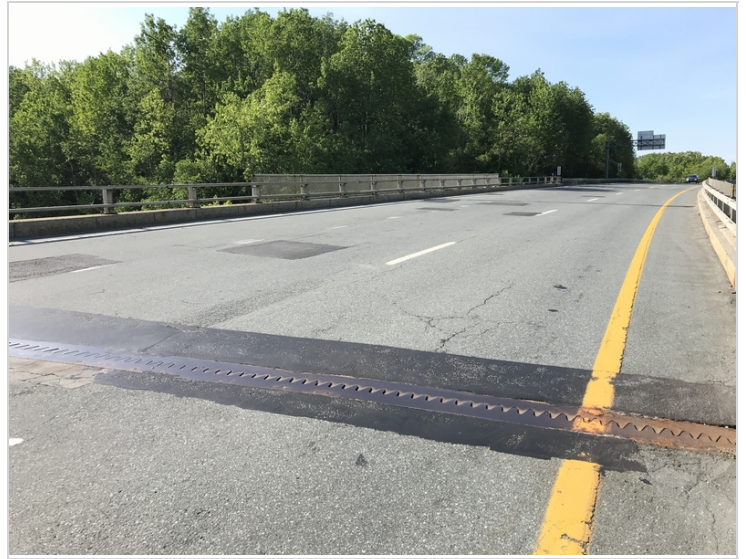
Wearing Surface from North End

Asphalt is in fair to poor condition with minor wearing in travel lanes and scattered cracking and small depressions along the top surface. Patches are present around joints with deterioration continuing to progress. Recent repairs have been completed with large cut out areas and new asphalt put in place which is holding up at this time.

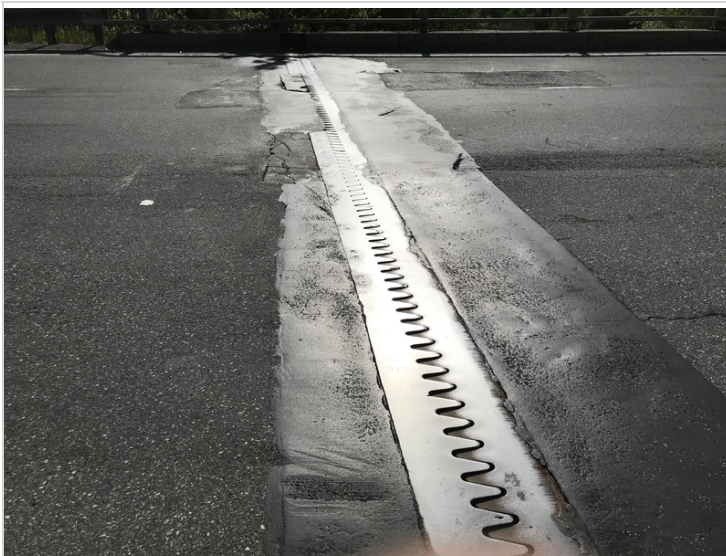
Asphaltic Plug Joint over Abutment #2

Steel finger plate joints are present over both abutments with steel plates having minor to moderate pitting and rusting along the curb lines and gouges and scrapes in travel lanes. Small section of steel plate is missing over abutment #2 near center line. Steel housing below has heavy rusting. Asphaltic plug joint is present over pier #2 having minor wear and a small patch on the eastern side.

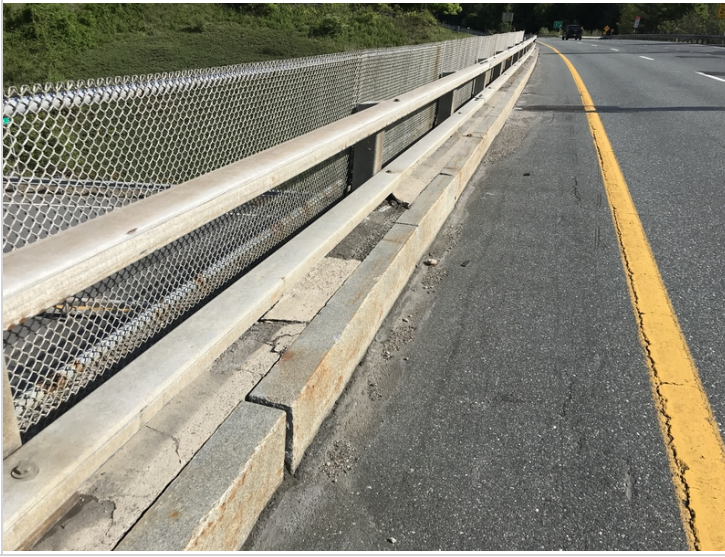
Western Curb

Concrete curbing with granite block facing is in fair to poor condition having areas of heavy concrete scaling and cracking behind granite blocks. A few of the granite blocks have slight translation away from concrete curbing. Heavy spalling exposing steel reinforcing is present in span #2 on the eastern fascia and surrounding joint areas. Remaining areas have lighter spalling / scaling scattered throughout.

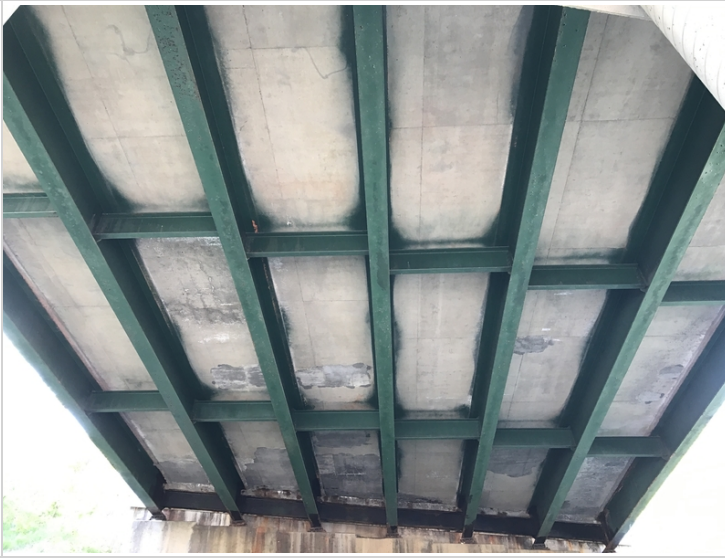
Span #1 Deck

Reinforced concrete deck is in fair condition having scattered large delaminations and transverse cracking with rust staining and efflorescence leakage present along the underside of deck. Large areas of patched areas are scattered throughout the deck underside are starting to become unsound with areas respalling. Large area of spalling is present in span #2 bay #3 that has exposed the first and second layer of steel reinforcing that has started to progress into concrete above reinforcing. Span #3 bay #5 has large patched area that is unsound with exposed steel reinforcing and is respalling.

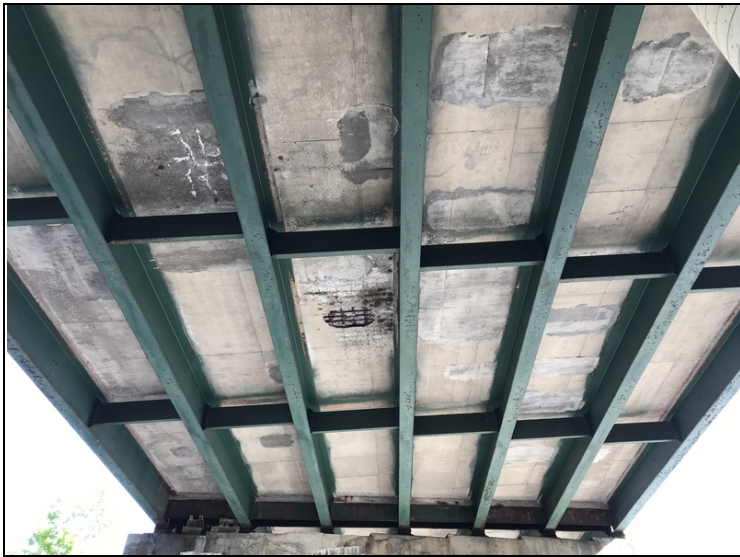
Span #2 Deck Facing North

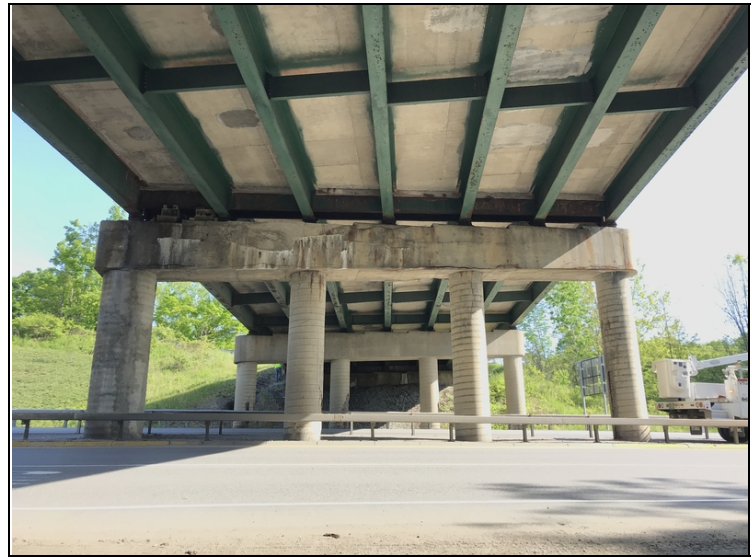
Pier #1 and #3 are in fairly good condition. Pier #2 has heavy concrete scaling / spalling exposing steel reinforcing with heaviest deterioration present along the western side of cap. Pier #2 cap has delaminations and cracking with rust stains and efflorescence scattered throughout. Laid up timber bunking is present along the western side to stabilize superstructure having

Pier #2 Span #2 and Timber Blocking

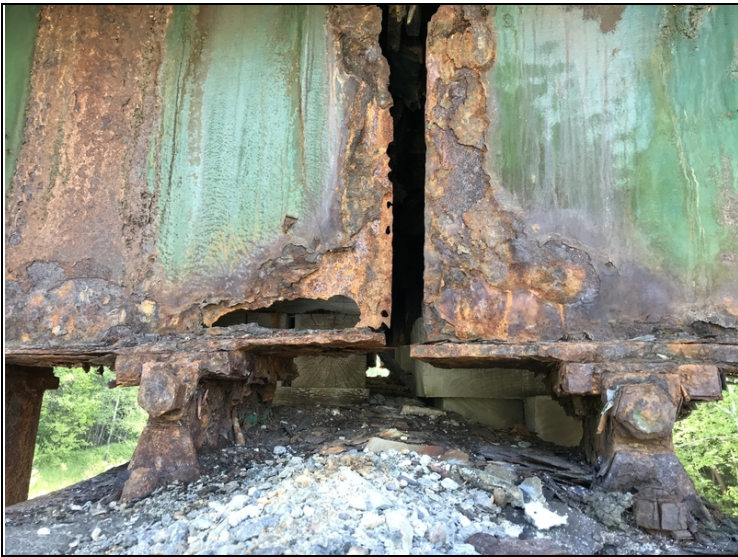
Pier #2 Beams #1 in Spans #2 and #3
