STATE OF VERMONT
AGENCY OF TRANSPORTATION

Scoping Report

FOR
WORCESTER BF 0241(56)

VT ROUTE 12, BRIDGE 87 OVER HARDWOOD BROOK

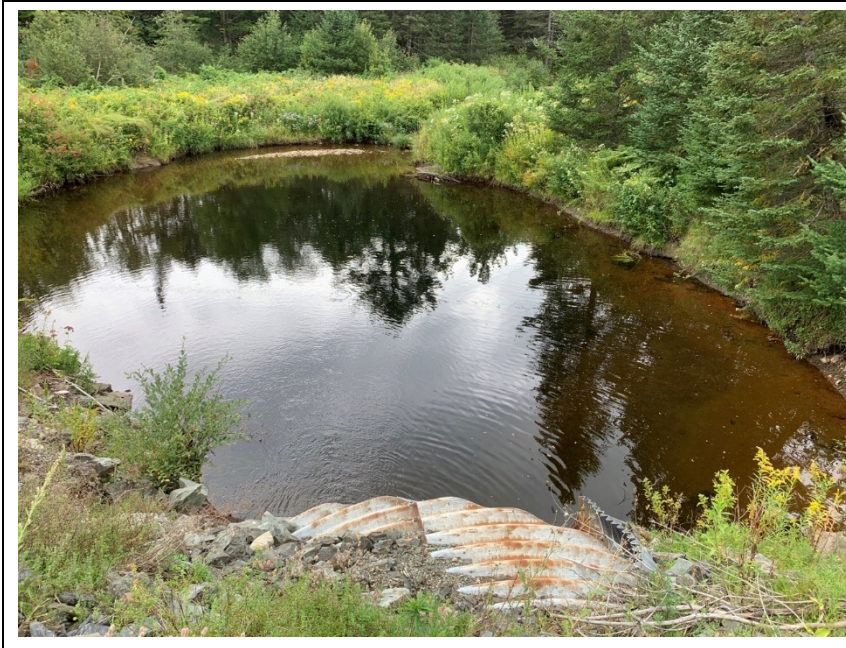
Culvert 87:Downstream pool
September 10, 2019
