**STATE OF VERMONT
AGENCY OF TRANSPORTATION**

Scoping Report

Worcester BF 0241(59)

VT Route 12, BRIDGE 84 Over the North Branch of Winooski River

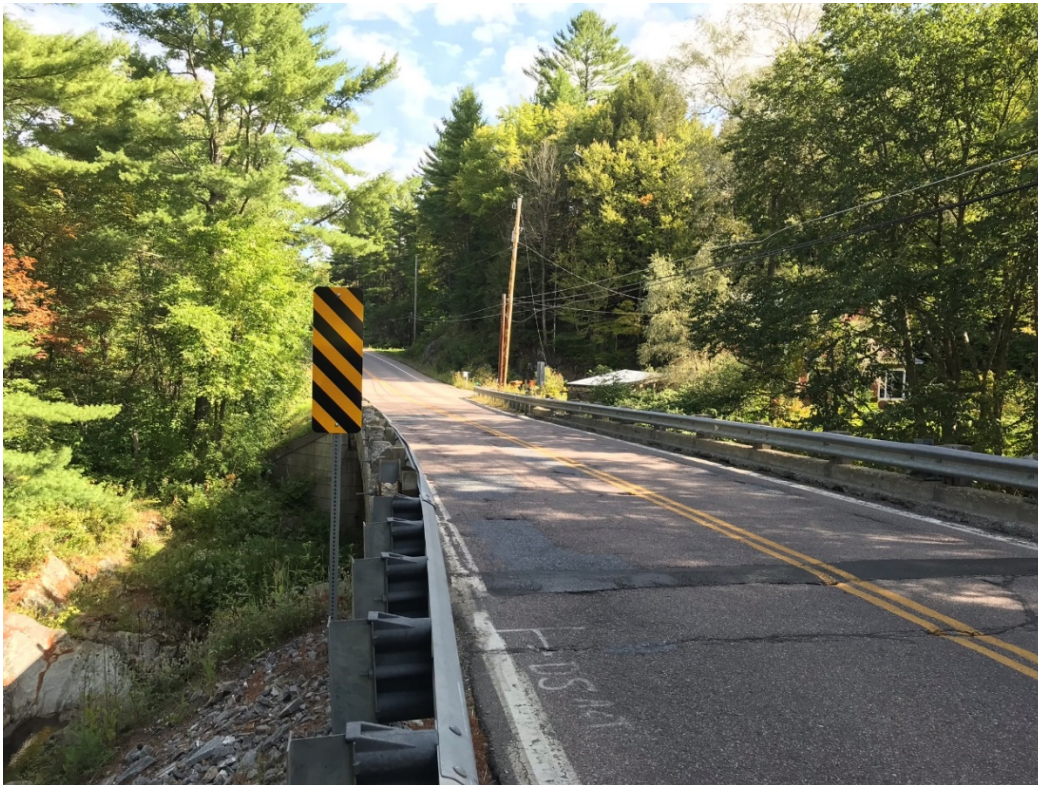
Figure 3.1: Facing north along VT Route 12; note overhead utilities to east of roadway.

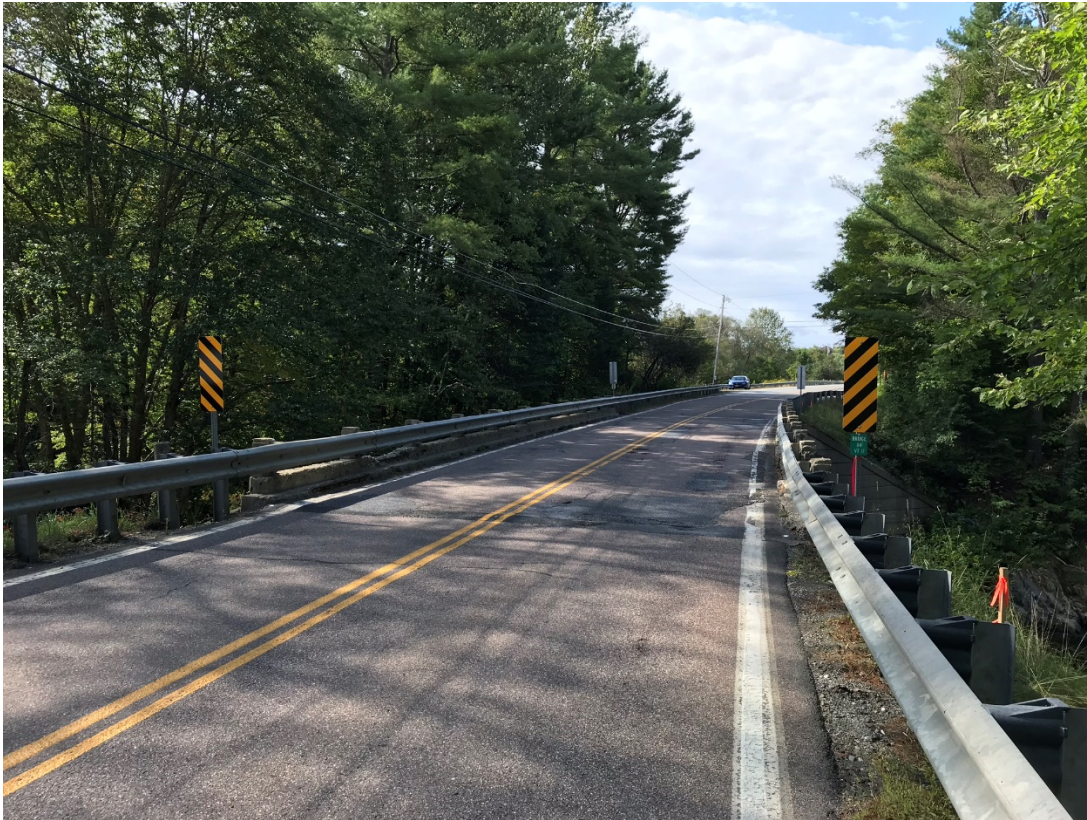
Figure 3.2: Facing south along VT Route 12; note overhead utilities to east of roadway.

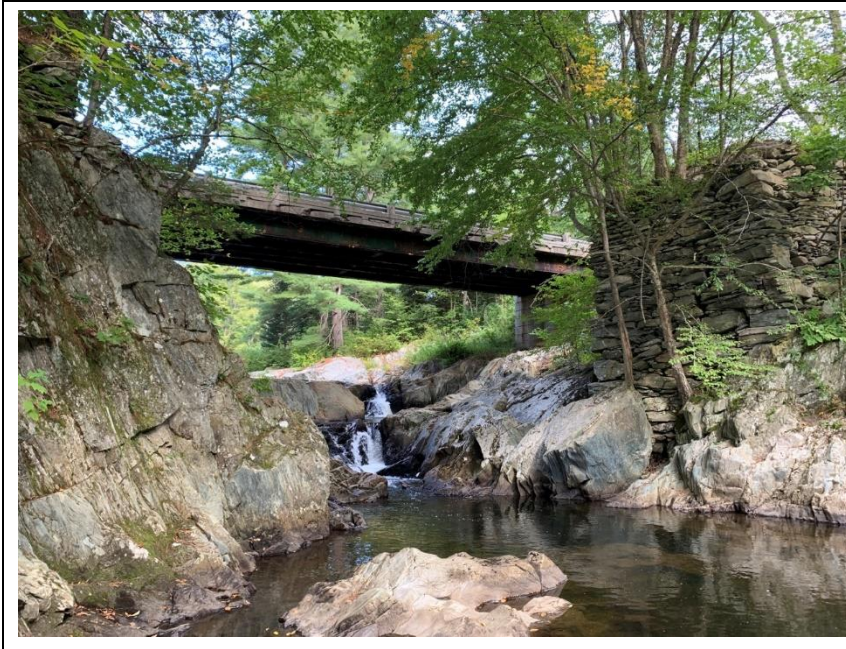
Downstream of structure looking upstream
September 10, 2019

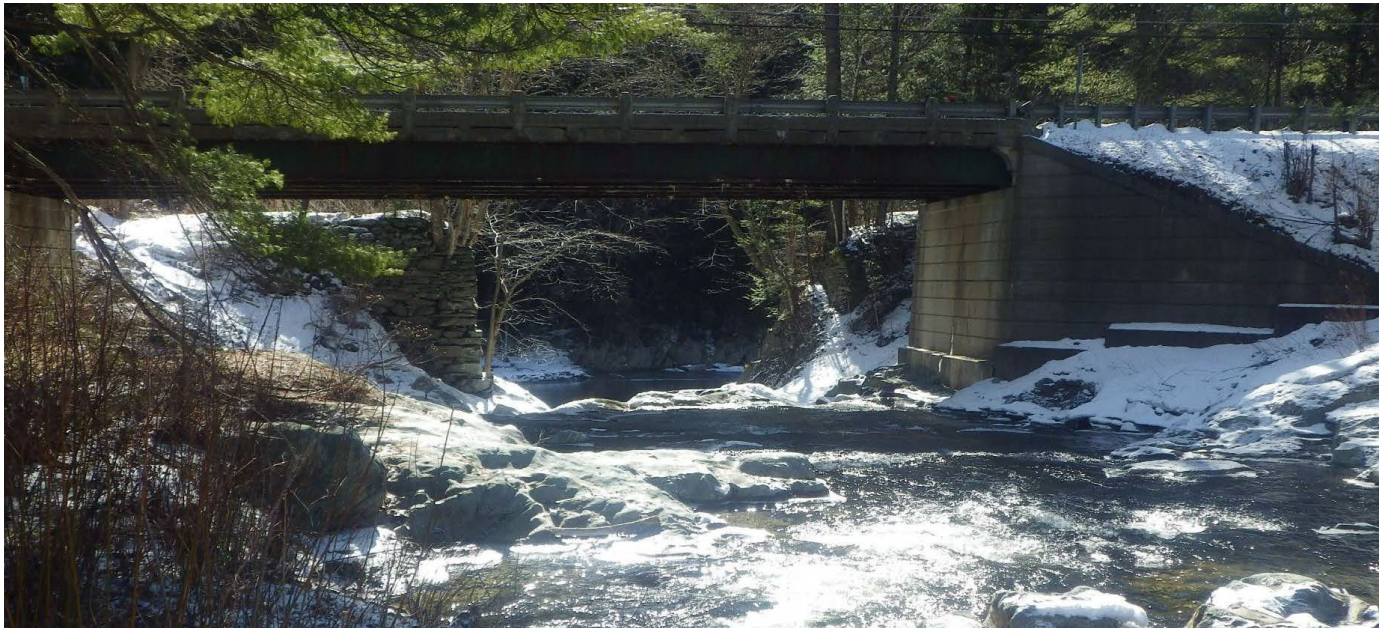
Bridge number 84 is a single span rolled steel beam bridge over the North Branch of the Winooski River on VT 12 (Figures 2 and 3). Built in 1936, this structure is approximately 84 feet long and features a concrete deck and abutments. This bridge allows for passage over a steep and rocky ravine, as well as a marshland.

Figure 2: Bridge number 84 in Worcester.

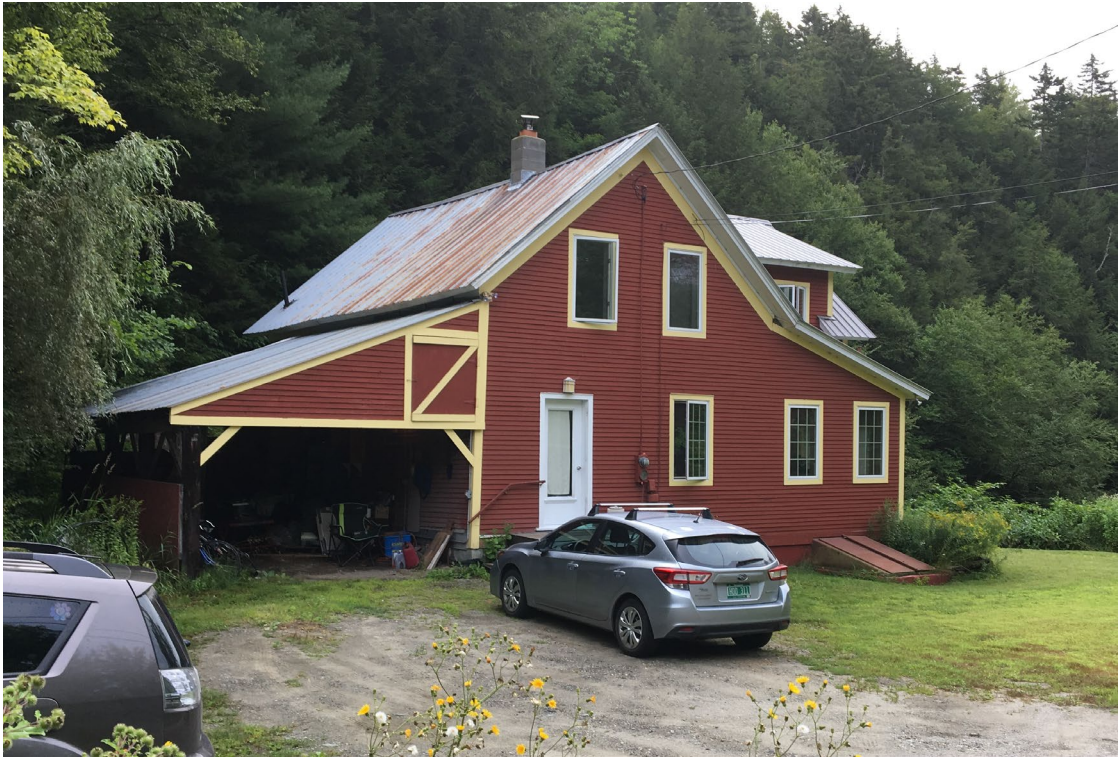
A third property was identified at 597 VT-12 in Worcester (Figure 5). This 1 ½ story gable roofed structure meets the 50-year age criteria for the National Register. However, changes to the building over time have sufficiently altered the character defining features of the property that this building no longer retains enough integrity to be eligible for the National Register.

Figure 5: Historic resource at 597 VT-12 that is no longer eligible for the National Register. Door and windows have been replaced and the shed roof additions on either side obscure the original building configuration.

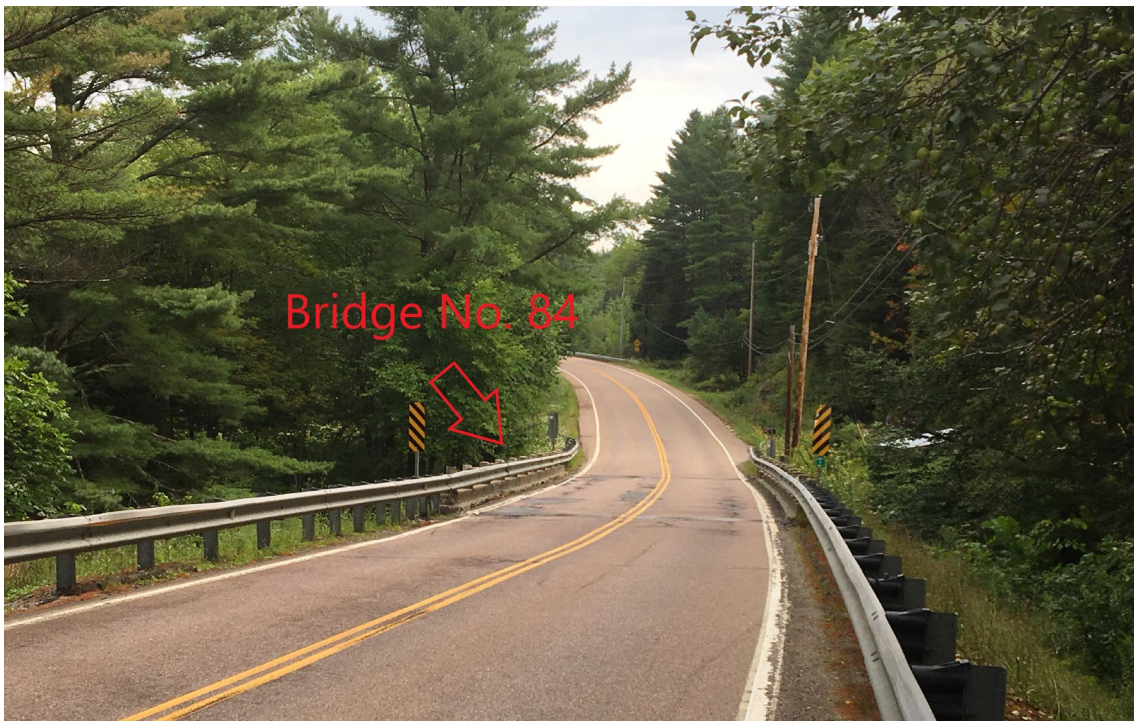
Figure 8: Looking north on VT-12 towards bridge number 84 in Worcester.
