**STATE OF VERMONT  
AGENCY OF TRANSPORTATION**

**Scoping Report**

**FOR  
WATERBURY IM CULV(109)**

**I-89 & US2 PID 68002 OVER SHARKEYVILLE BROOK**

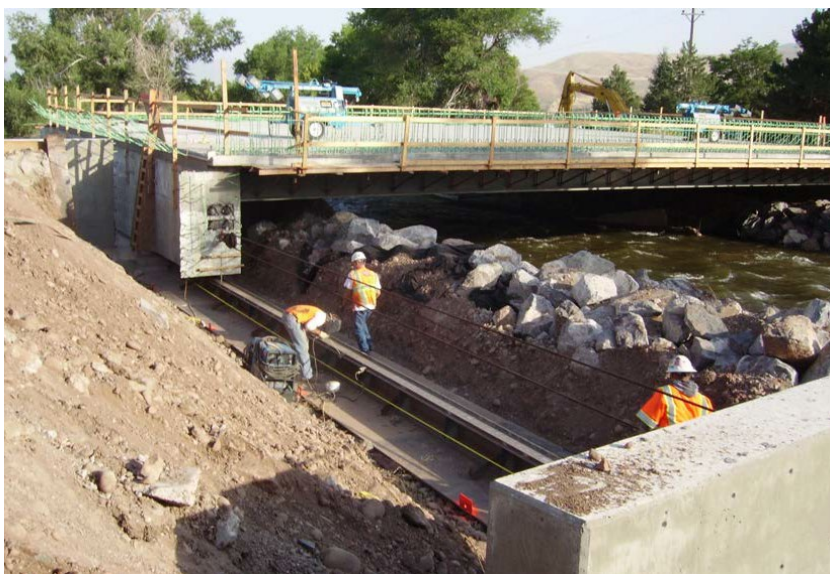
A lateral slide consists of constructing an entire superstructure adjacent to the location where it is intended and physically pushing or pulling the structure into its design location along lubricated rails. This allows traffic to be maintained on the existing structure while construction of the bridges takes place. Traffic would then be detoured for approximately 3 days while the existing bridge is removed and the new bridge is moved into place.

[Images from “Accelerated Bridge Construction - Experience in Design, Fabrication and Erection of Prefabricated Bridge Elements and Systems” from FHWA (2011).]

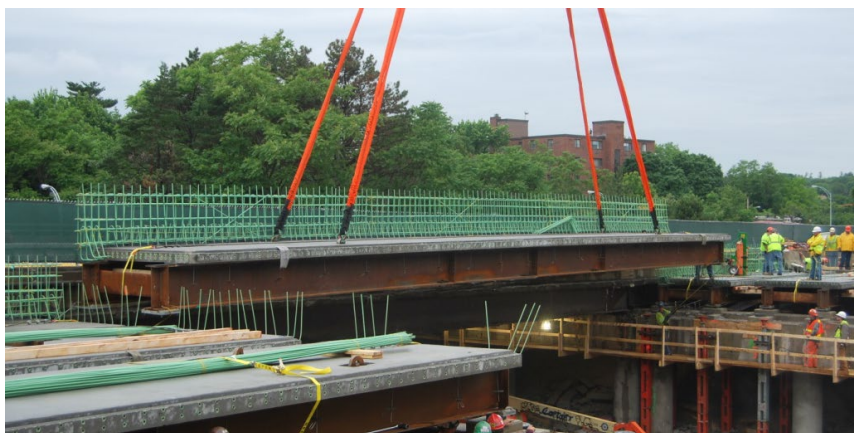
Another method of constructing the bridge in a safer and less restricted environment is to prefabricate portions of the bridge structure and deliver those pieces to the construction site to be joined together to form the bridge. These bridge superstructure pieces are referred to as Prefabricated Bridge Units, or PBUs. Many substructure pieces can be prefabricated as well and lifted into place before the PBUs are placed.

Using rapid setting concrete for the joint closure pours, the closure period can be reduced to 3 days per bridge for this method of superstructure replacement as well.

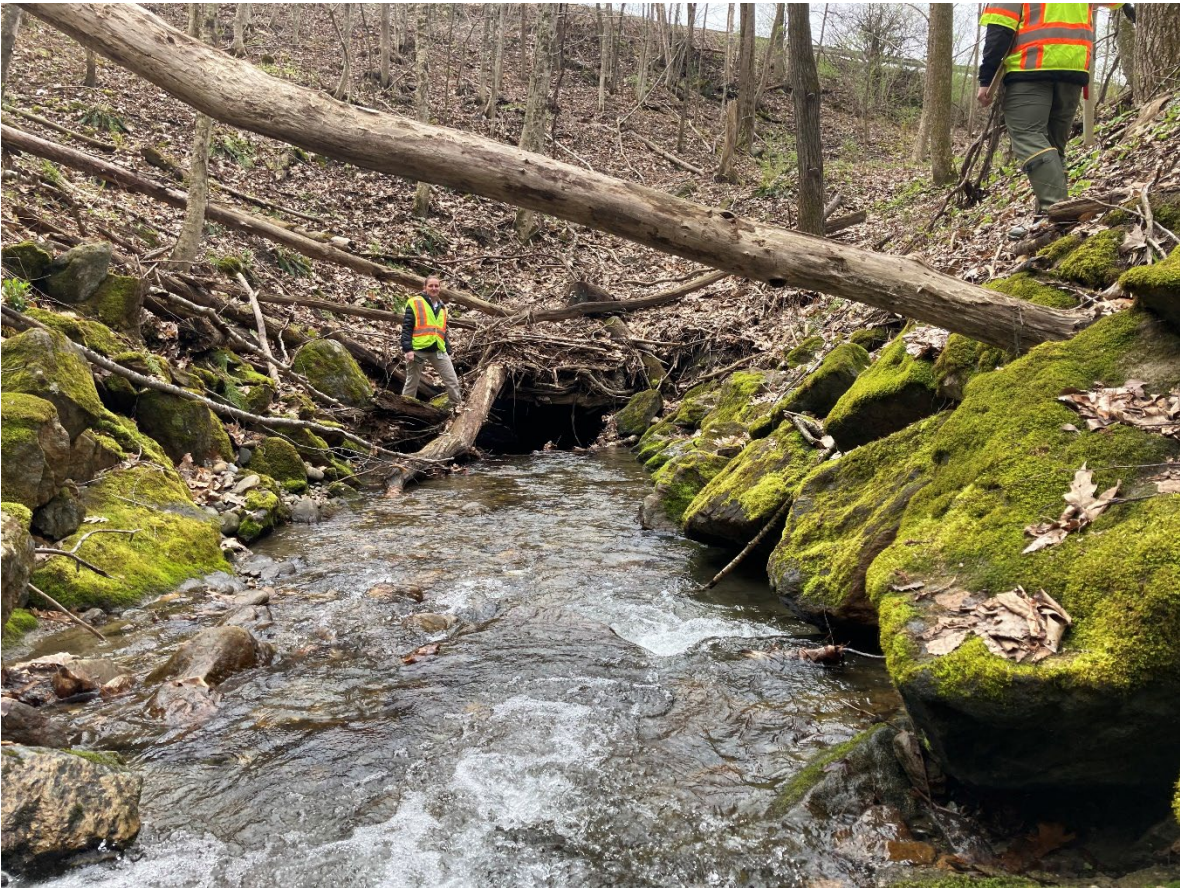
Inlet of PID68002

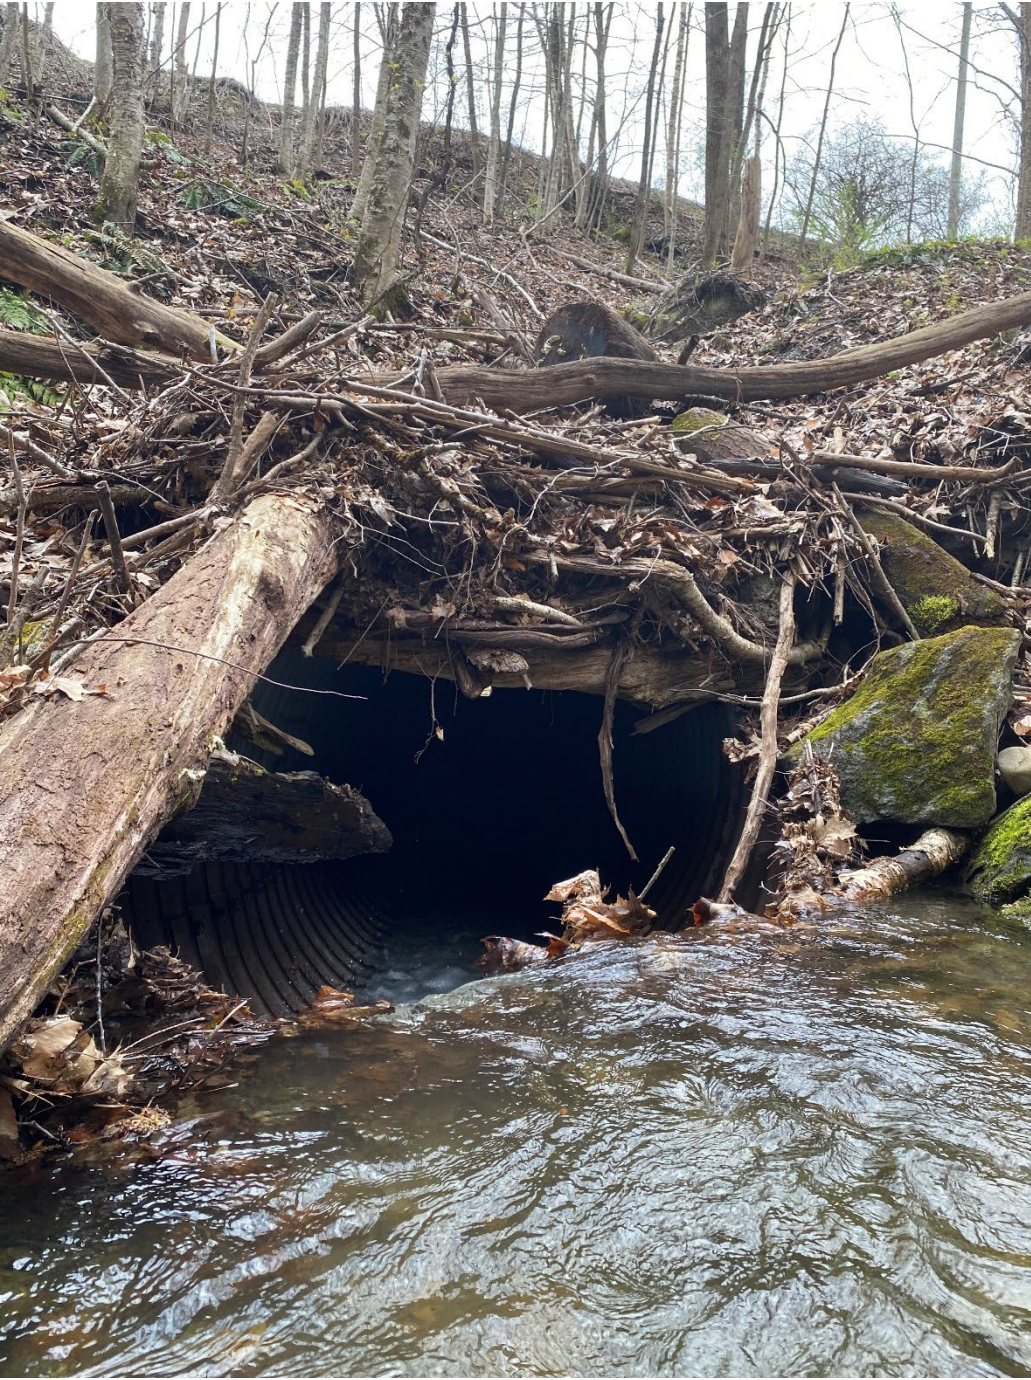
Close up of inlet at PID68002

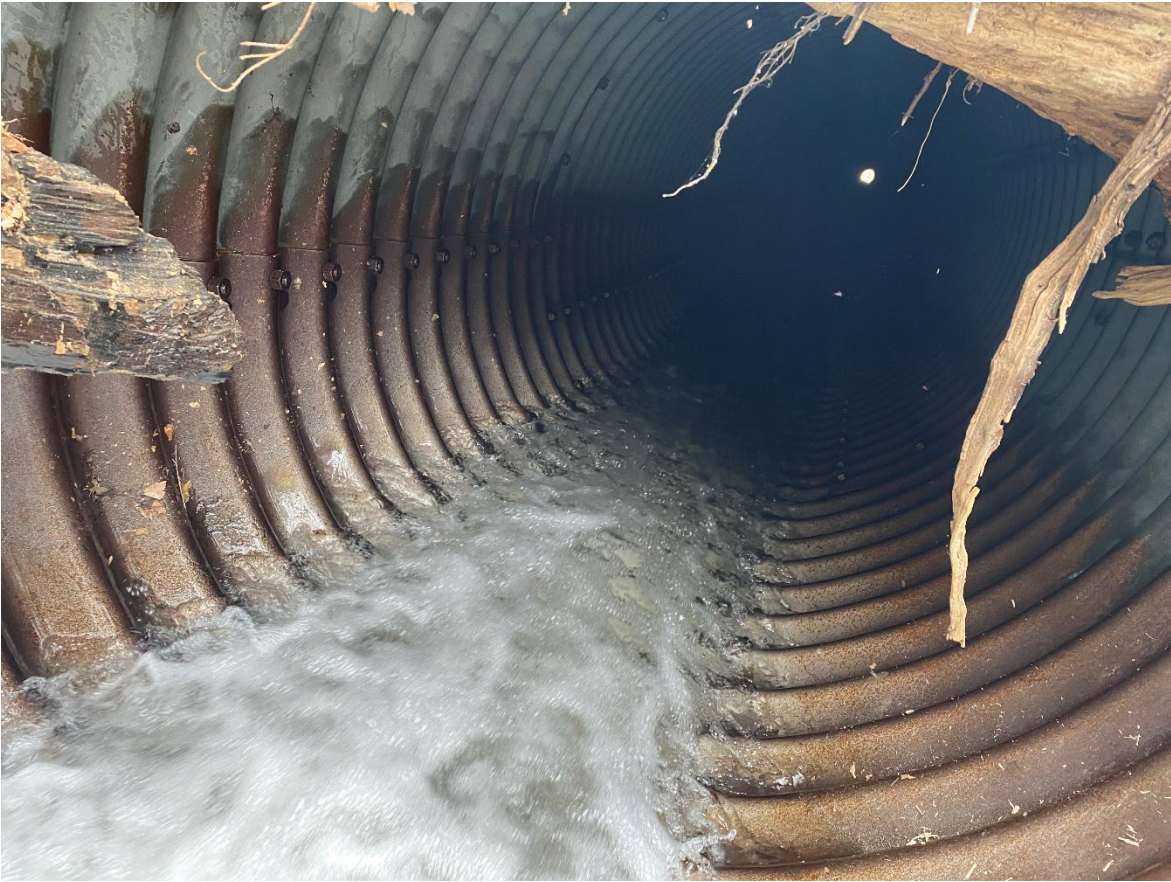
Looking through the culvert from inlet side.

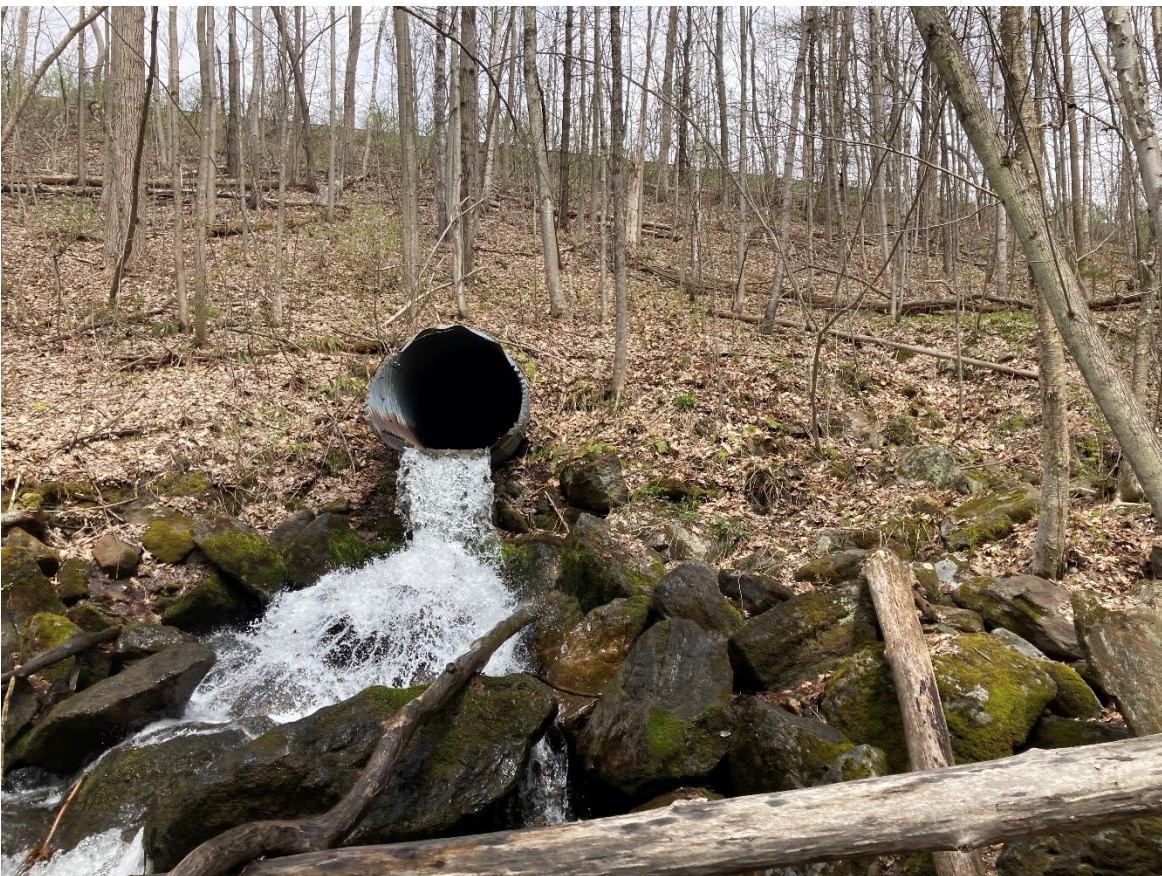
Outlet of PID68002 (looking north)

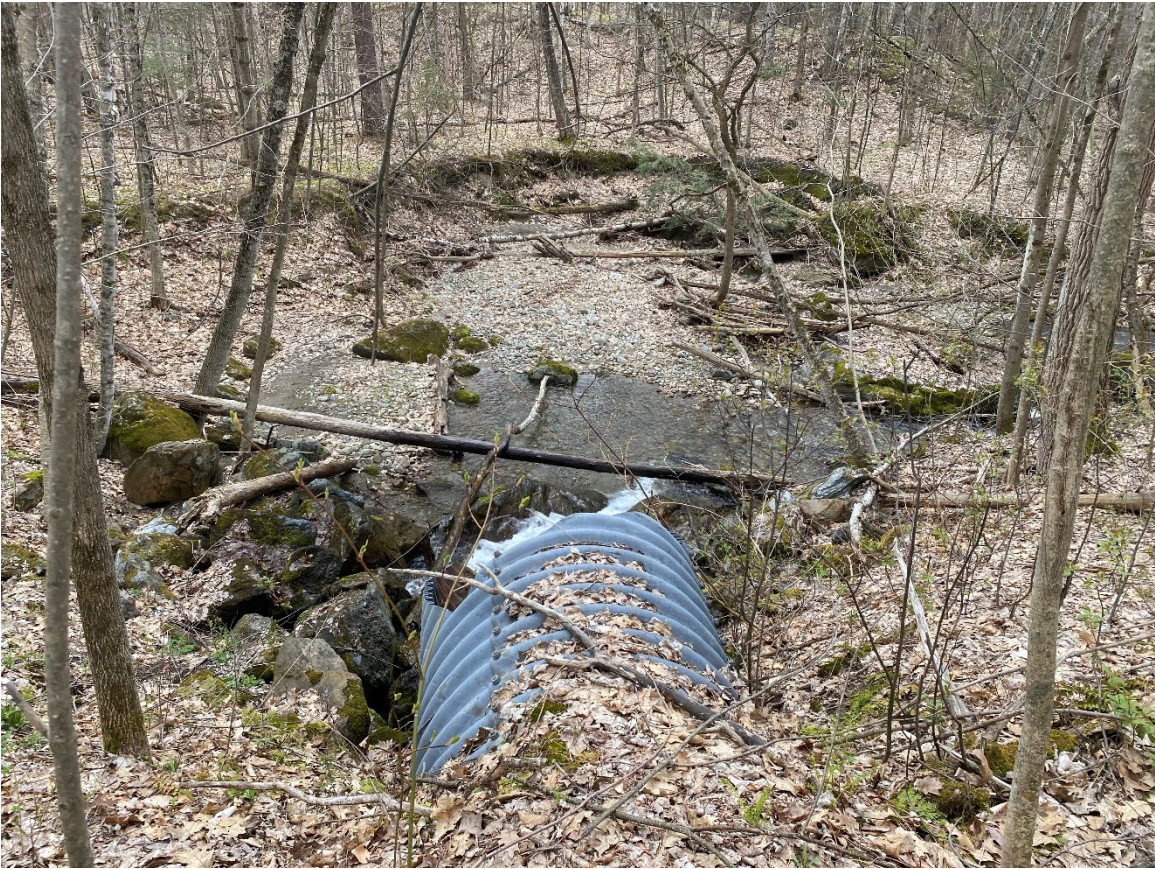
Looking southwest over the outlet at scour hole.

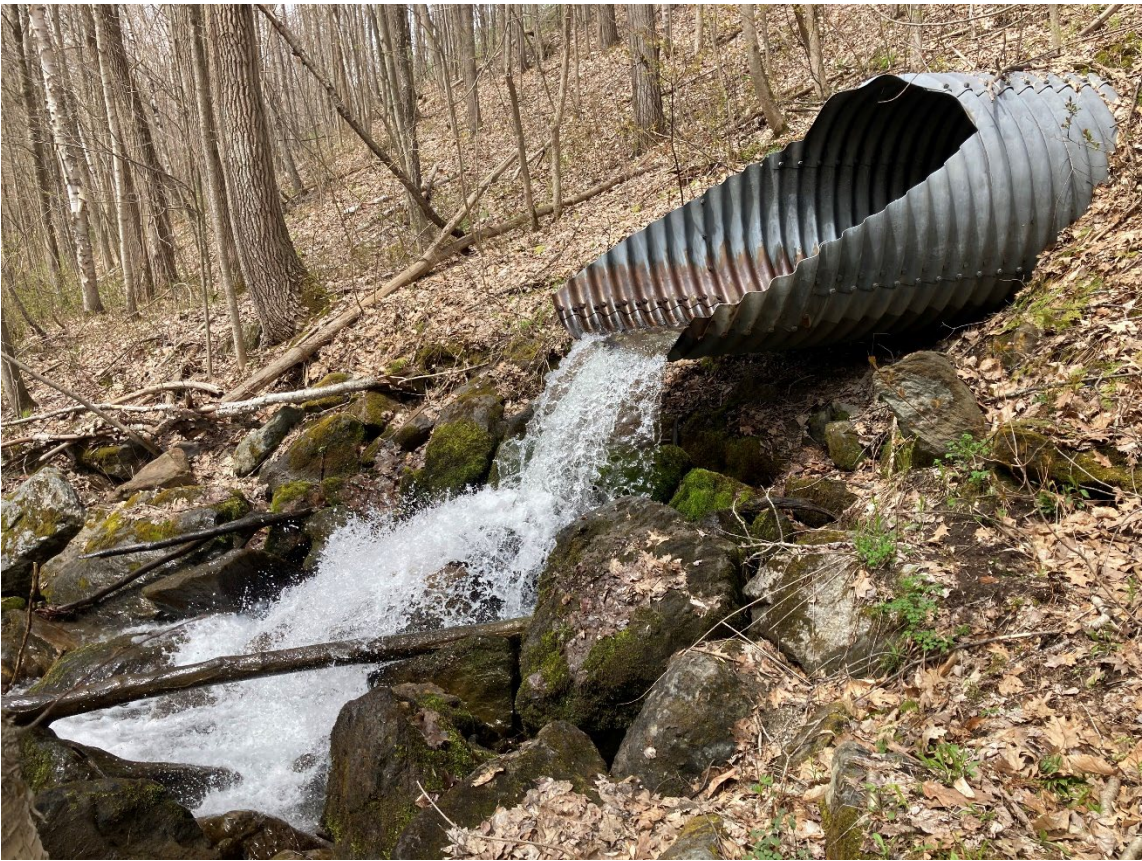
Profile of outlet perch PID68002

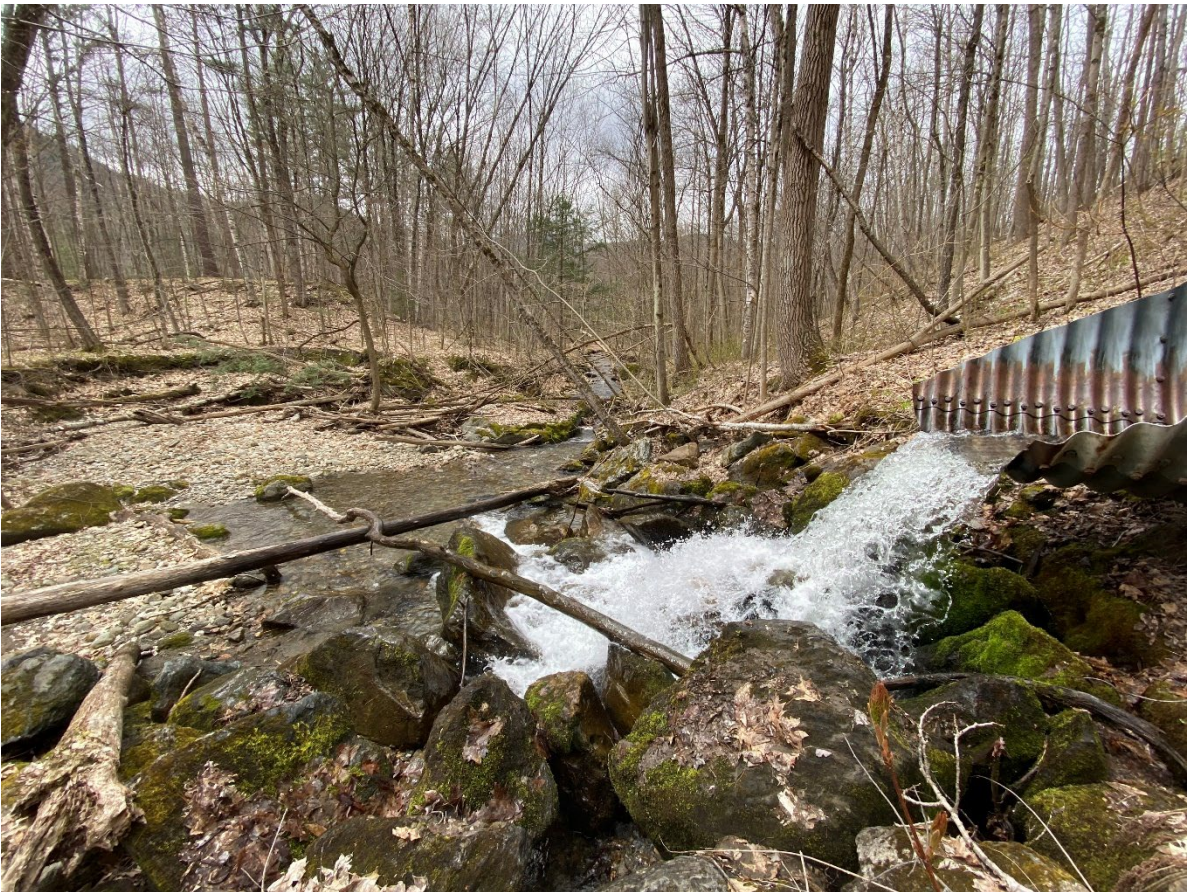
Perch view and downstream view from outlet

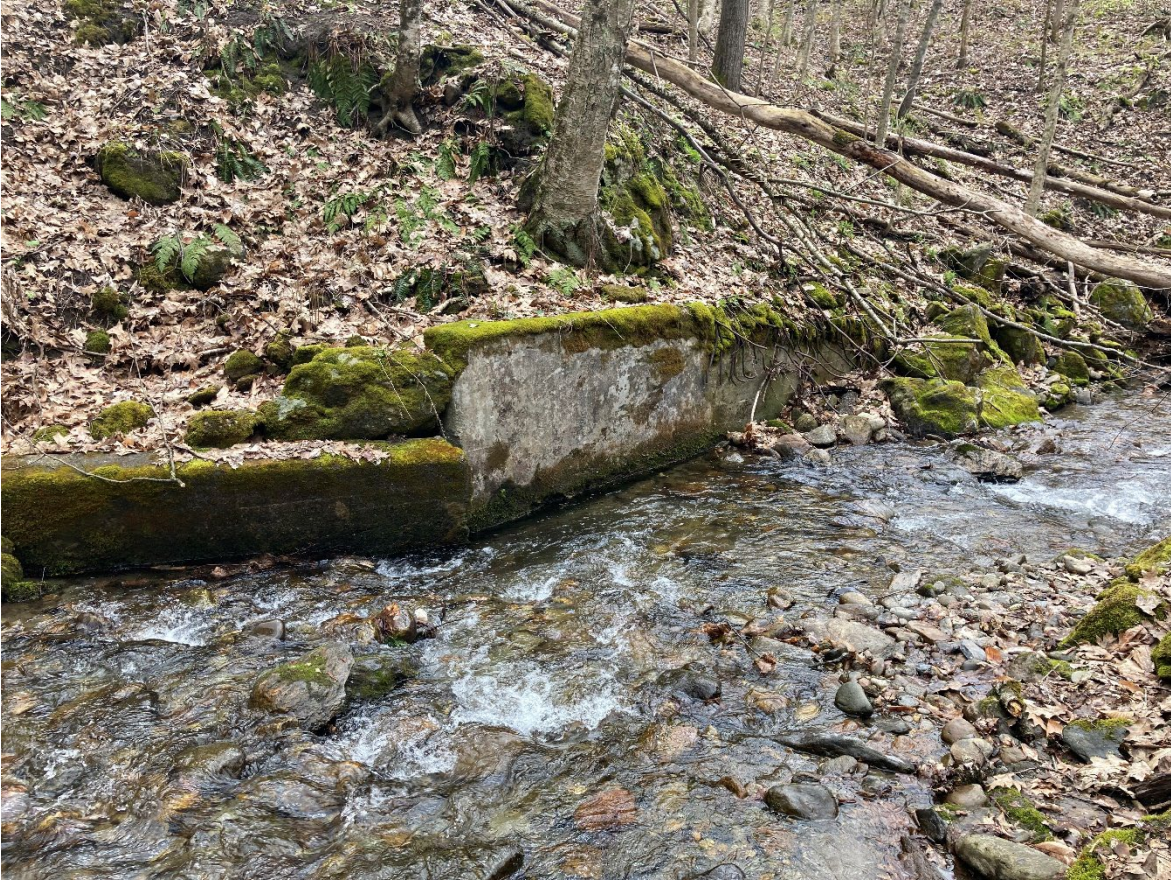
Concrete “wingwall” on east bank upstream of inlet (view from west bank upstream of inlet).

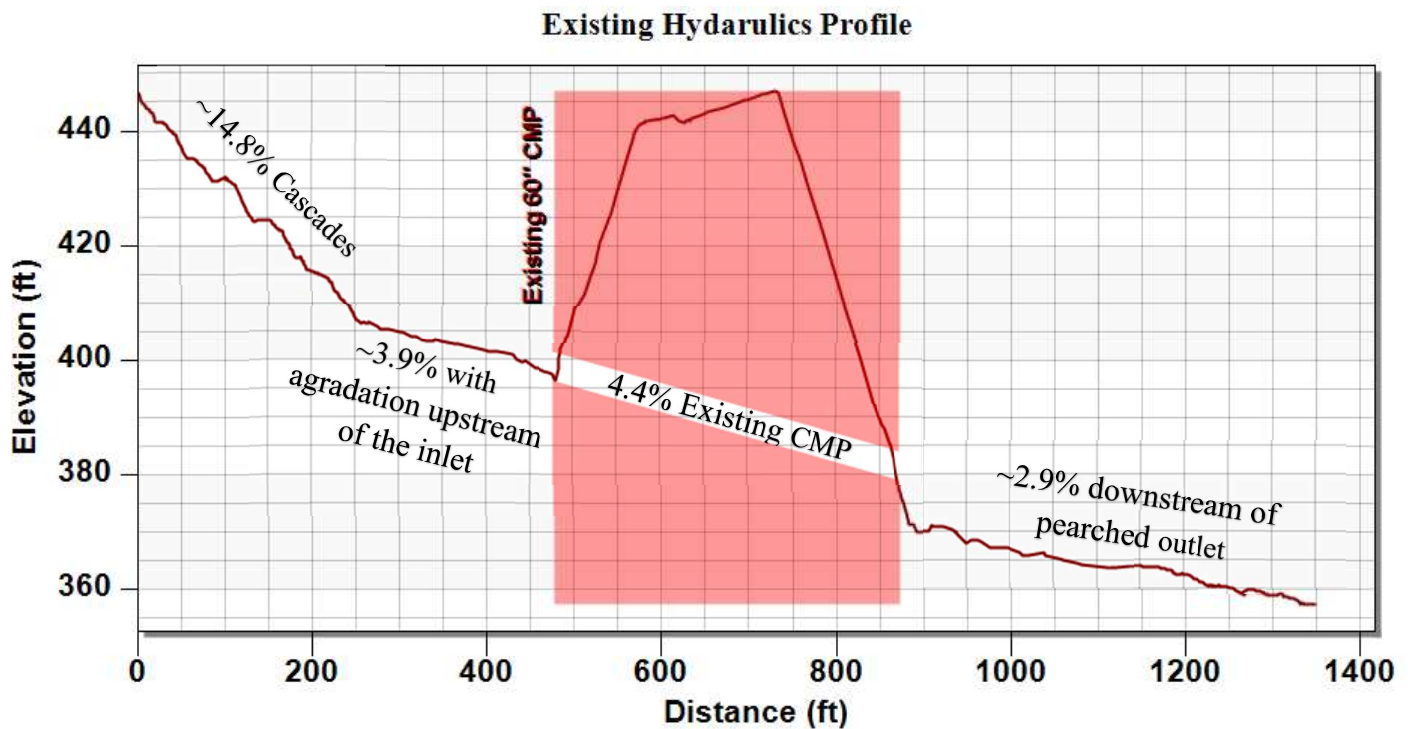
*Figure 1: Existing profile generated from survey and lidar elevation data.*

For options 1 and 2, E-Stone, Type III will need to be used to grade the channel through the respective structures. The channel has significant aggradation upstream of the structure and channel/bank erosion downstream of the structure, see figure 1. We recommend an approximate proposed structure slope of 4.4 to 5.5% and regrading the upstream channel with E-stone, Type III to allow for a better profile alignment, see figure 2. If this grading recommendation cannot be met, please coordinate with the hydraulics unit on other proposed structure slopes. Stone Fill, Type III shall be used to protect any disturbed channel banks or roadway slopes at the structure’s inlet and outlet.

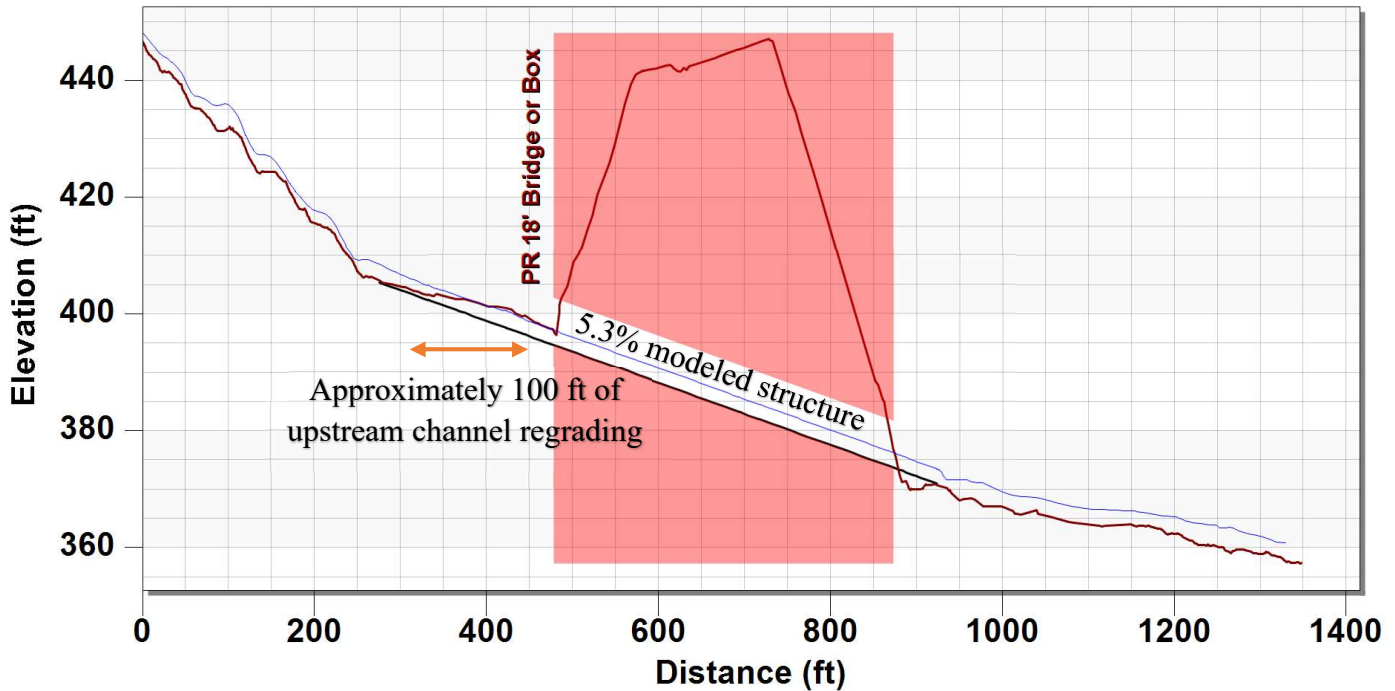
Figure 2: Modeled proposed structure/ channel regrading slope (black) and Q100 water surface elevation (blue)

For option 1, bed retention sills should be added in the bottom of the structure. Sills should be 12 inches high across the full width of the structure. Sills should be spaced no more than 8 feet apart throughout the structure with one sill placed at both the inlet and the outlet.

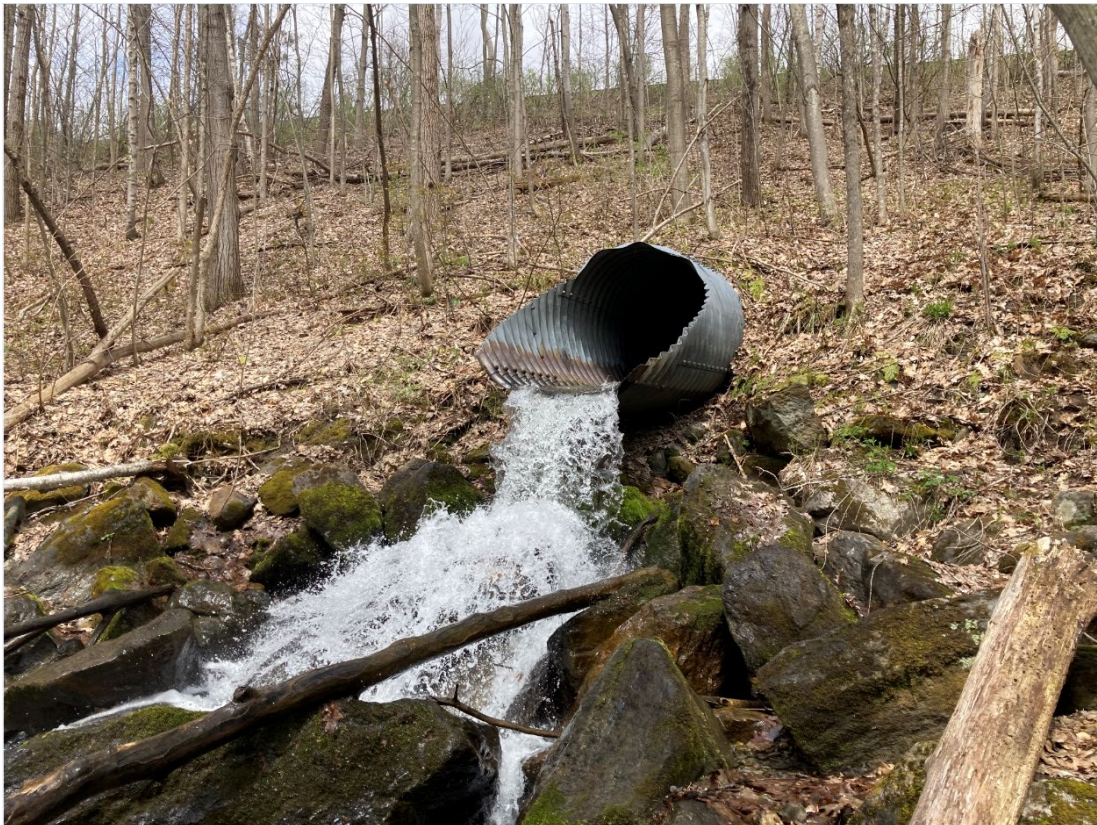
**Figure 1:** *Outlet of the Pipe Showing Steep Wooded Embankment*

A site investigation was not conducted by Geotechnical Section staff however photos from inspections, a site visit conducted by the Structures Section, and satellite imagery were reviewed to evaluate the feasibility of boring operations and assess general site conditions as they relate to the proposed project. Overhead utilities run along the north side of US 2 in the location of the culvert. The subsurface investigation can be adjusted to avoid the overhead utilities and still evaluate the subsurface conditions in this location. The embankments are steep and heavily vegetated which can be seen in Figure 1. If borings are requested in the area of the inlet and outlet, access will need to be constructed and the trees will need to be cleared.

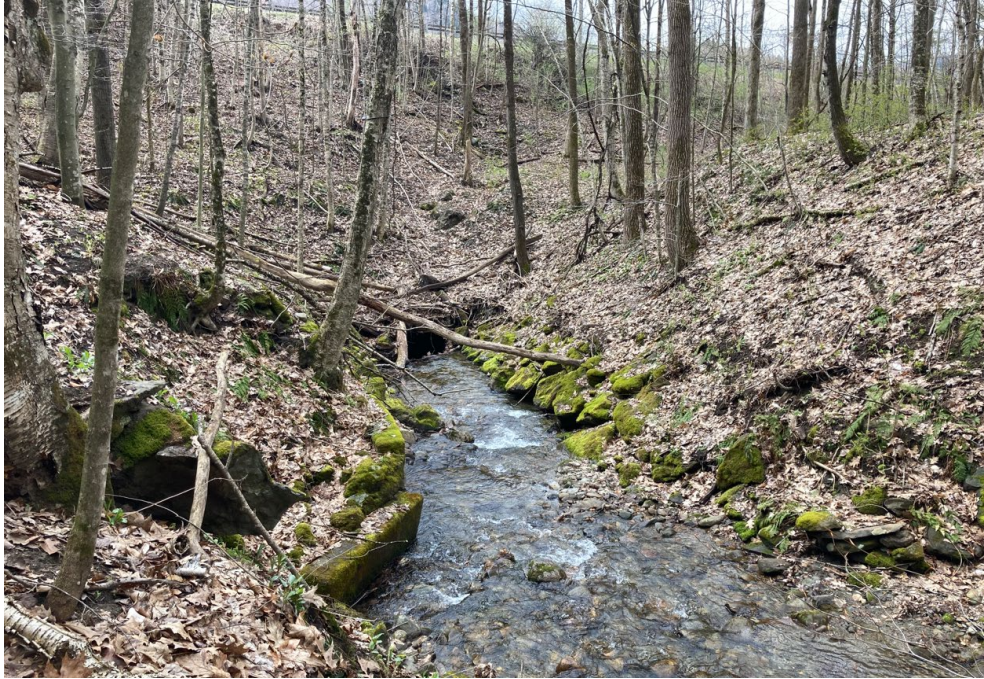
Image of culvert at north (inlet) end. Note concrete slabs center left and row of stones (rip rap) center right of stream channel

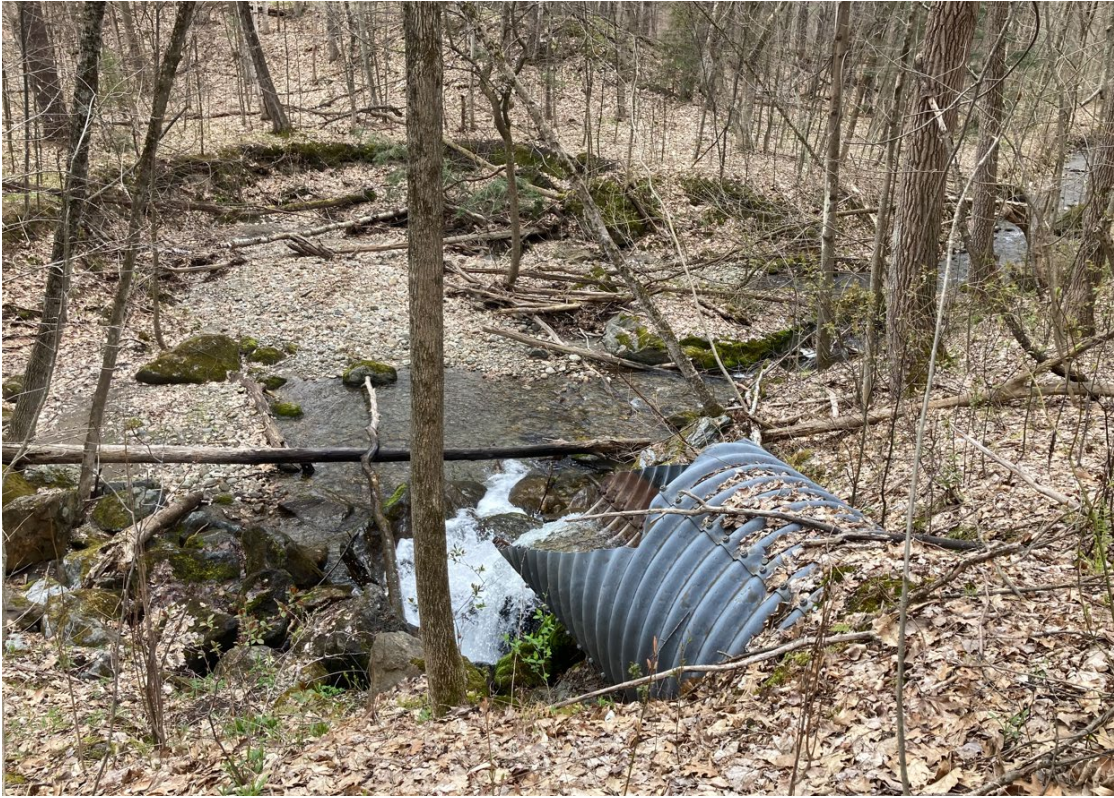
View of outlet end and scour area from slope. Portions of the lower level terrace can be seen beyond the scour area before the land rises to the higher terrace.

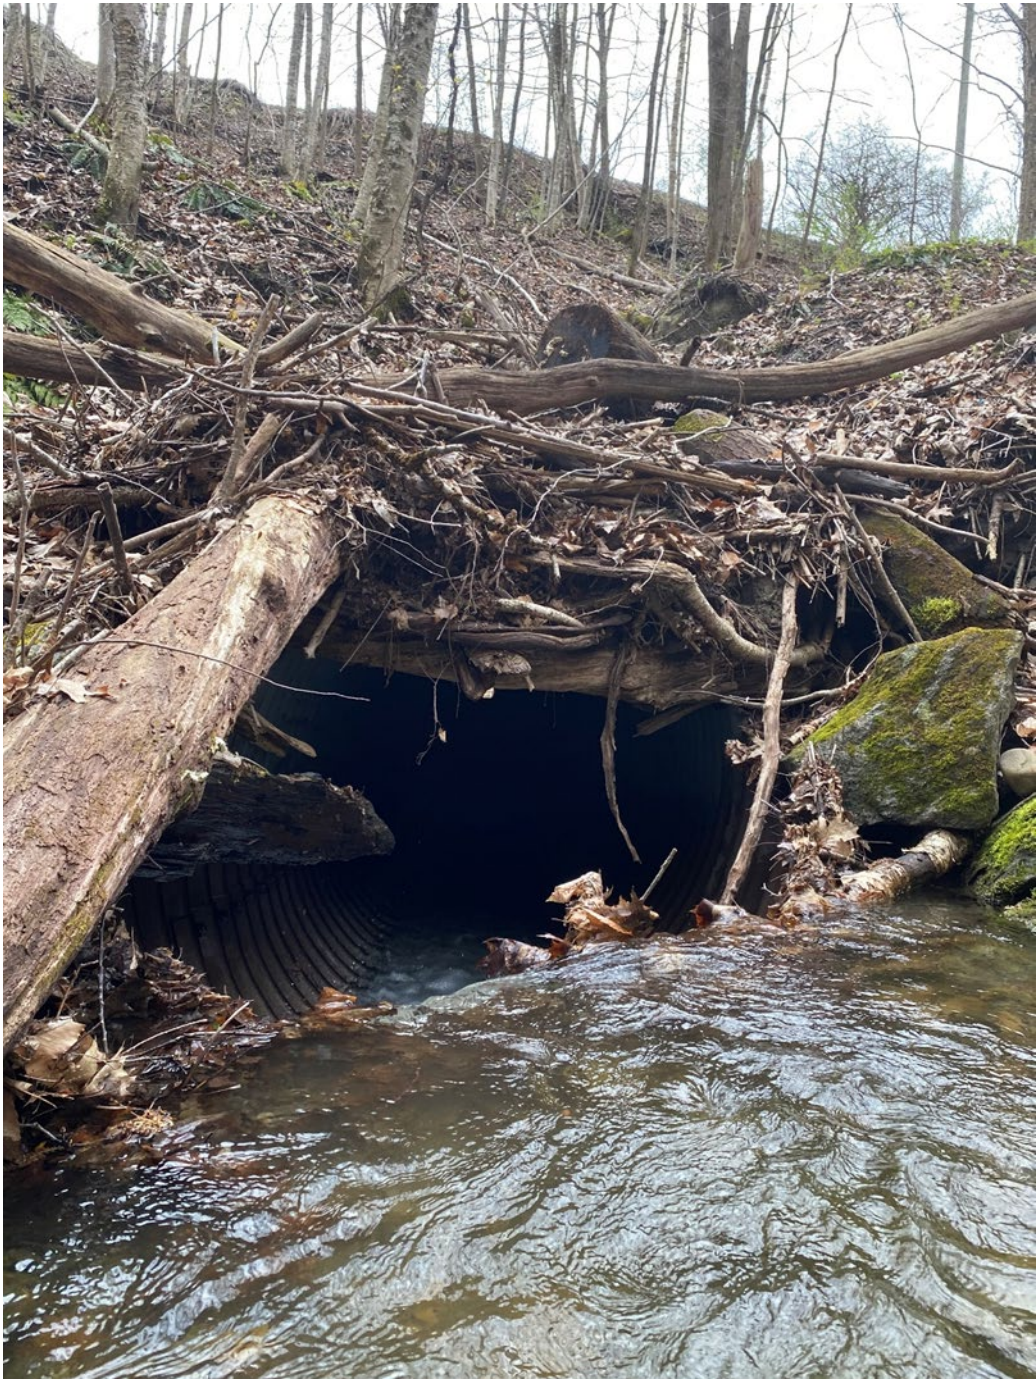
Culvert inlet

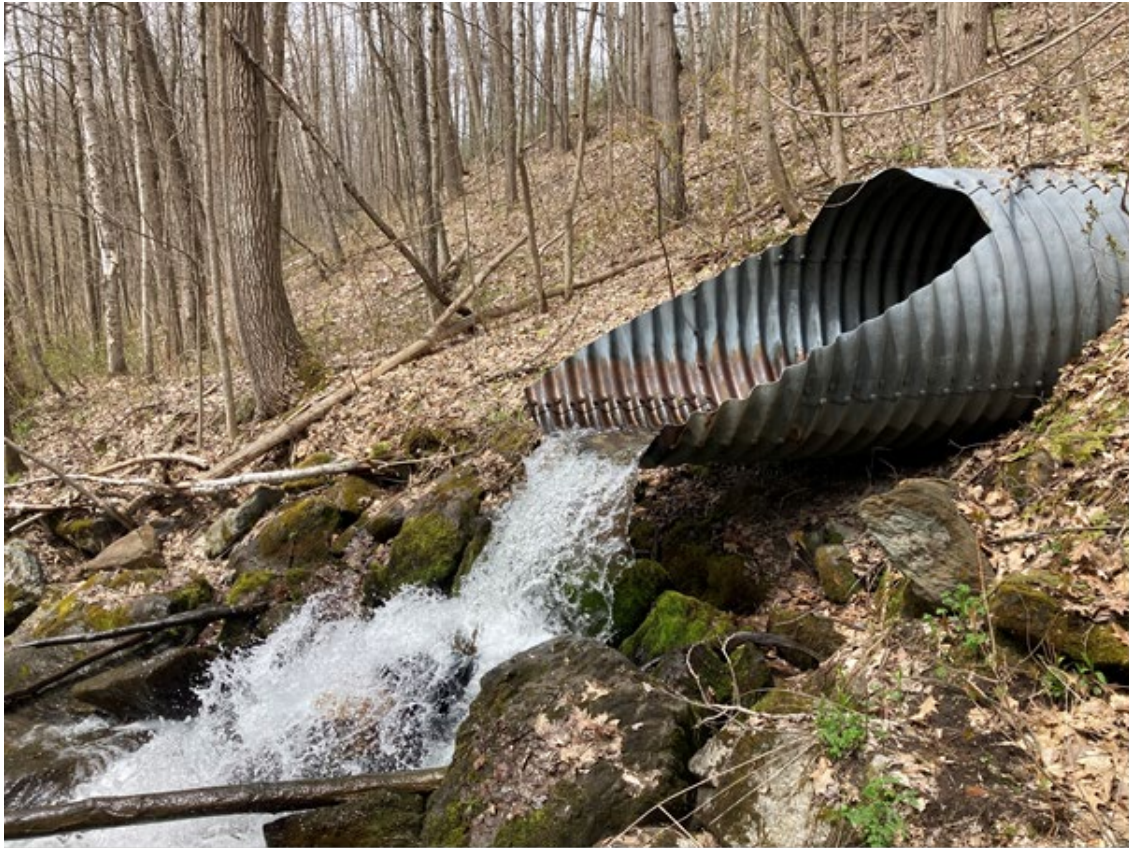
Culvert outlet

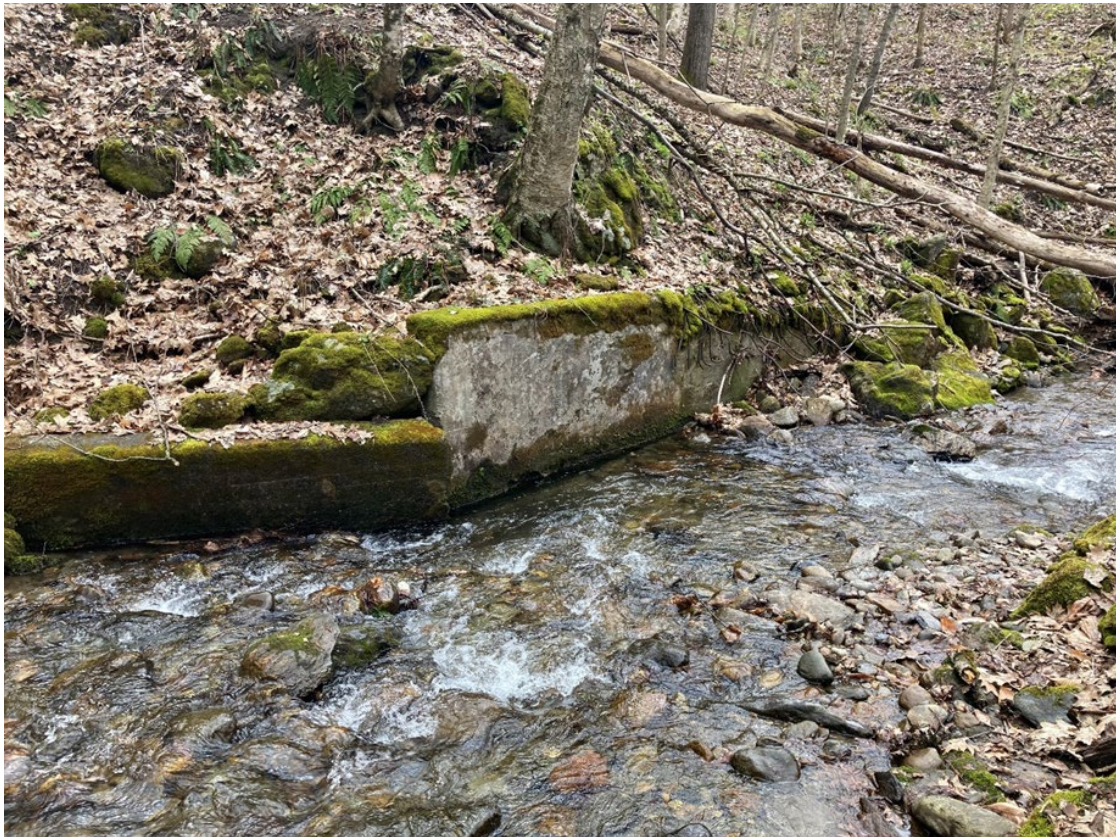
Concrete headwall

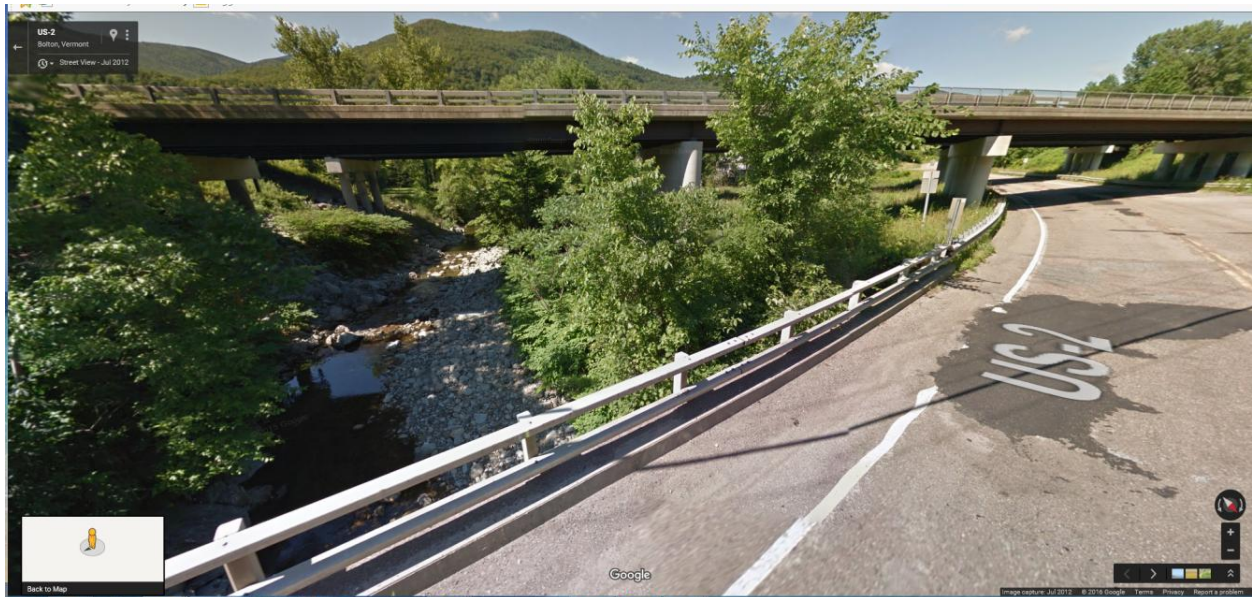
#### **Photo 1. I-89 bridge over US 2 and Joiner Brook in Bolton Village**

*(Bolton Valley Road is on the right – Google Maps image)*

Only 3 squirrel tracks and one unidentifiable track were found under the I-89 bridge over US Route 2 and Joiner Brook in Bolton Village, even though there appears to be ample room for wildlife movement (Photo 1). There are, however, a river, adjoining road, school, homes, and other potential barriers in this area.

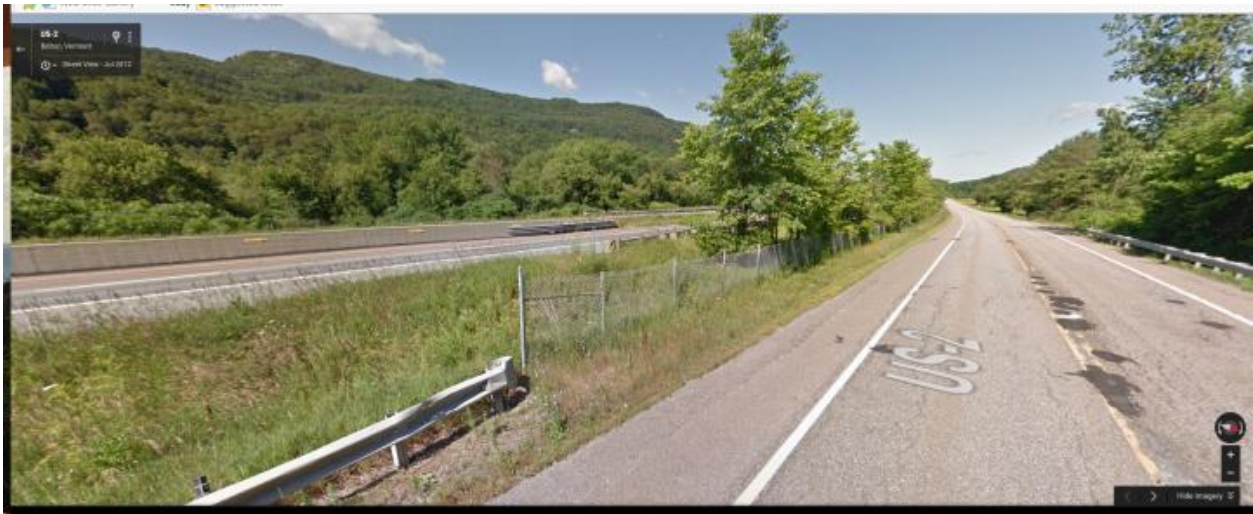
**Photo 2. End of chain link fence and beginning of median Jersey barrier**

*(Facing west in the vicinity of Pineo Brook Road - Google Street View image)*

between I-89 and US Route 2, as shown in Photos 2 and 3 below. Portions of the fence have fallen down or become overgrown with vegetation, but the fence is largely intact and may be a barrier to some species. There are anecdotal reports of the fence deterring animals from successfully crossing the roadway corridor.

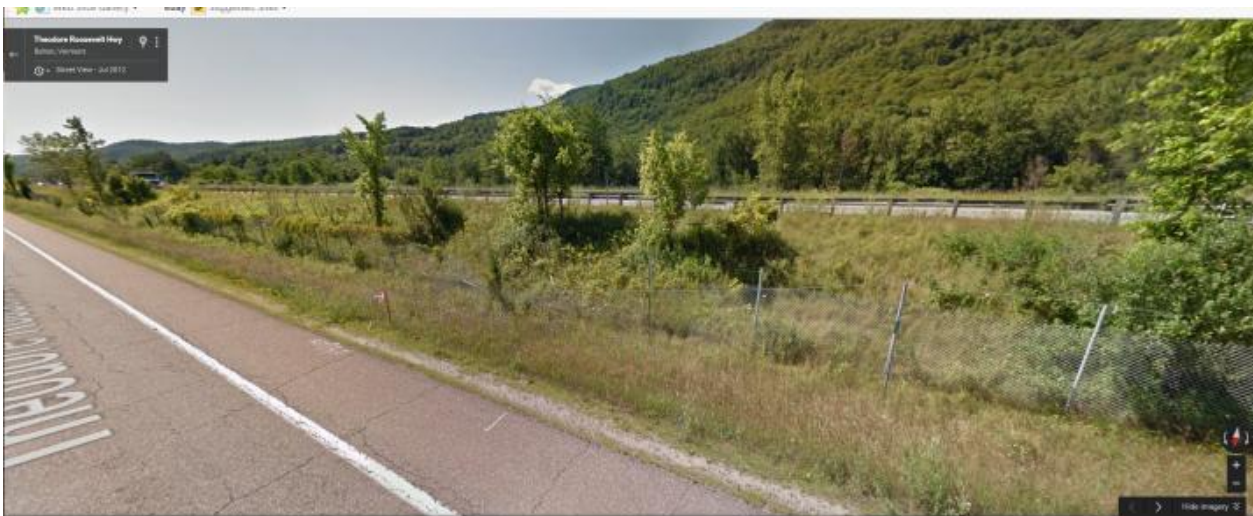
**Photo 3. Condition of chain link fence**

*(Between I-89 and US 2 between Pineo and Joiner Brooks – Google Maps image)*

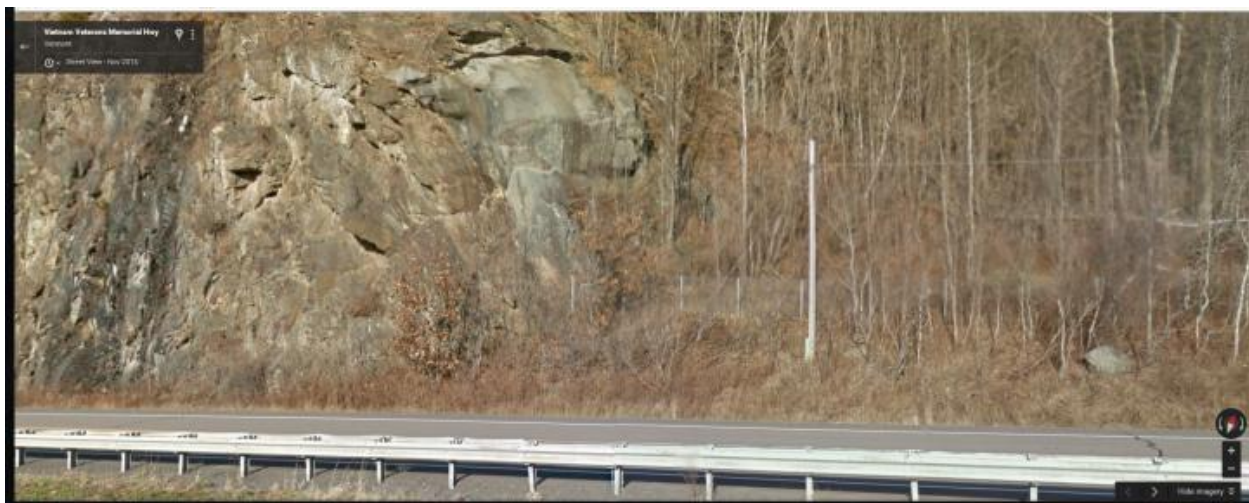
**Photo 5. Chain link fence meeting rock cut section**

*(Between Sharkeyville and Orchard Estates near MM 67.1 – Google Maps image)*

From Pineo Brook Road and continuing east past Sharkeyville Road and the east end of the Jersey barriers roughly to Orchard Springs Estates, there were relatively high numbers of tracks, crossing both over the highway (55 animals) and through culverts (27 animals). The most common animals crossing over the road included coyote, deer, and fox, plus 3 fishers and 1 raccoon. The common animals using culverts included mink and fox, along with 3 raccoons and 2 each of coyote, weasel, and fisher. The effect of the Jersey barrier on animal movement is not known, though it may deter smaller animals from crossing. There is a possible divide at the sharp curve in the road, where there is a rock cut and a segment of chain link fence (see Figure 4 and Photos 4 and 5 below).

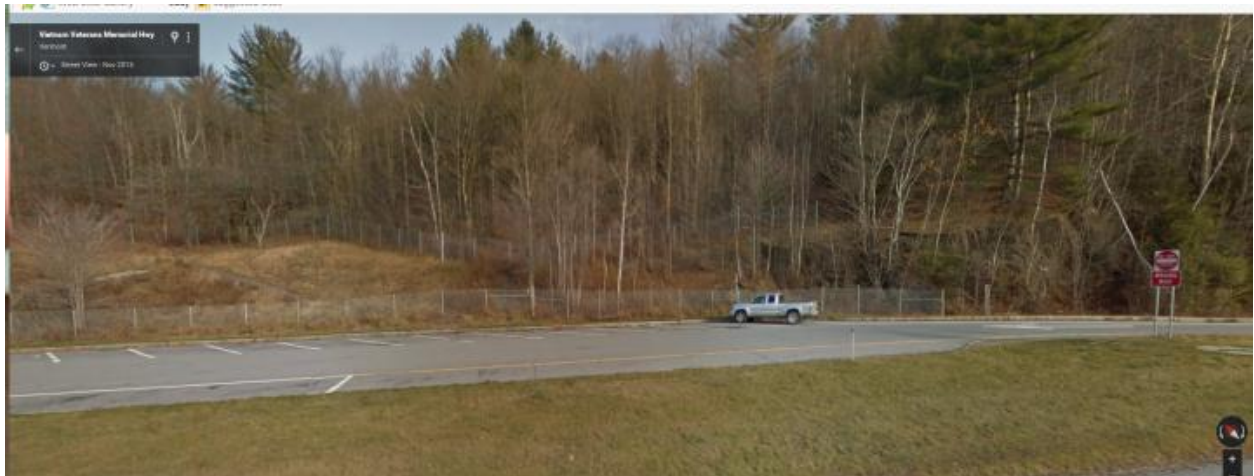
**Photo 6. Rest area with parallel chain link fences and smaller rock cut**

*(West of Little River – Google Maps image)*

East of Orchard Springs Estates, continuing to Little River, was an area of scattered wildlife travel. In this segment, 66 animals crossed over the road surface, 18 via culvert, and 4 under the bridge over US Route 2 by Farr's Landing Road. The road crossings were mostly coyotes and foxes, plus 6 deer, 3 mink, 3 raccoon, 2 fisher, and 1 weasel. The culvert crossings included 7 mink, 2 each of fisher, fox, raccoon, and weasel, with 1 squirrel and several unidentifiable. Passing under the bridge were 2 skunks, 1 raccoon, and 1 squirrel. One segment has a rest area with two parallel chain link fences (Photo 6).

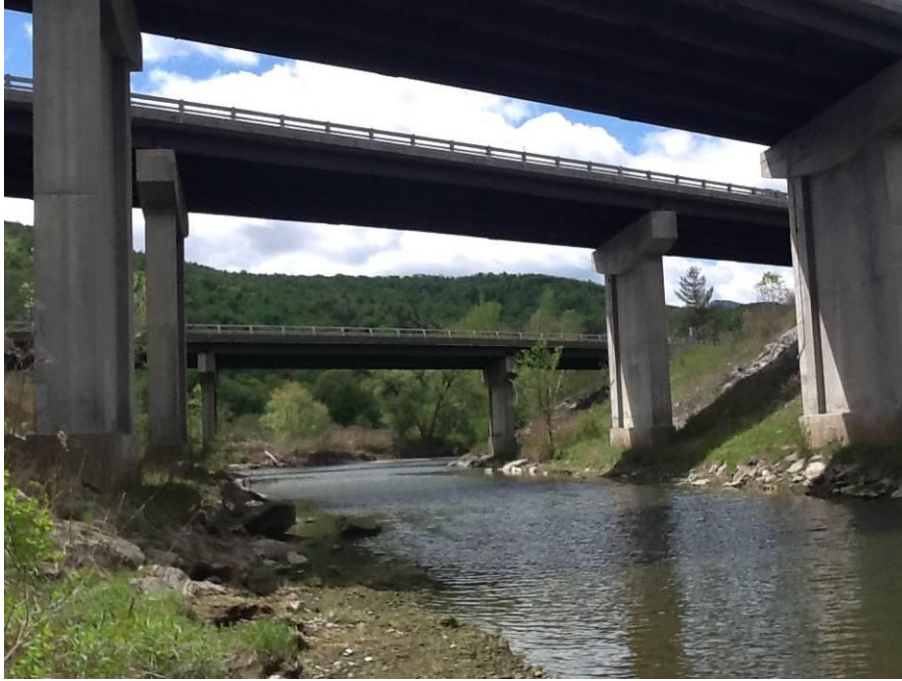
I-89 and US Route 2 bridges over Little River, facing south
