**STATE OF VERMONT  
AGENCY OF TRANSPORTATION**

**Scoping Report**

**FOR  
WATERBURY IM CULV(109)**

**I-89 & US2 PID 68002 OVER SHARKEYVILLE BROOK**

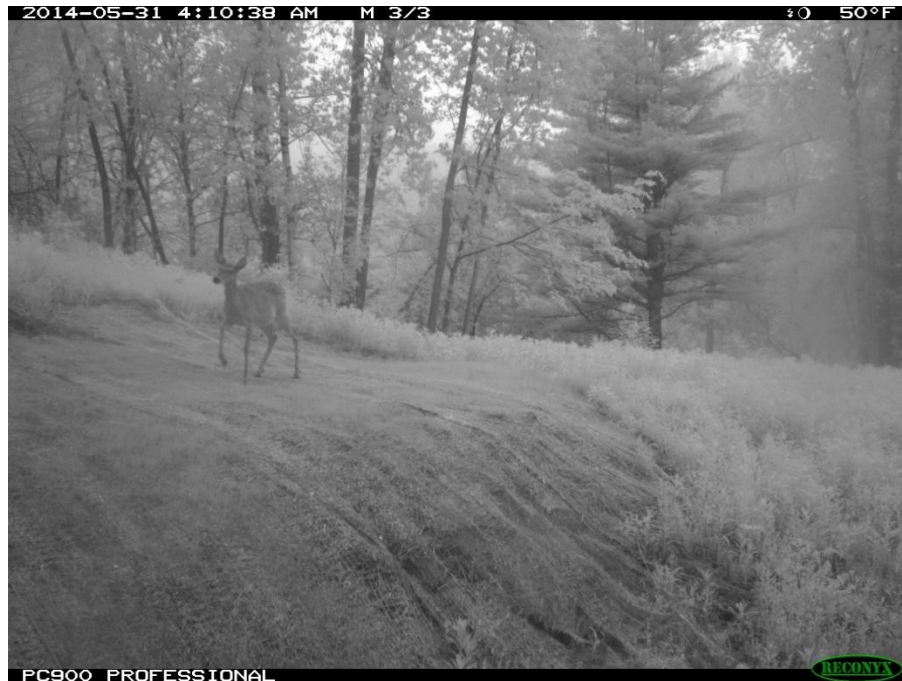
Constructed shelf on west side under Little River bridge

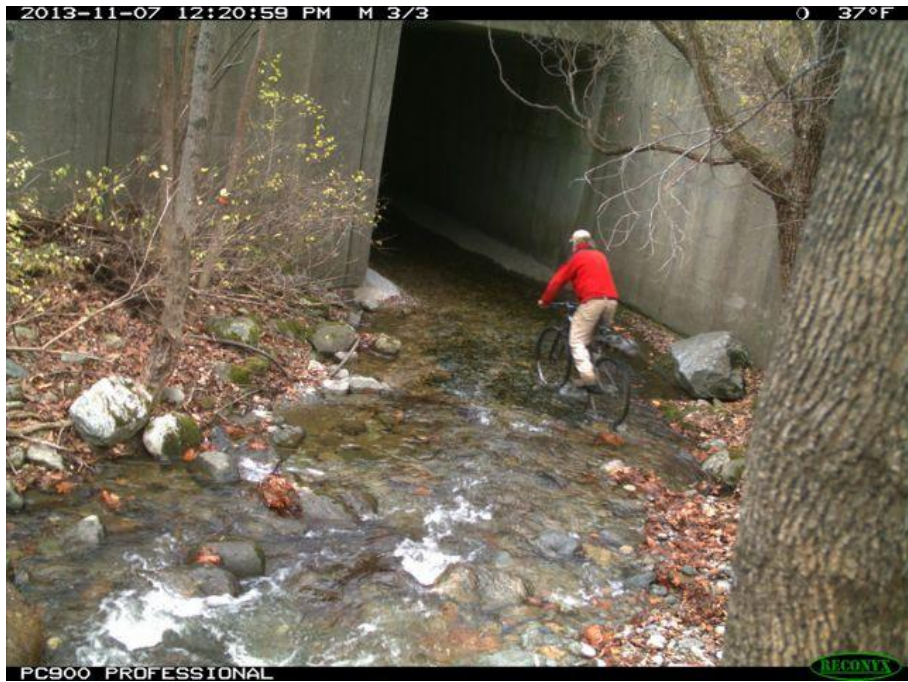
Pineo Brook inlet, north side of US Route 2, facing south

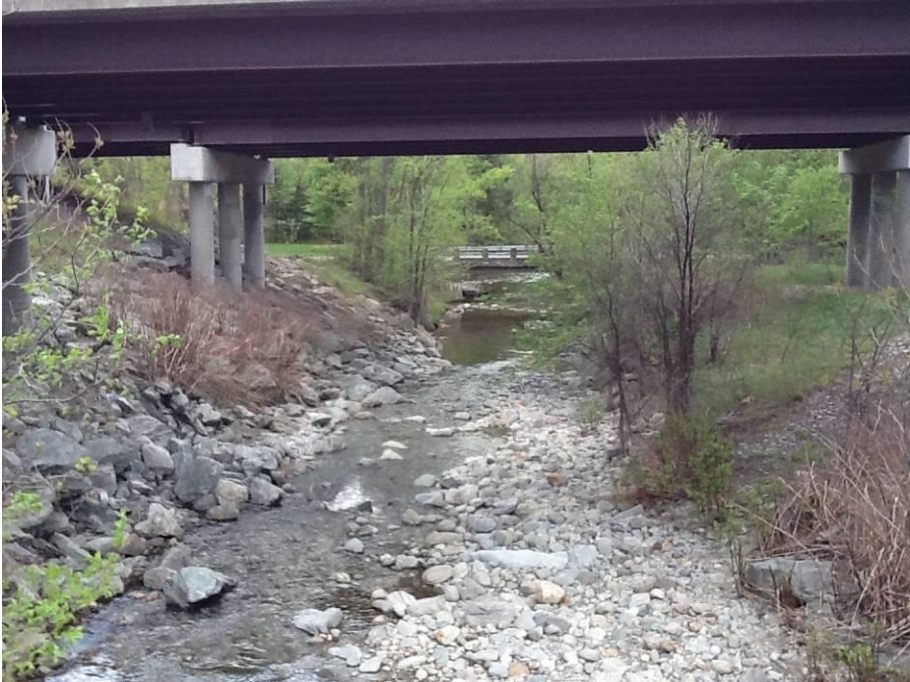
I-89 over Joiner Brook

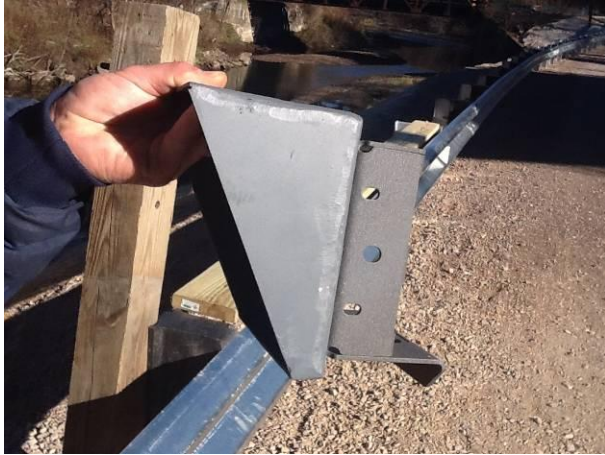
Fabricated housing for angling camera down

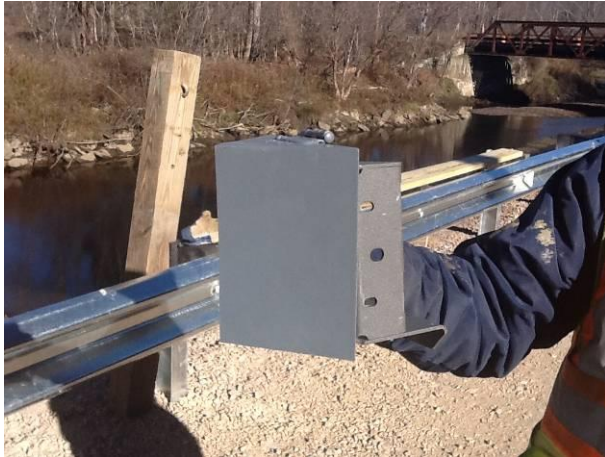
Fabricated housing for angling camera to the side

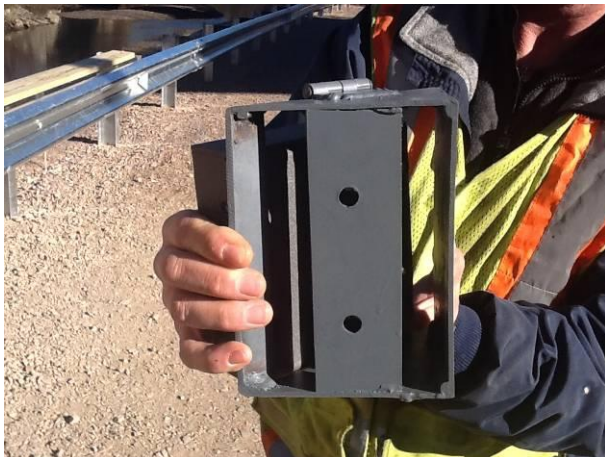
Back side of fabricated housing for angling to the side

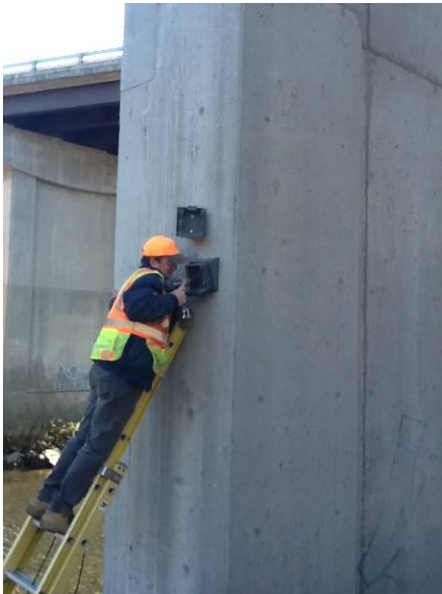
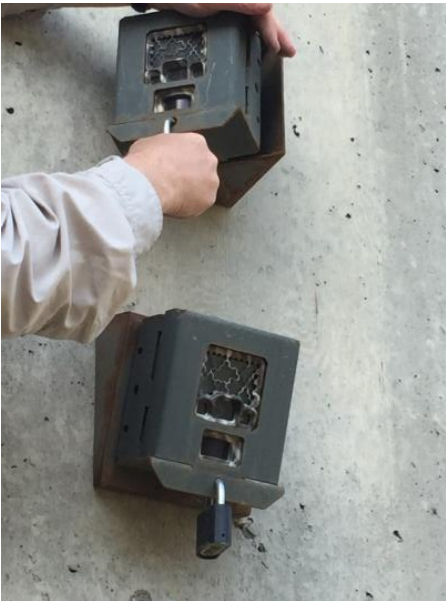
Cameras being installed on abutment, one angled down, the other angled to the side

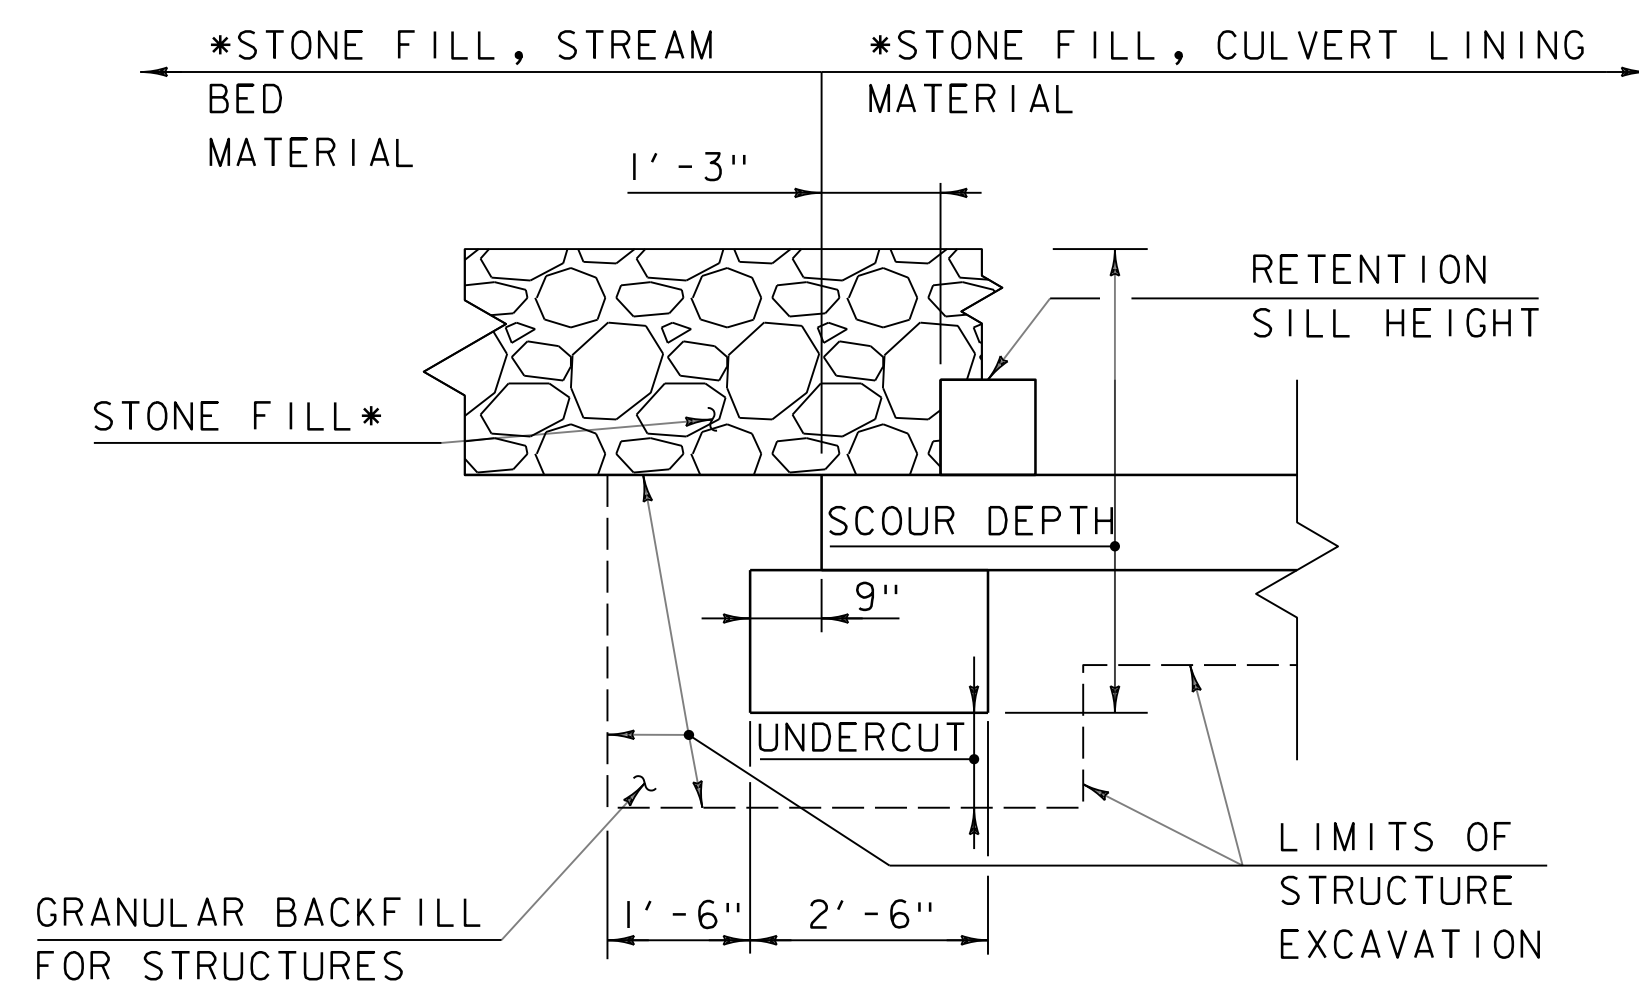
**CUTOFF WALL TYPICAL SECTION**

**CUTOFF WALL - CRITICAL DIMENSIONS**

DIMENSION
SCOUR DEPTH	4' - 0"
RETENTION SILL HEIGHT	1' - 0"
UNDERCUT	1' - 0"

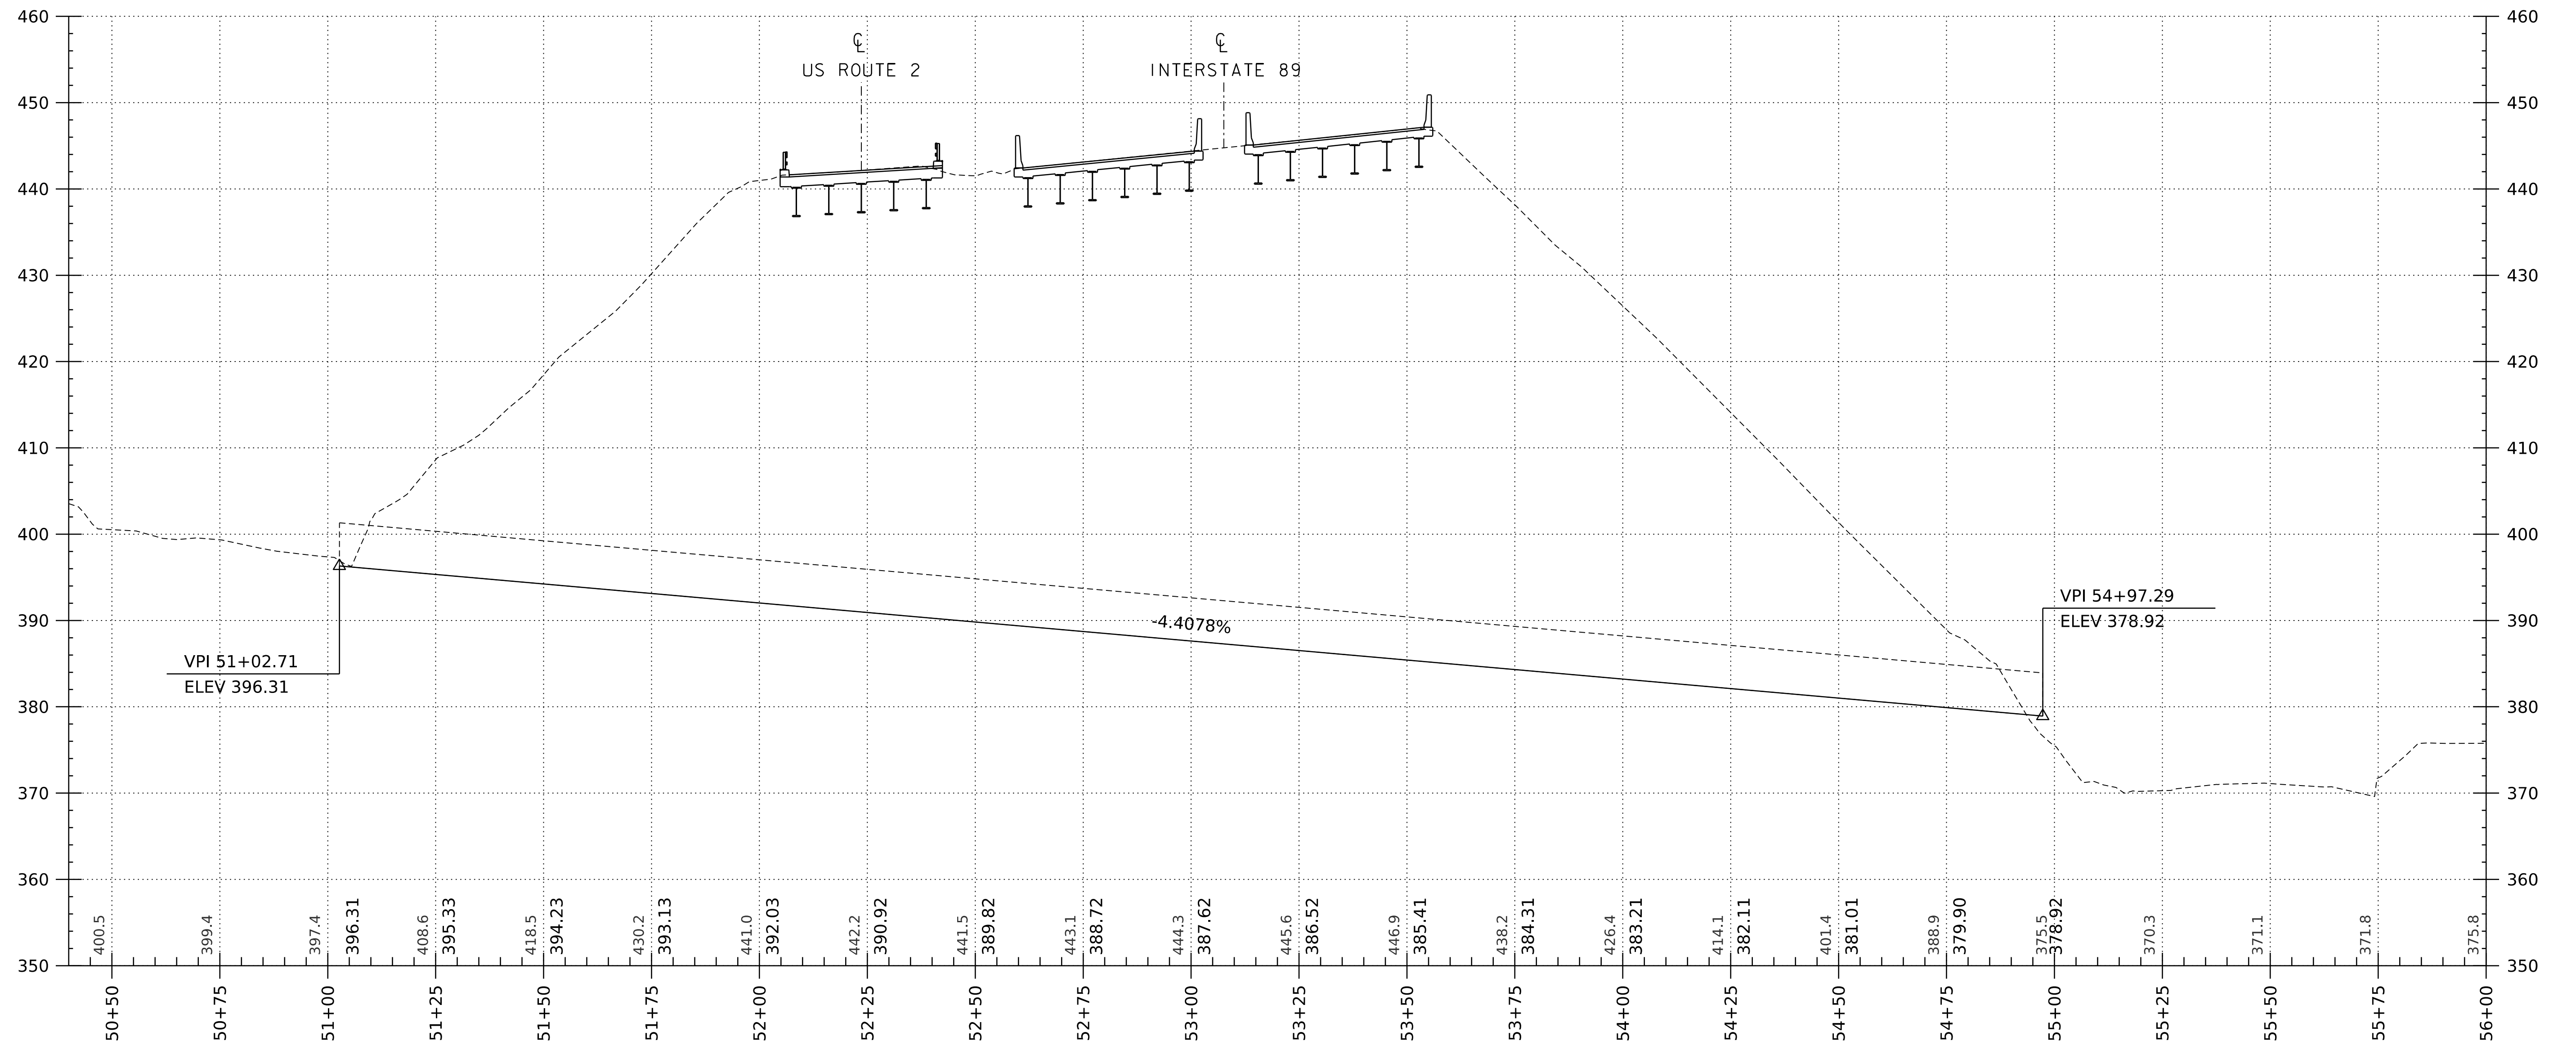
**NEW BRIDGES PROFILE**

NOTE:  
 GRADES SHOWN TO THE NEAREST TENTH ARE EXISTING GROUND ALONG  $\phi$   
 GRADES SHOWN TO THE NEAREST HUNDREDTH ARE FINISH GRADE ALONG  $\phi$
