**STATE OF VERMONT
AGENCY OF TRANSPORTATION**

Scoping Report

**FOR
WATERBURY IM CULV(109)**

I-89 & US2 PID 68002 OVER SHARKEYVILLE BROOK

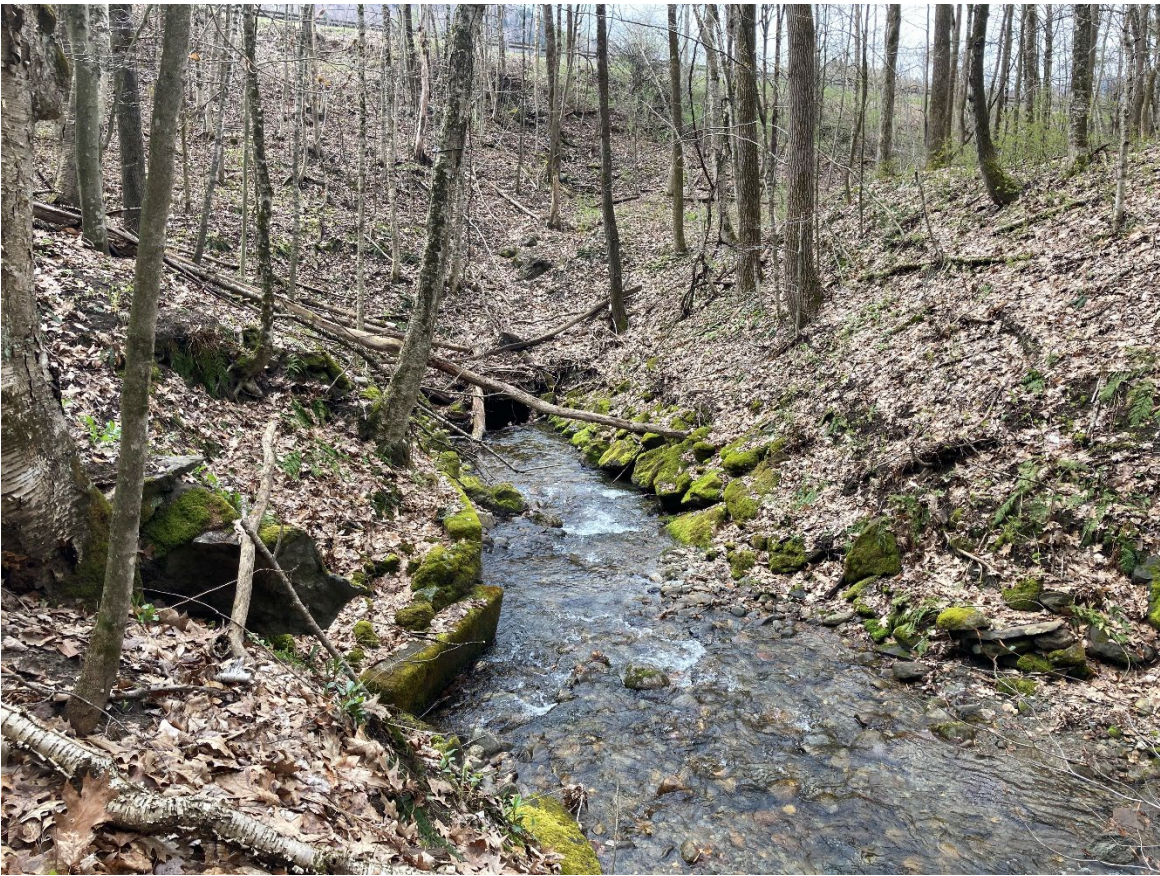
Looking South at Inlet of PID68002

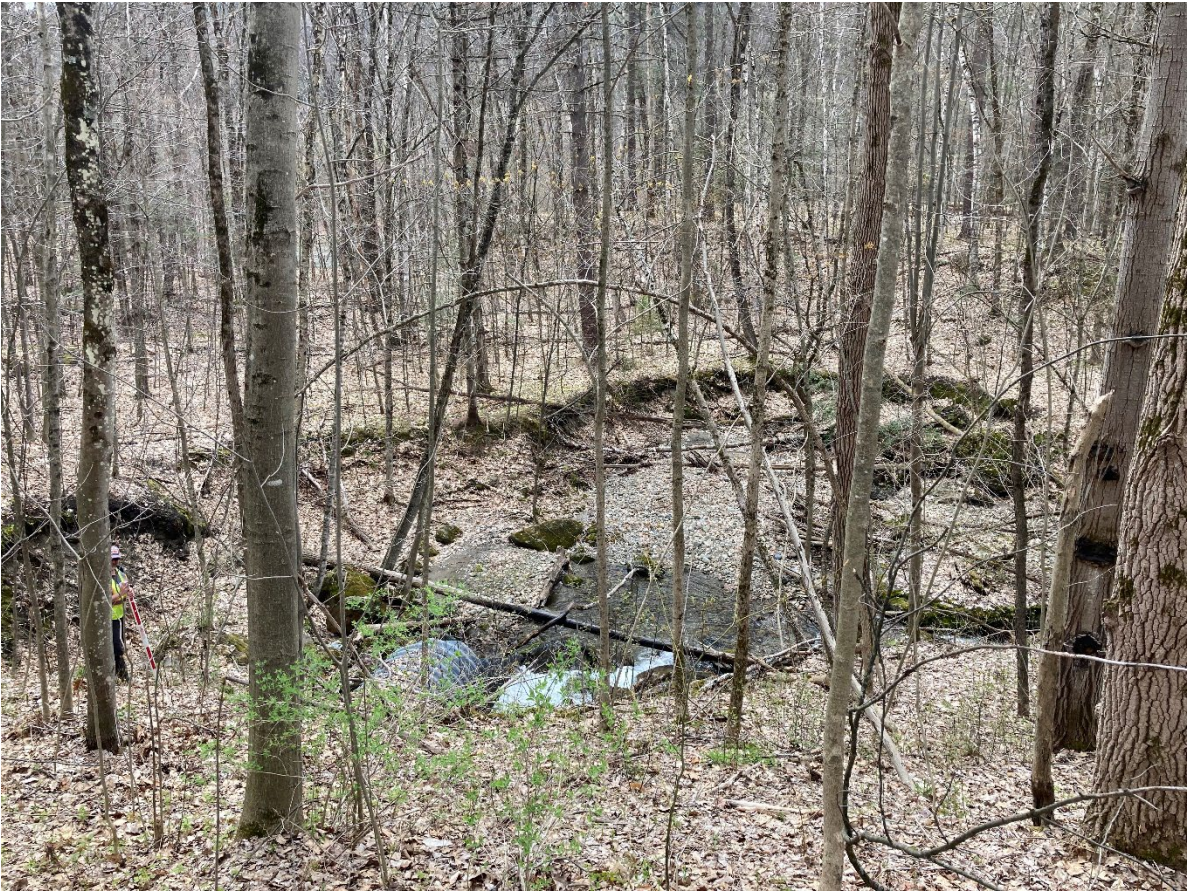
Scour pool view from north of outlet

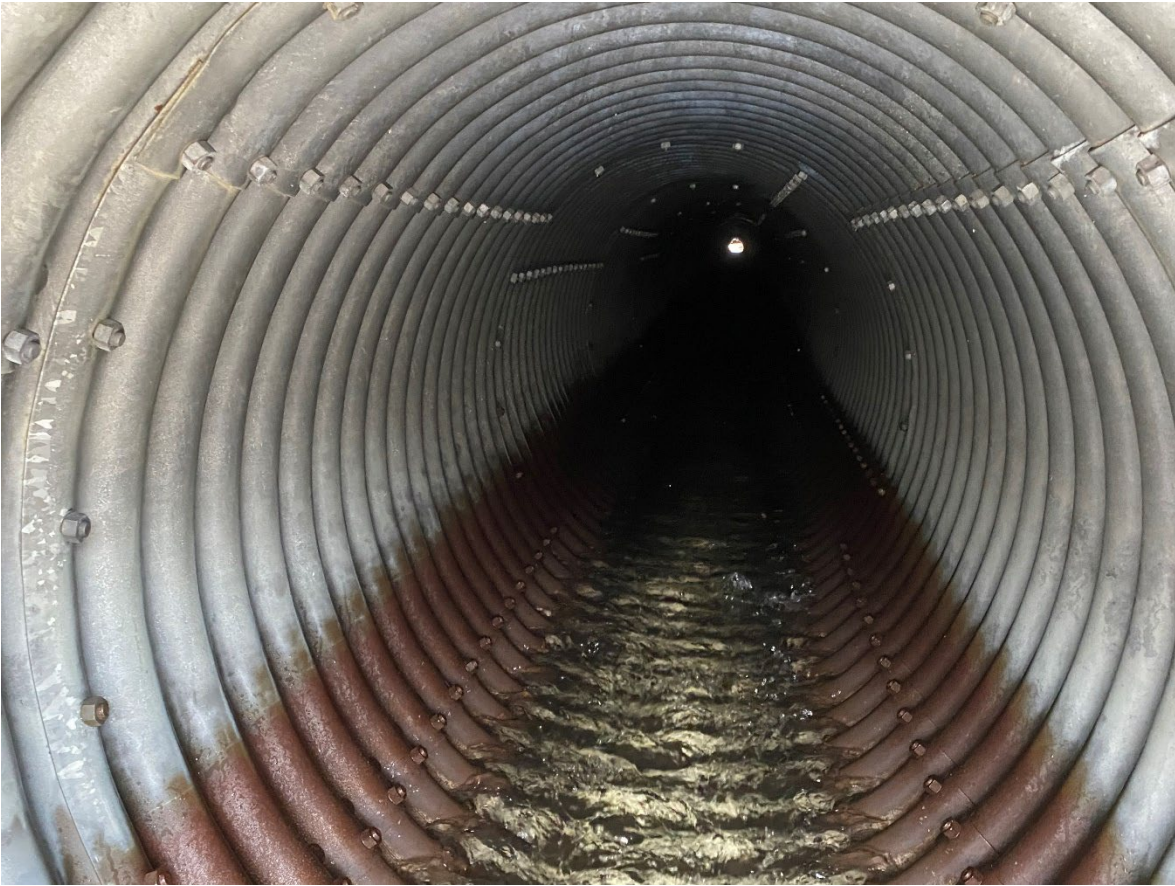
Looking up through culvert to the inlet from the outlet side.

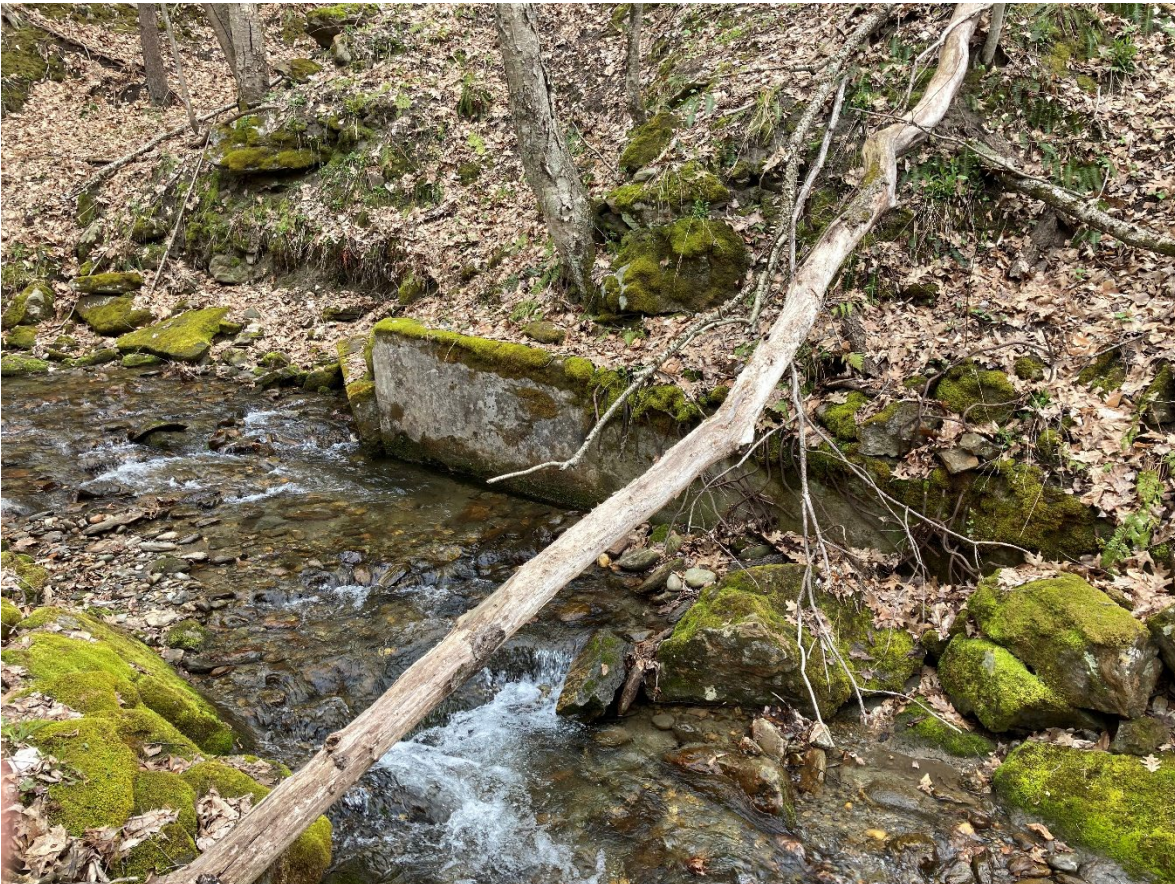
Concrete "wingwall" on east bank upstream of inlet.

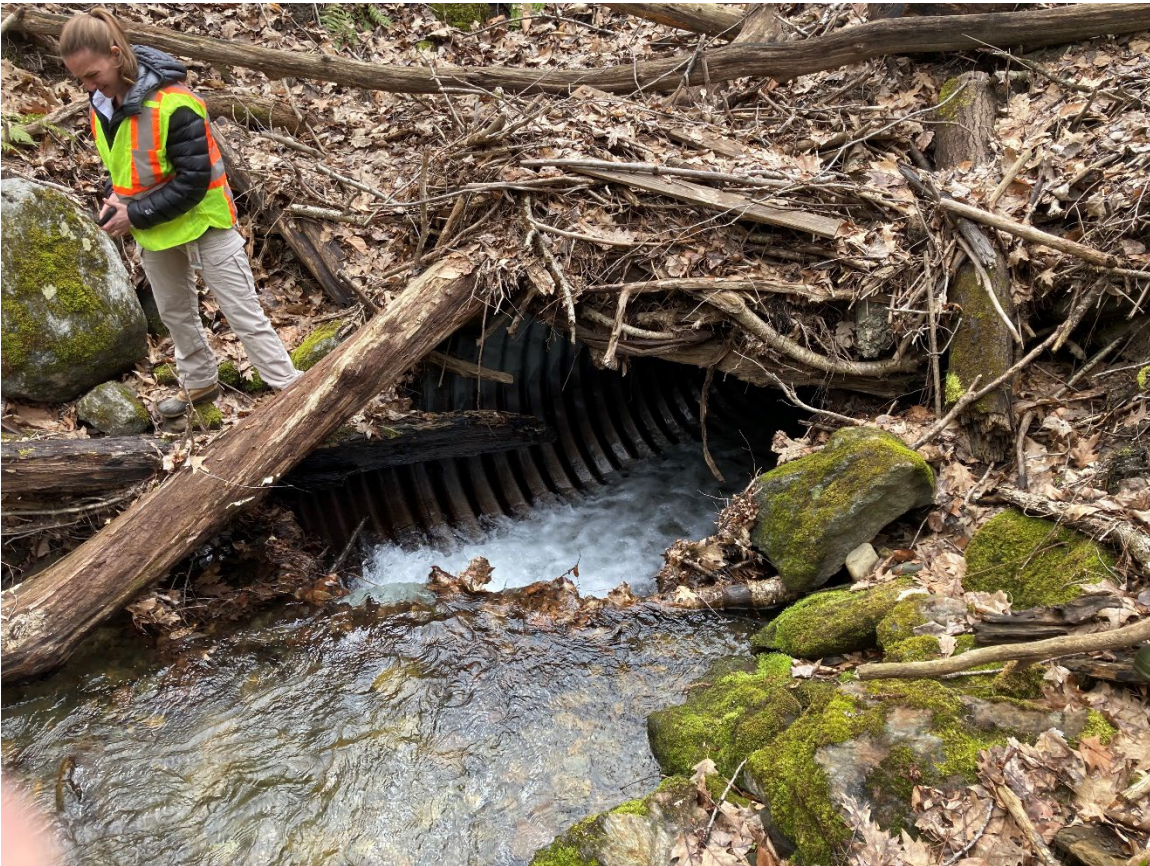
Inlet of PID68002, close up of woody debris.

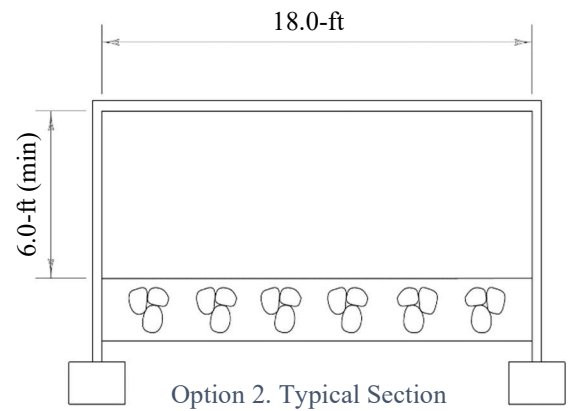
Model Results: This structure results in freeboard of 2.7 and 2.4 -feet at the design and check AEP, respectively.

Hydraulic Standards: This option meets both the current hydraulics standards and state stream equilibrium standards for bankfull width. Option 2 does not increase the 100-year base flood elevations.

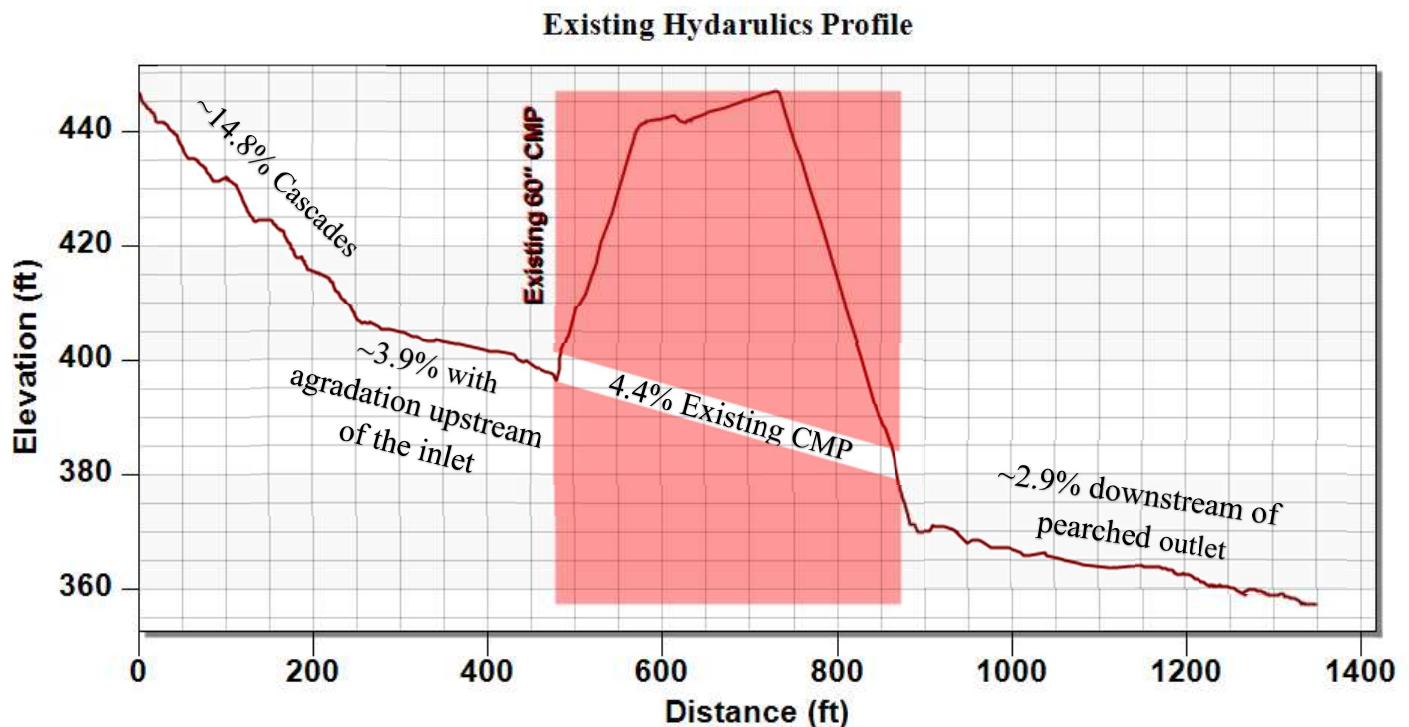
Figure 1: Existing profile generated from survey and lidar elevation data.

For options 1 and 2, E-Stone, Type III will need to be used to grade the channel through the respective structures. The channel has significant aggradation upstream of the structure and channel/bank erosion downstream of the structure, see figure 1. We recommend an approximate proposed structure slope of 4.4 to 5.5% and regrading the upstream channel with E-stone, Type III to allow for a better profile alignment, see figure 2. If this grading recommendation cannot be met, please coordinate with the hydraulics unit on other proposed structure slopes. Stone Fill, Type III shall be used to protect any disturbed channel banks or roadway slopes at the structure's inlet and outlet.

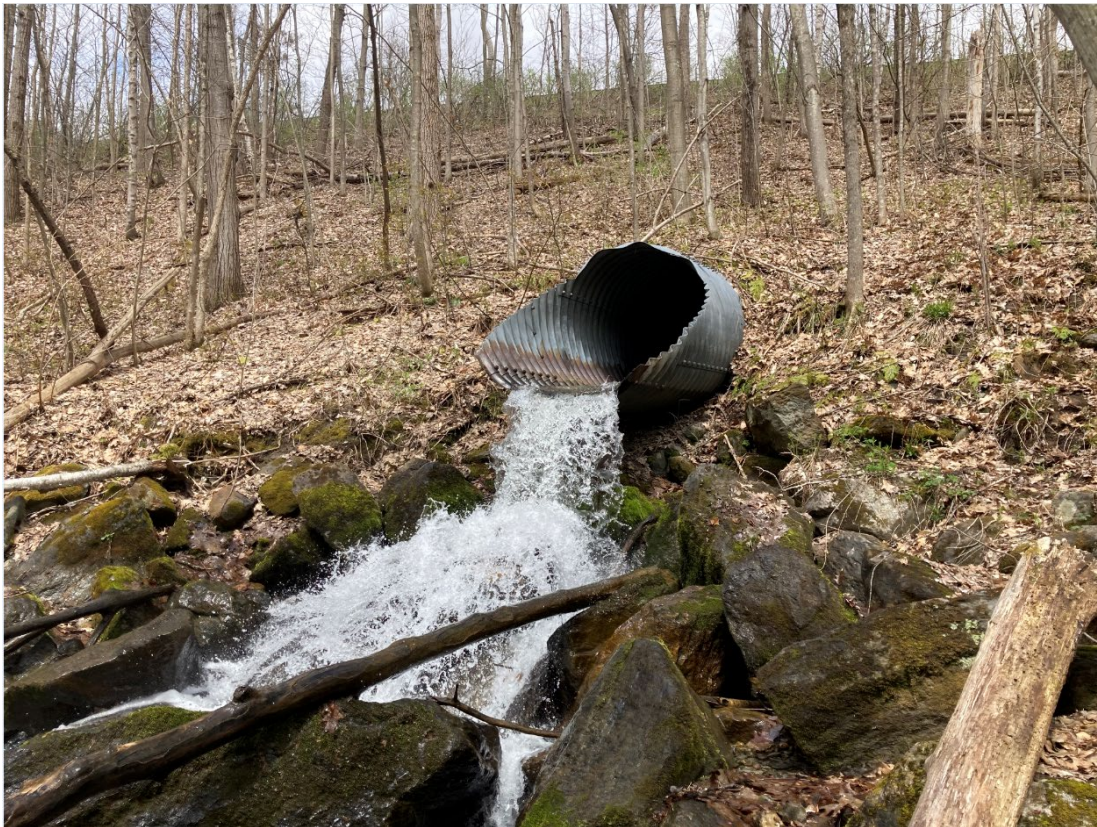
Figure 1: *Outlet of the Pipe Showing Steep Wooded Embankment*

A site investigation was not conducted by Geotechnical Section staff however photos from inspections, a site visit conducted by the Structures Section, and satellite imagery were reviewed to evaluate the feasibility of boring operations and assess general site conditions as they relate to the proposed project. Overhead utilities run along the north side of US 2 in the location of the culvert. The subsurface investigation can be adjusted to avoid the overhead utilities and still evaluate the subsurface conditions in this location. The embankments are steep and heavily vegetated which can be seen in Figure 1. If borings are requested in the area of the inlet and outlet, access will need to be constructed and the trees will need to be cleared.

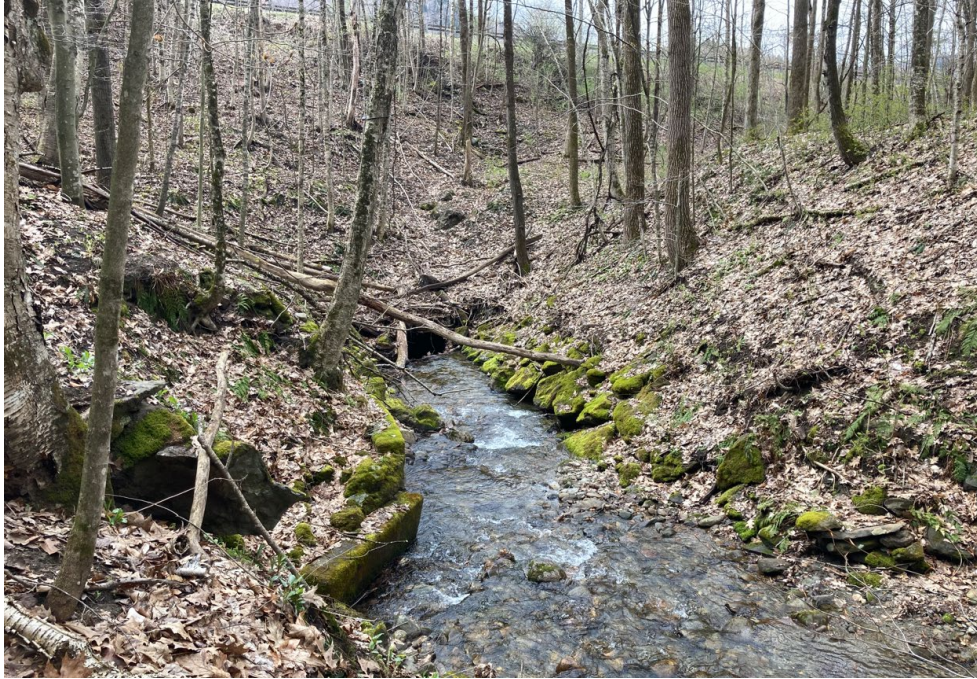
Image of culvert at north (inlet) end. Note concrete slabs center left and row of stones (rip rap) center right of stream channel

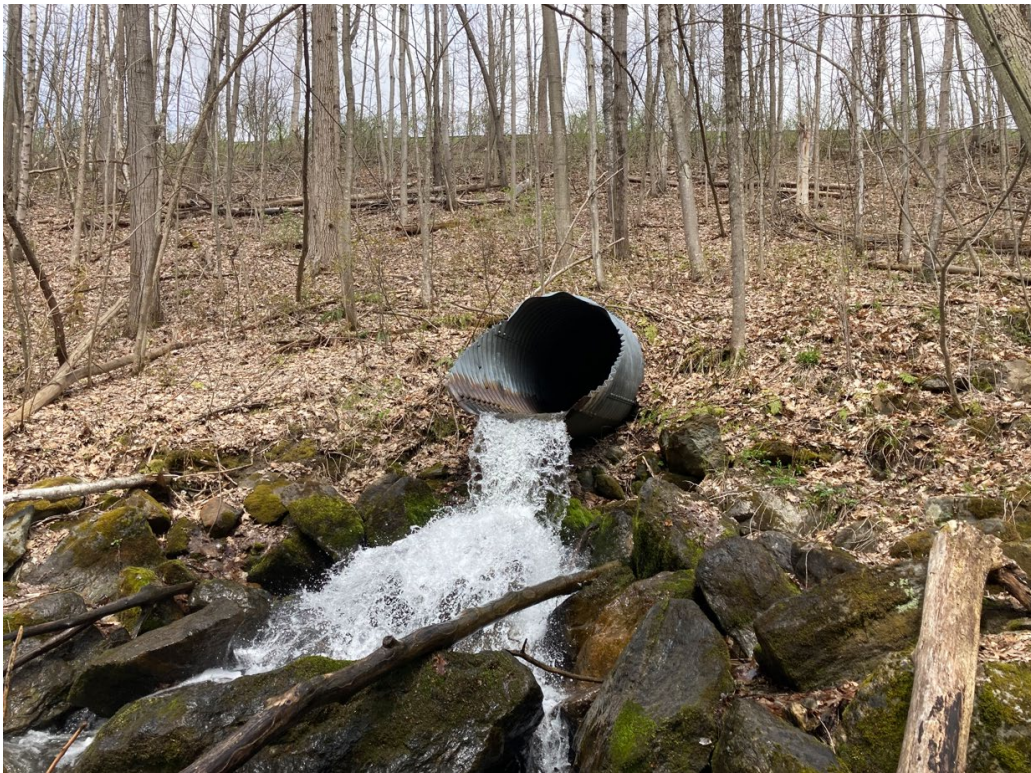
View of outlet end from base of slope looking upward toward I-89

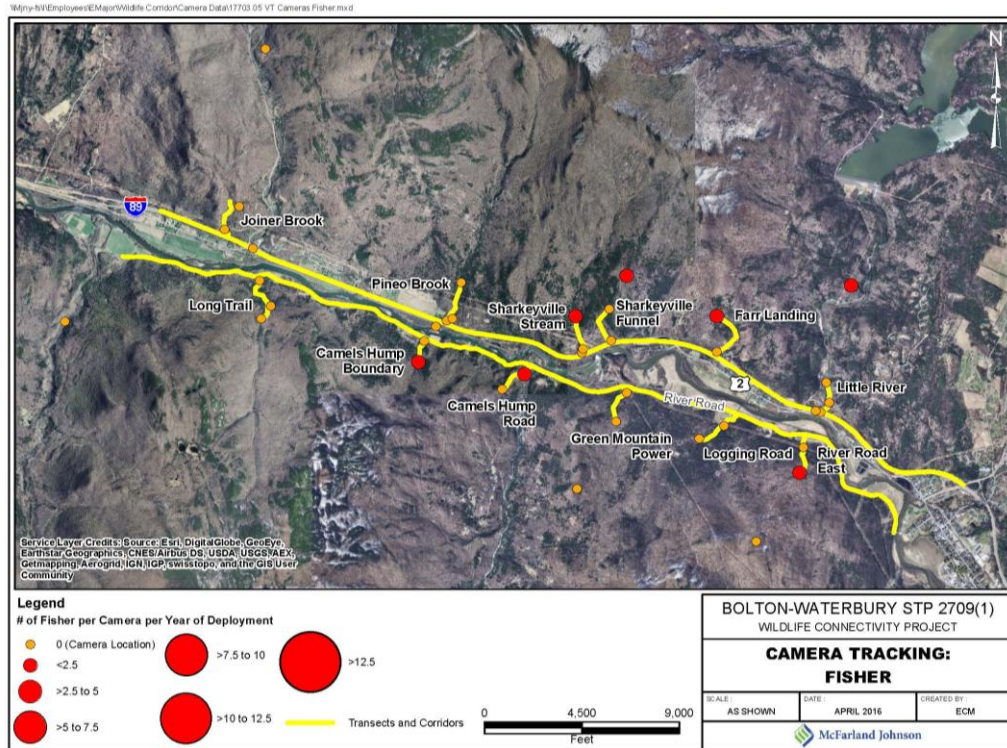
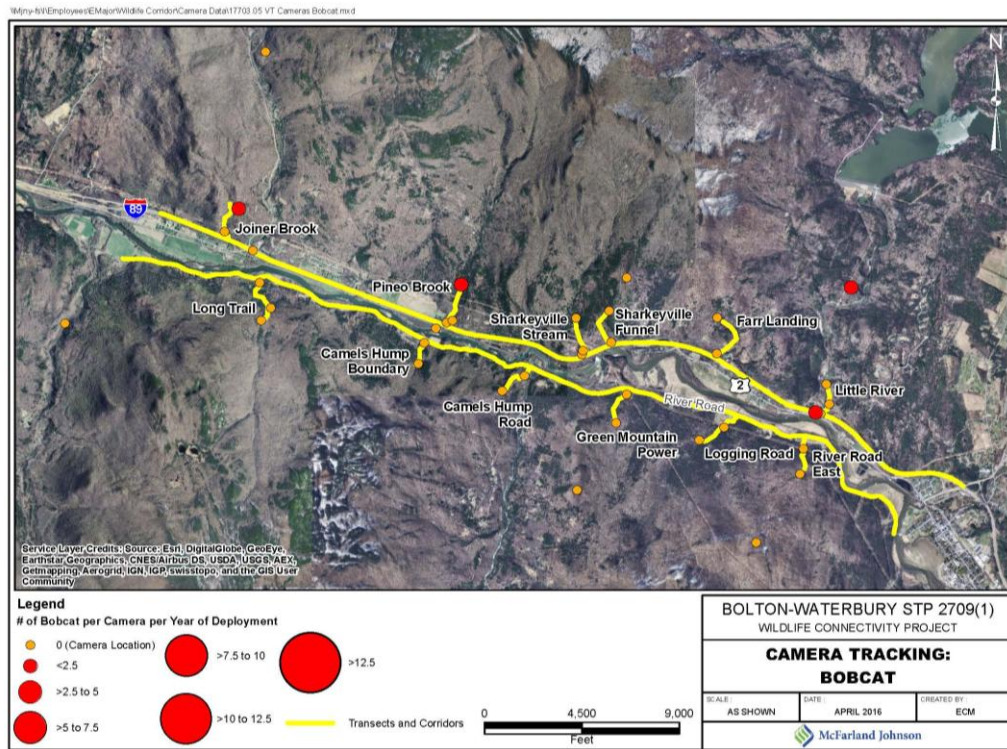
Figure 10. Number of fishers photographed at each camera station (per camera/year)

Figure 11. Number of bobcats photographed at each camera station (per camera/year)

- Fishers and bobcats (Figures 10 and 11), based on a relatively small number of photographs, were most abundant at the Far and Remote camera stations. Fishers were only photographed at one Near camera, at no culvert or bridge cameras, and at only one camera in the western half of the study area. Bobcats were photographed at two Far cameras, one Remote camera, and the Little River bridge, all on the north side of the corridor.

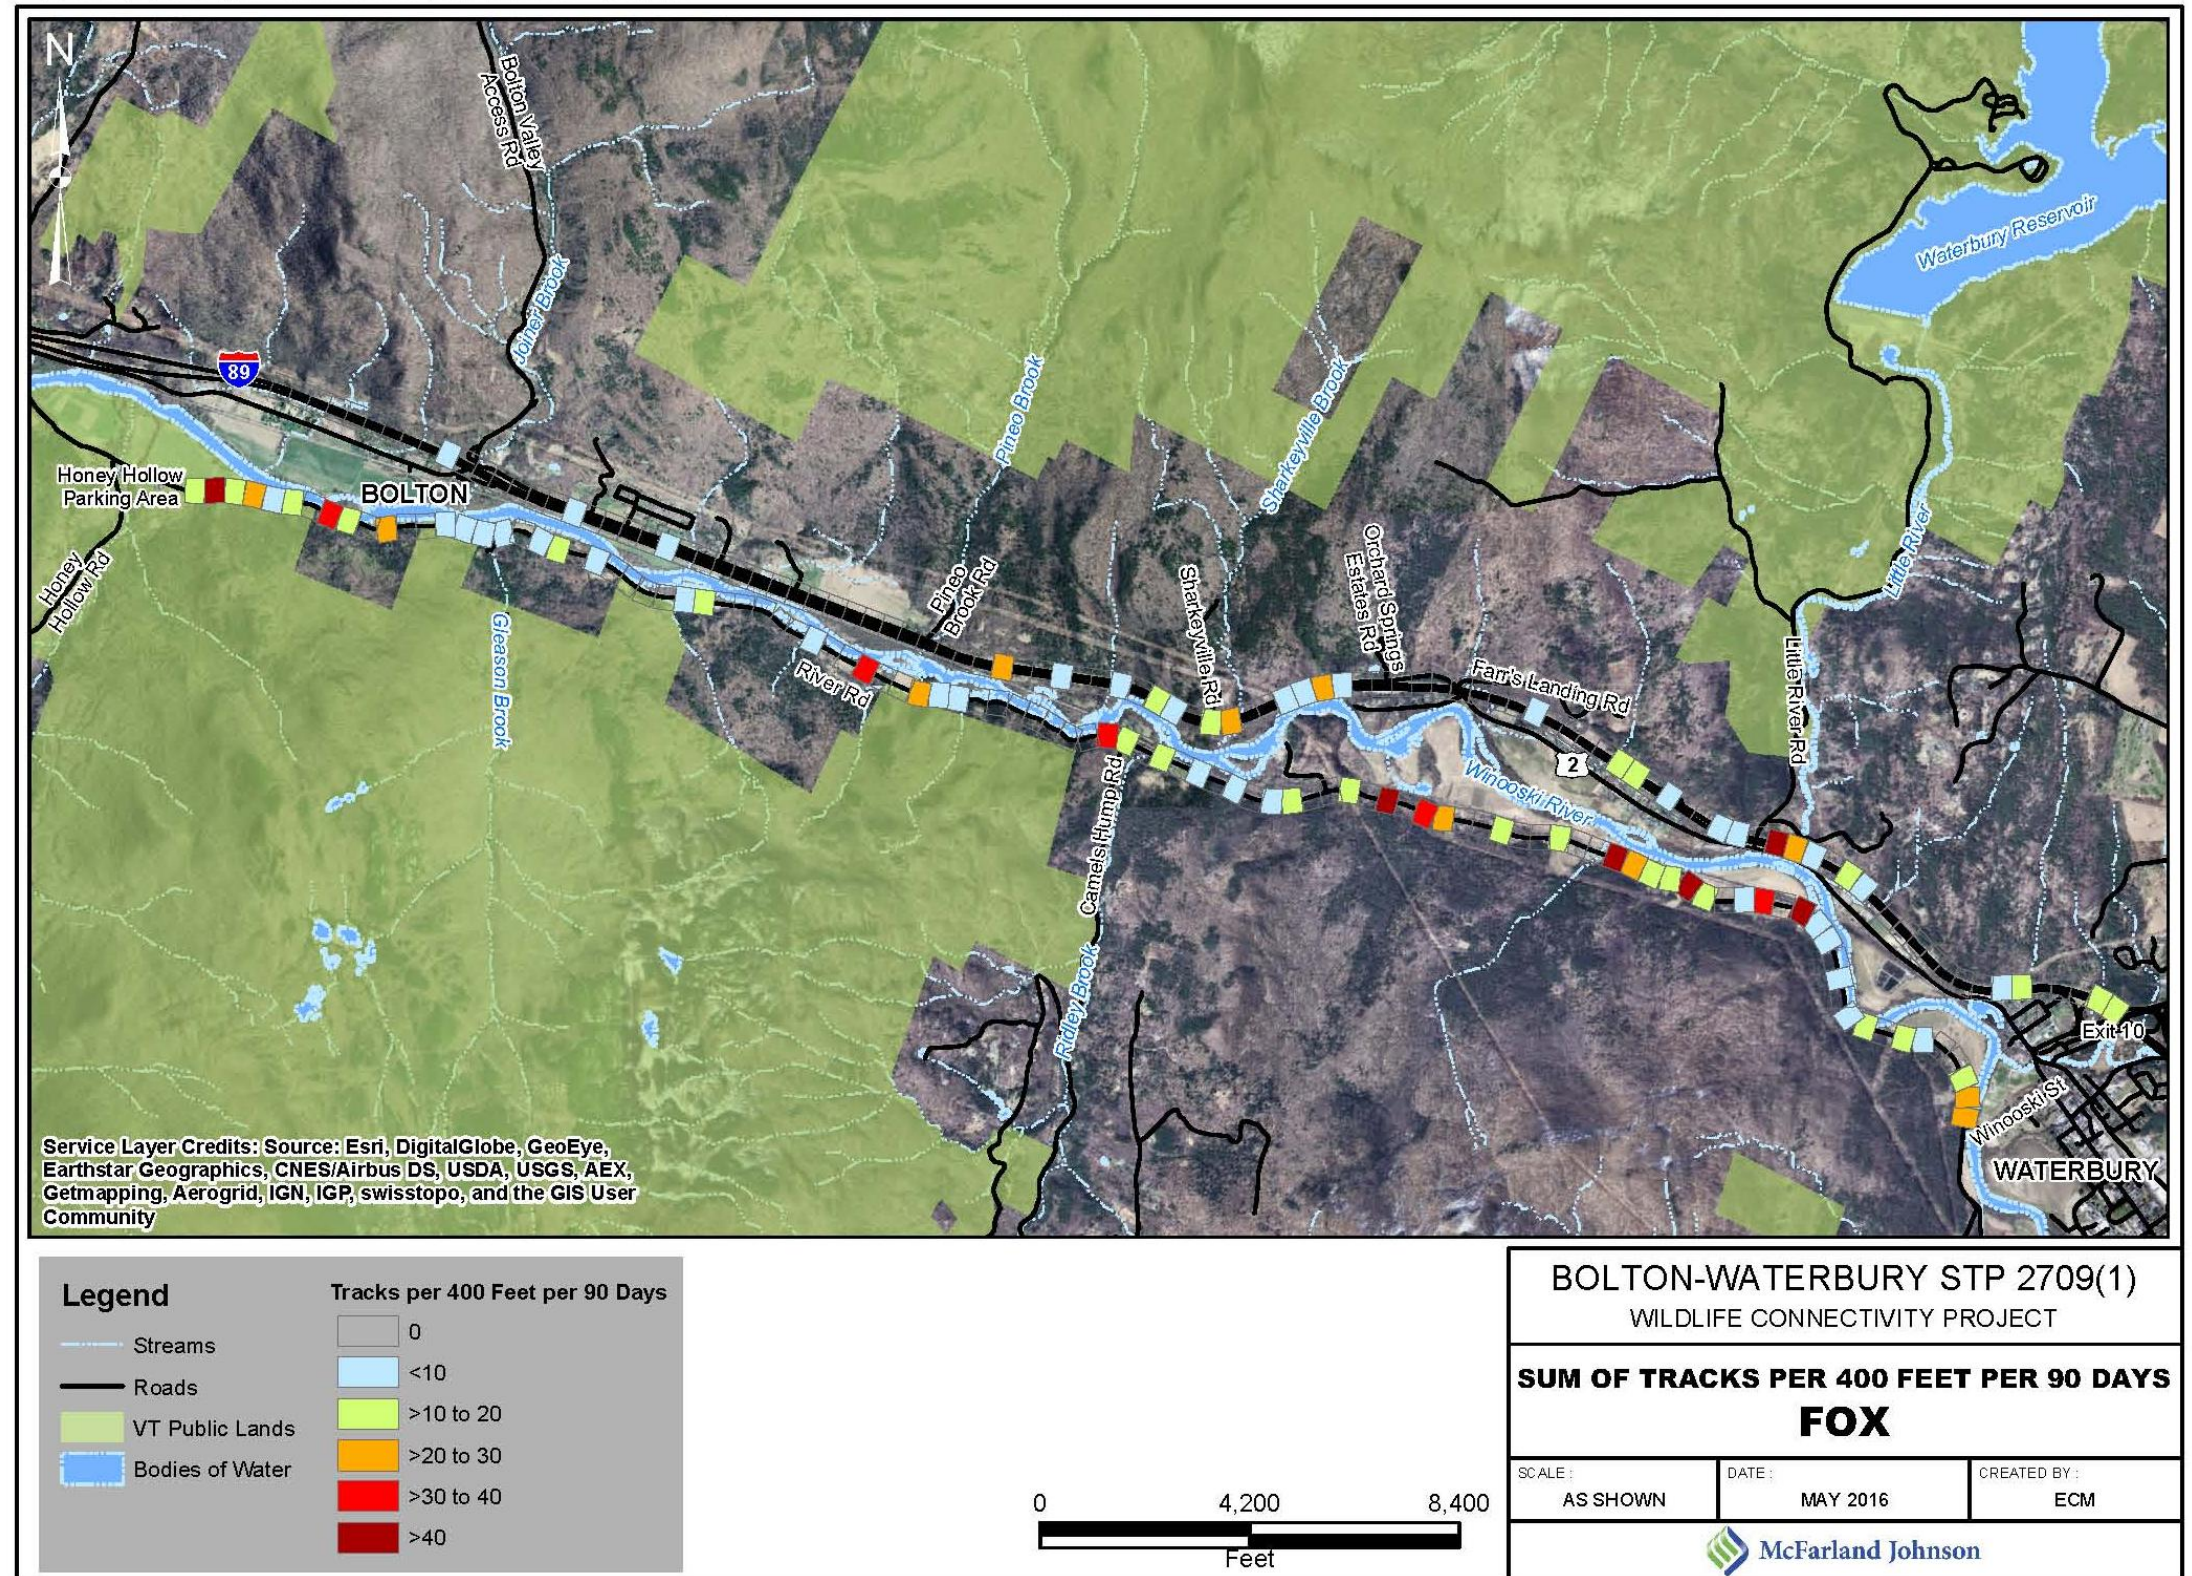
Figure 38. Track densities along I-89 and River Road segments – fox

Note: Track densities include partial road crossings, full road crossings, and crossings through culverts and bridges

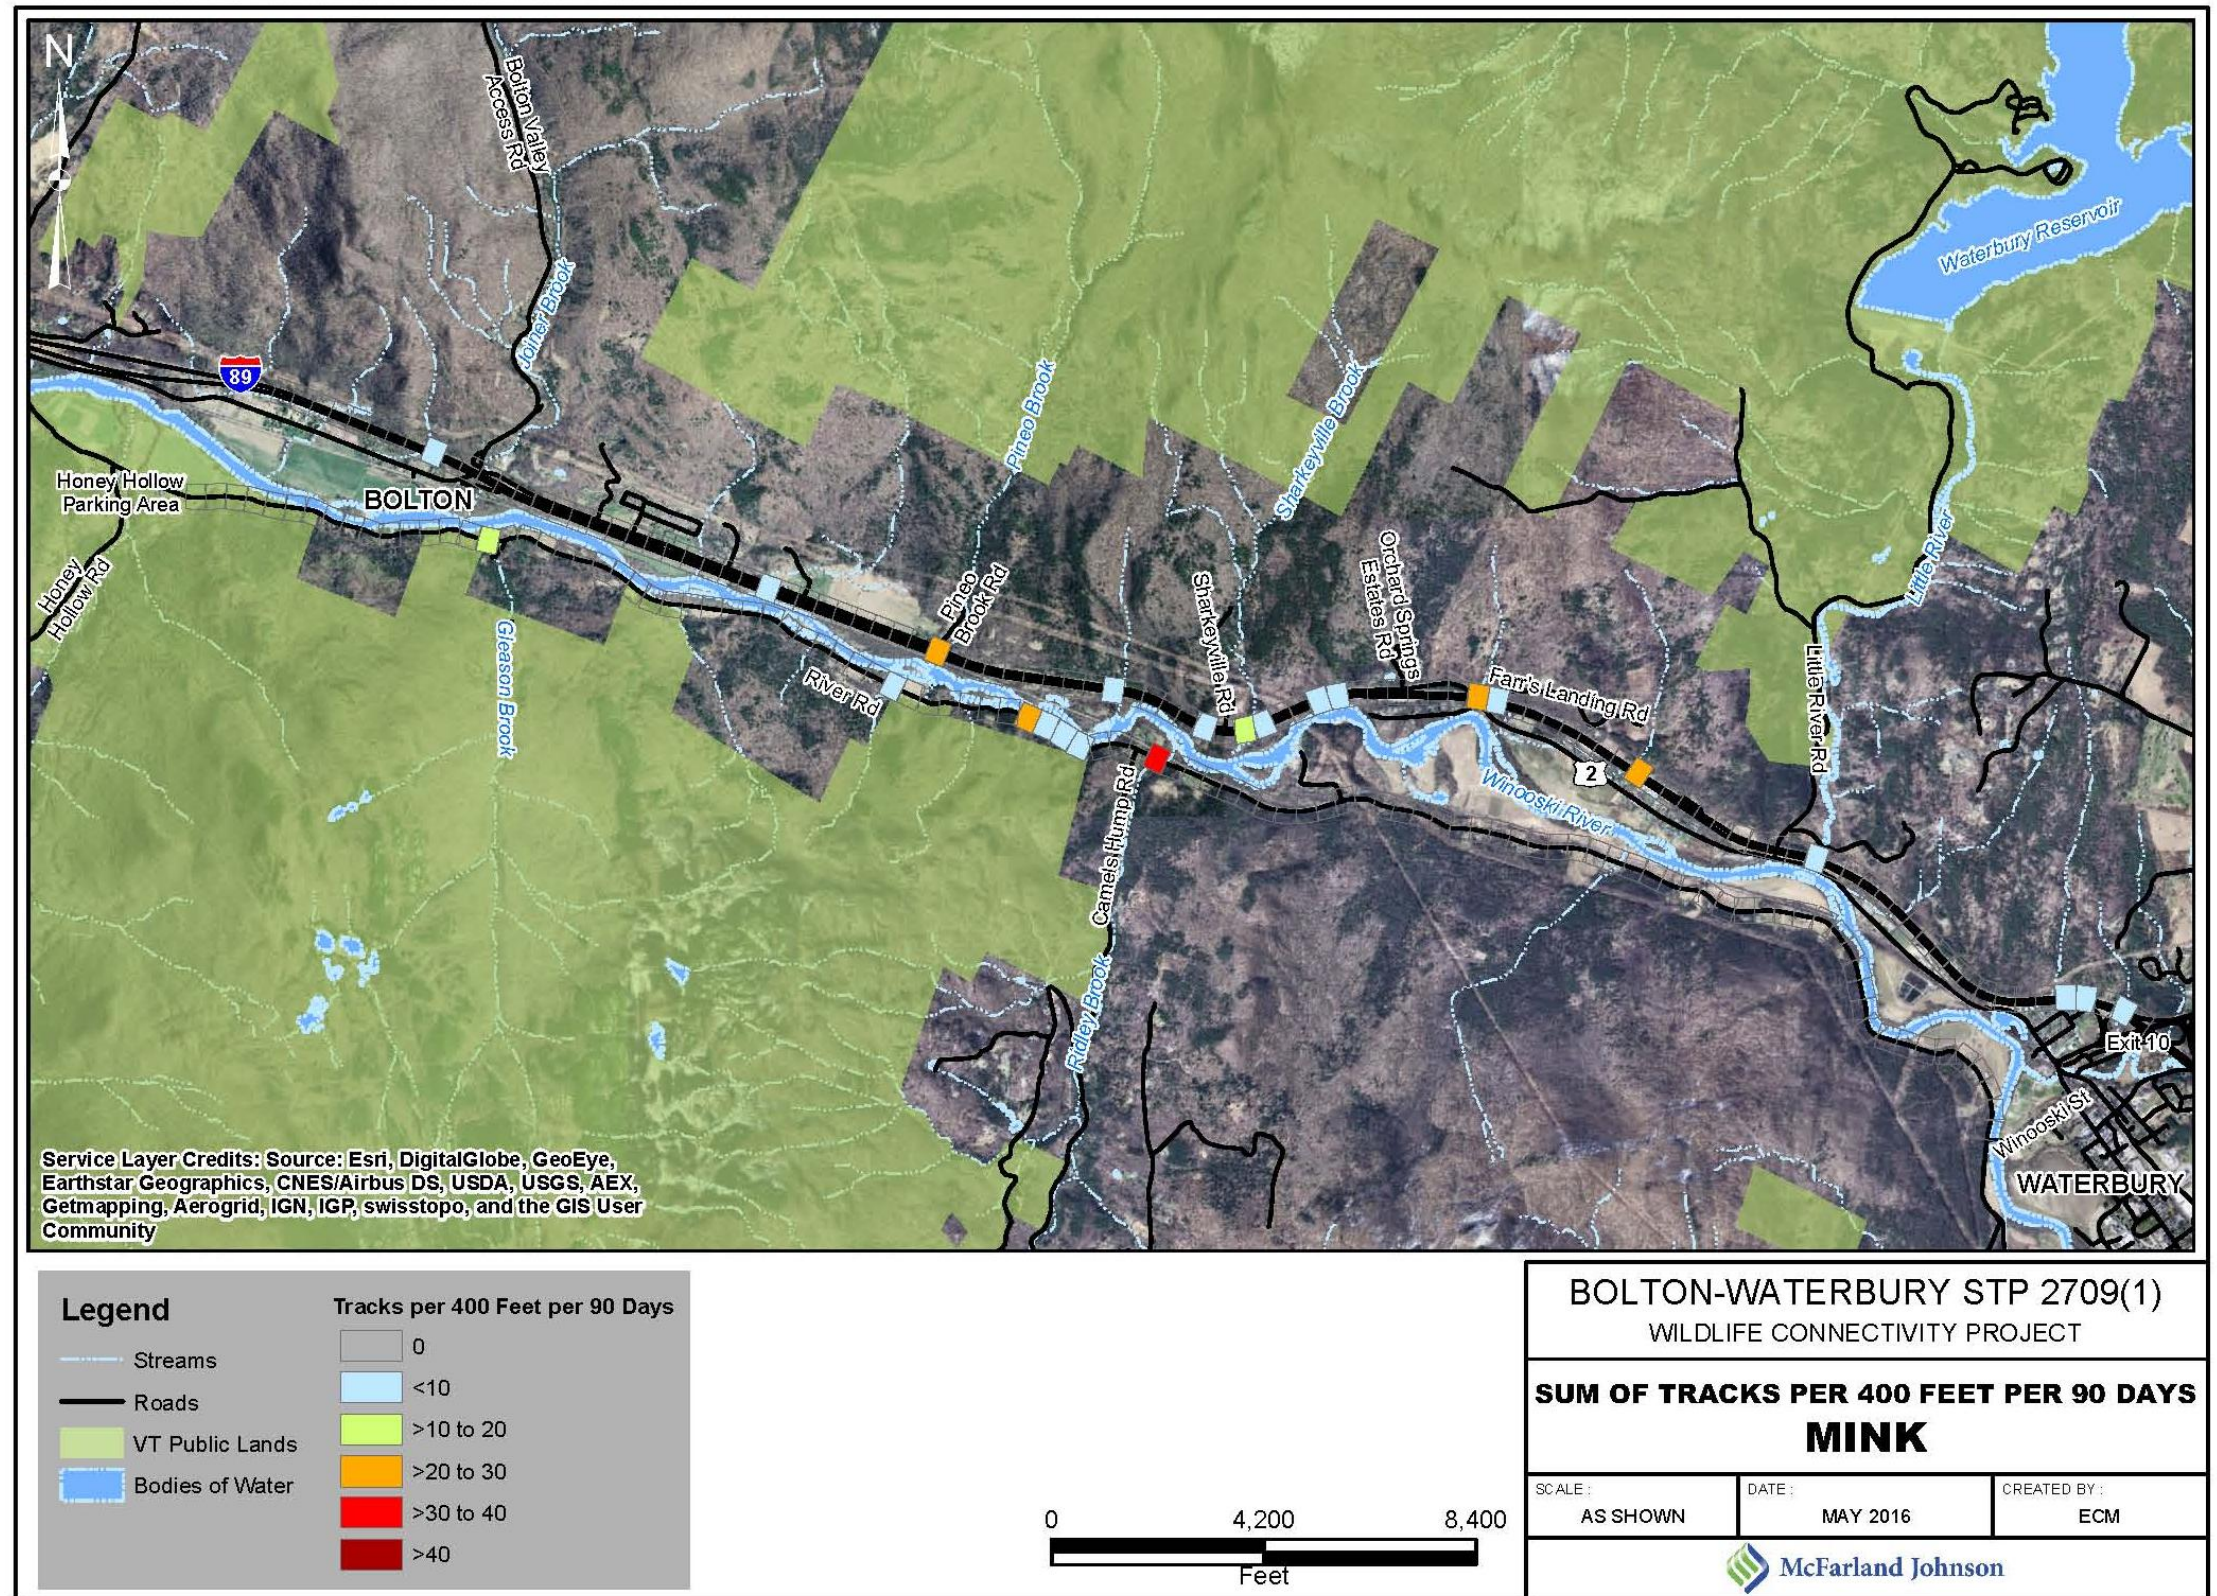
Figure 40. Track densities along I-89 and River Road segments – mink

Note: Track densities include partial road crossings, full road crossings, and crossings through culverts and bridges

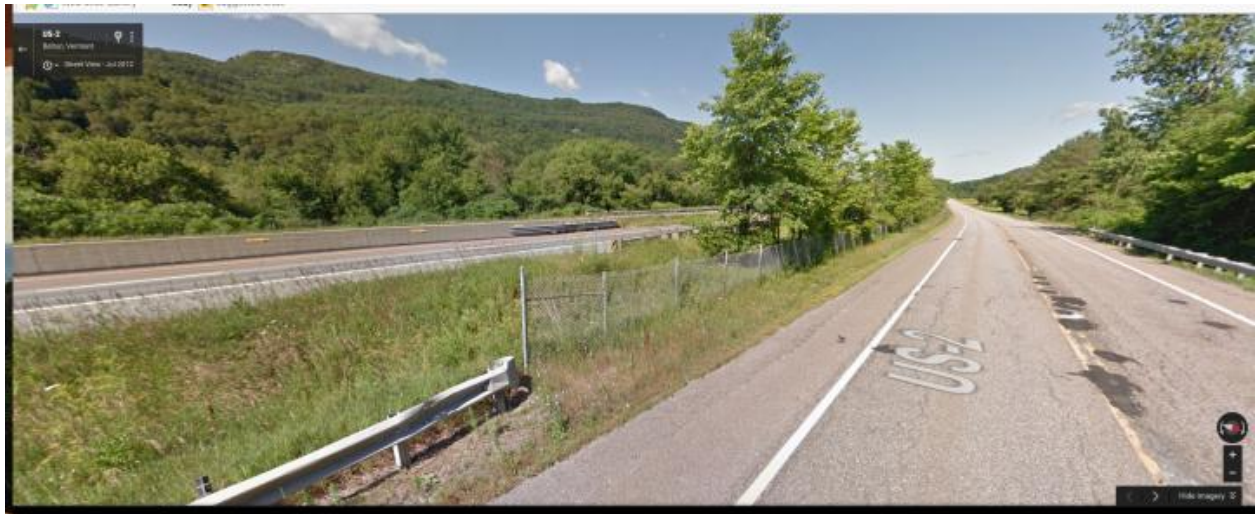
Photo 2. End of chain link fence and beginning of median Jersey barrier

(Facing west in the vicinity of Pineo Brook Road - Google Street View image)

between I-89 and US Route 2, as shown in Photos 2 and 3 below. Portions of the fence have fallen down or become overgrown with vegetation, but the fence is largely intact and may be a barrier to some species. There are anecdotal reports of the fence deterring animals from successfully crossing the roadway corridor.

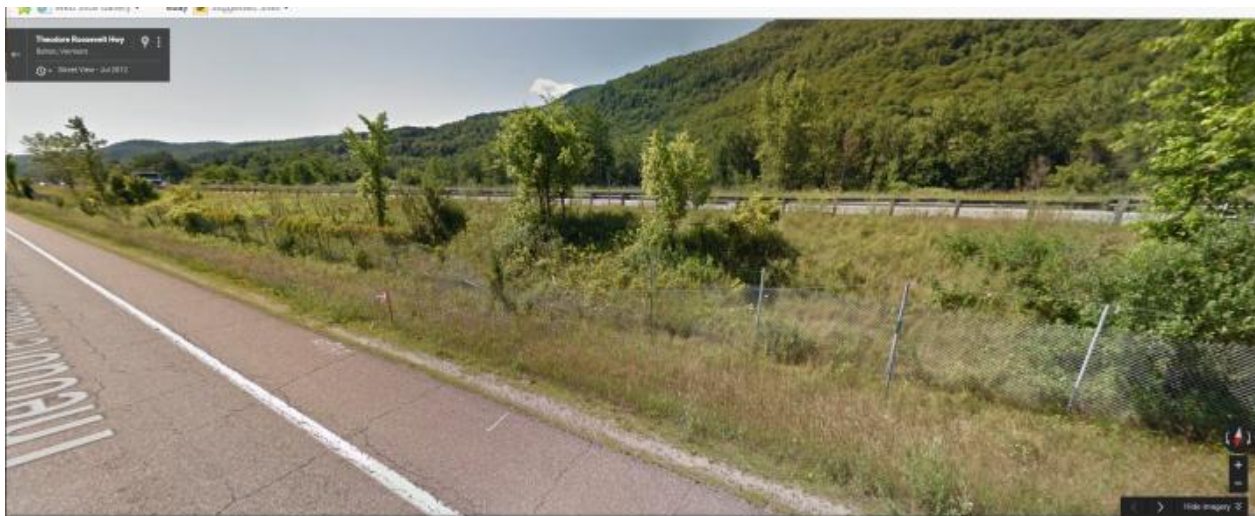
Photo 3. Condition of chain link fence

(Between I-89 and US 2 between Pineo and Joiner Brooks – Google Maps image)

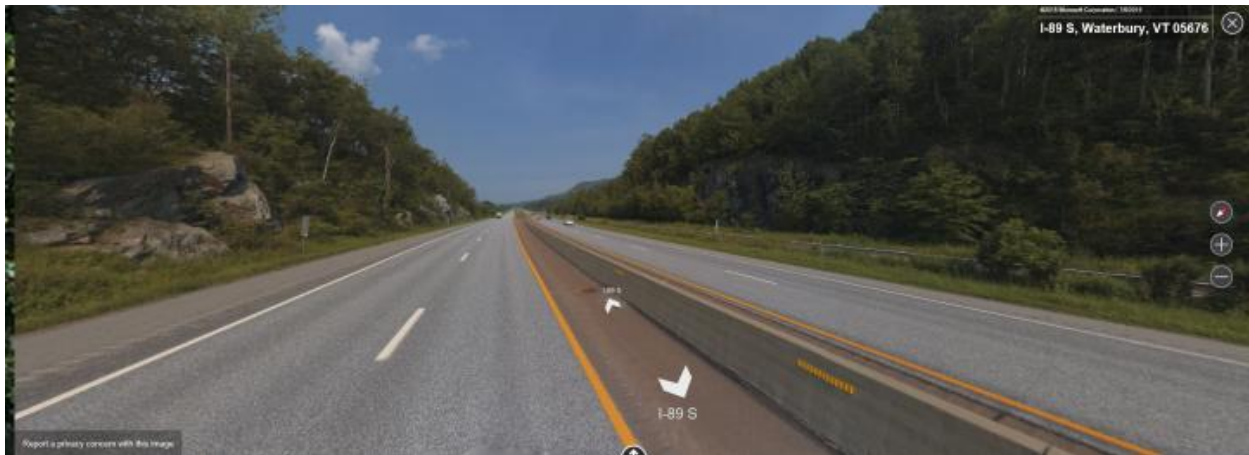
Photo 4. Segment with Jersey barrier in median and rock cuts on both sides of I-89

(east of Pineo Brook - Bing Maps image)

From Pineo Brook Road and continuing east past Sharkeyville Road and the east end of the Jersey barriers roughly to Orchard Springs Estates, there were relatively high numbers of tracks, crossing both over the highway (55 animals) and through culverts (27 animals). The most common animals crossing over the road included coyote, deer, and fox, plus 3 fishers and 1 raccoon. The common animals using culverts included mink and fox, along with 3 raccoons and 2 each of coyote, weasel, and fisher. The effect of the Jersey barrier on animal movement is not known, though it may deter smaller animals from crossing. There is a possible divide at the sharp curve in the road, where there is a rock cut and a segment of chain link fence (see Figure 4 and Photos 4 and 5 below).

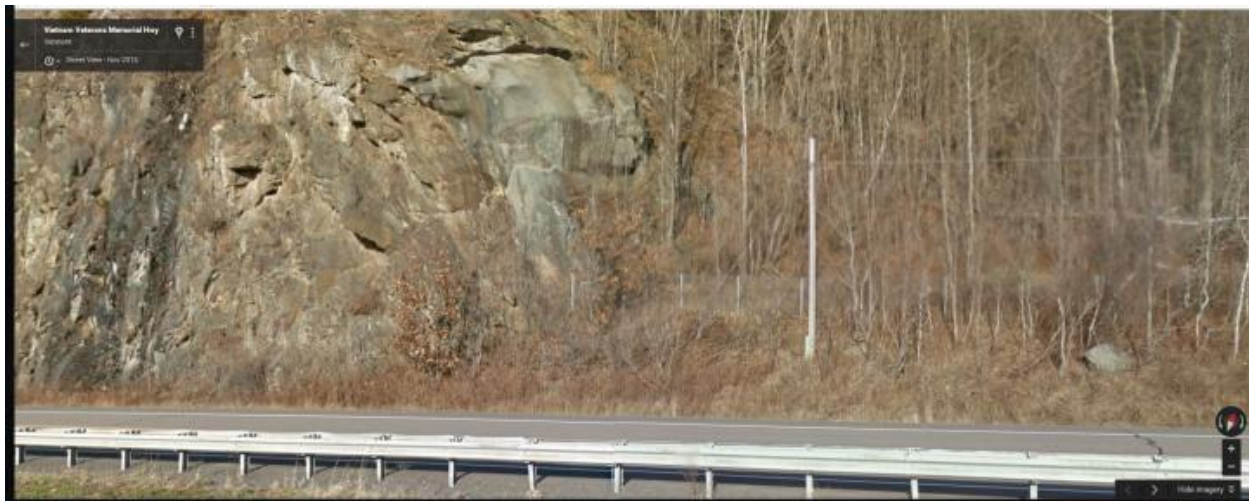
Photo 5. Chain link fence meeting rock cut section

(Between Sharkeyville and Orchard Estates near MM 67.1 – Google Maps image)

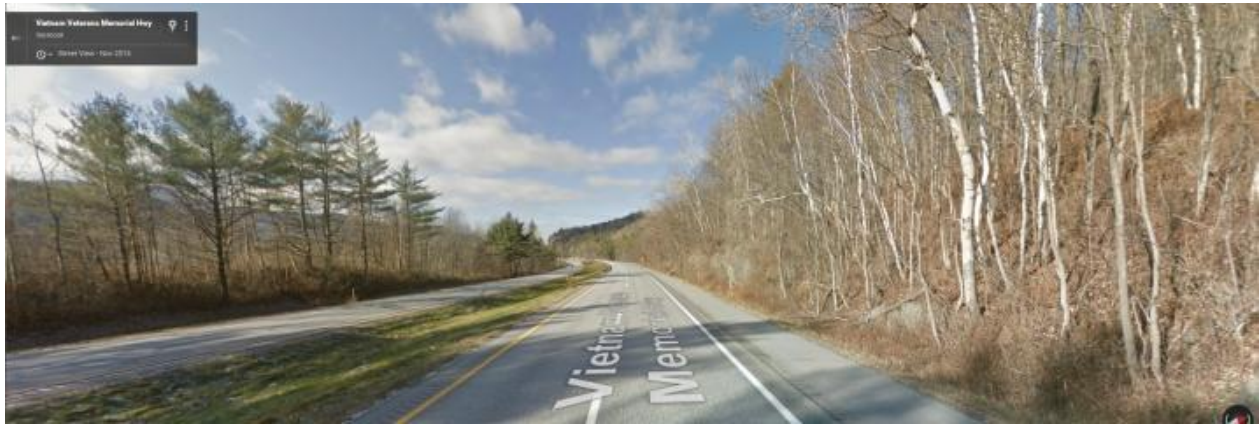
Photo 7. I-89 forested both sides to pavement edge with no obvious barriers

(East of Little River – Google Maps image)

East of the Little River bridge to the Exit 10 ramps (Photo 7), animal tracks were spotty. Of 40 sets of tracks, 32 crossed over the road surface and 8 passed through culverts. Crossing over the road were 7 coyotes and lesser numbers of fox, weasel, hare, mink, deer, fisher, raccoon, and cottontail. Using culverts were 6 foxes and 2 raccoons.

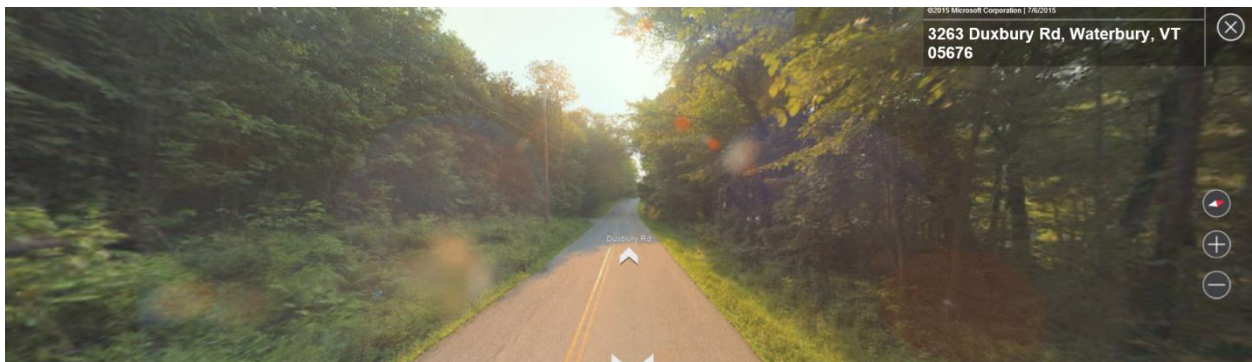
Photo 8. Typical segment of River Road (Duxbury Road) in study area

(Western portion of road – Bing Maps image)

River Road had a generally higher density of animal tracks than I-89. There are few obvious patterns along River Road, and most of the road appears to be highly permeable to wildlife movement. The two sections of River Road immediately west of the Camel’s Hump Boundary transect and the Logging Road transect both had relatively few animal tracks. These correspond to segments of I-89 with relatively low numbers of tracks. The primary focus species may be more concentrated on River Road near the middle and western sections of the road, which correspond to concentrations on I-89. However, the patterns are not distinct and it is difficult to draw any conclusions regarding links between findings on I-89 and River Road. Comparing the numbers of individual species on I-89 and River Road, there was more coyote traffic on I-89 and more fisher and fox activity on River Road.
