**STATE OF VERMONT
AGENCY OF TRANSPORTATION**

Scoping Report

**FOR
WATERBURY IM CULV(109)**

I-89 & US2 PID 68002 OVER SHARKEYVILLE BROOK

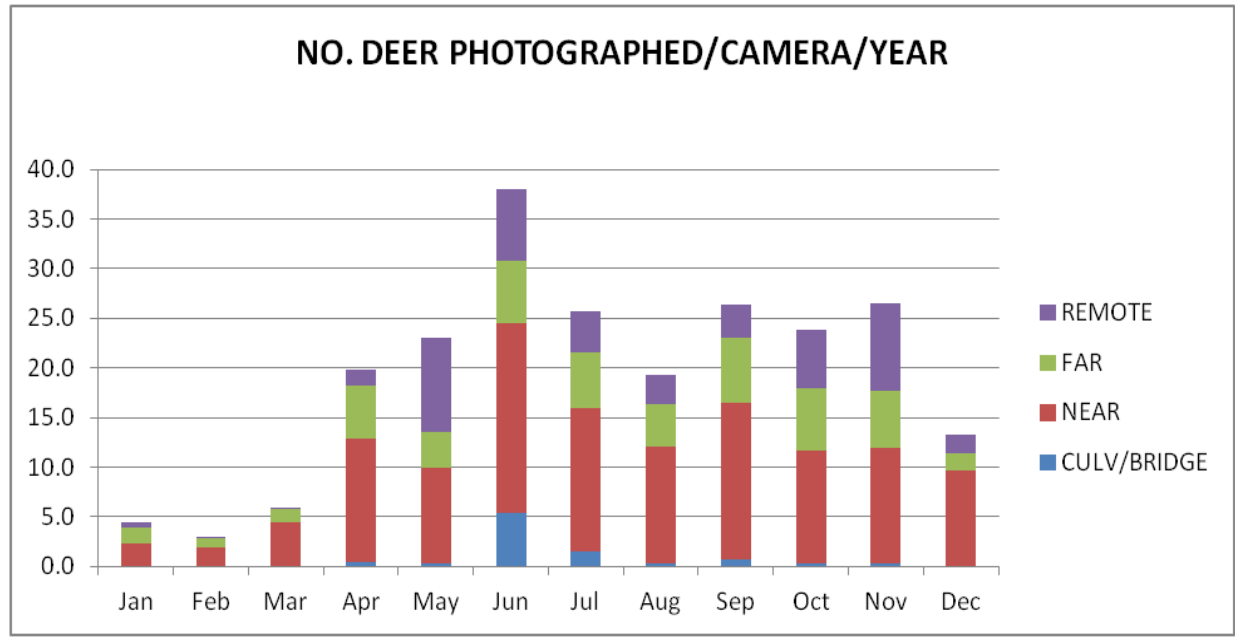
Figure 45. Numbers of deer photographed by month of year and corridor location

Cameras showed more deer near the roadways (Near cameras), while winter transect tracking encountered more deer at the more distant portions of the transects. To determine whether the deer have a different winter distribution that would explain this result, the camera data were analyzed by month (Figure 45).

As shown in the figure, there are more deer at the Near cameras (compared to the Far and Remote cameras) all year round, including winter, when tracking found more deer further from the roads. It is possible that either the transect or camera results reflect pockets of deer activity that skew the results. It is a reminder that the study, while covering a broad area, relies on specific locations – camera stations, roads, and transects – for the data, and does not necessarily yield results that can be extrapolated to the entire study area.

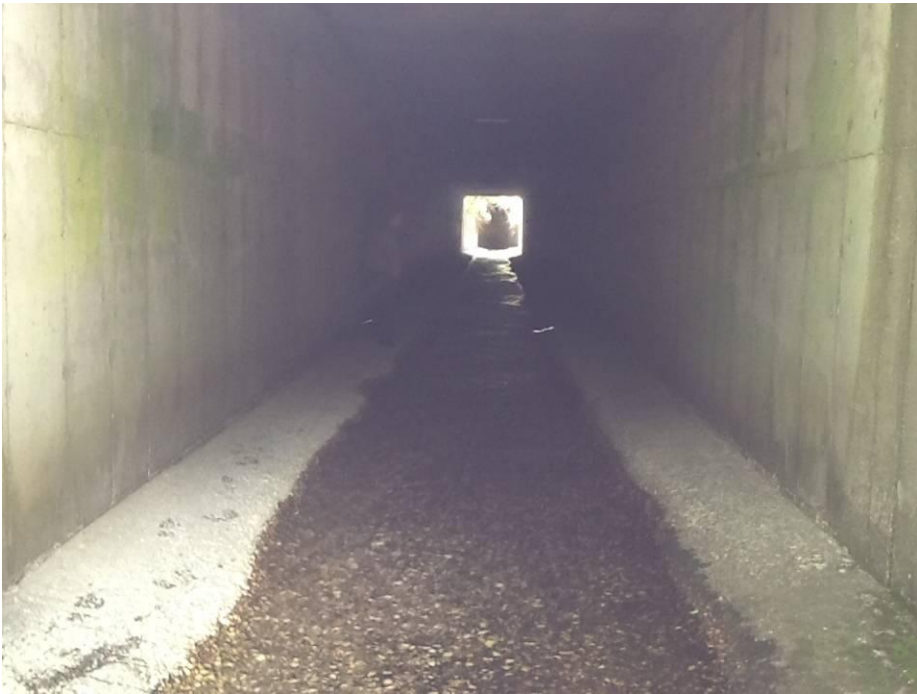
Interior of Pineo Brook culvert, with I-89 median opening visible

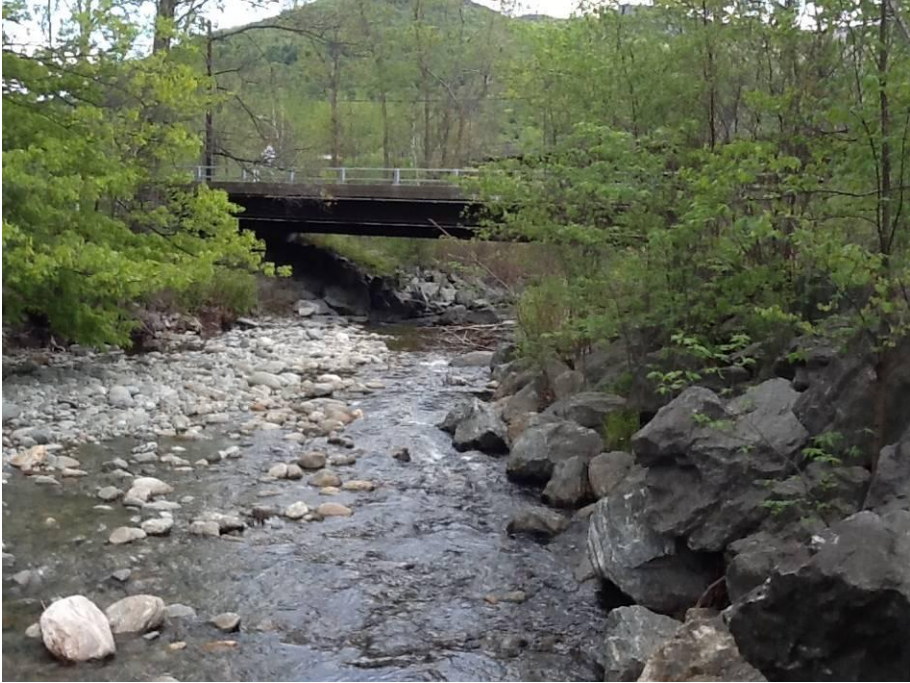
US Route 2 bridge over Joiner Brook

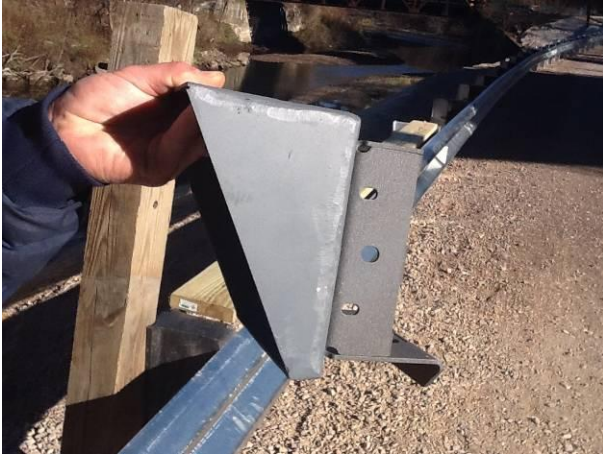
Fabricated housing for angling camera down

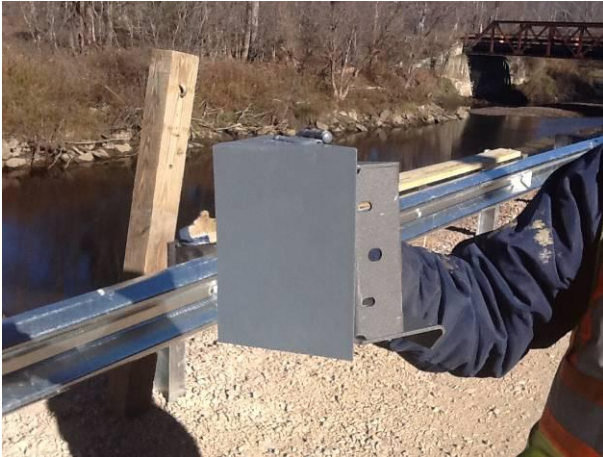
Fabricated housing for angling camera to the side

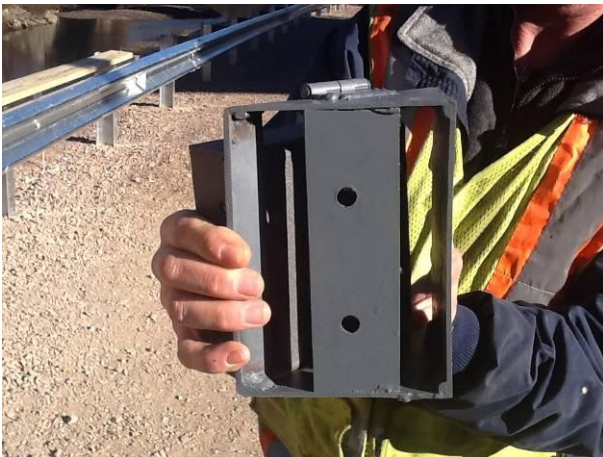
Back side of fabricated housing for angling to the side

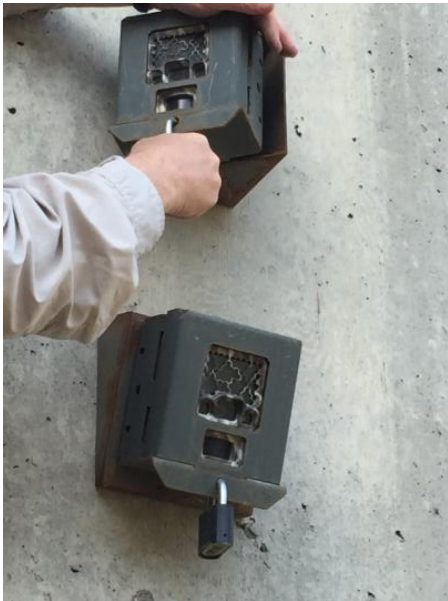
Cameras being installed on abutment, one angled down, the other angled to the side

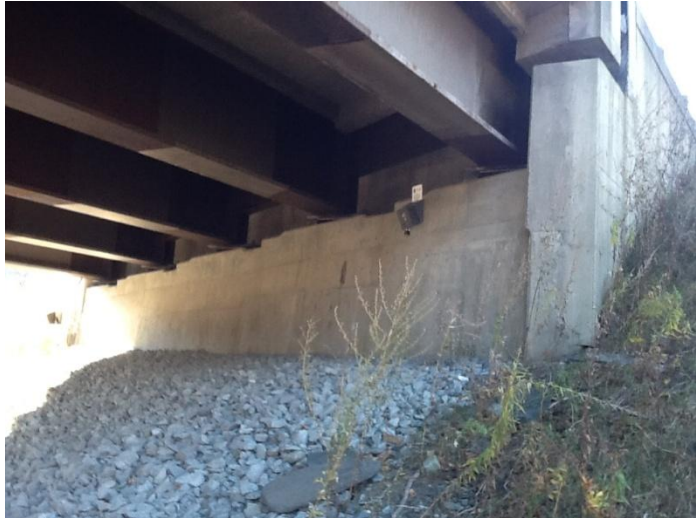
Camera on western bridge abutment

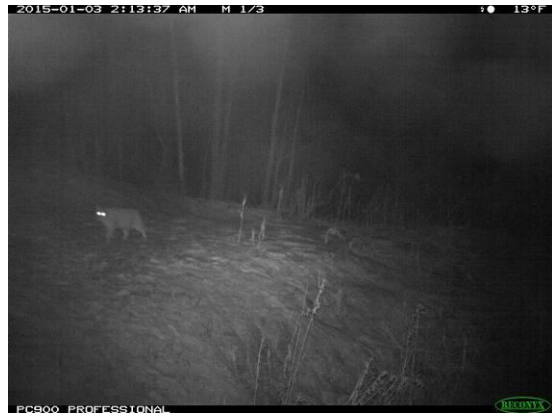
Bobcat on constructed shelf under Little River bridge

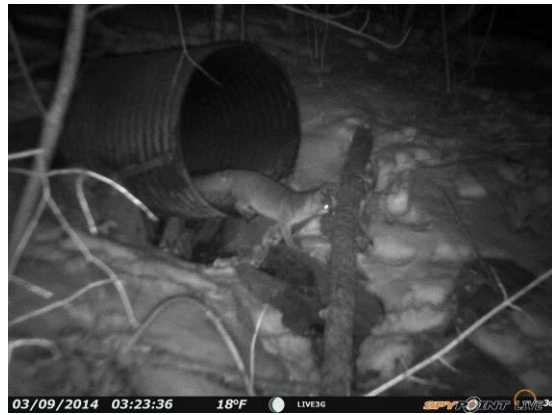
Fox exiting culvert (VTrans photo)

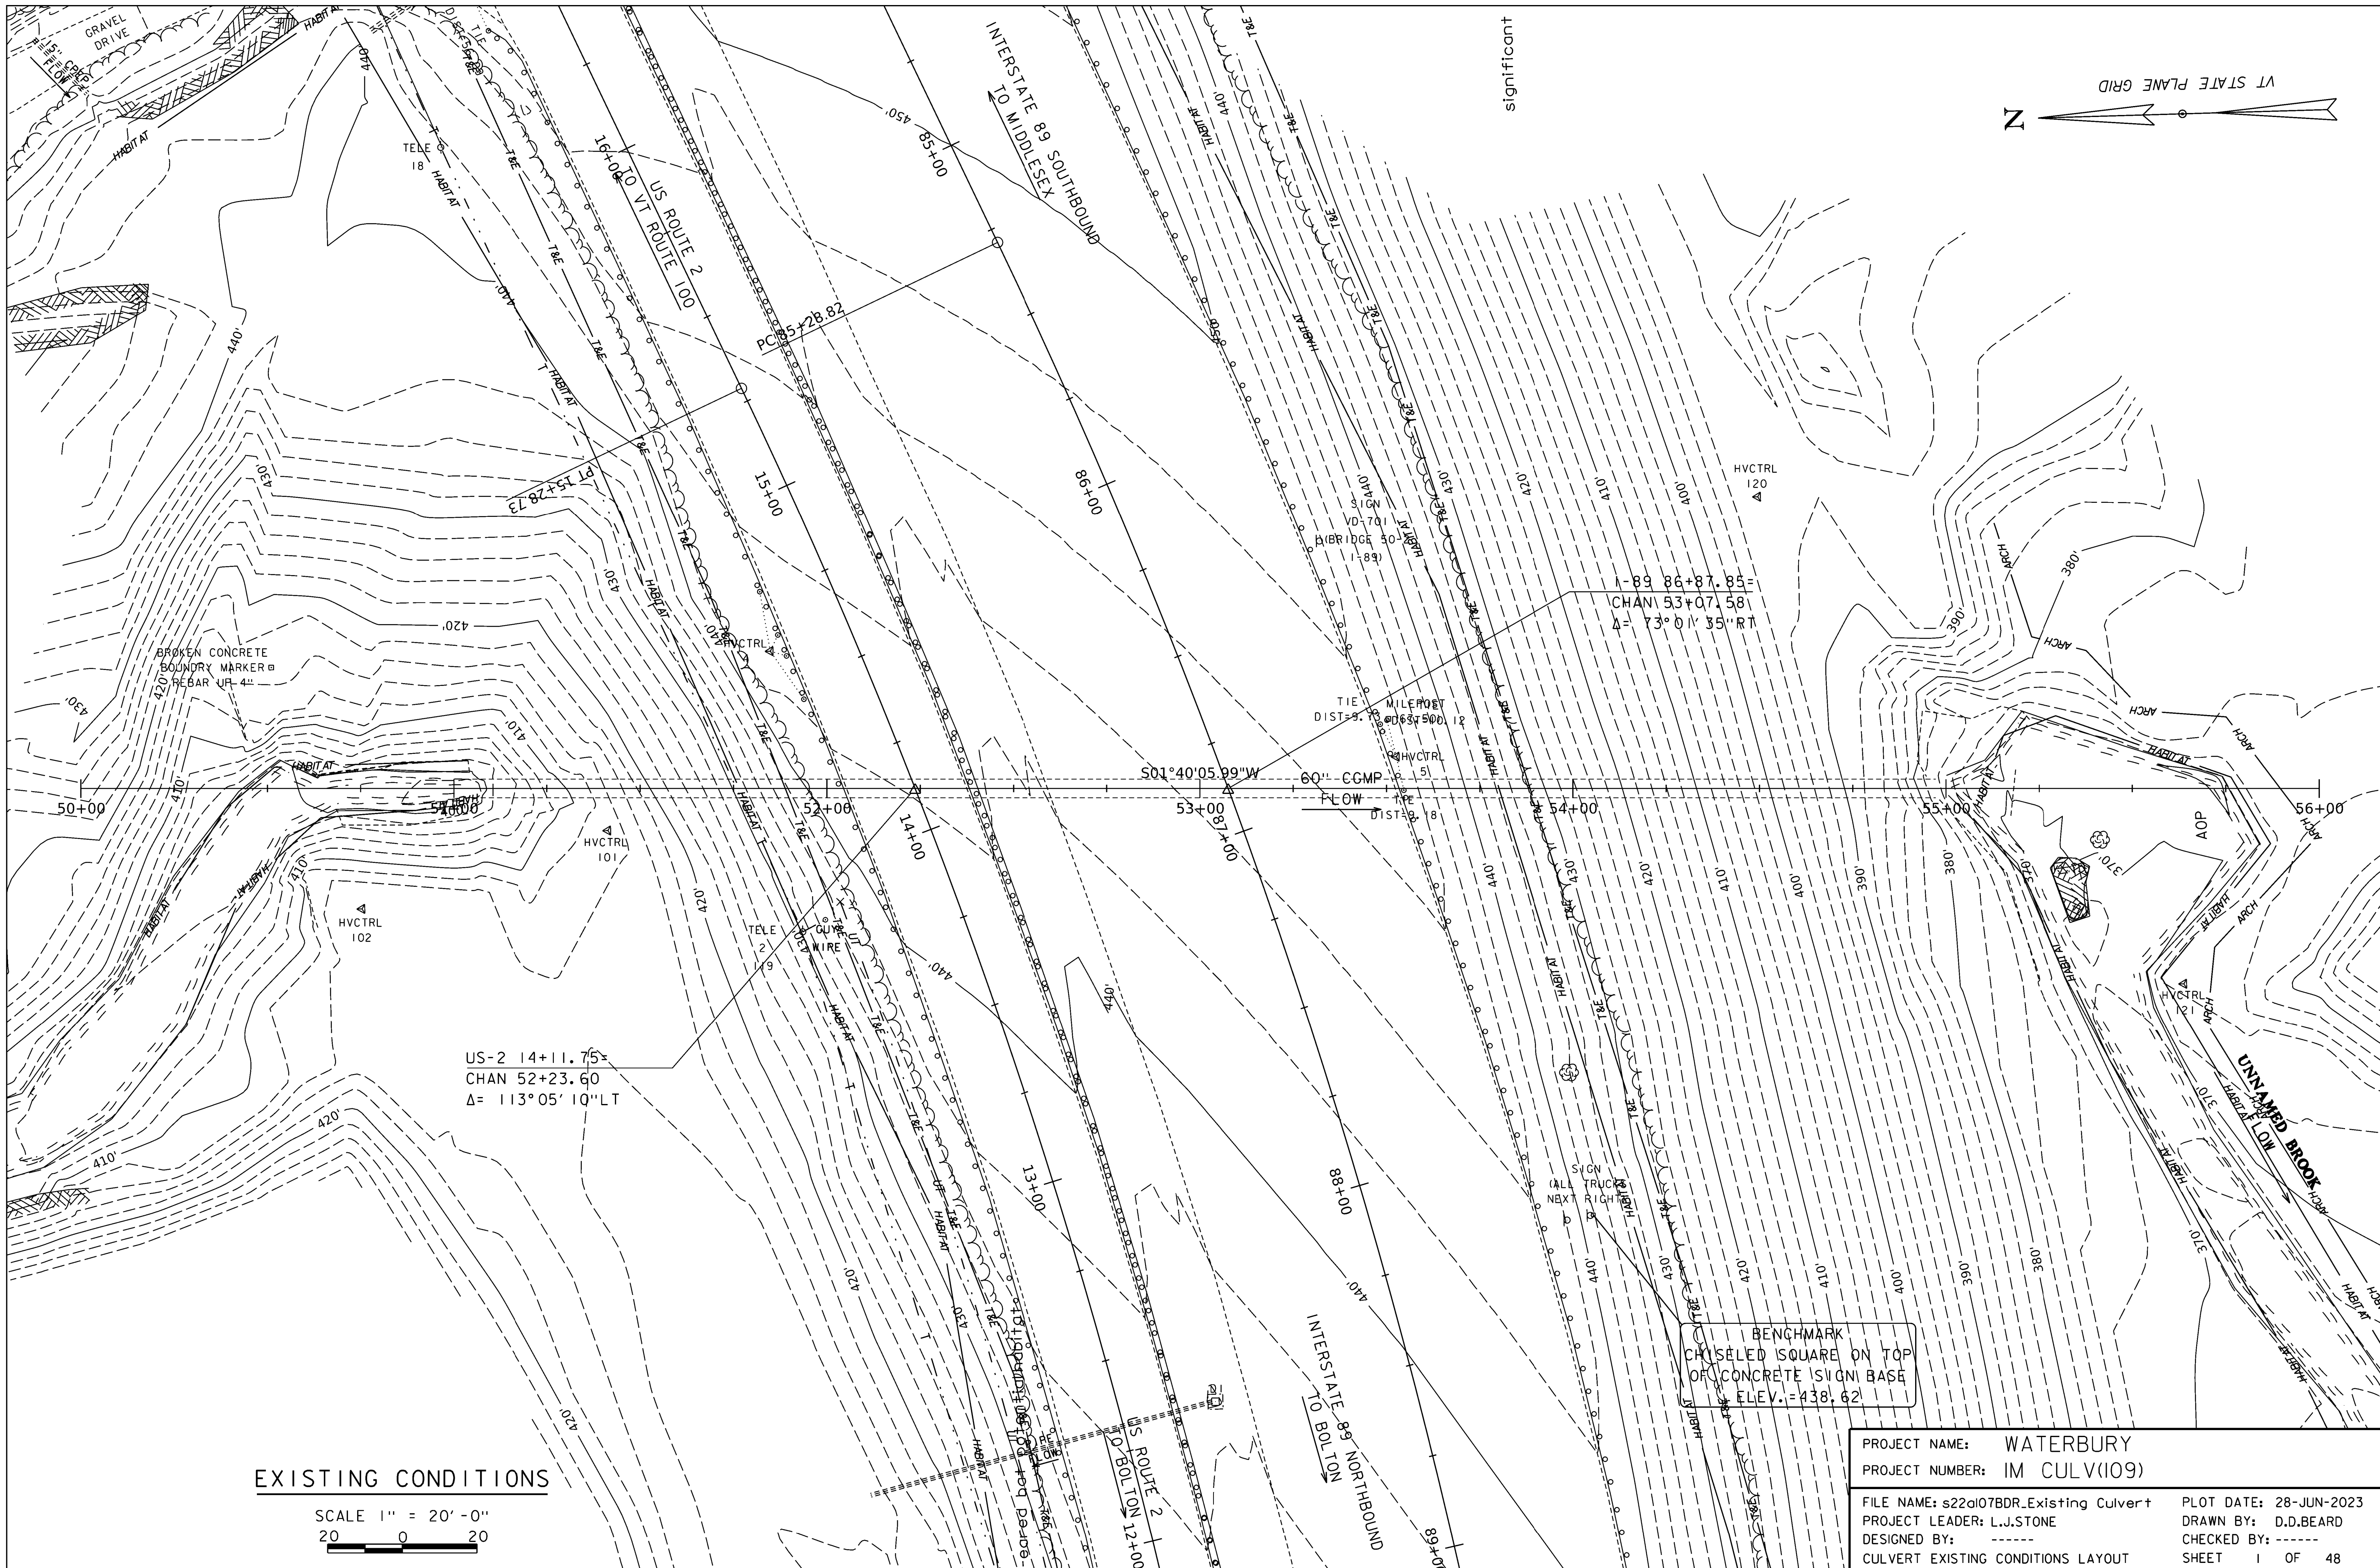
PROJECT NAME:	WATERBURY	FILE NAME:	s22a107BDR.Existing Culvert	PLOT DATE:	28-JUN-2023
PROJECT NUMBER:	IM CULV(109)	PROJECT LEADER:	L.J.STONE	DRAWN BY:	D.D.BEARD
		DESIGNED BY:	-----	CHECKED BY:	-----
		CULVERT EXISTING CONDITIONS LAYOUT		SHEET	1 OF 48

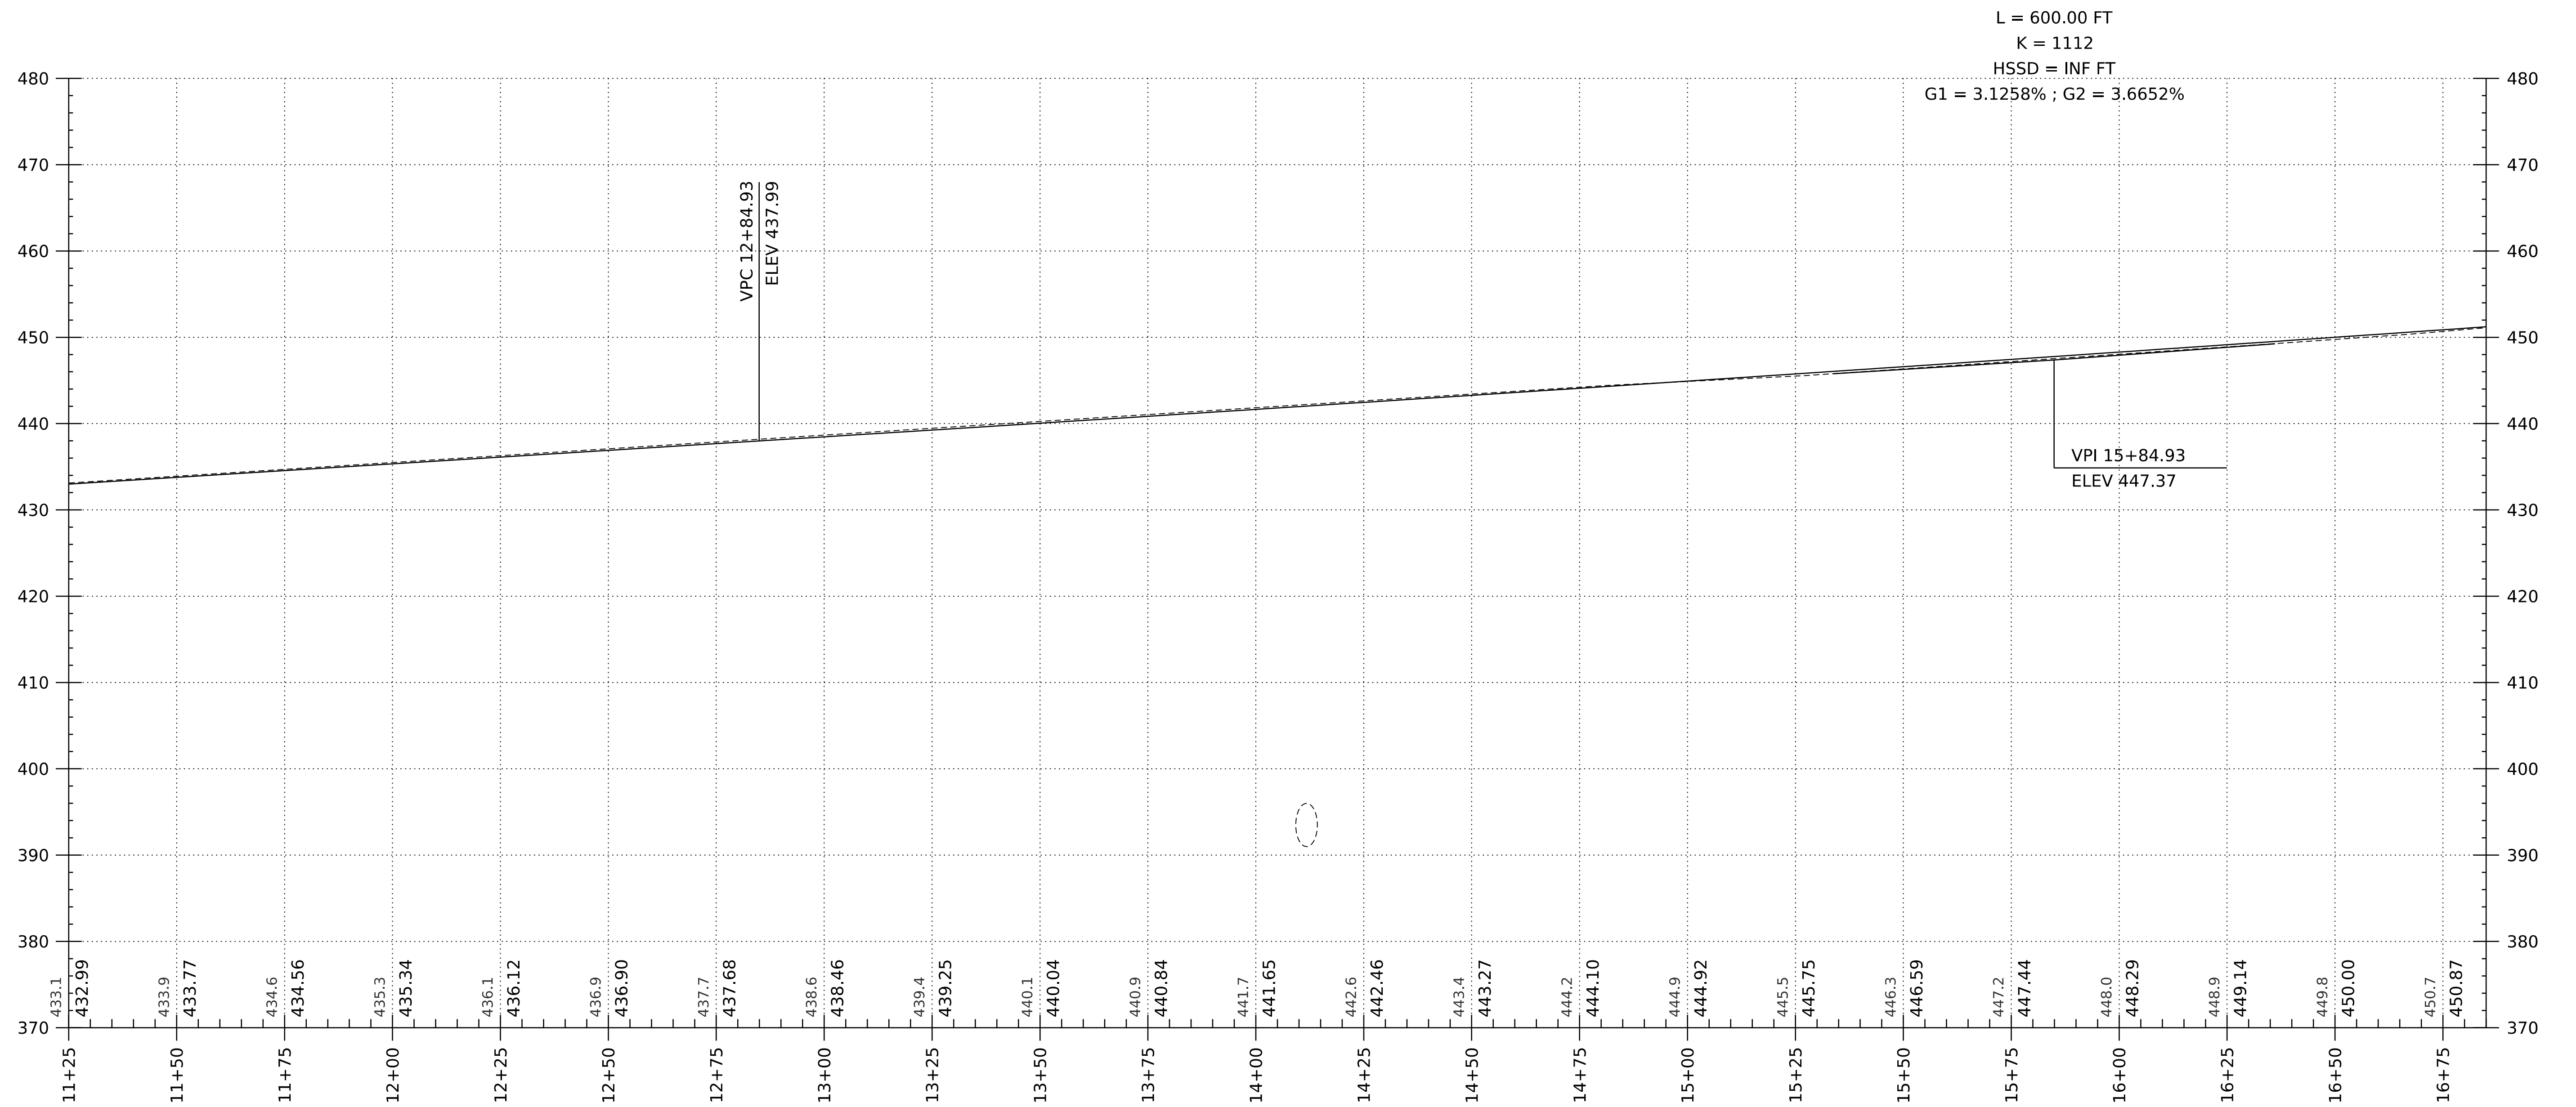
PROJECT NAME: WATERBURY	PLOT DATE: 28-JUN-2023
PROJECT NUMBER: IM CULV(109)	DRAWN BY: D.D.BEARD
FILE NAME: s22a107profile.dgn	CHECKED BY: -----
PROJECT LEADER: L.J.STONE	SHEET 7 OF 48
DESIGNED BY: -----	
US ROUTE 2 EXISTING PROFILE SHEET

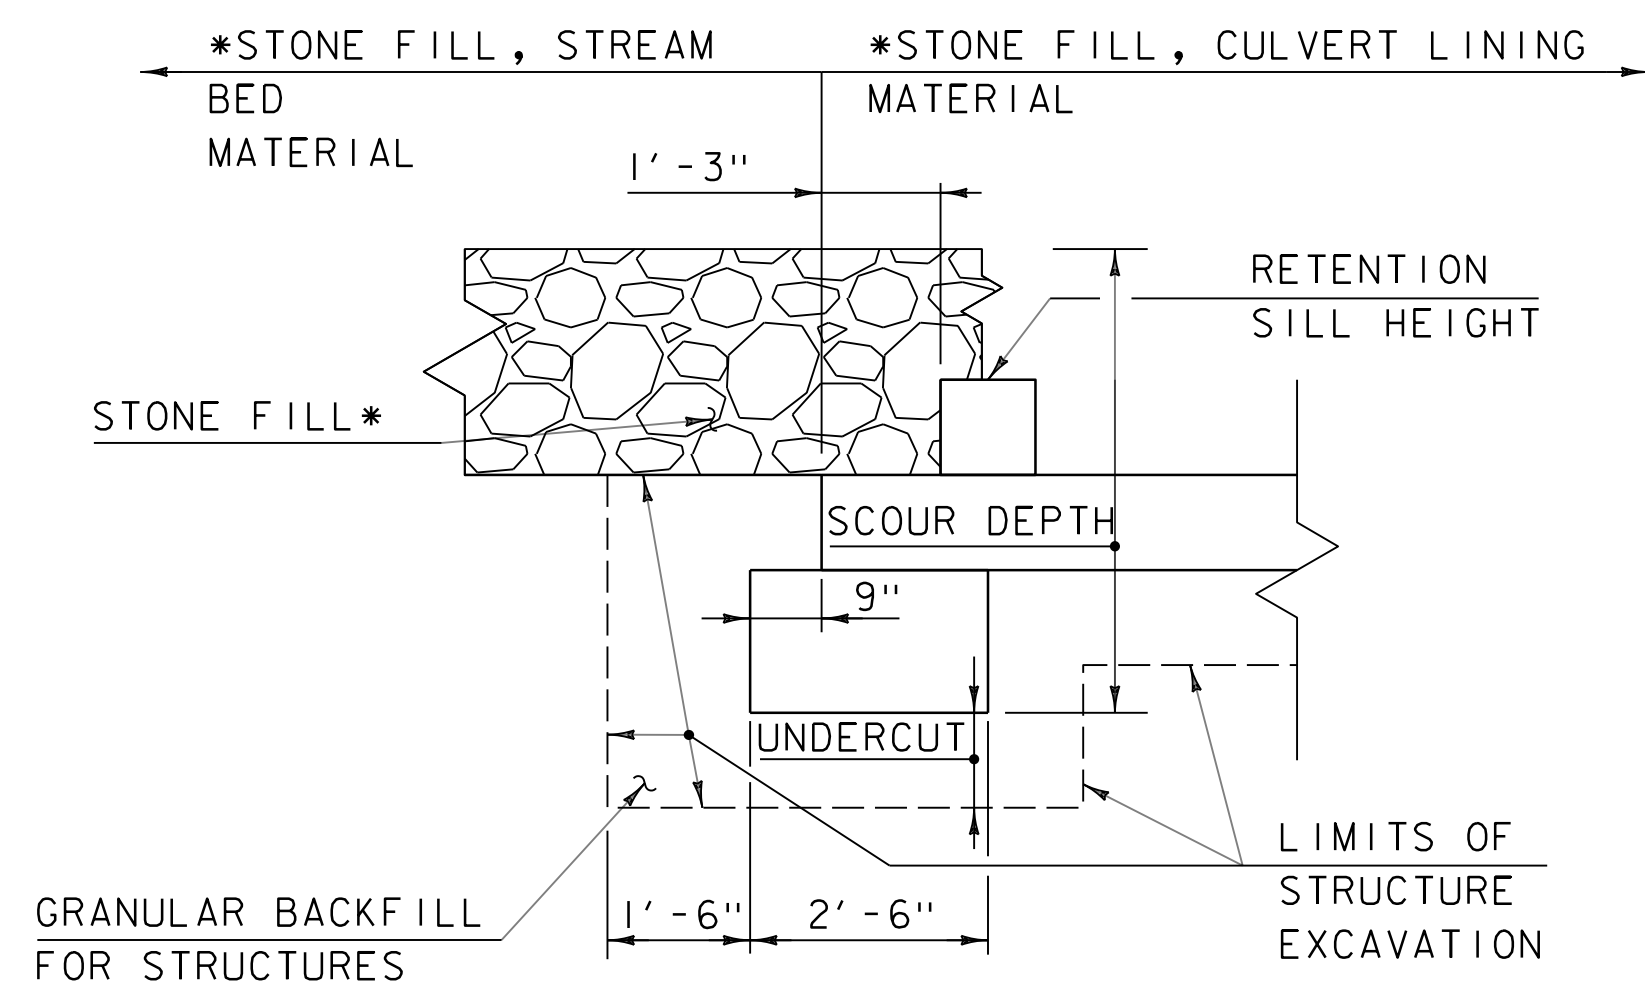
CUTOFF WALL TYPICAL SECTION

CUTOFF WALL - CRITICAL DIMENSIONS

DIMENSION
SCOUR DEPTH	4' - 0"
RETENTION SILL HEIGHT	1' - 0"
UNDERCUT	1' - 0"

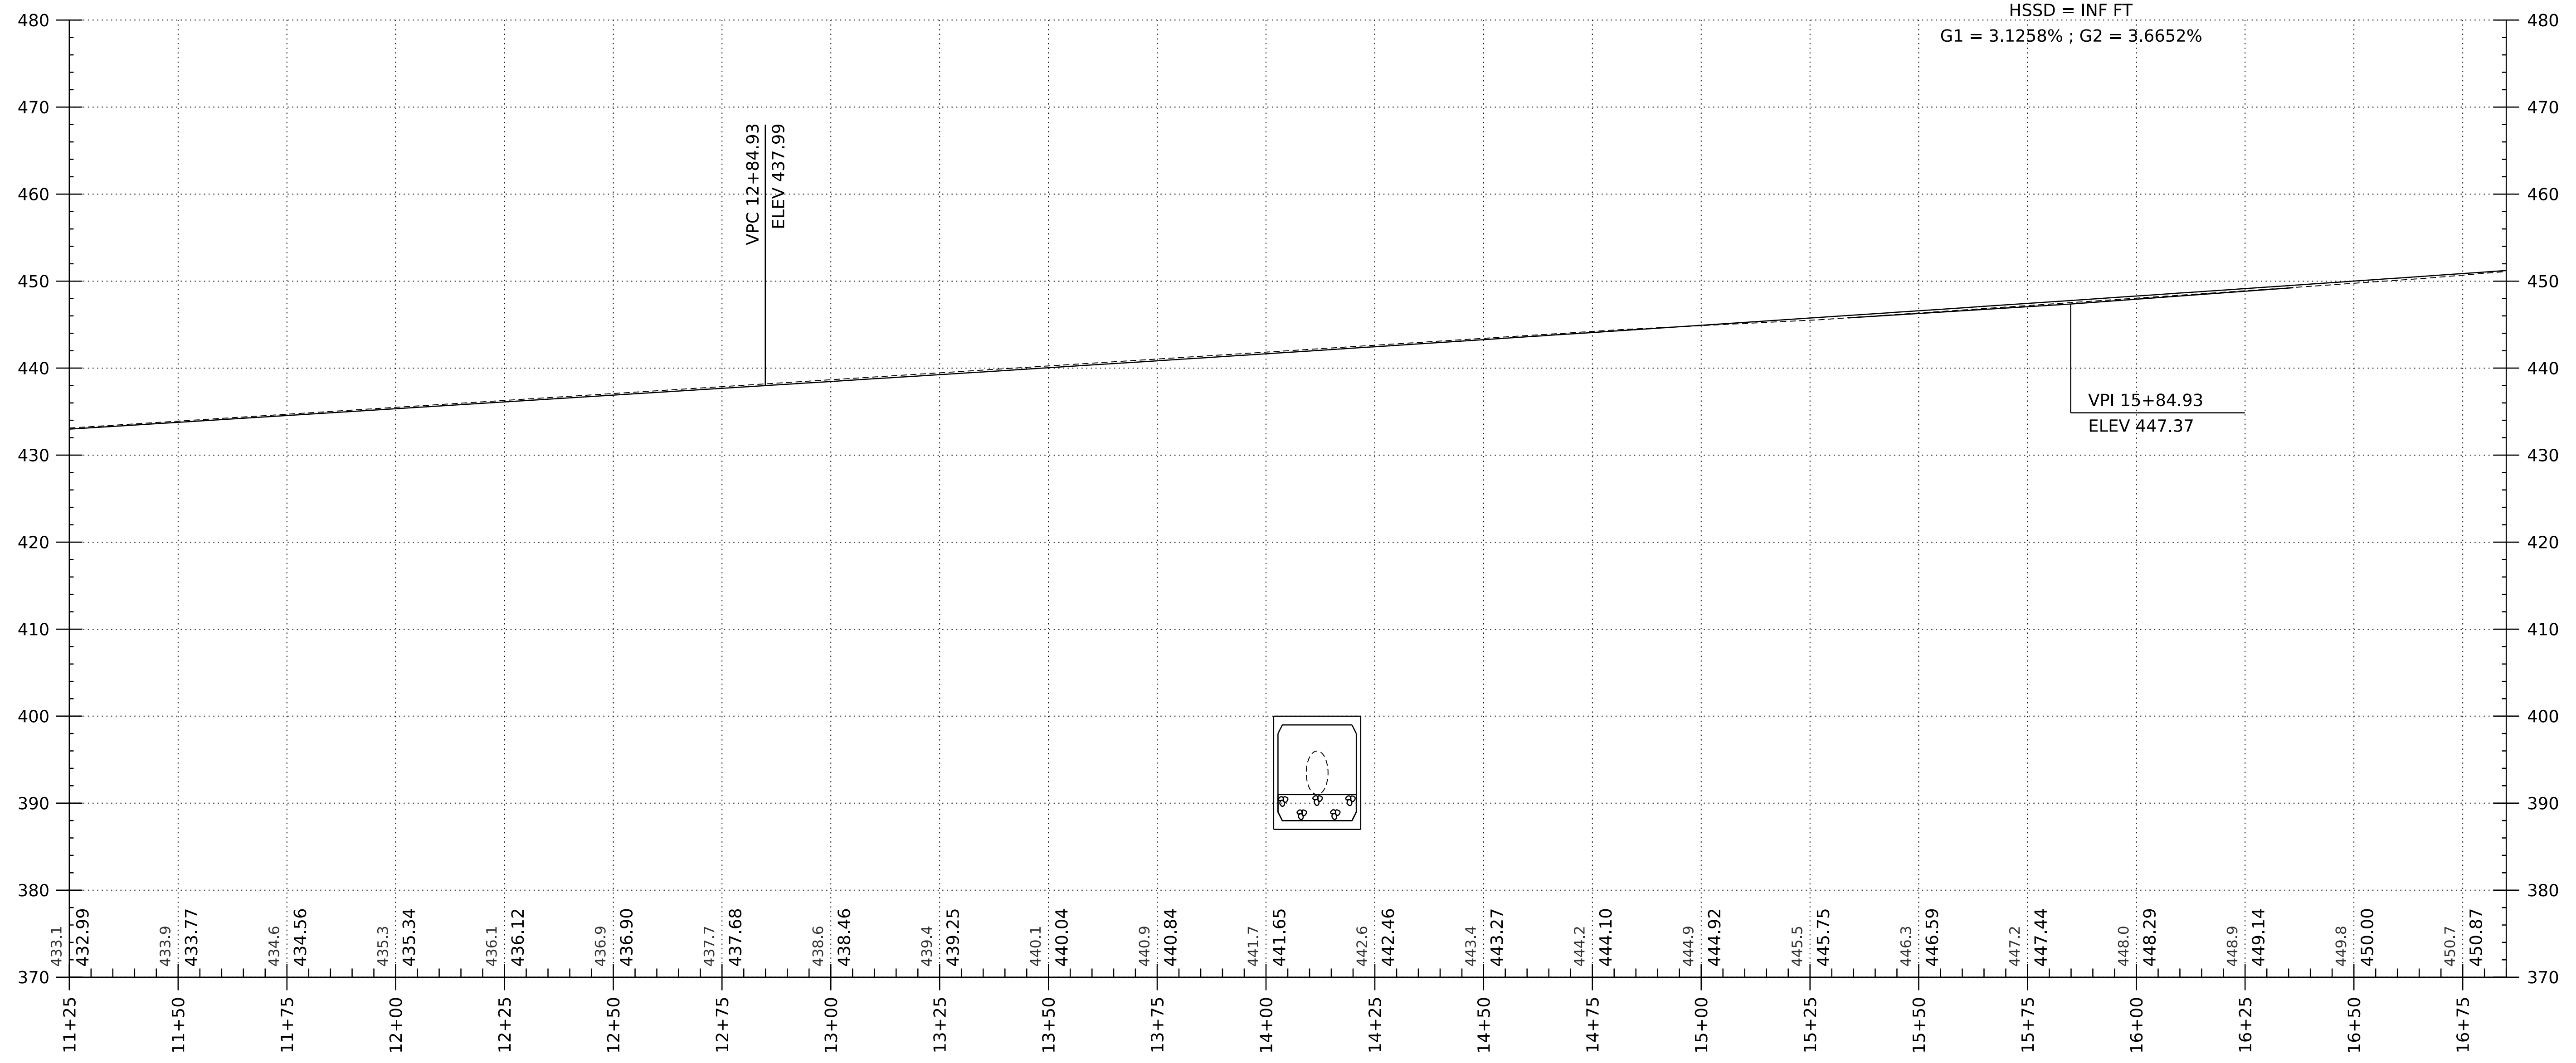
PROJECT NAME:	WATERBURY
PROJECT NUMBER:	IM CULV(109)
FILE NAME:	s22a107profile.dgn
PROJECT LEADER:	L.J.STONE
DESIGNED BY:	-----
US ROUTE 2 BOX CULVERT PROFILE SHEET	
PLOT DATE:	28-JUN-2023
DRAWN BY:	D.D.BEARD
CHECKED BY:	-----
SHEET	14 OF 48

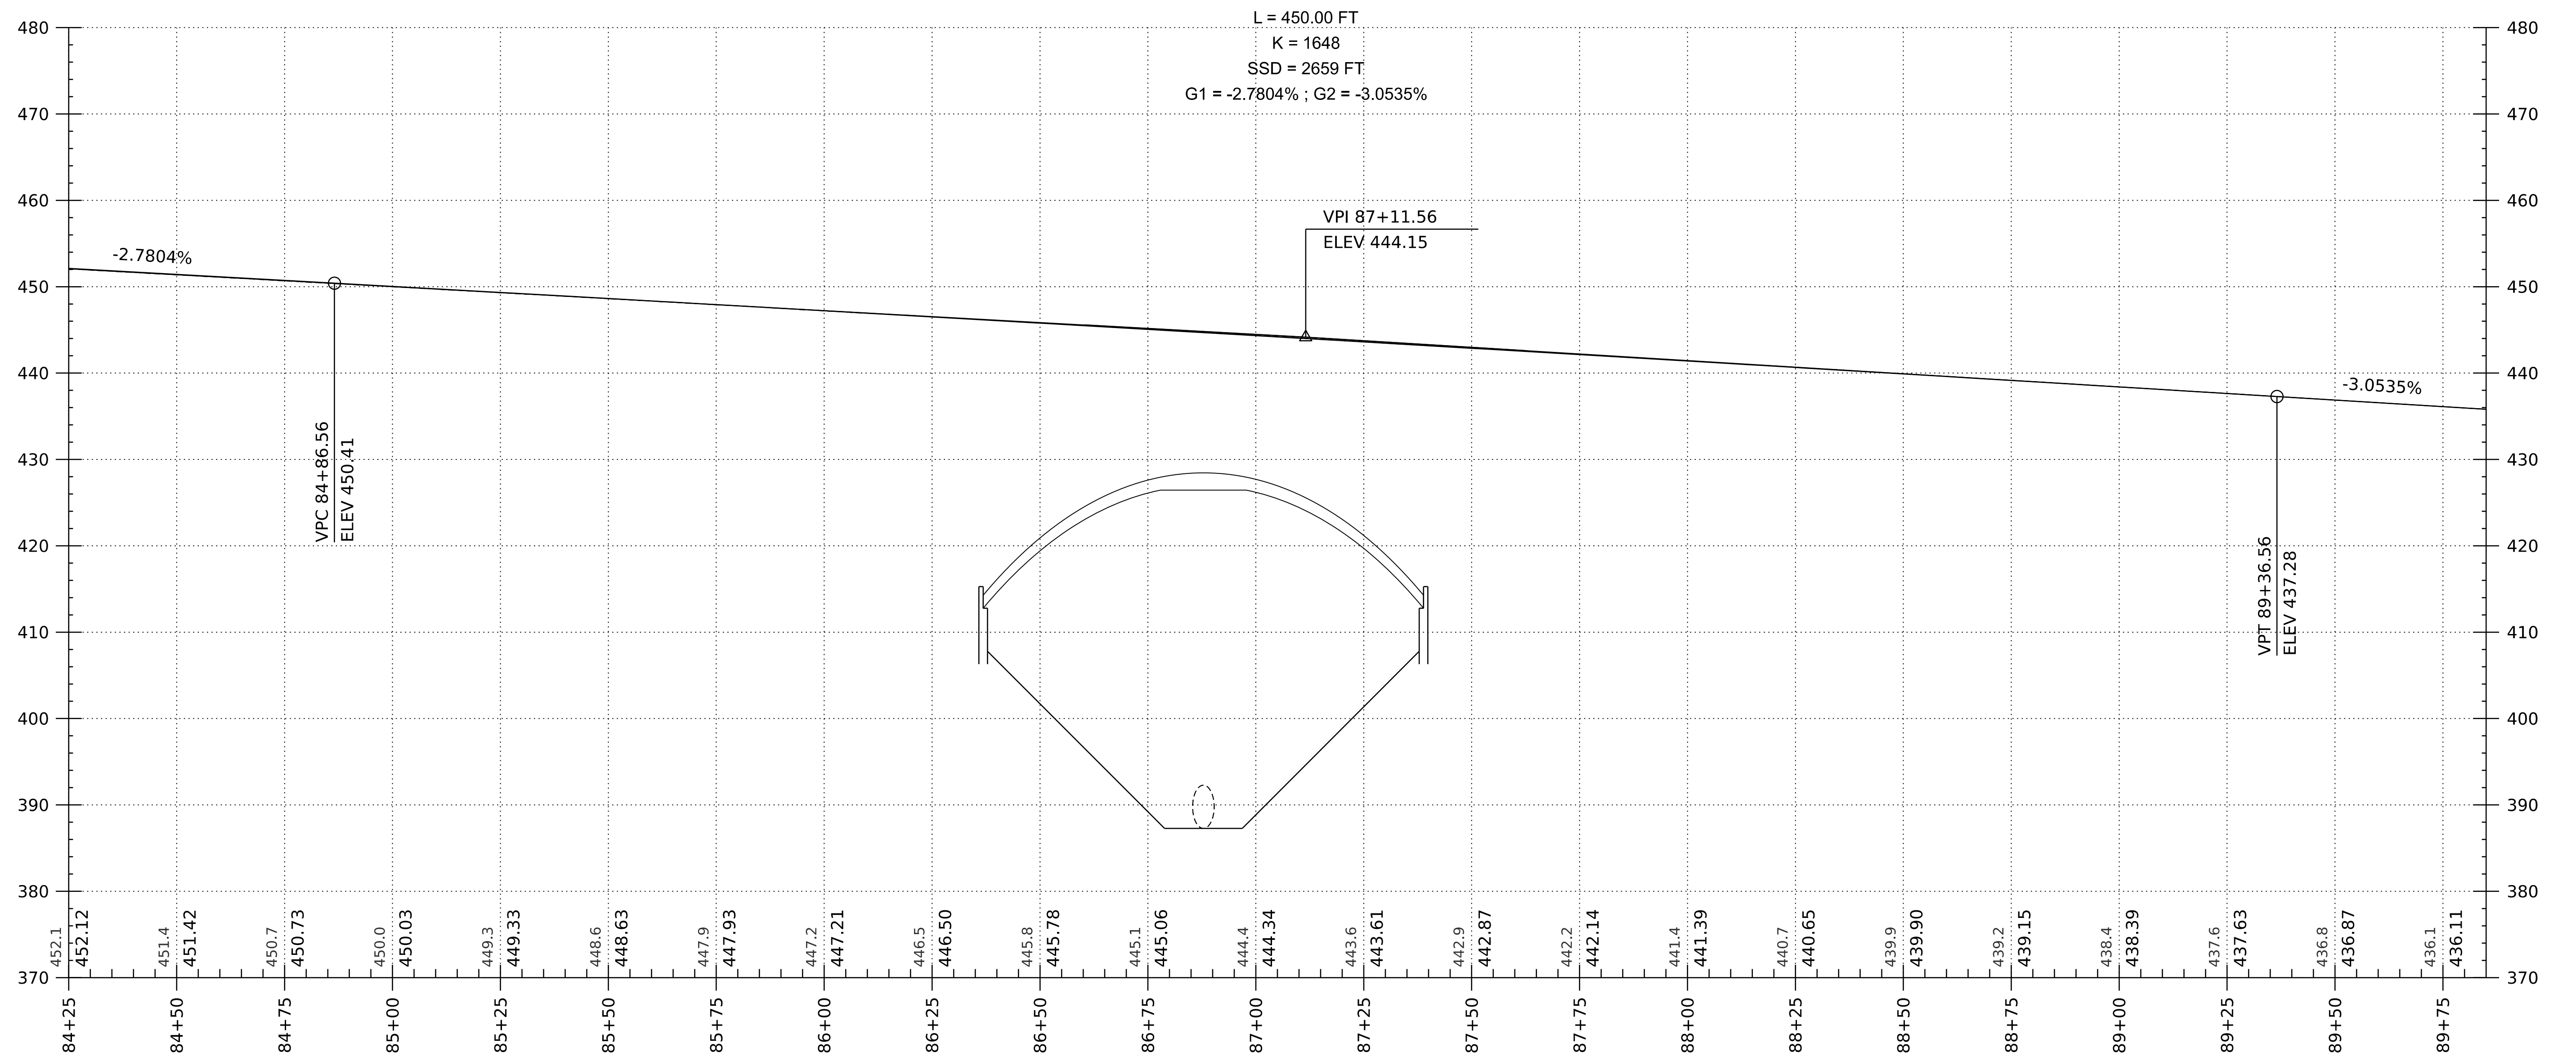
INTERSTATE 89 NEW PRECAST ARCH BRIDGE PROFILE

PROJECT NAME: WATERBURY	
PROJECT NUMBER: IM CULV(109)	
FILE NAME: s22a107profile.dgn	PLOT DATE: 28-JUN-2023
PROJECT LEADER: L.J.STONE	DRAWN BY: D.D.BEARD
DESIGNED BY: -----	CHECKED BY: -----
INTERSTATE 89 PRECAST ARCH PROFILE SHEETSHEET 17 OF 48

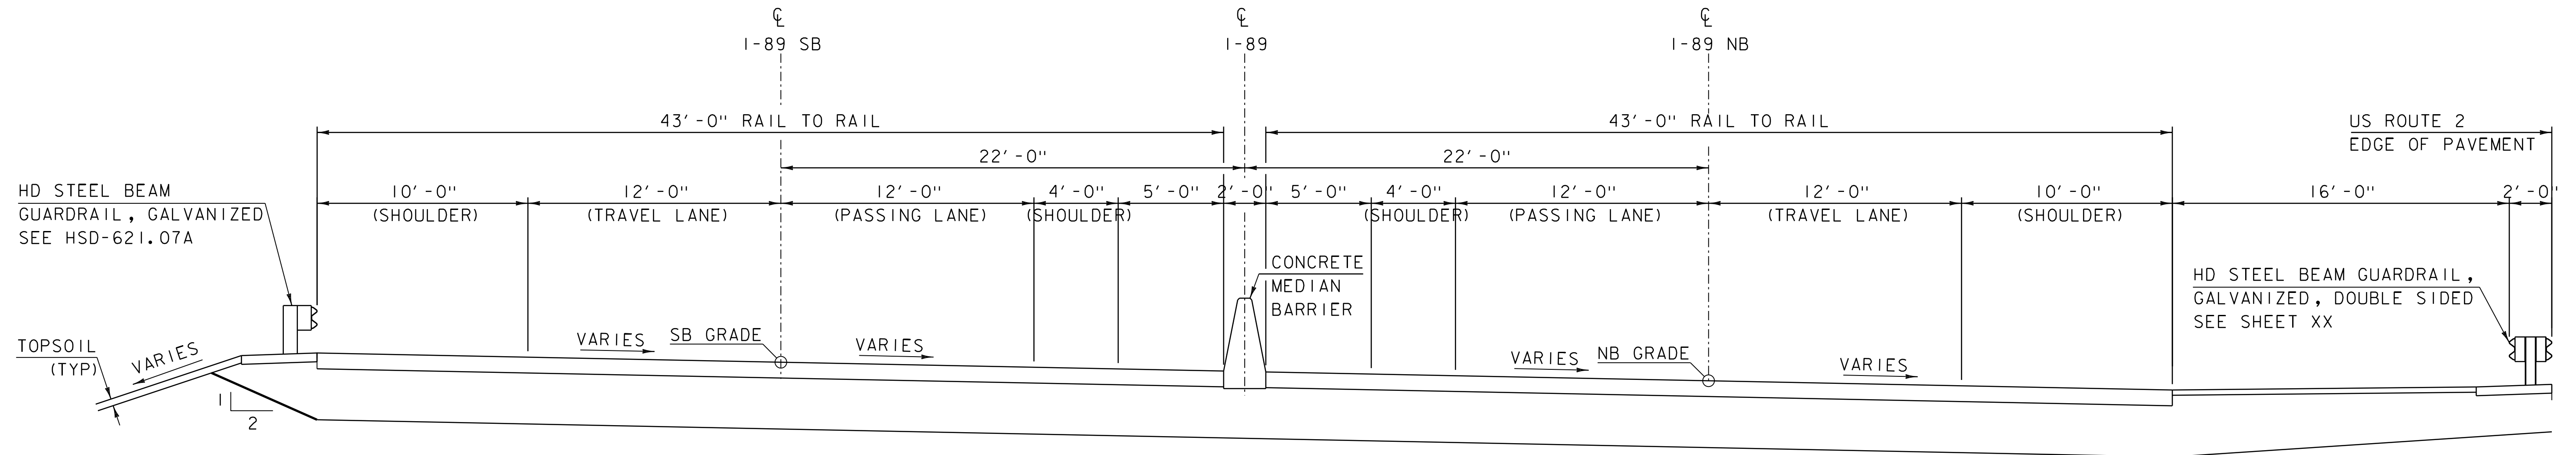
I-89 NEW BRIDGE TYPICAL SECTION

SCALE: 1/4" = 1'-0"

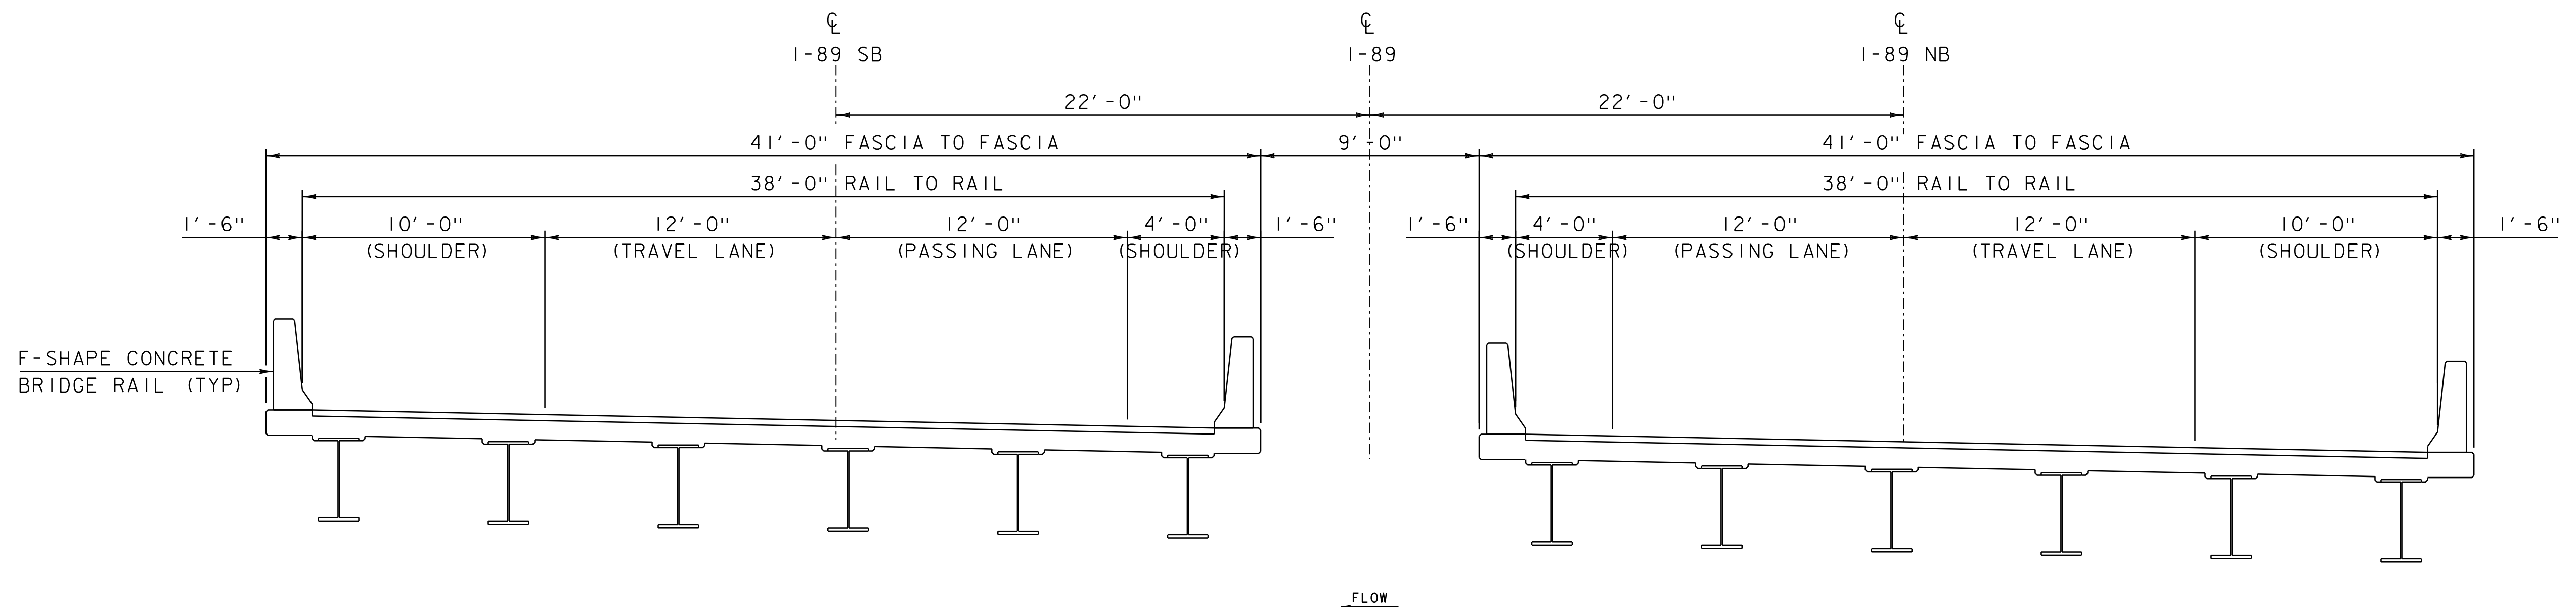
I-89 NEW BRIDGE TYPICAL SECTION

SCALE: 1/4" = 1'-0"
