**STATE OF VERMONT
AGENCY OF TRANSPORTATION**

Scoping Report

**FOR
WATERBURY IM CULV(109)**

I-89 & US2 PID 68002 OVER SHARKEYVILLE BROOK

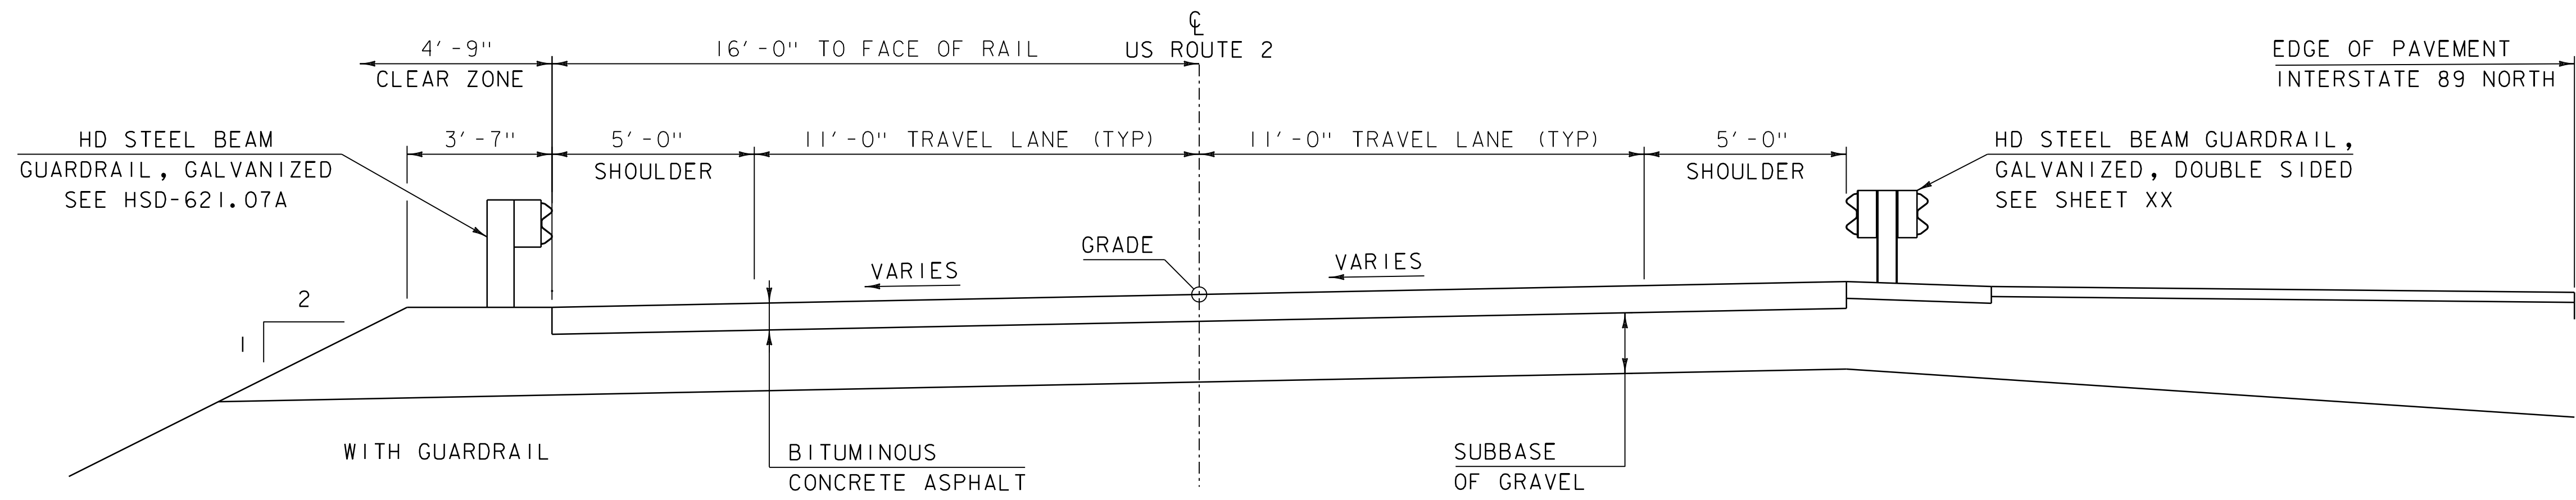
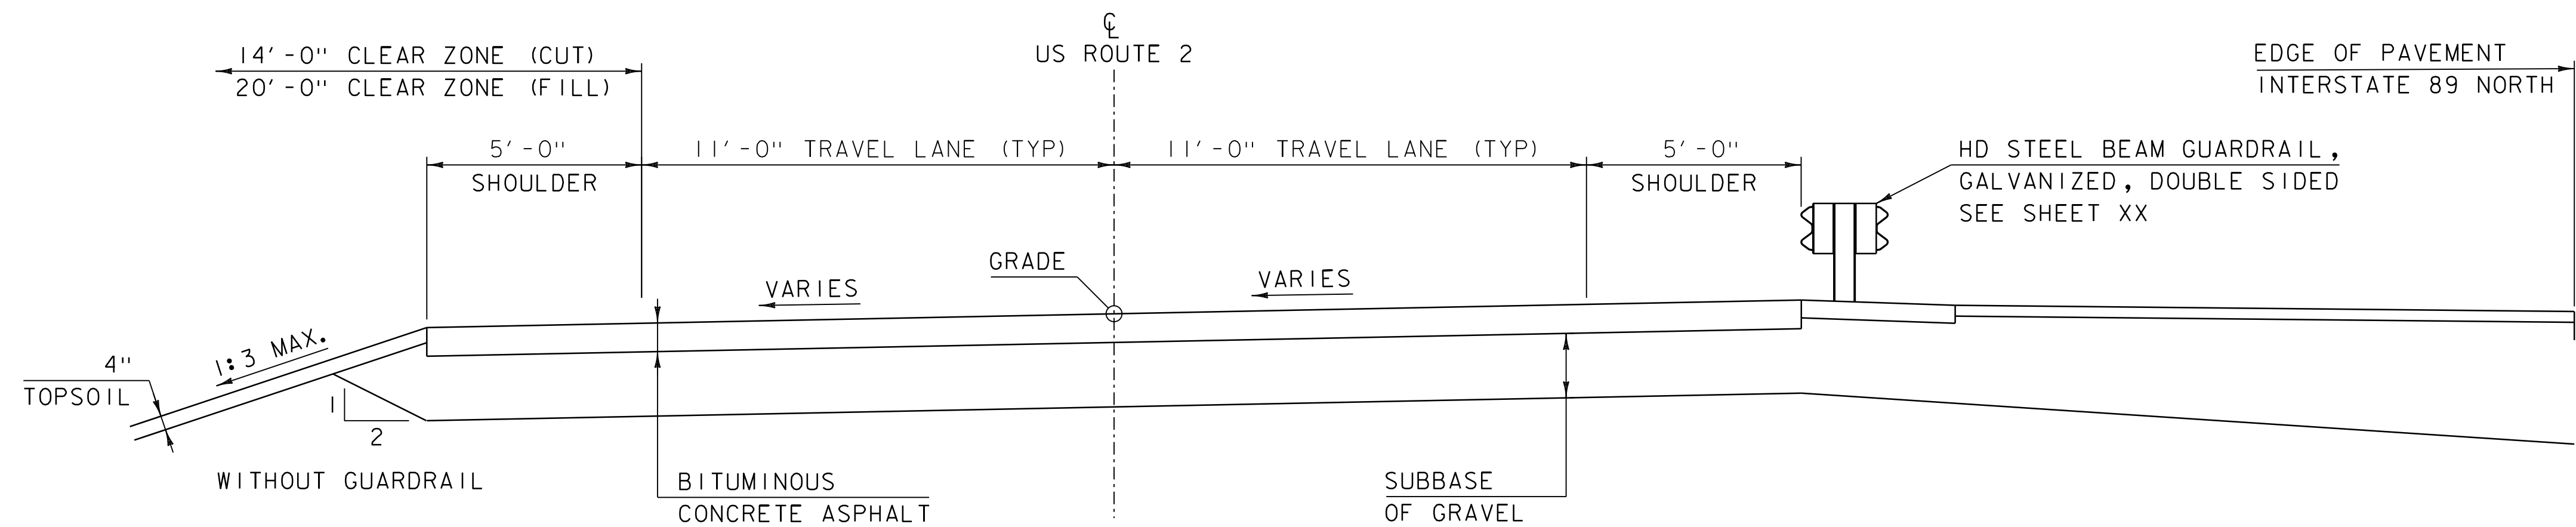
PROPOSED US ROUTE 2 TYPICAL SECTION

SCALE 3/8" = 1'-0"

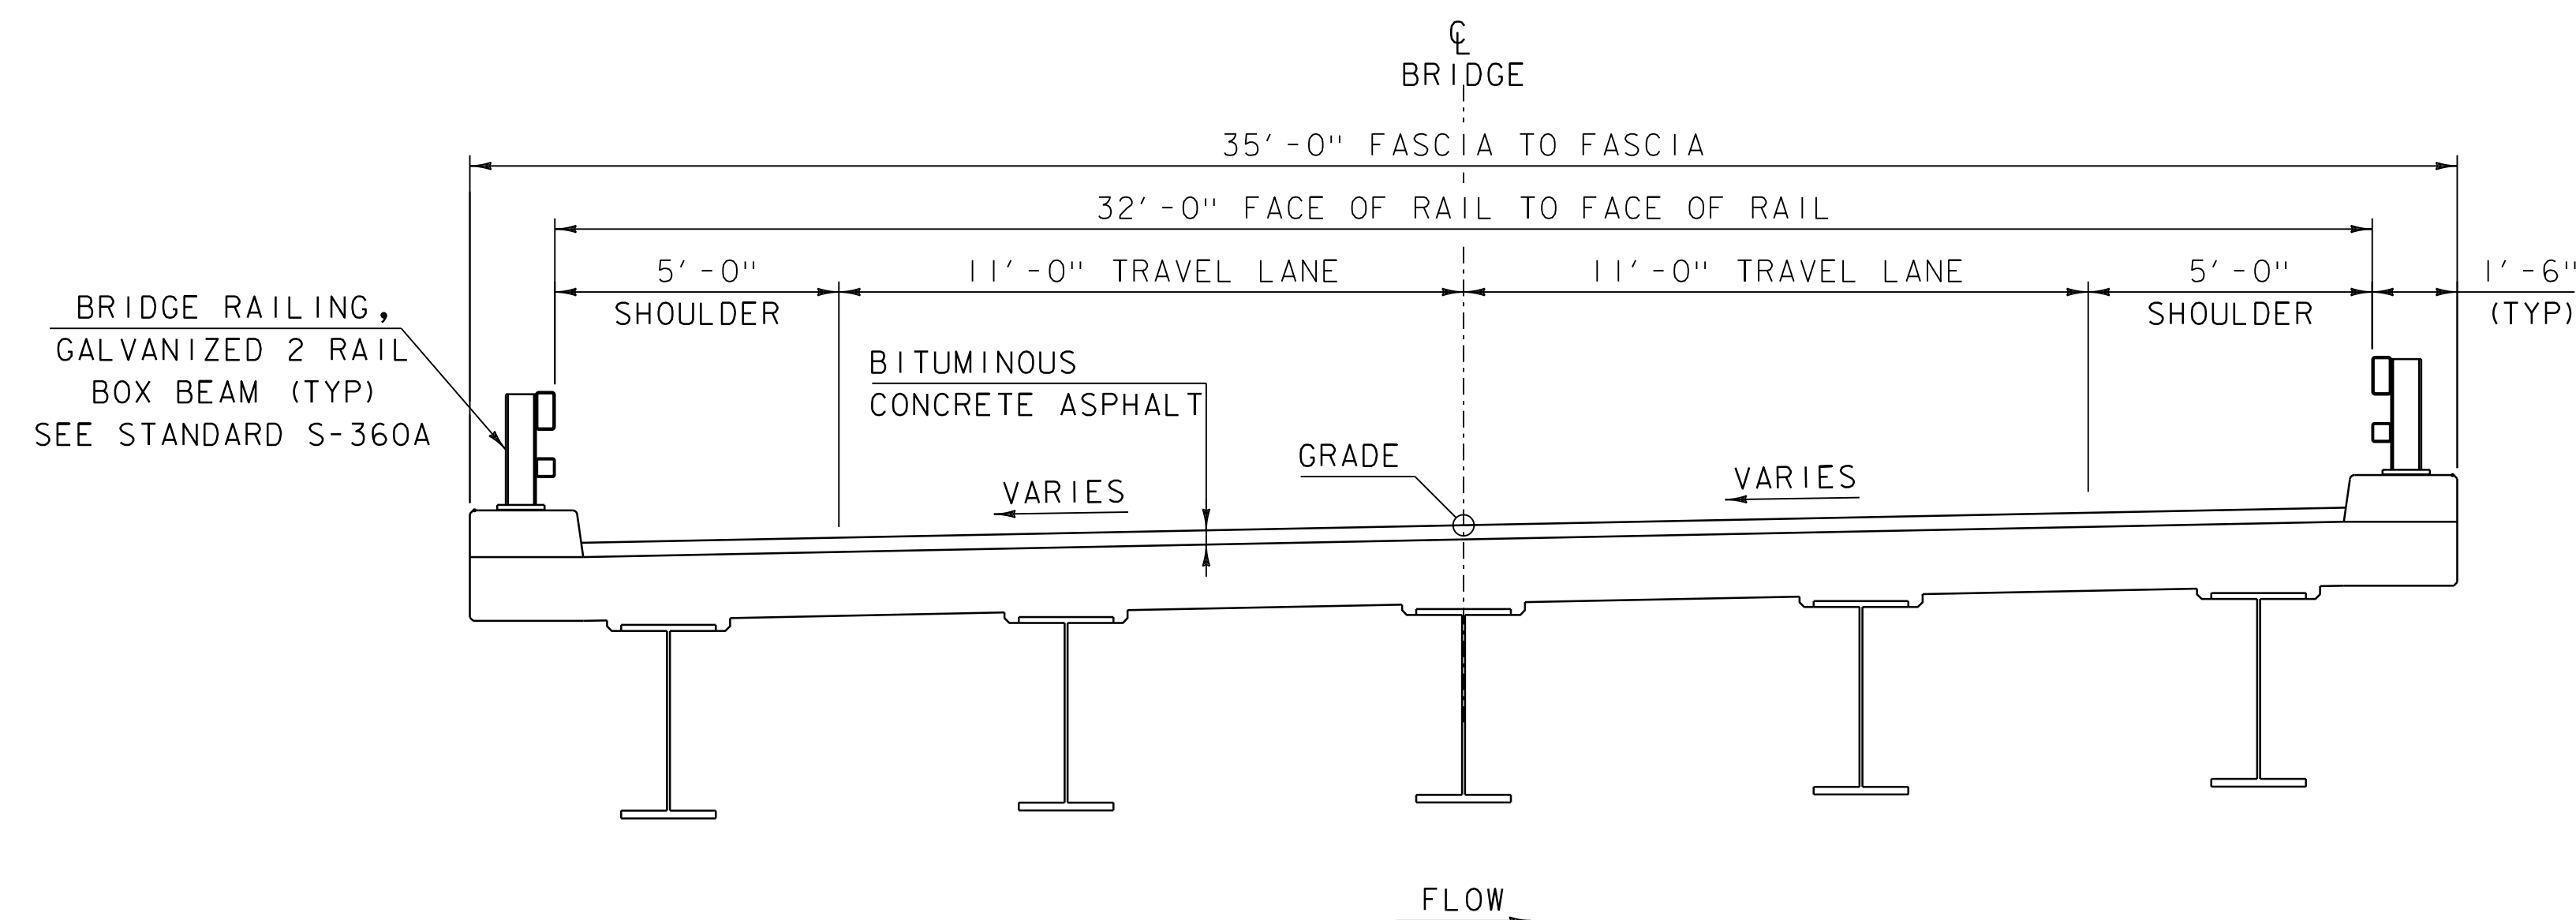
PROPOSED BRIDGE TYPICAL SECTION

SCALE 3/8" = 1'-0"

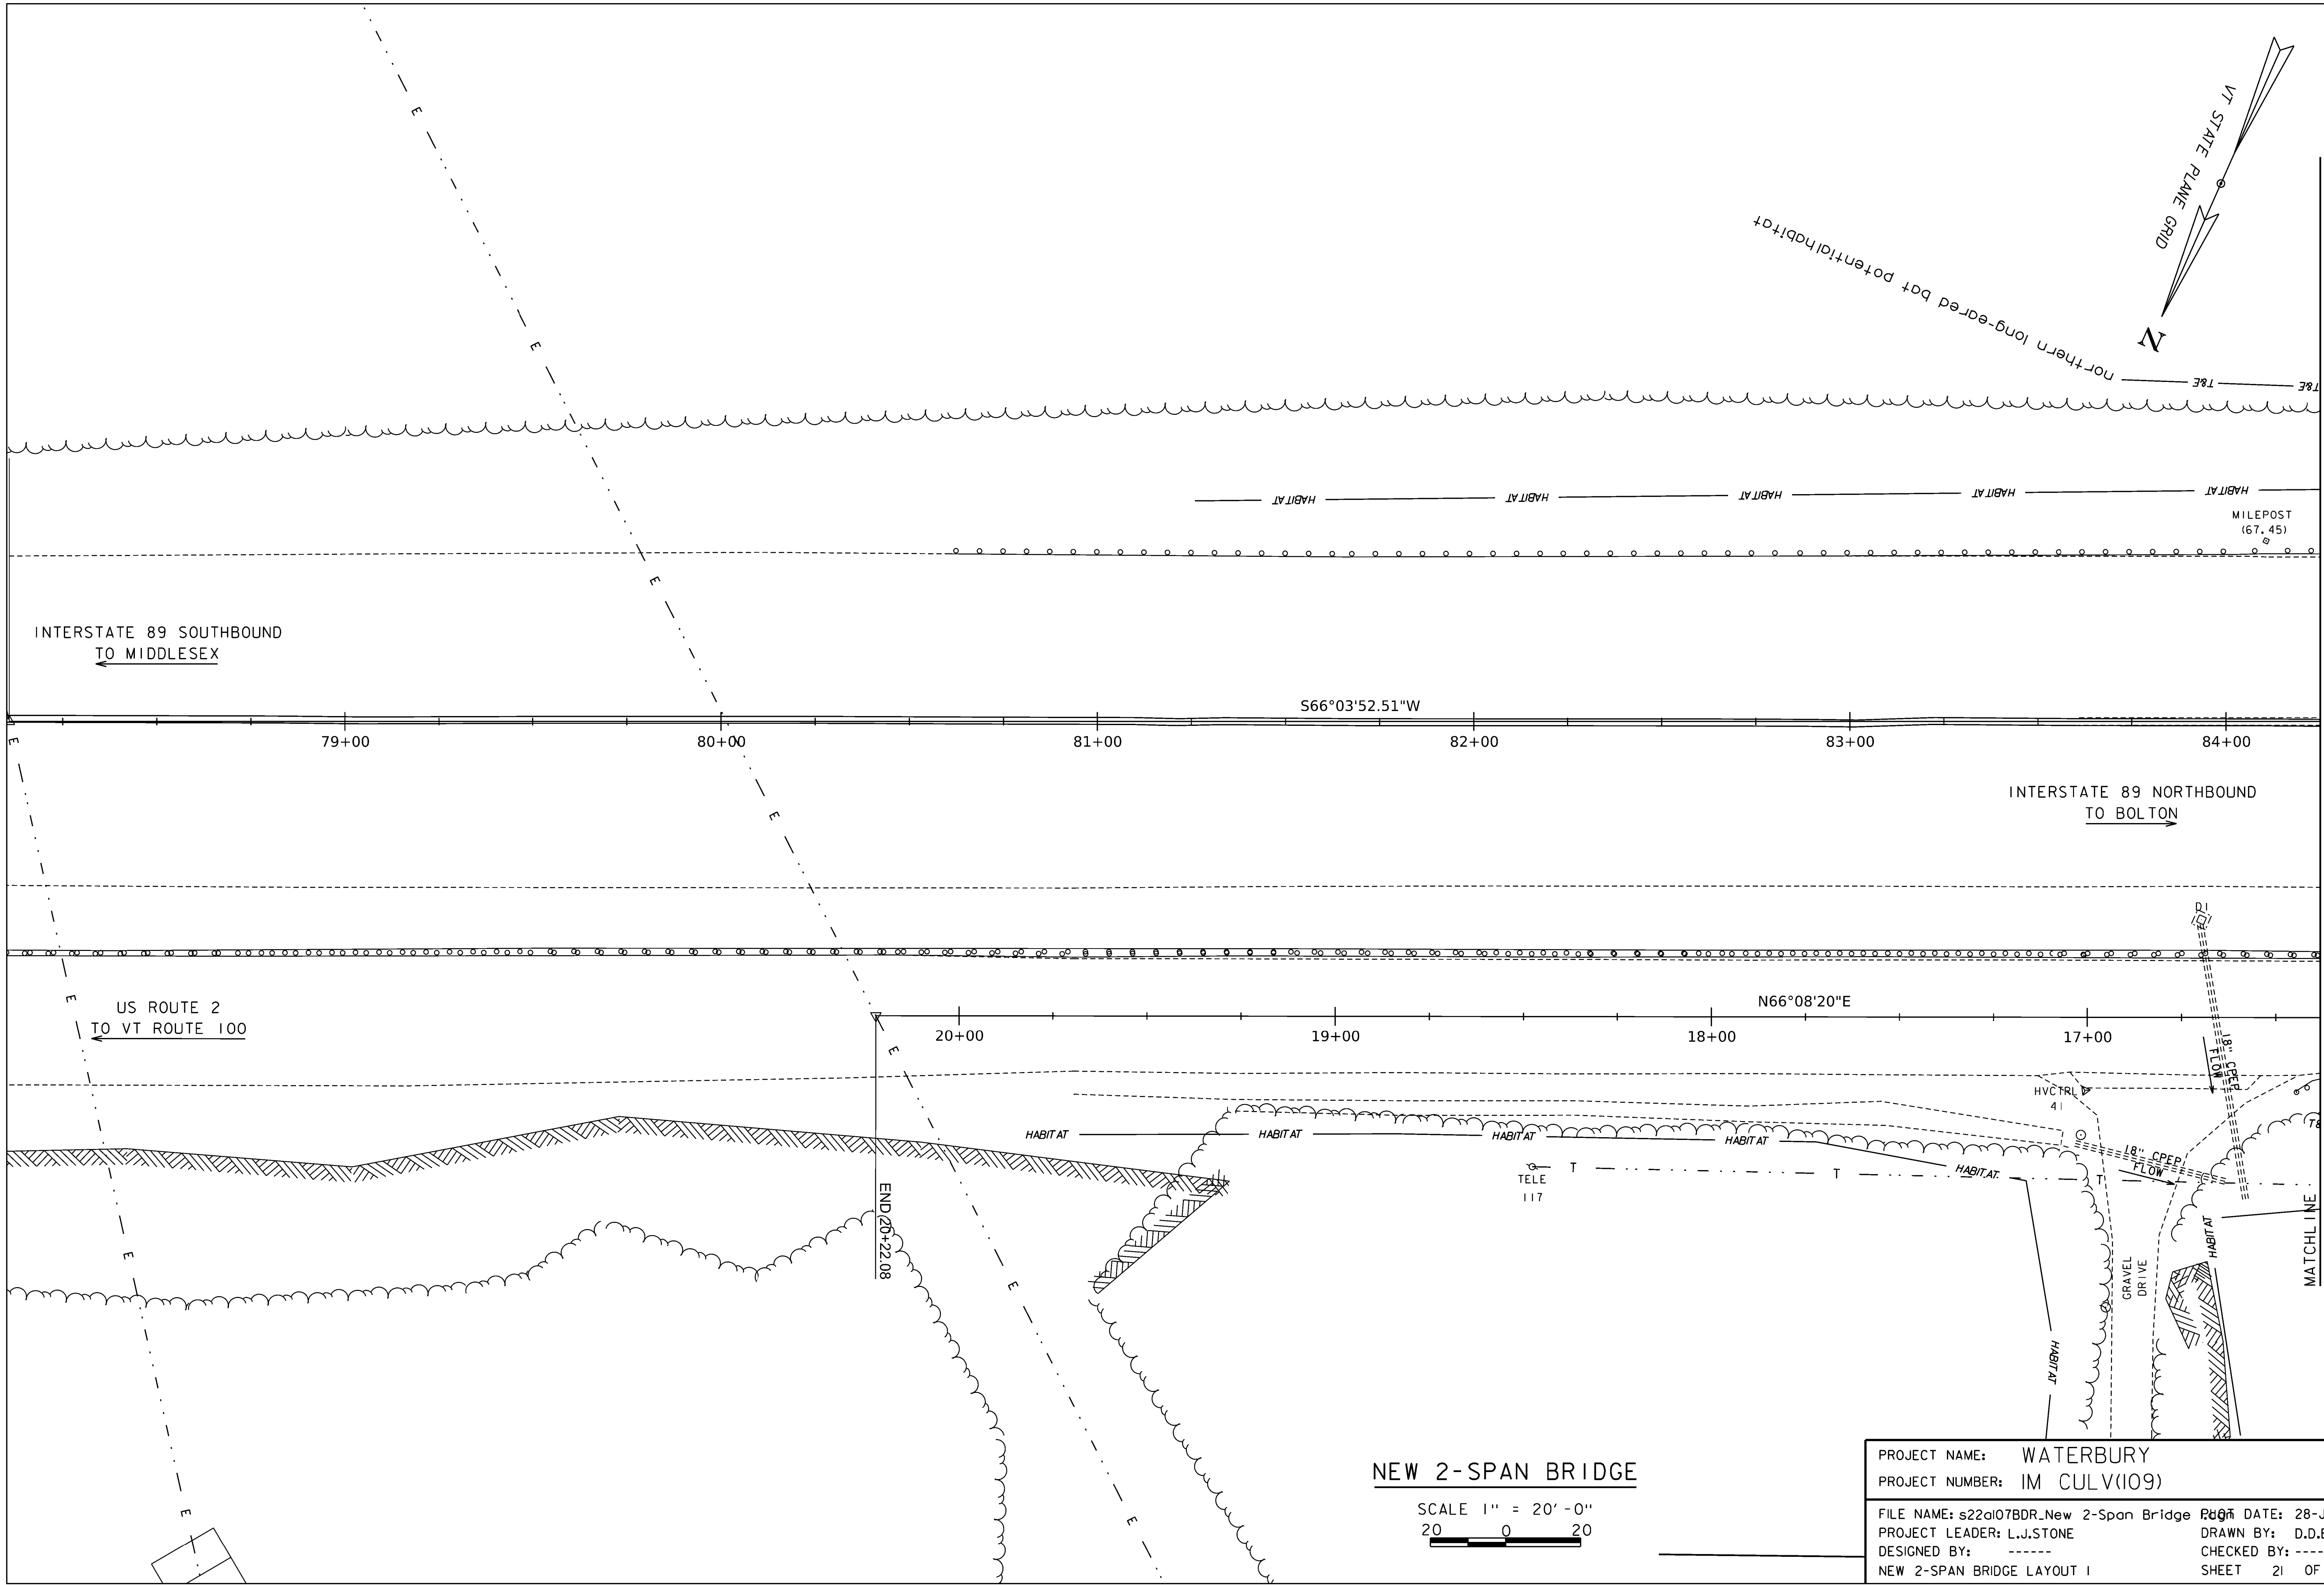
PROJECT NAME:	WATERBURY		
PROJECT NUMBER:	IM CULV(109)		
FILE NAME:	s22a107BDR.New 2-Span Bridge	DATE:	28-JUN-2023
PROJECT LEADER:	L.J.STONE	DRAWN BY:	D.D.BEARD
DESIGNED BY:	-----	CHECKED BY:	-----
NEW 2-SPAN BRIDGE LAYOUT 1		SHEET	21 OF 48

INTERSTATE 89 SOUTHBOUND
TO MIDDLESEX

INTERSTATE 89 NORTHBOUND
TO BOLTON

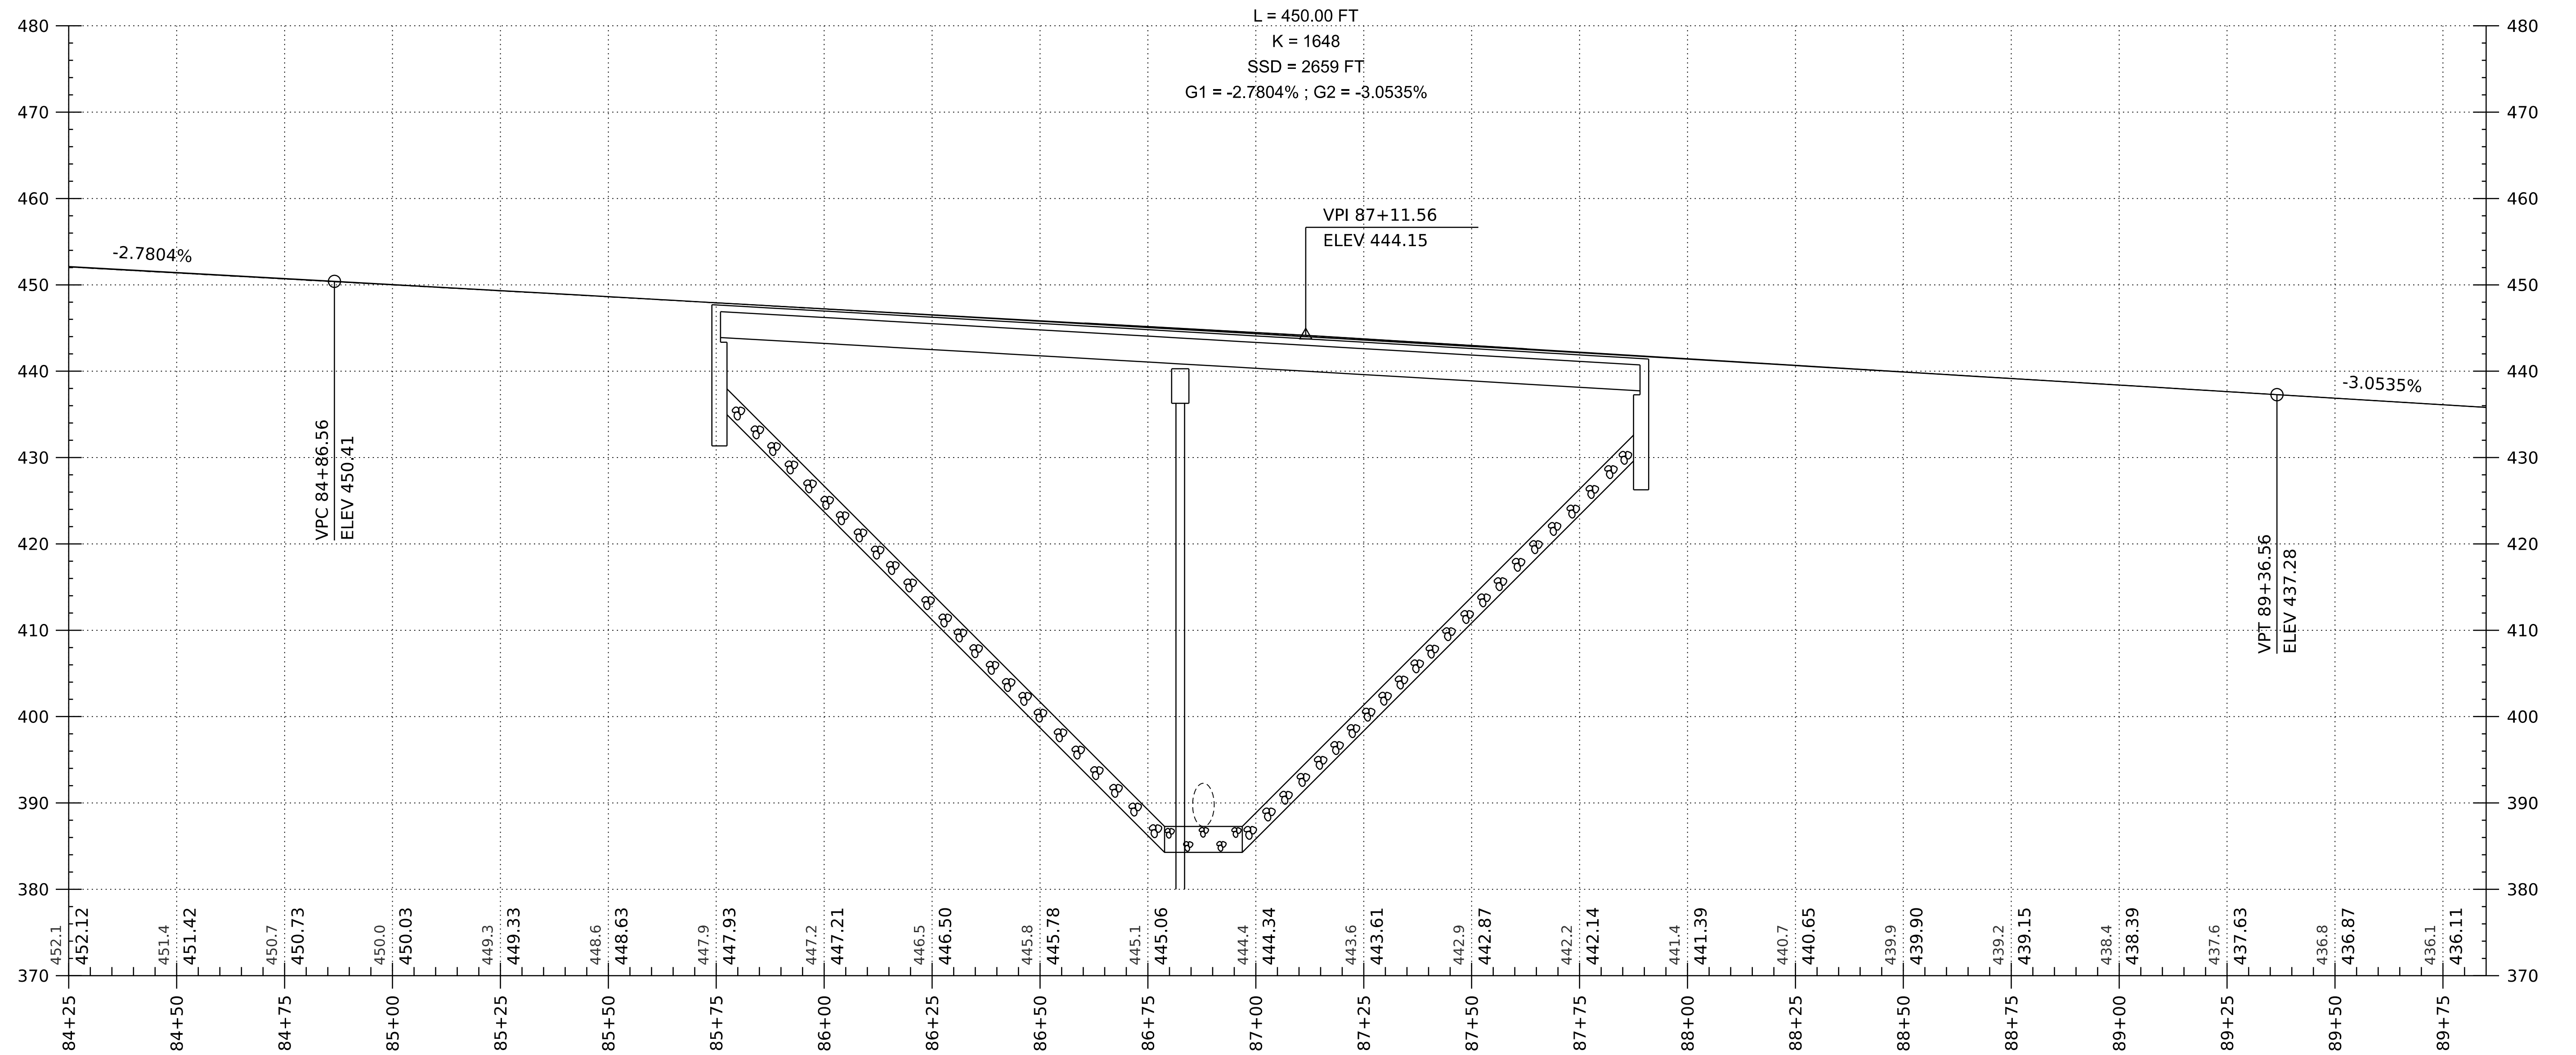
INTERSTATE 89 NEW 2-SPAN BRIDGE PROFILE

SCALE: HORIZONTAL 1"=20'-0"
 VERTICAL 1"=10'-0"

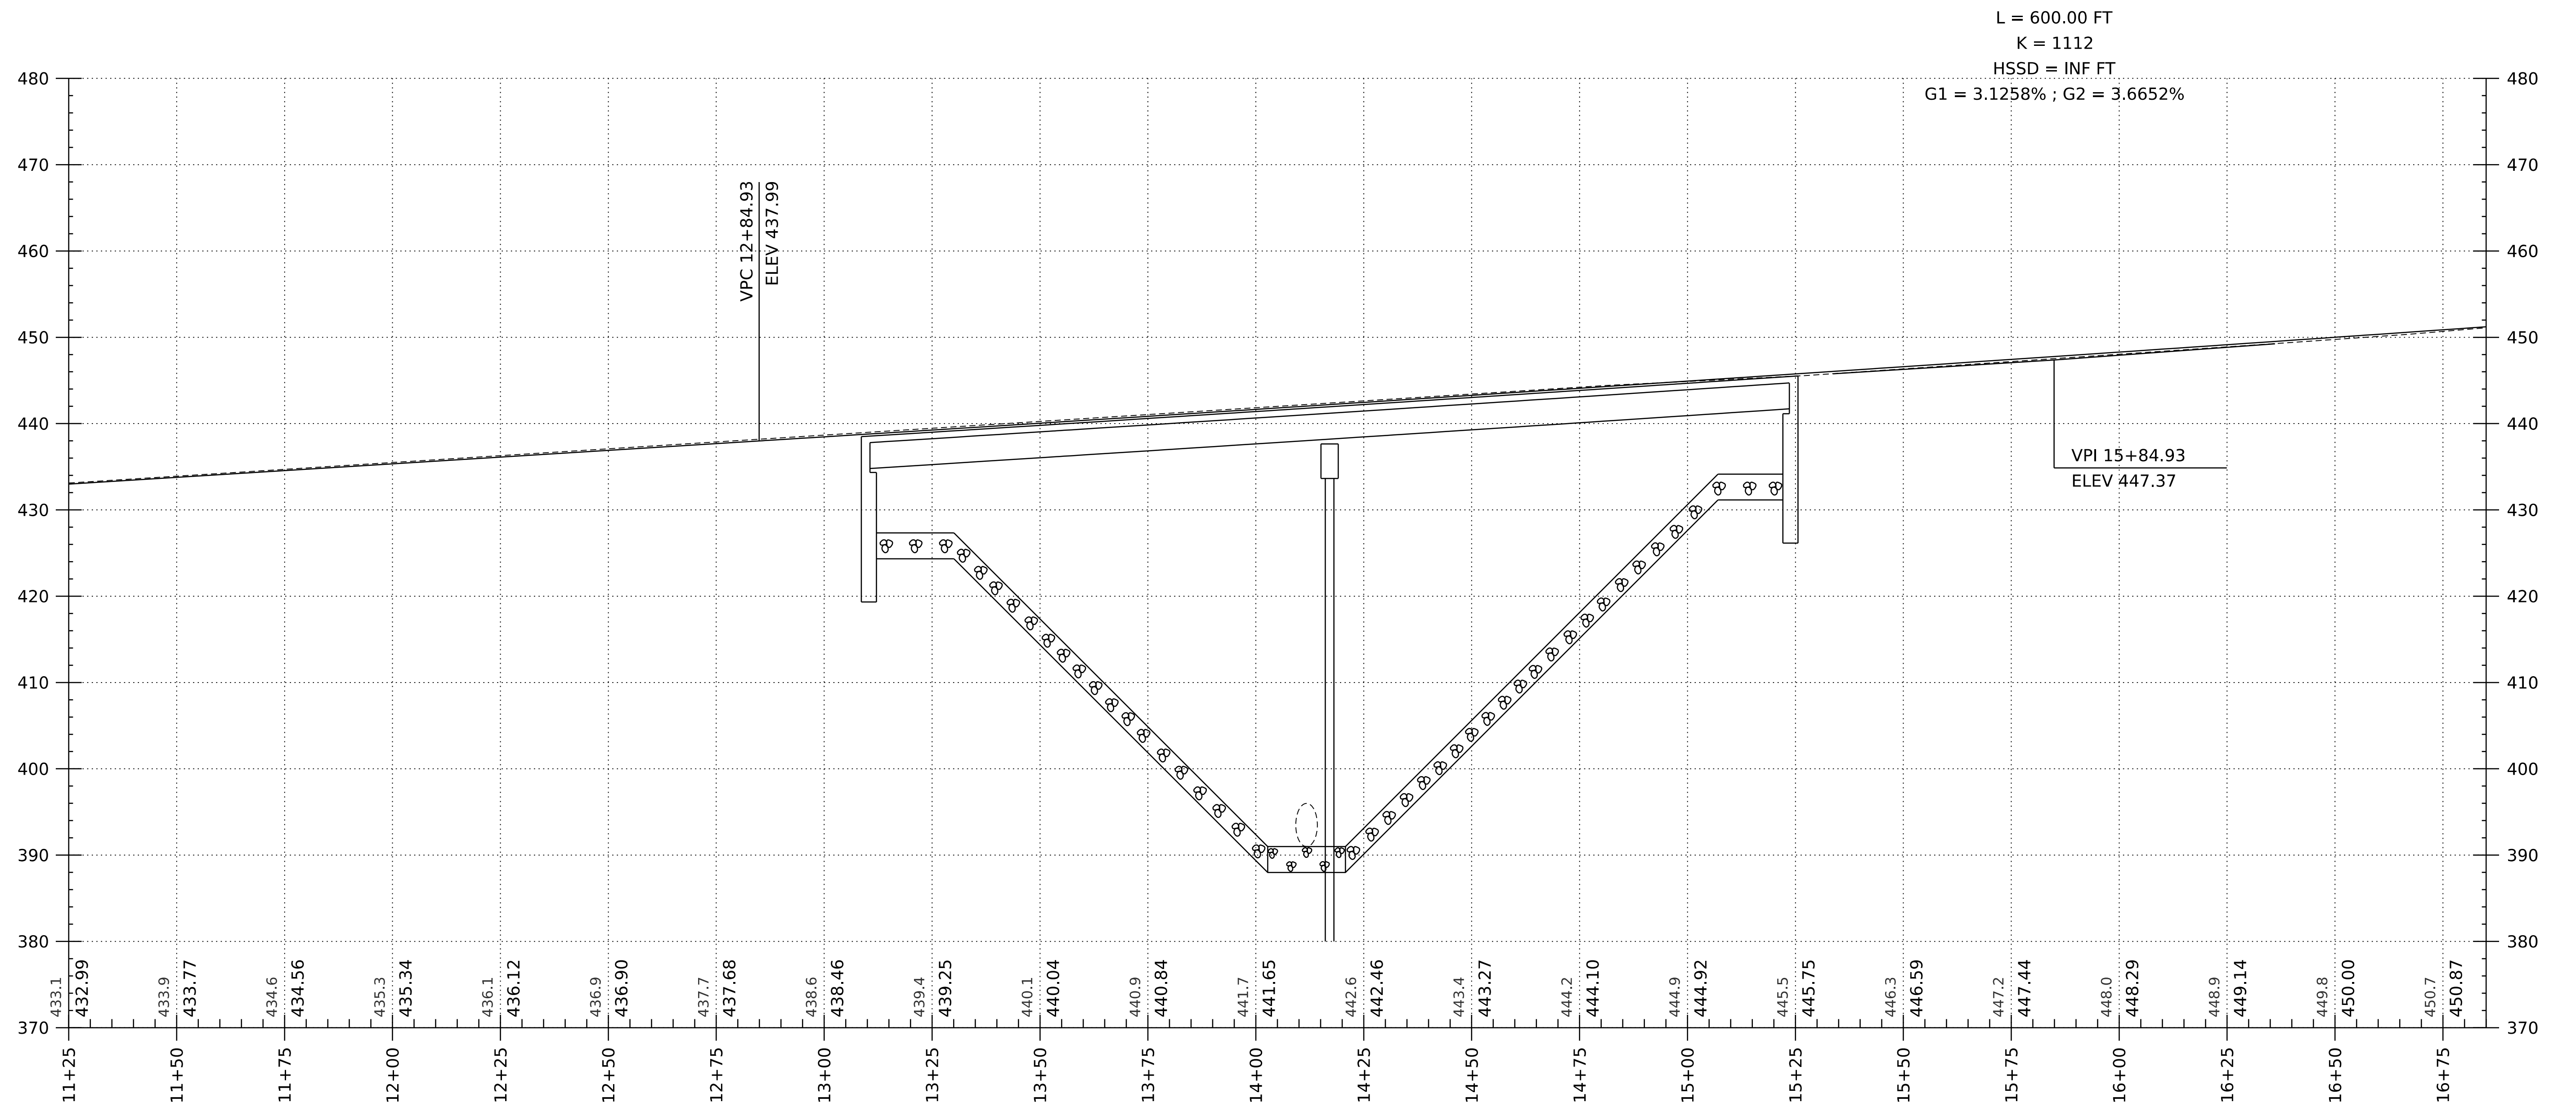
US ROUTE 2 NEW 2-SPAN BRIDGE PROFILE

SCALE: HORIZONTAL 1"=20'-0"
 VERTICAL 1"=10'-0"

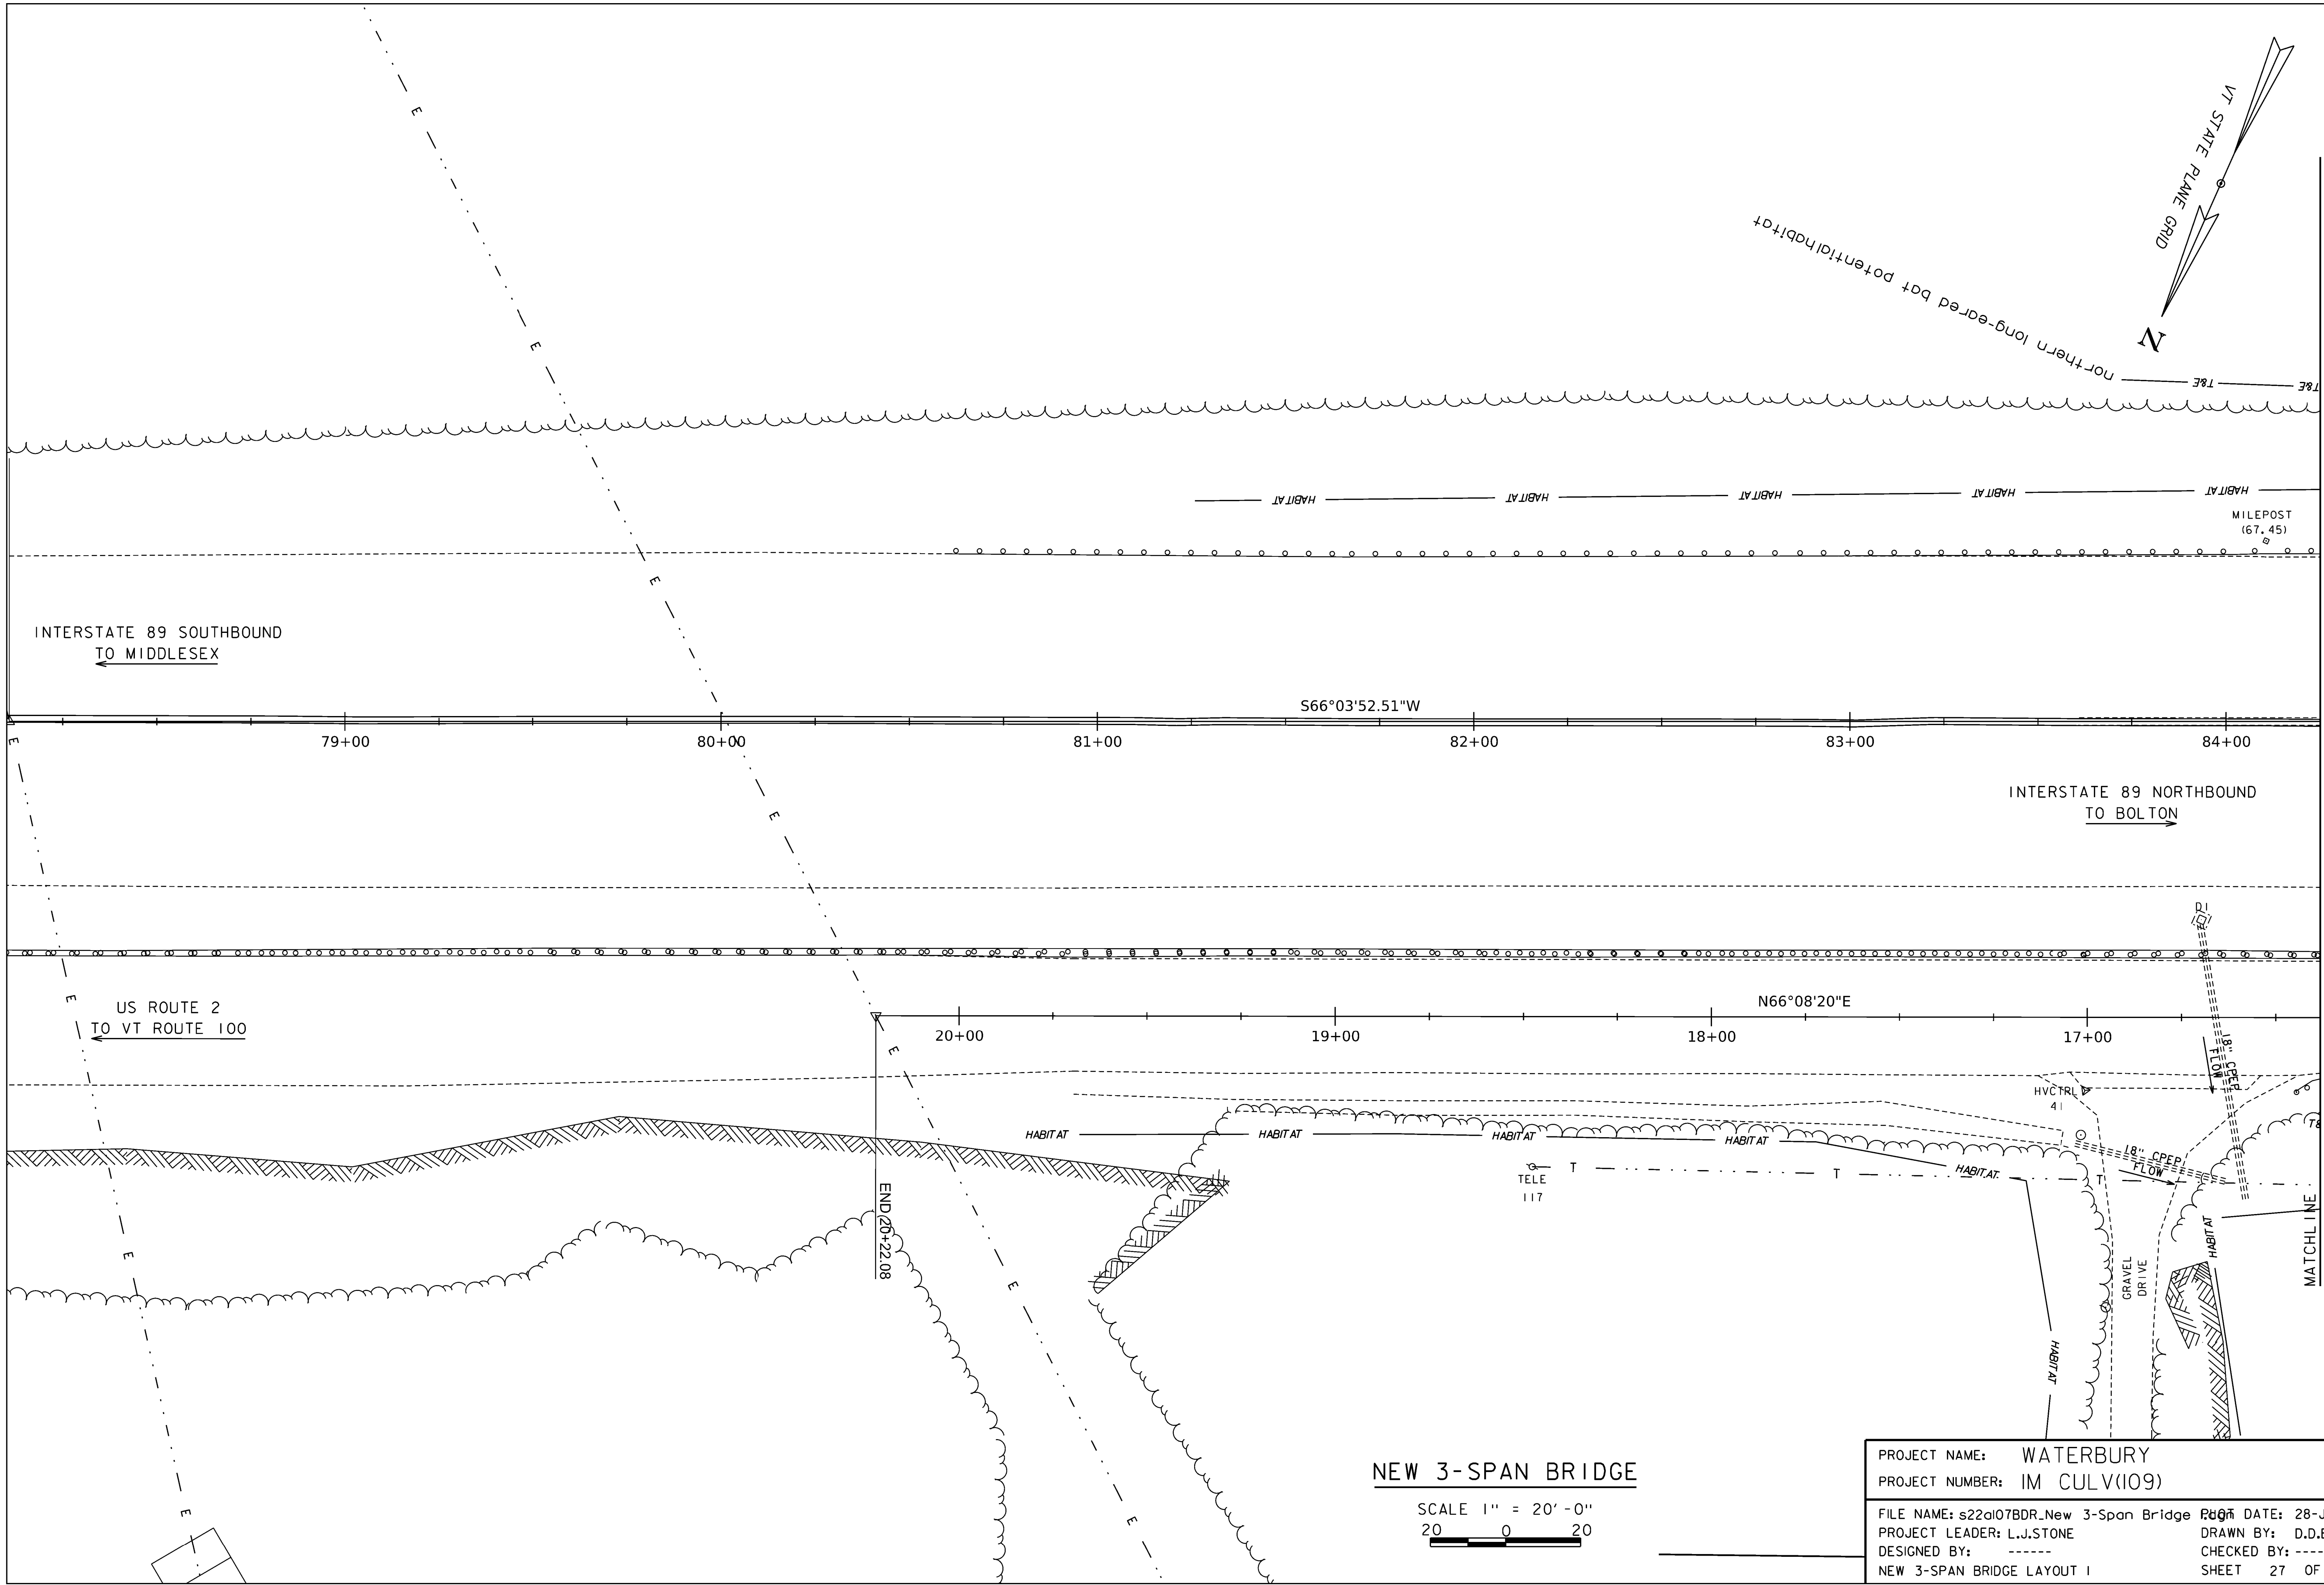
NEW 3-SPAN BRIDGE

SCALE 1" = 20' - 0"
 20 0 20

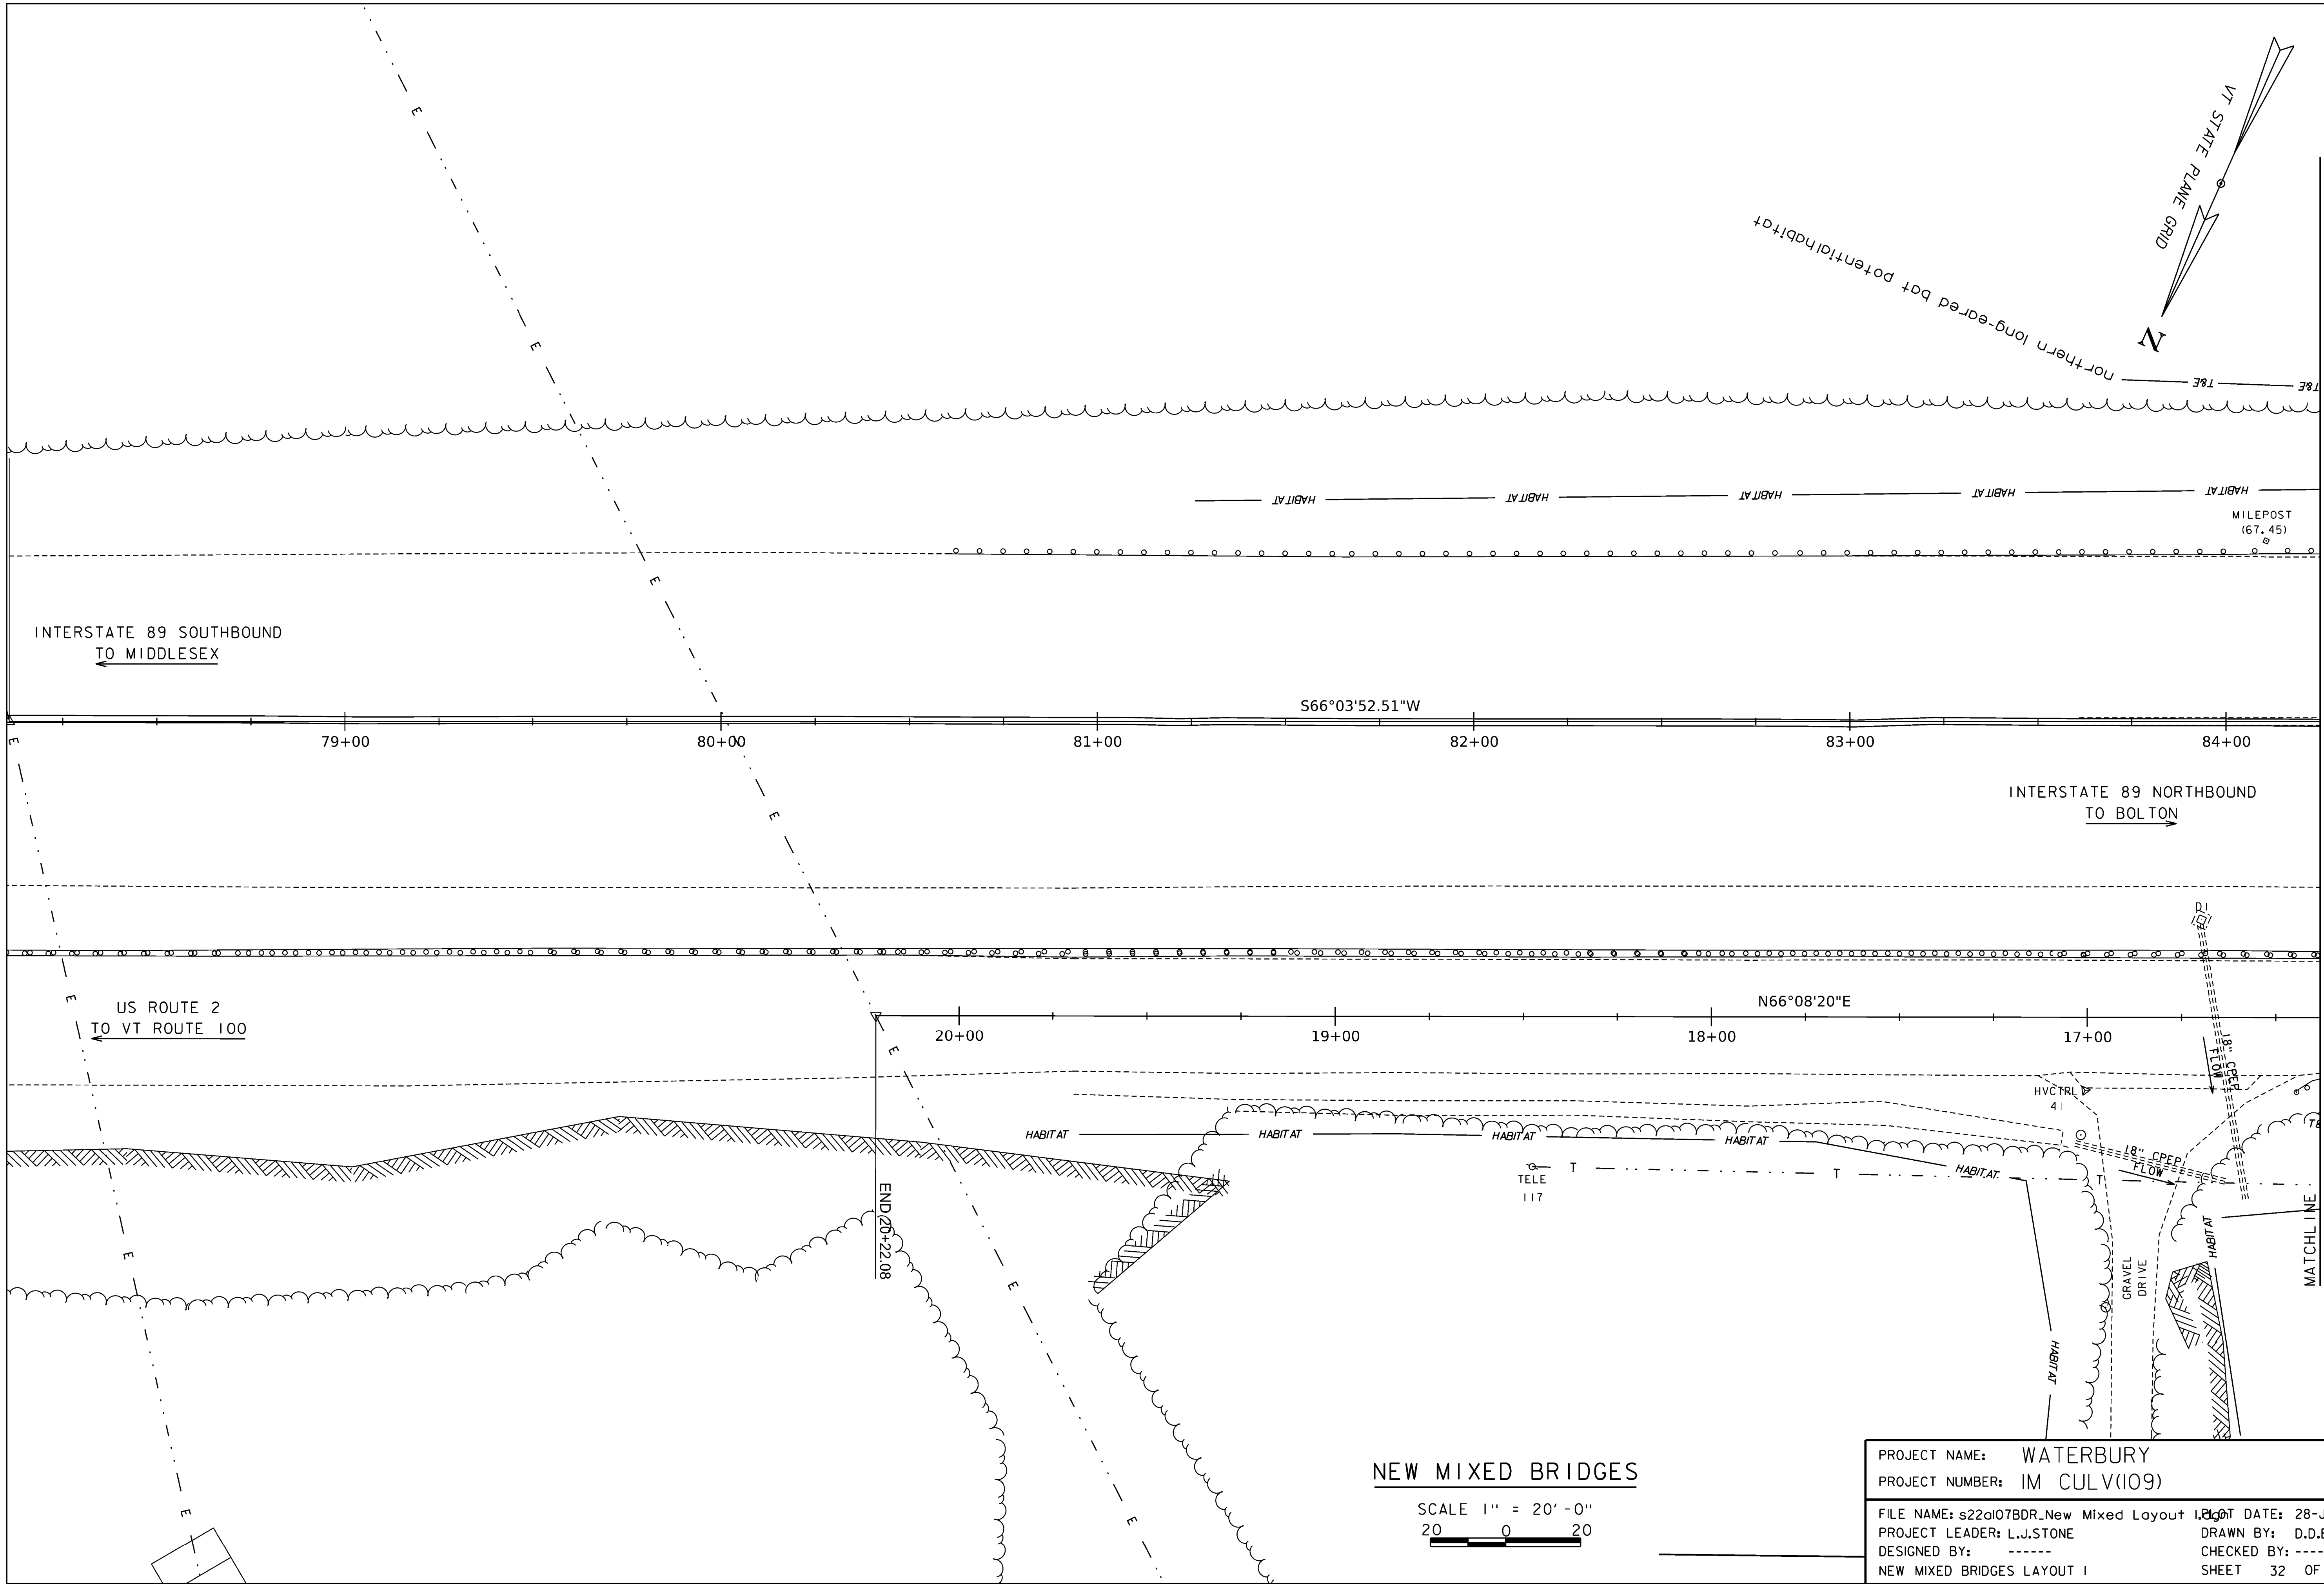
NEW MIXED BRIDGES

SCALE 1" = 20' - 0"
 20 0 20
