**STATE OF VERMONT
AGENCY OF TRANSPORTATION**

Scoping Report

**FOR
WATERBURY IM CULV(109)**

I-89 & US2 PID 68002 OVER SHARKEYVILLE BROOK

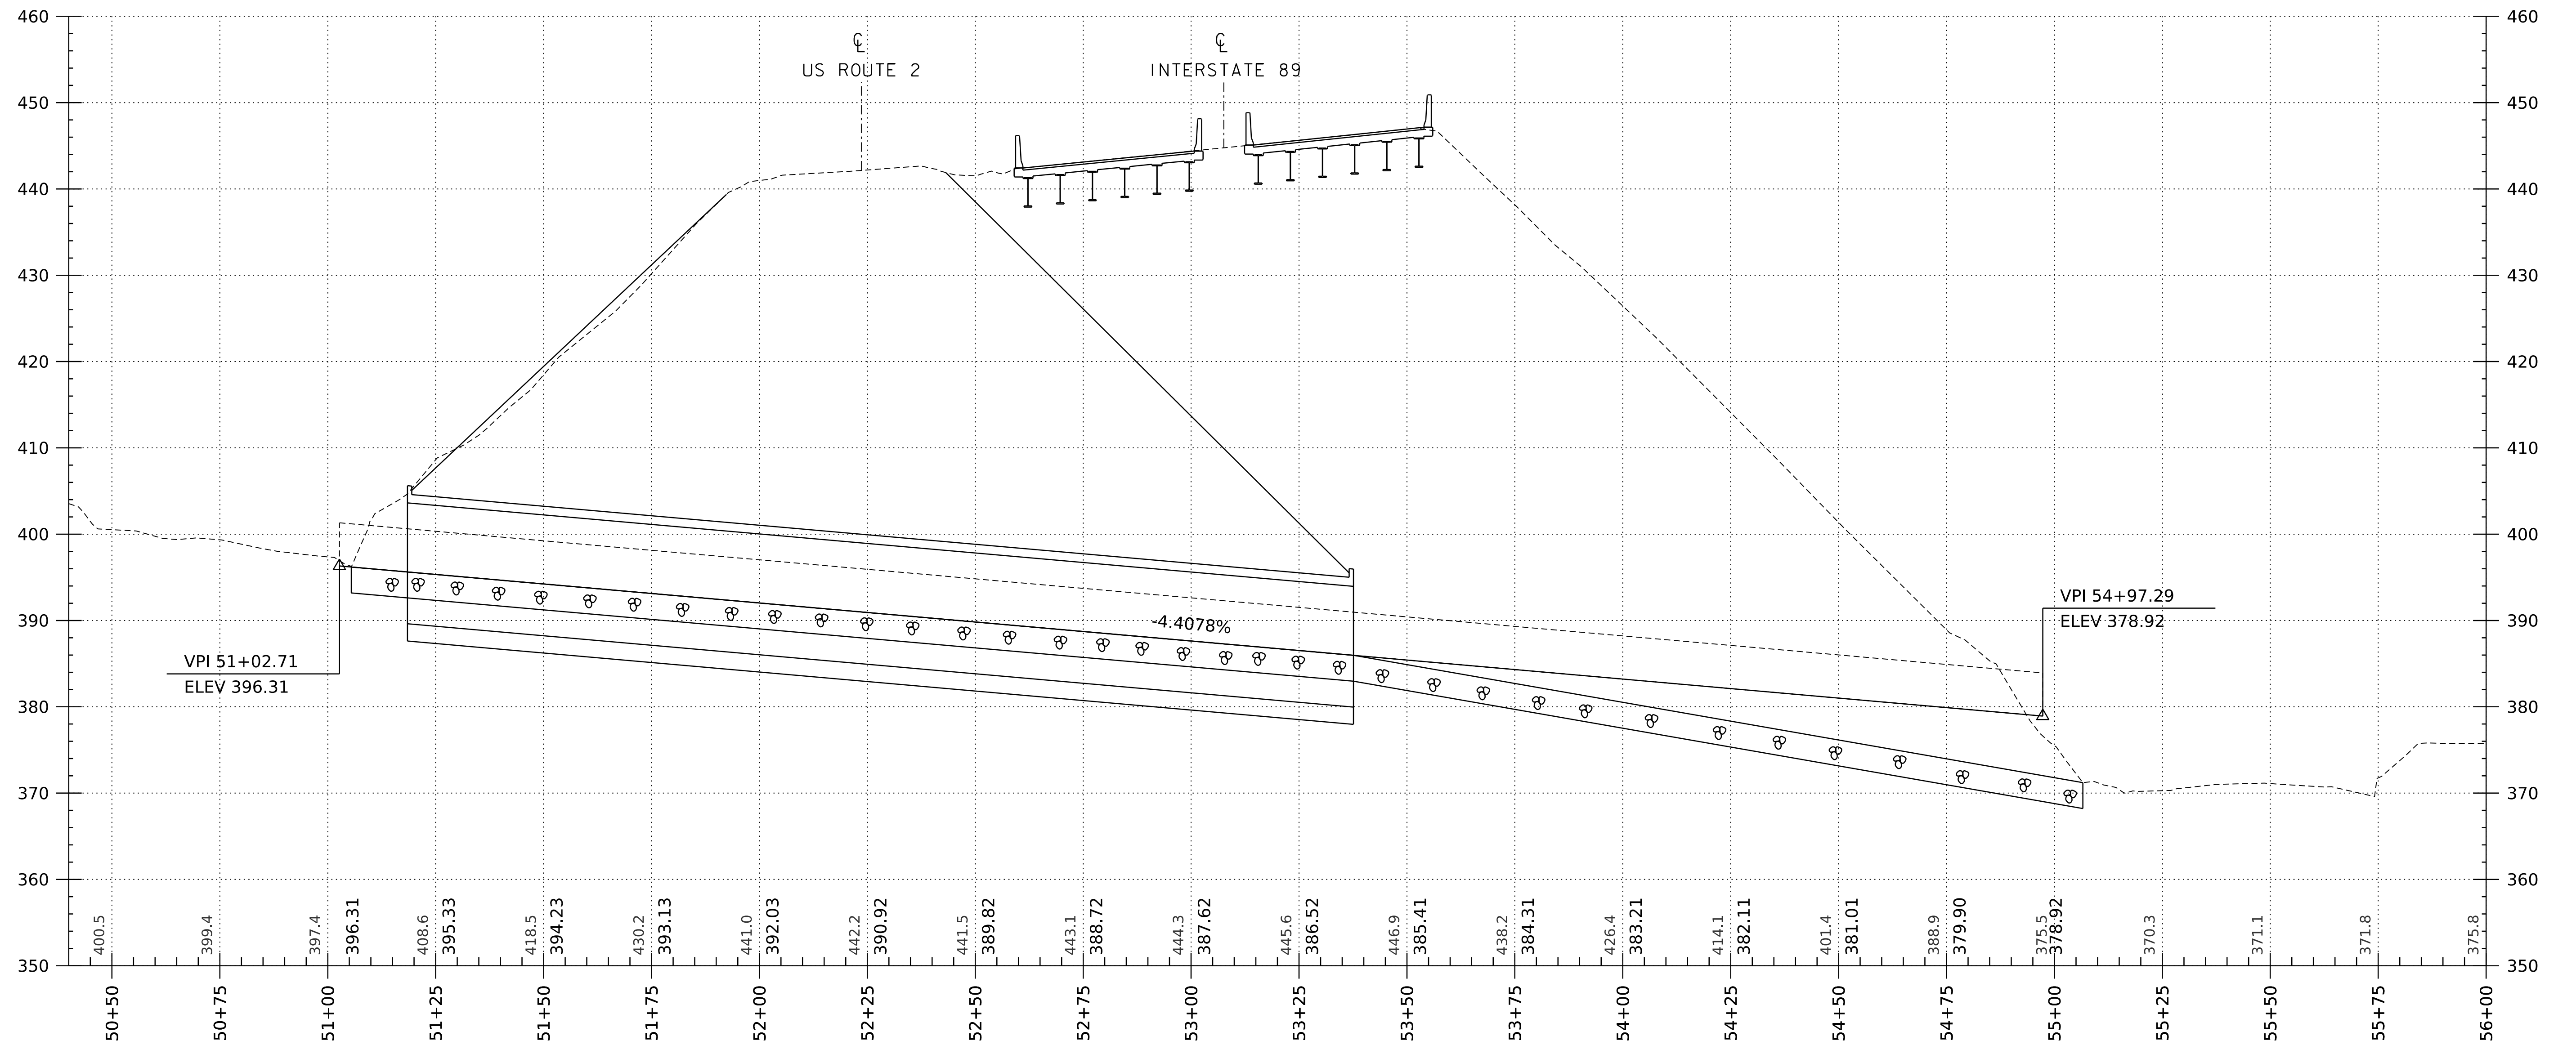
NEW BRIDGES-PIPE ARCH PROFILE

SCALE: HORIZONTAL 1"=20'-0"
 VERTICAL 1"=10'-0"

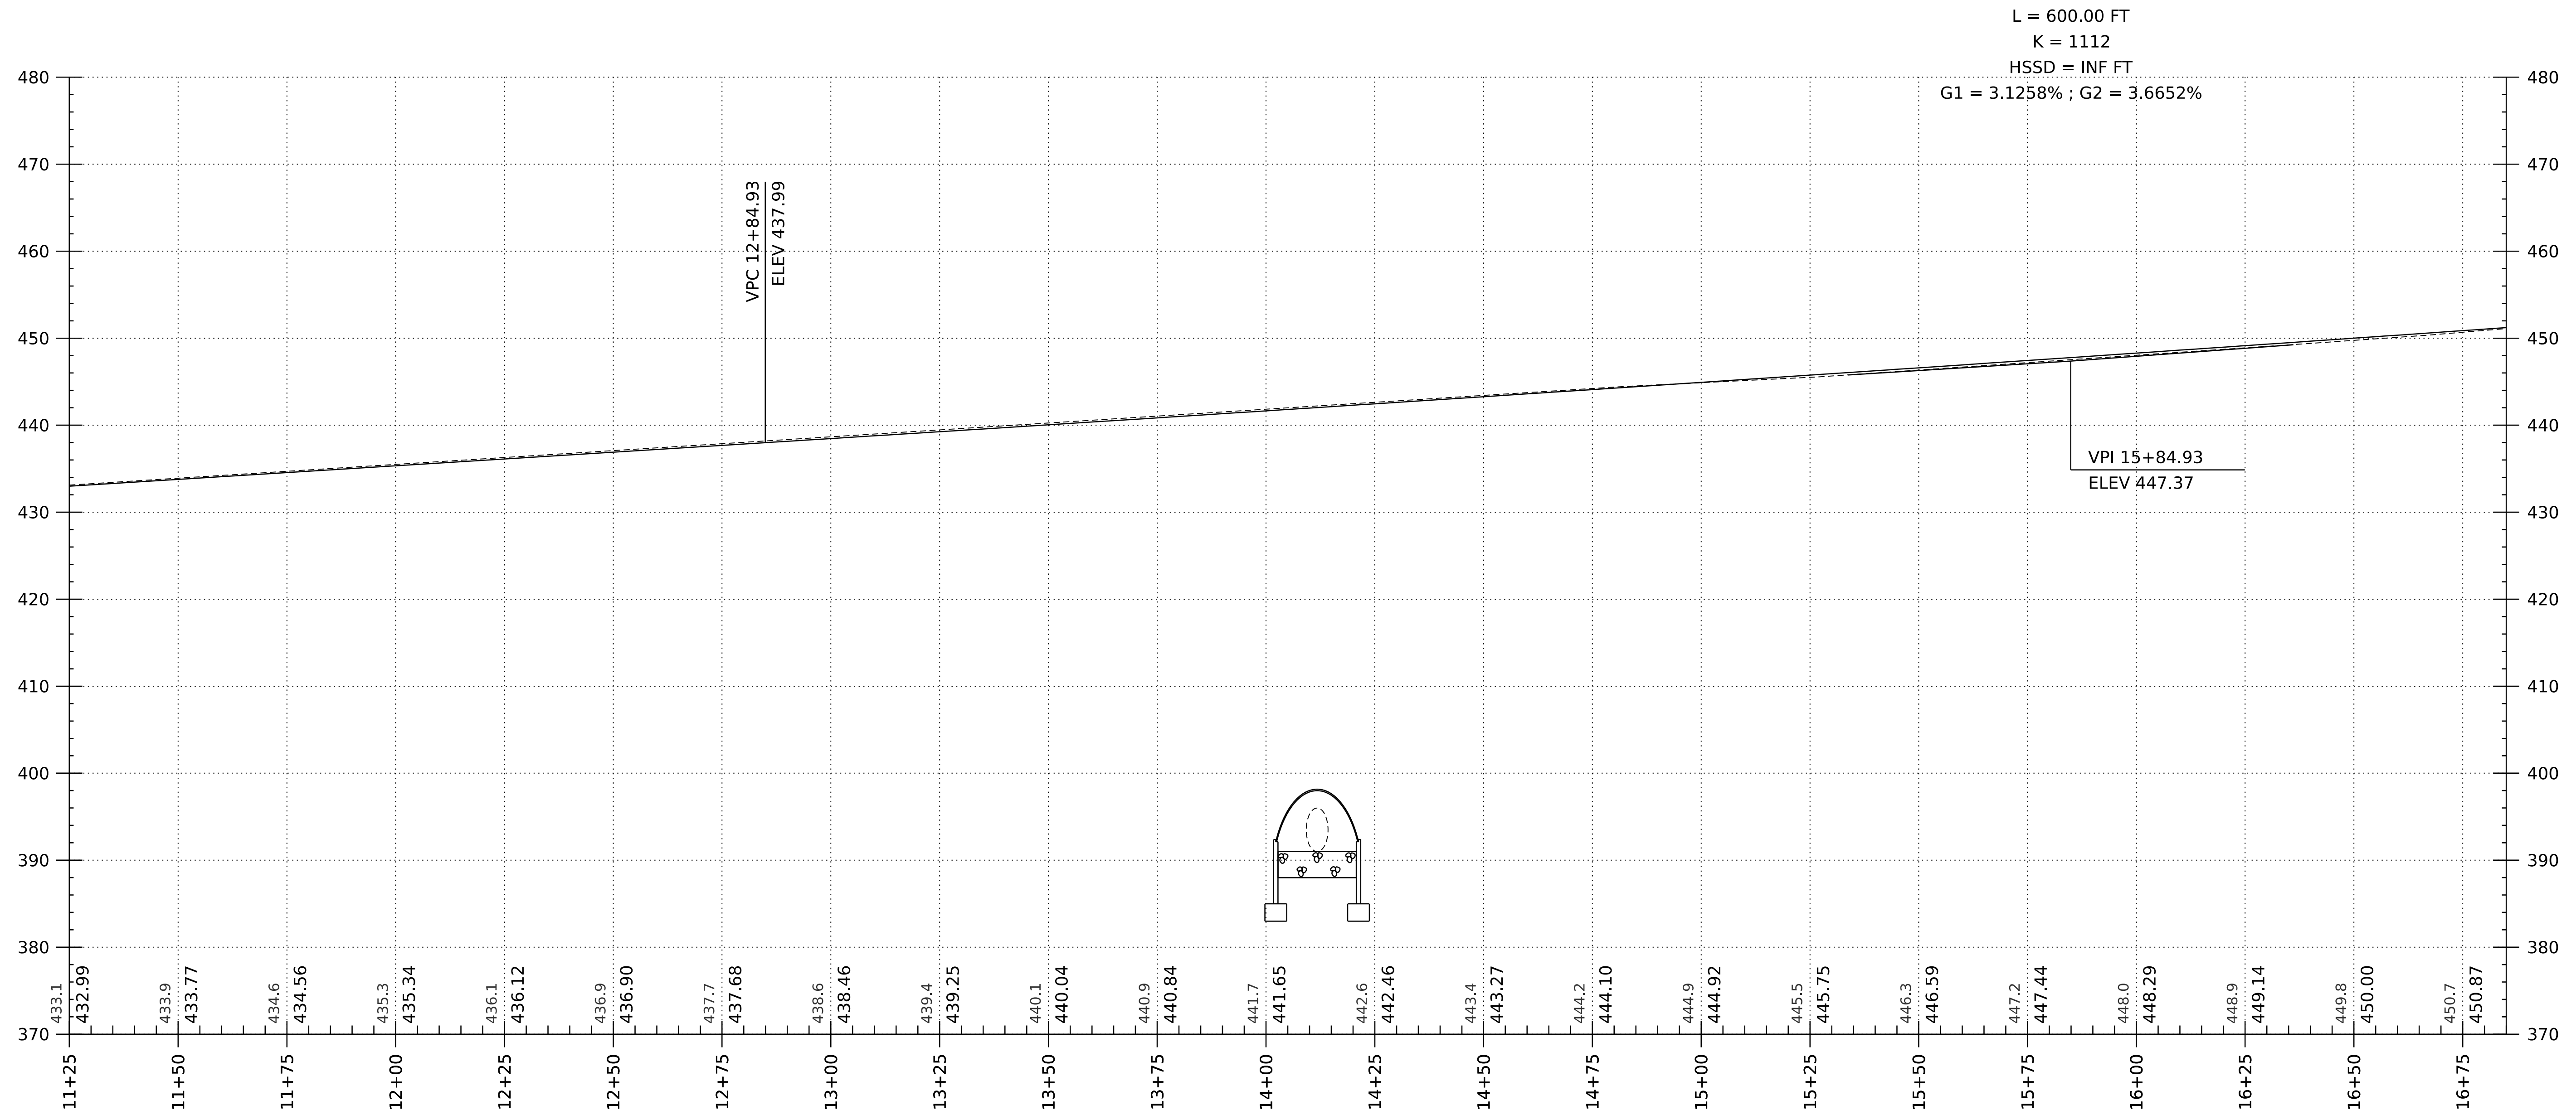
US ROUTE 2 PIPE ARCH PROFILE

SCALE: HORIZONTAL 1"=20'-0"
 VERTICAL 1"=10'-0"

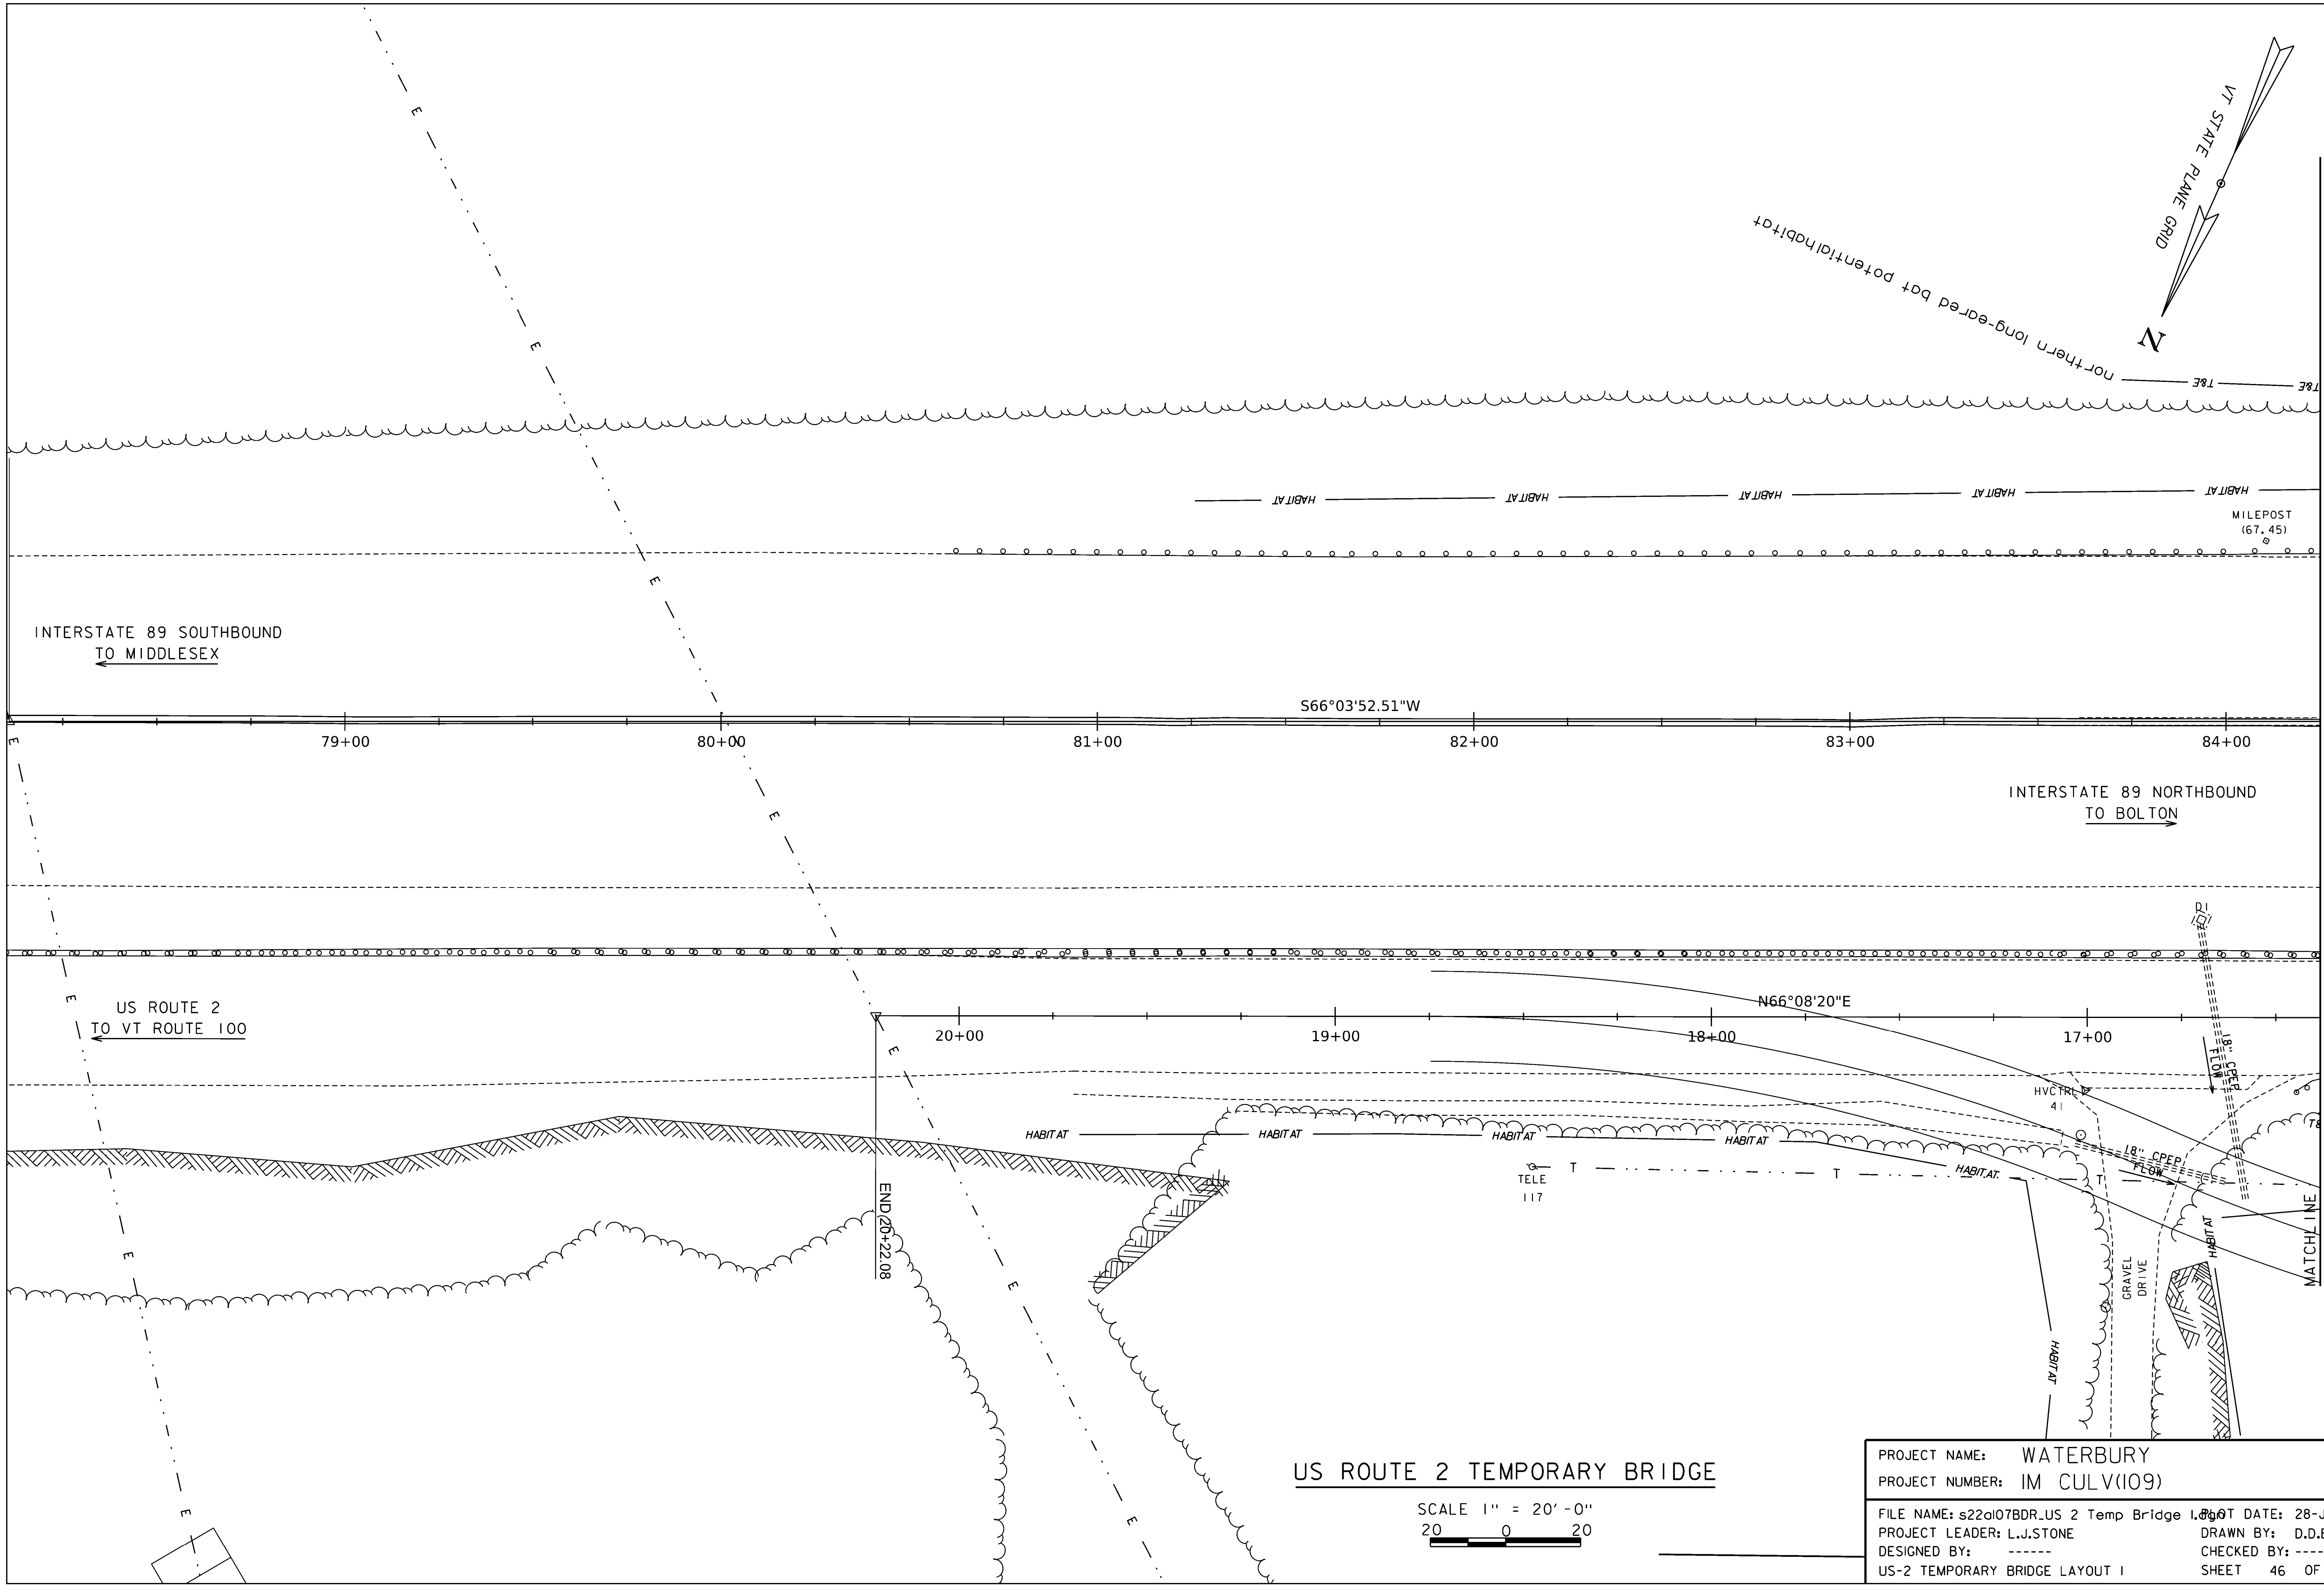
US ROUTE 2 TEMPORARY BRIDGE

SCALE 1" = 20' - 0"
 20 0 20

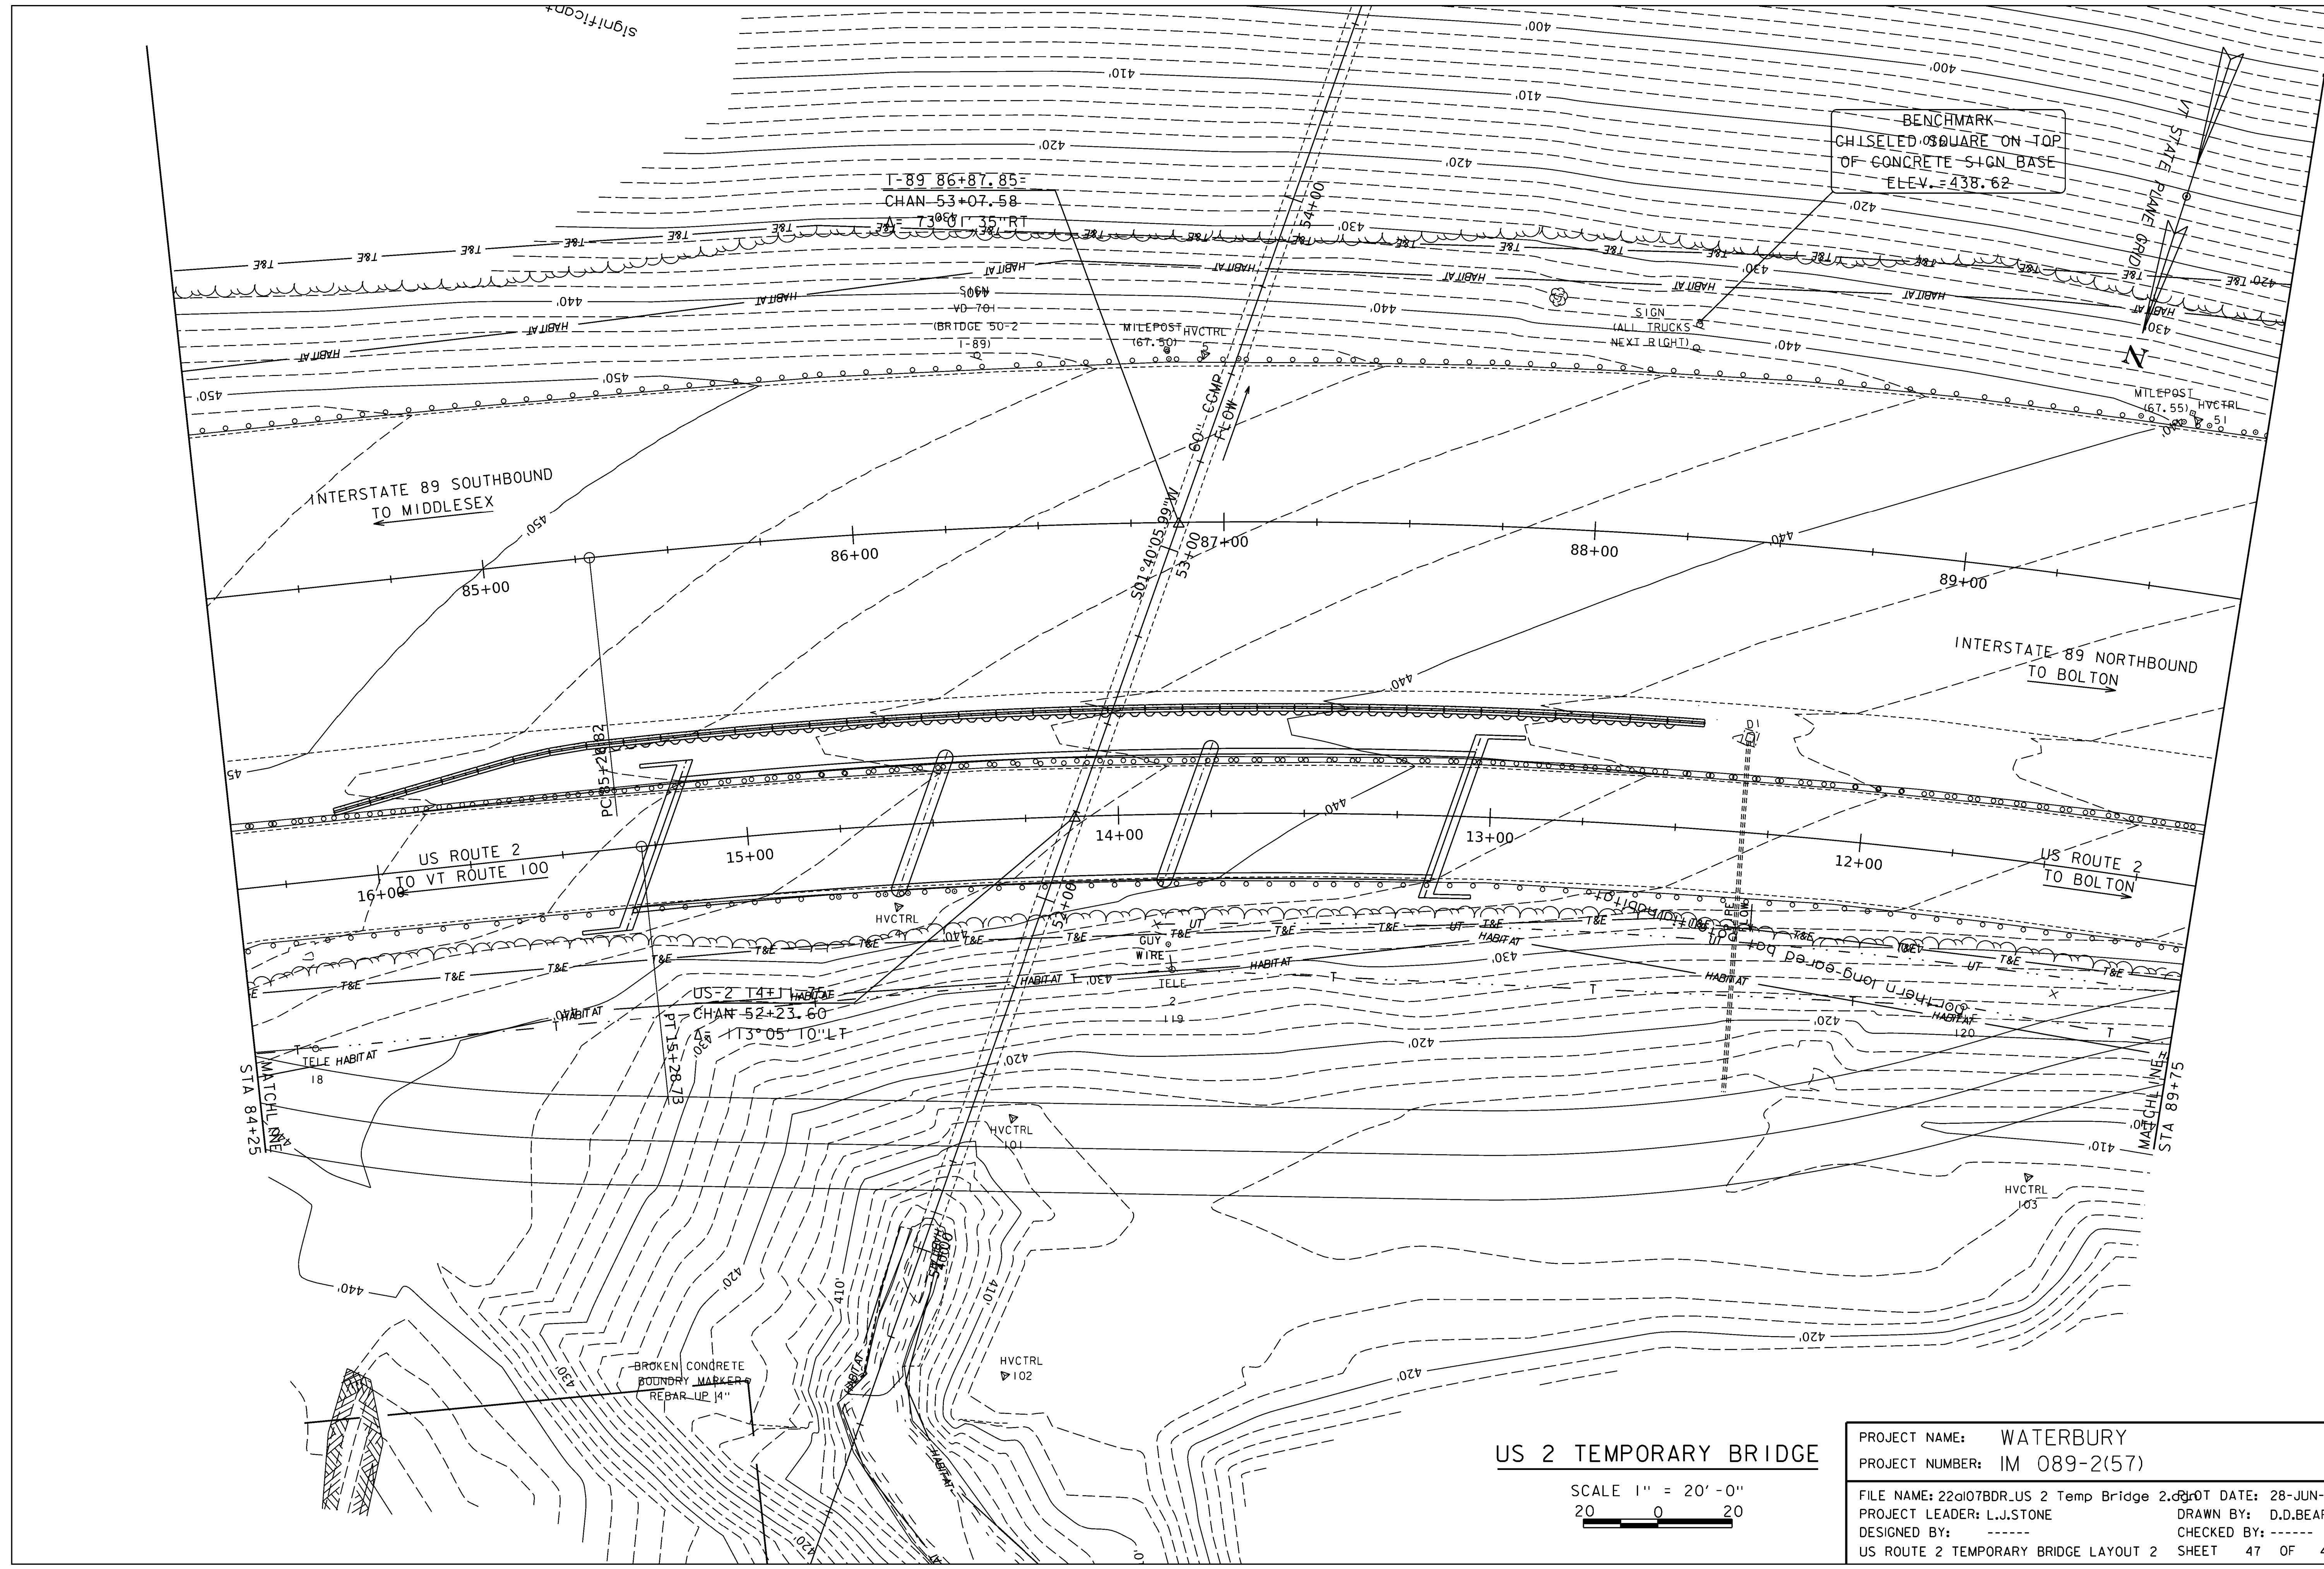
US 2 TEMPORARY BRIDGE

SCALE 1" = 20'-0"
 20 0 20
