STATE OF VERMONT
AGENCY OF TRANSPORTATION

Scoping Report

FOR
WORCESTER BF 0241(56)

VT ROUTE 12, BRIDGE 87 OVER HARDWOOD BROOK

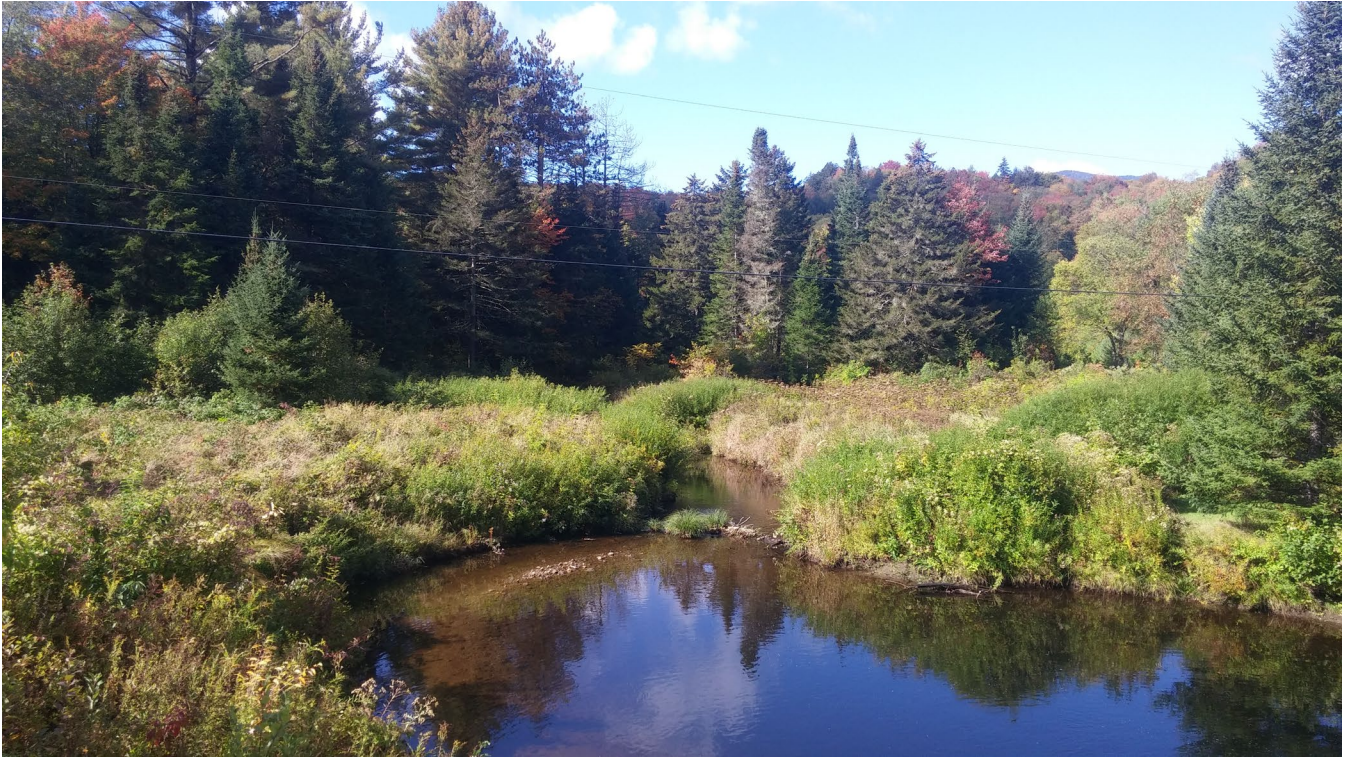
Figure 3: Flooded soils to the west of the culvert
