**STATE OF VERMONT
AGENCY OF TRANSPORTATION**

Scoping Report

Worcester BF 0241(59)

VT Route 12, BRIDGE 84 Over the North Branch of Winooski River

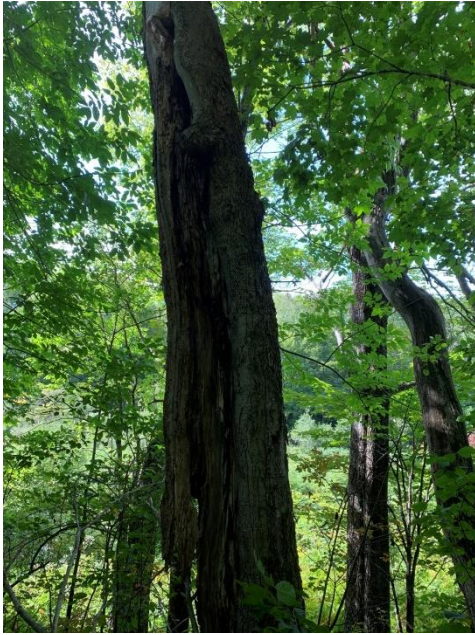
Potential Bat Roost Tree
September 10, 2019

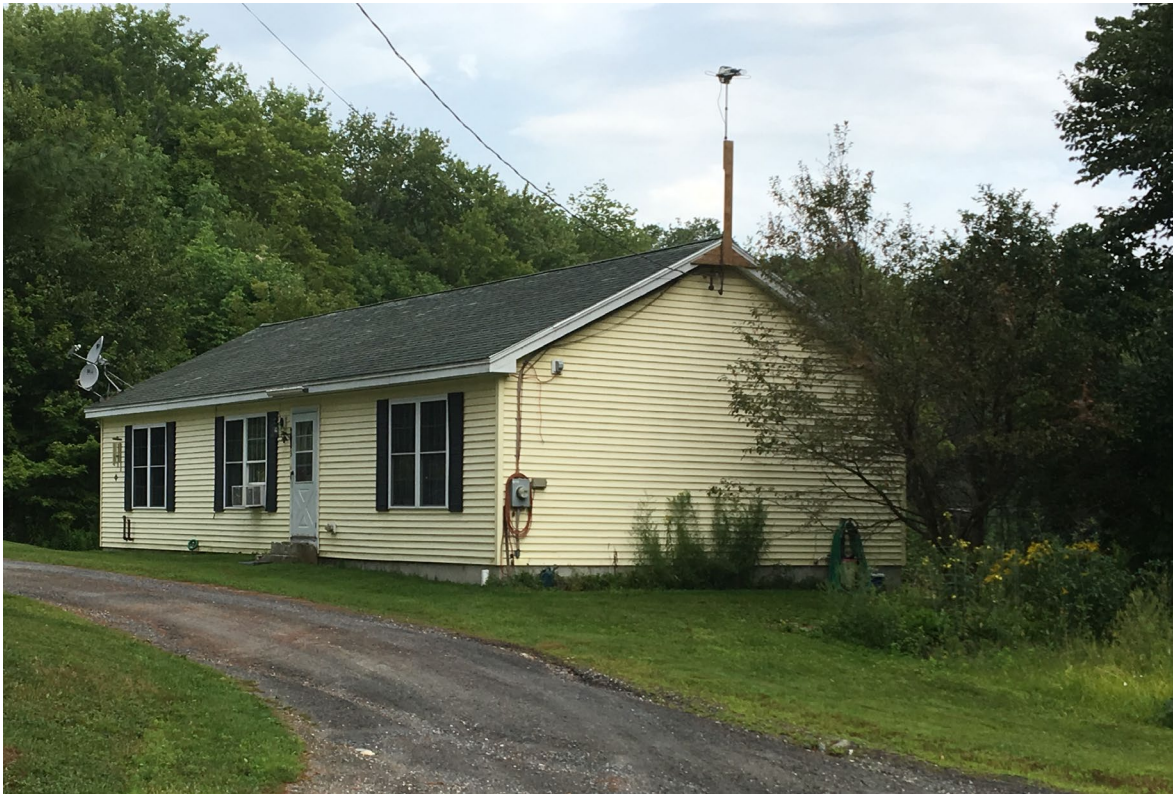
Figure 6: Ineligible resource on Moose Hollow Rd.

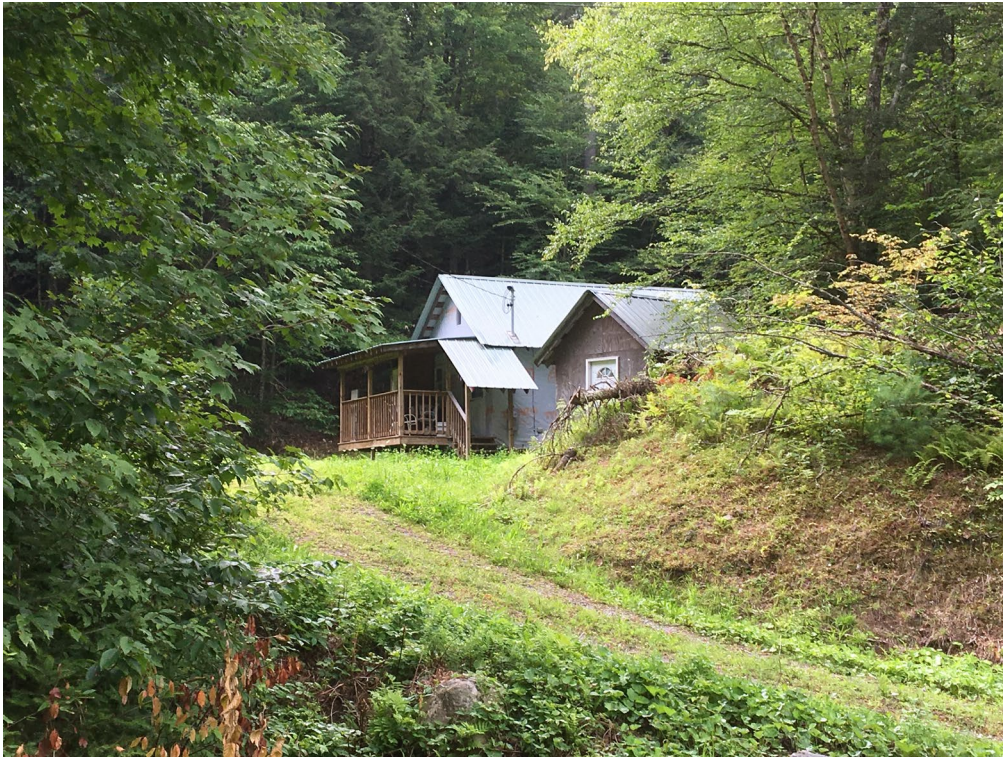
Figure 7: Ineligible resource at 599 VT-12.
